**NEW GOLD RAINY RIVER MINE  
APPENDIX L  
WILDLIFE MORTALITY LOG**

**NEW GOLD RAINY RIVER MINE  
APPENDIX M  
EXCEEDANCE LETTER SUBMITTED  
TO MECP**

**RE:1000L Ferrous Sulfate Spill – SAC Reference #2157-B4ZRSU**

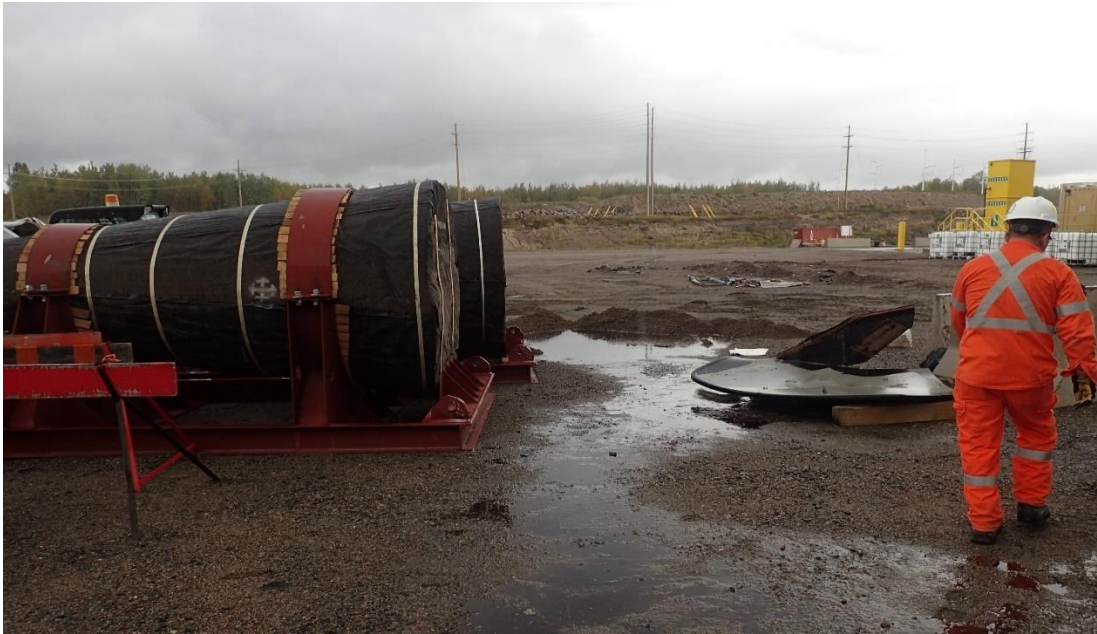
This reagent was new onsite as it is being tested for possible use. The spill was caused by a forklift puncturing a tote containing ferrous sulphate while unloading the tote. (See photo below)

The ferrous sulphate was found immediately after the spill occurred, by the forklift operator.

There was no impact to any water bodies as the spill was discharged in a gravel parking lot and was contained by berms. The spill was caught quickly by the operator and work ceased. The spill was collected by a vac truck and pumped into the tailings management area on site. Also, it is worth noting that during the spill it was raining, and water is a neutralizing agent for ferrous sulphate.

Forklift operations procedures will be reviewed. If ferrous sulphate is used permanently it will be kept in a structure that will help mitigate the risk of any future spill.

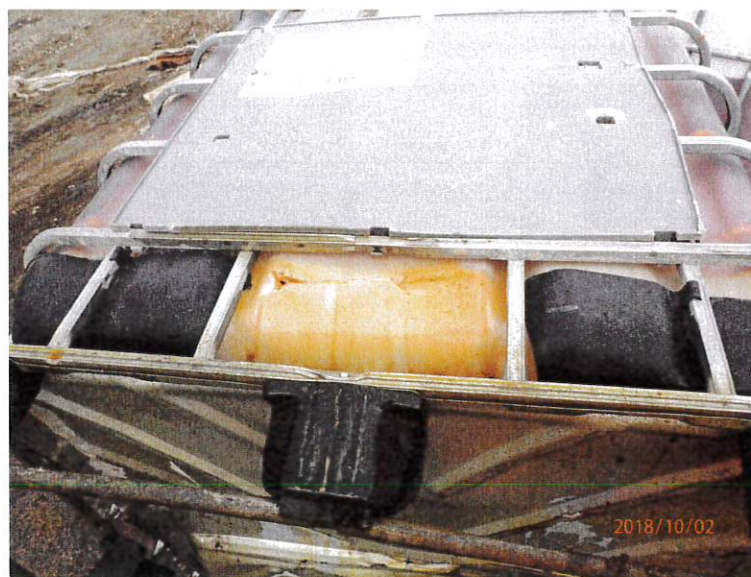
The event occurred within the confines of a Laydown area with no impact to any water bodies. Spill pads were used to soak up the spilled oil and the affected ground was scraped up and placed into a contaminated soil bin, with final disposal by contracted hazardous waste management company, Green For Life (GFL).

*Figure 1 shows Telehandler puncture in the tote of gear oil.*

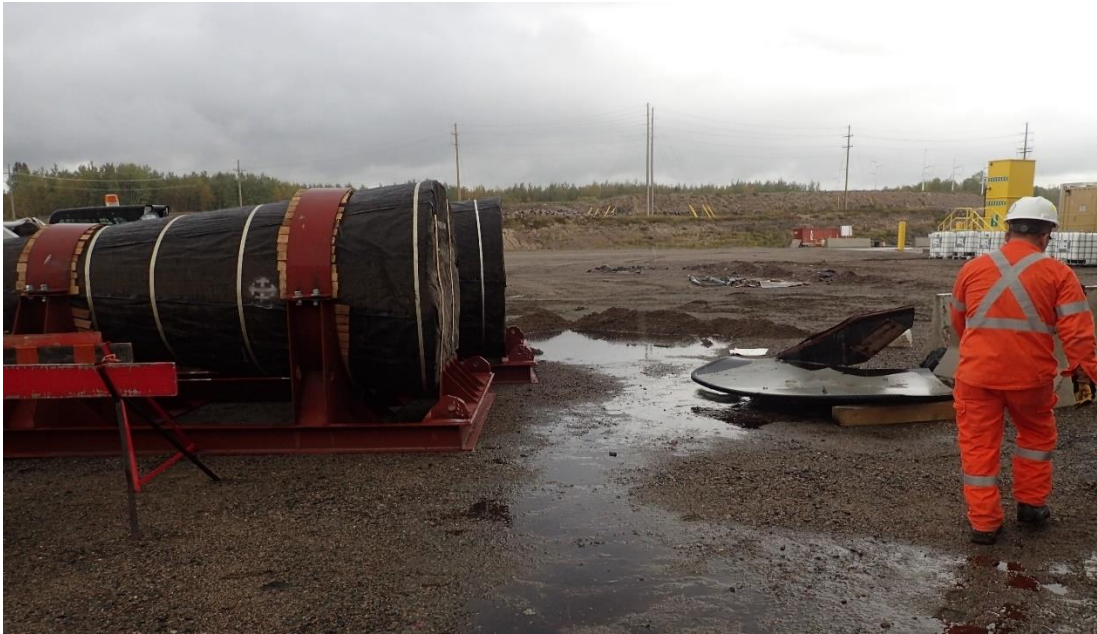
This reagent was new onsite as it is being tested for possible use. The spill was caused by a forklift puncturing a tote containing ferrous sulphate while unloading the tote. (See photo below)

The ferrous sulphate was found immediately after the spill occurred, by the forklift operator.

There was no impact to any water bodies as the spill was discharged in a gravel parking lot and was contained by berms. The spill was caught quickly by the operator and work ceased. The spill was collected by a vac truck and pumped into the tailings management area on site. Also, it is worth noting that during the spill it was raining, and water is a neutralizing agent for ferrous sulphate.

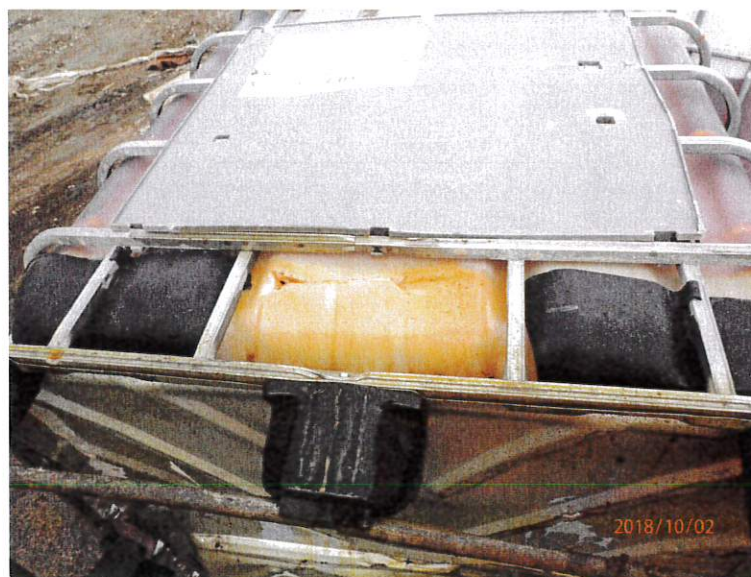
The event occurred within the confines of a Laydown area with no impact to any water bodies. Spill pads were used to soak up the spilled oil and the affected ground was scraped up and placed into a contaminated soil bin, with final disposal by contracted hazardous waste management company, Green For Life (GFL).

*Figure 1 shows Telehandler puncture in the tote of gear oil.*

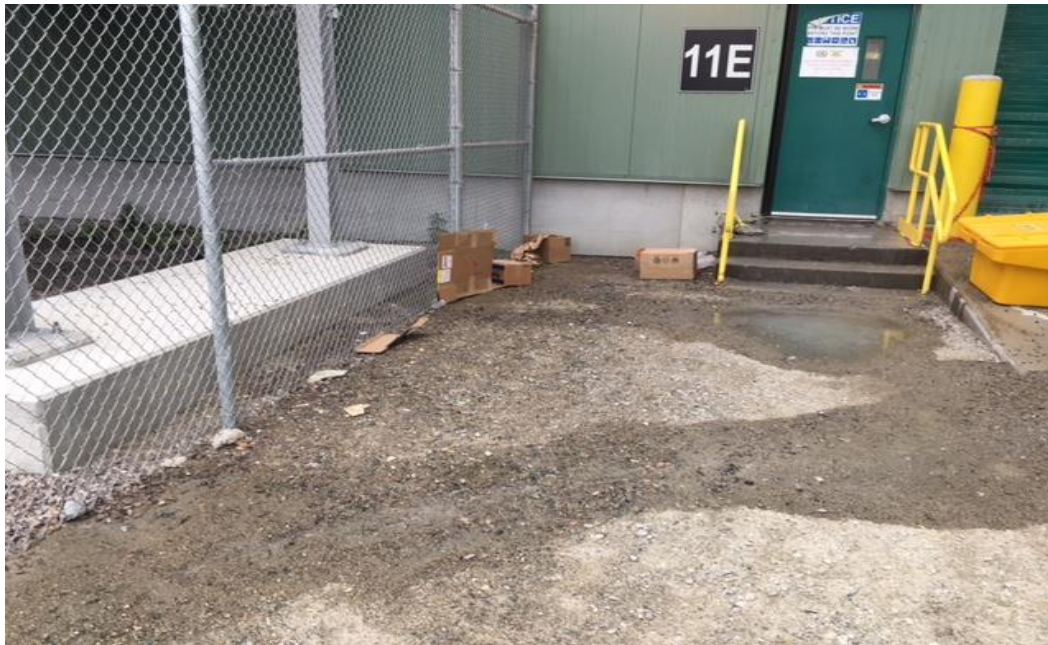
On August 31<sup>st</sup> at approximately 1200, process water was found to be backing up into the Millwright shop from the mill floor. This water was found to have escaped the man door of the Millwright shop and made contact with the ground outside the mill. (See photo below)

The mill was in upset conditions which caused a great deal of process slurry to settle in the works. When the mill was restarted various filter screens, cyclones and sumps were clogged and overtopped onto the mill floor. The process water separated from the slurry and backed up into the Millwright shop then spilled out door 11E. There was no impact to any water body as the process water only migrated about 5 meters outside the door resulting in 20L exiting the mill. This spill was caught quickly by the operators and work ceased. The gravel containing the process water was placed inside the mill and returned into the process, this was completed by the end of the day shift.

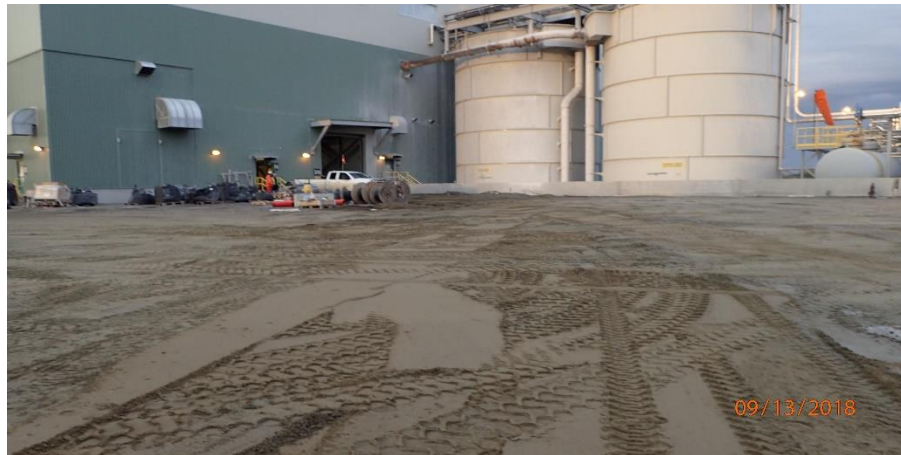
On September 13th at approximately 1215 am, tailings was found to be exiting door 3N from the tailings sump pump box and migrated 55 meters to the northeast. See photo below (clean-up was well underway at time of photo)

The cause of this event was a combination of power failures along with process software updates which caused upset conditions in the mill, resulting in failed alarms and pumps operating incorrectly. An internal investigation is on-going.

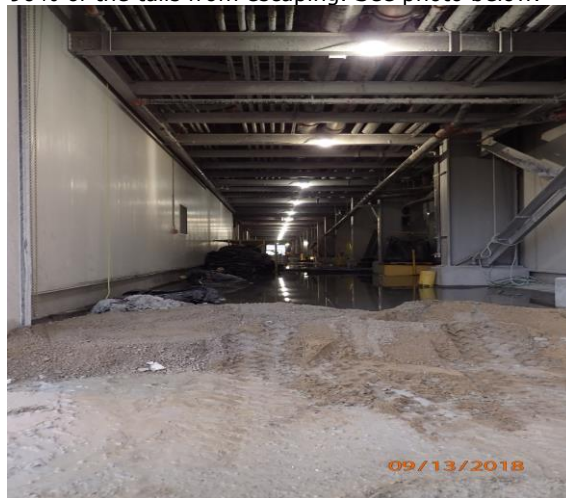
The spill only lasted a few minutes and quick action by the operators placing sand over the existing berm (speed bump) in front of door 3N stopped 80-90% of the tails from escaping. See photo below.

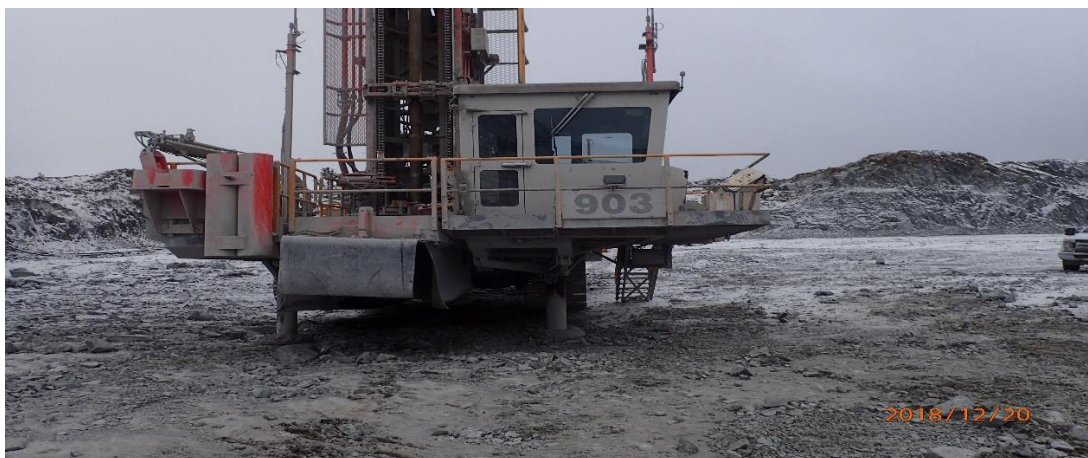
Photo 2: Drill 903

The operator called maintenance for assistance and dismounted to look for a leak. He discovered that he had backed over a large rock and punctured the fuel tank, he then moved the drill off the rock and tilted the drill back to mitigate further spillage (as can be seen in photo 2 above).

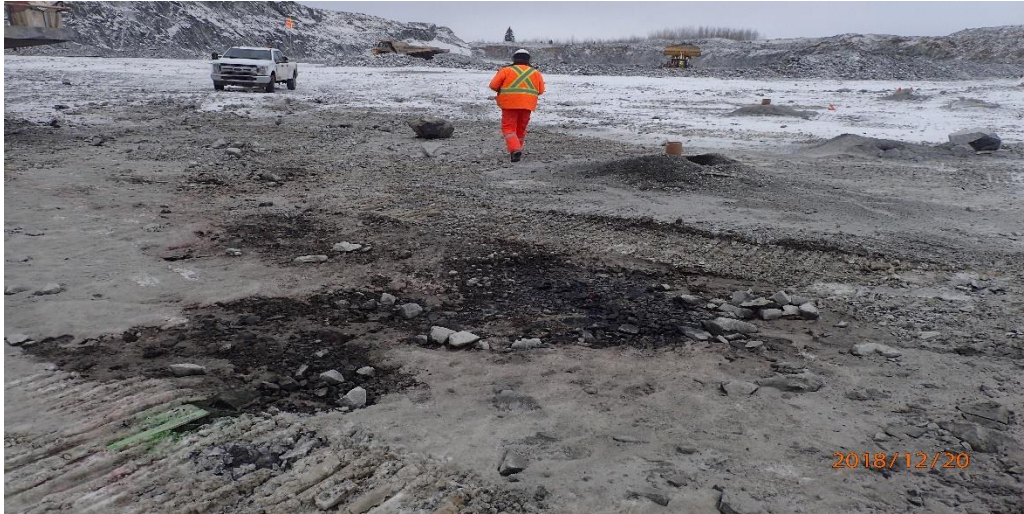
At surface, the spill did not appear to be significant but upon further inspection it was noticed that a large amount of fuel had seeped into the shattered rock (see photos 3 and 4 below). Three drill holes were found to be contaminated with dyed diesel.

Photo 3: Spill site

If the rock is found to be contaminated, it will be sent through the mill as a treatment. If the rock is found to be clean, it will be used onsite to build required infrastructure.

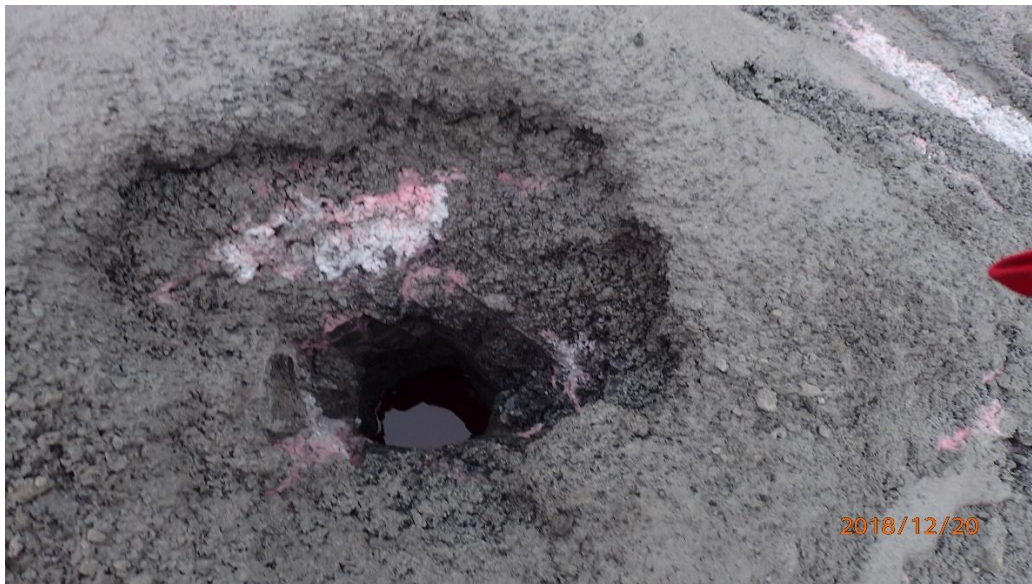
Photo 4: Drill hole

By mid-day a vacuum truck had collected as much fuel as possible from the drill holes and placed it in used oil totes for pick up by Green For Life, a licensed hazardous waste disposal company.

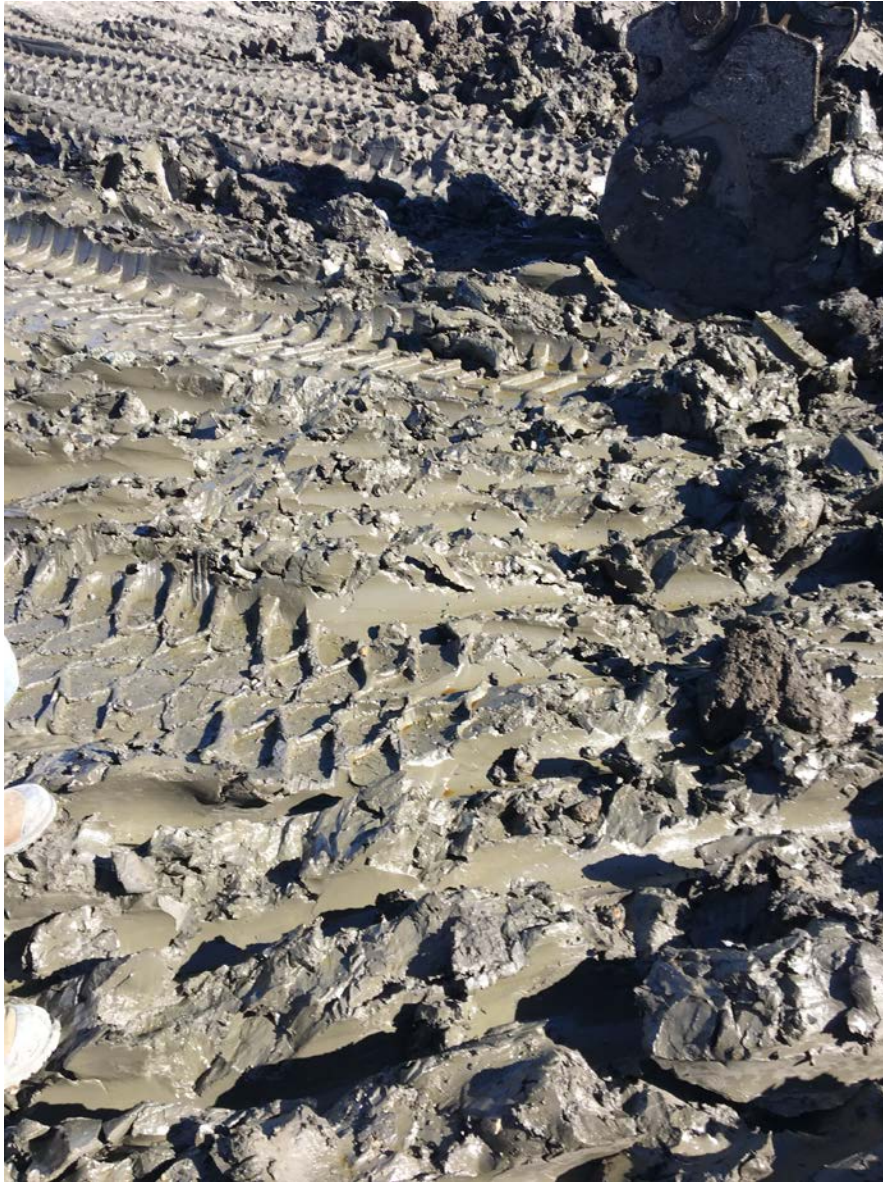
Photo 1 – Clay affected by hydraulic line failure

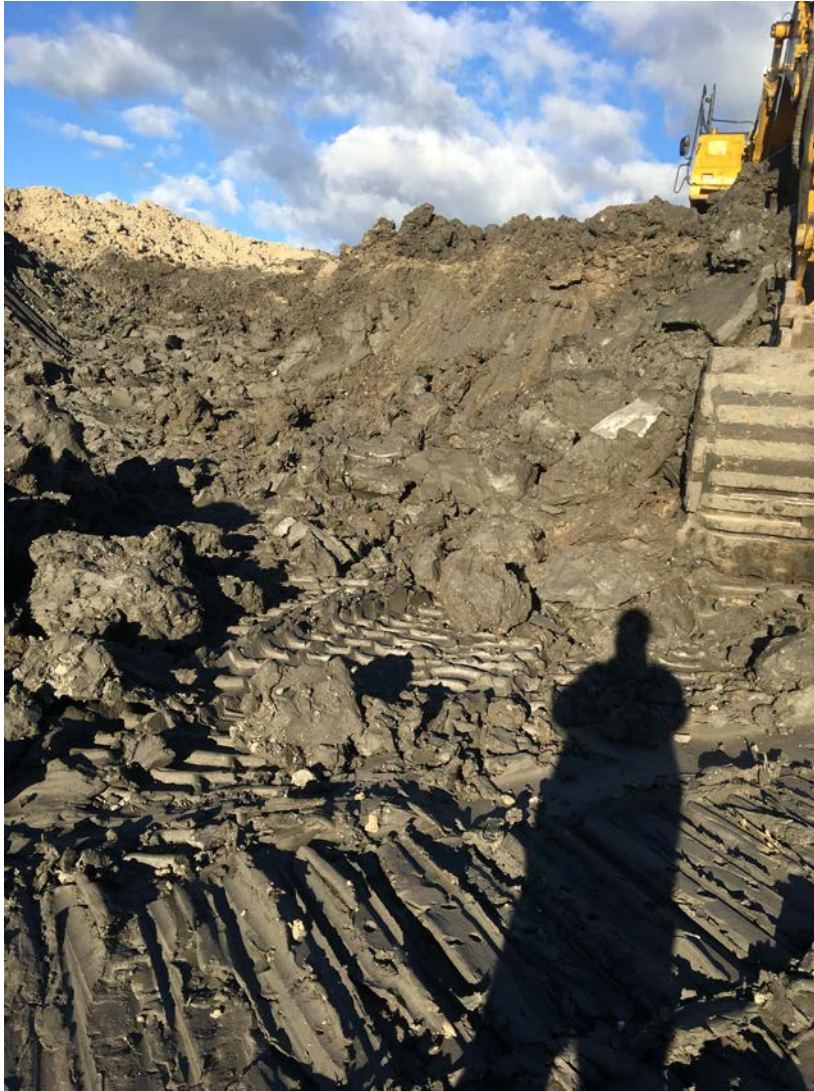
Photo 2 – Spill location after removal of affected clay

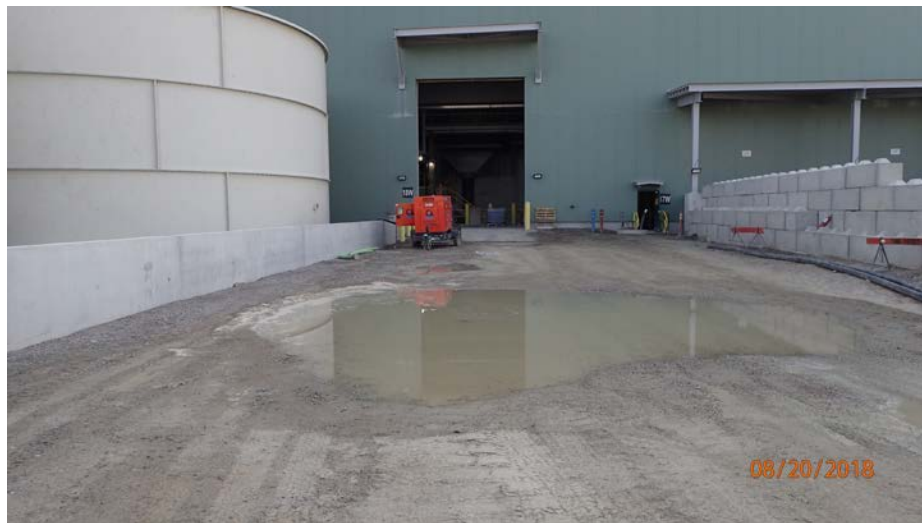
During the early morning hours on August 20, while checking a pump and hose line into the secondary containment area around the thickener and leach tanks, a mill employee discovered the line laying on the ground and process water flowing into the truck alleyway in front of Door 18W (Photo 1). Mill Door 18W is located on the west side of the process building, adjacent to the thickener and leach tank secondary containment area.

Photo 1. Extent of process water spill into truck alleyway of Door 18W.

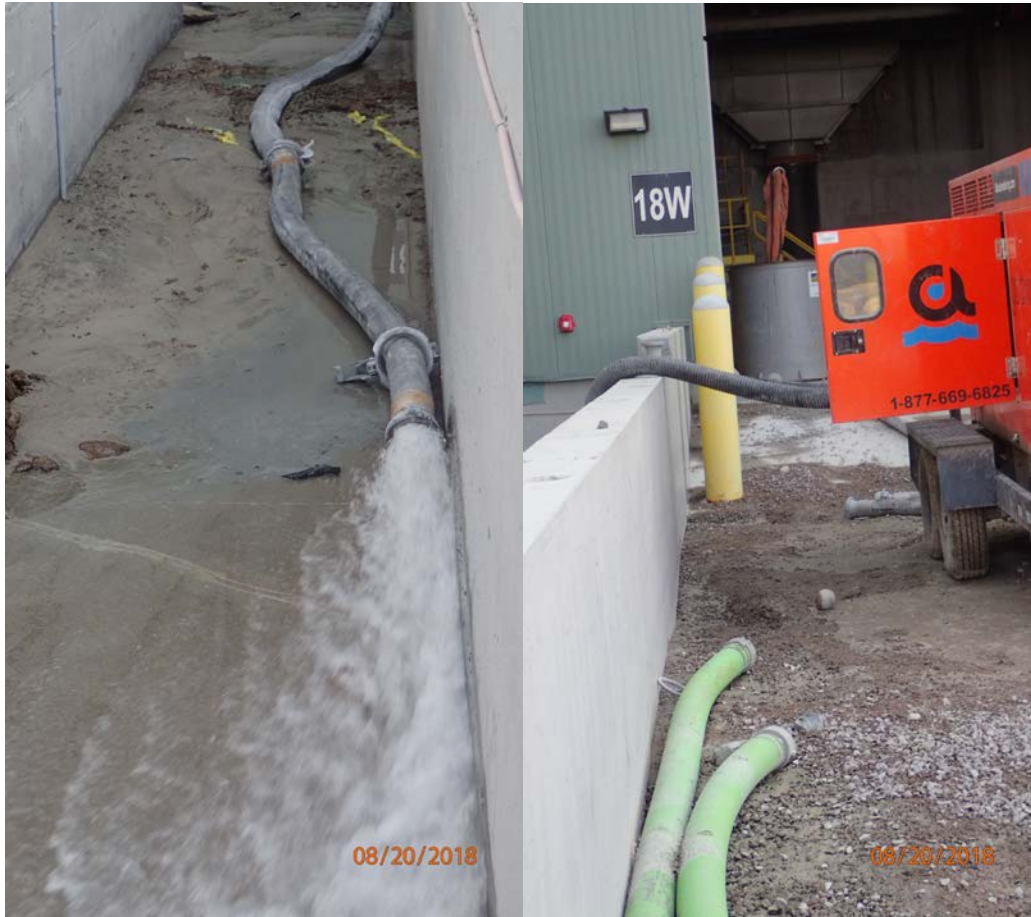
At that time of the event, it was observed that the green hose line connected to the pump and positioned over the wall into the containment area was too short. When the pump surged, the force knocked the line back over the wall and onto the ground surface. The green hose line was replaced with a longer black hose line which reached onto the containment area floor (Photo 3).

Photo 3. Black replacement hose on floor of containment area. Green hose line along containment wall.

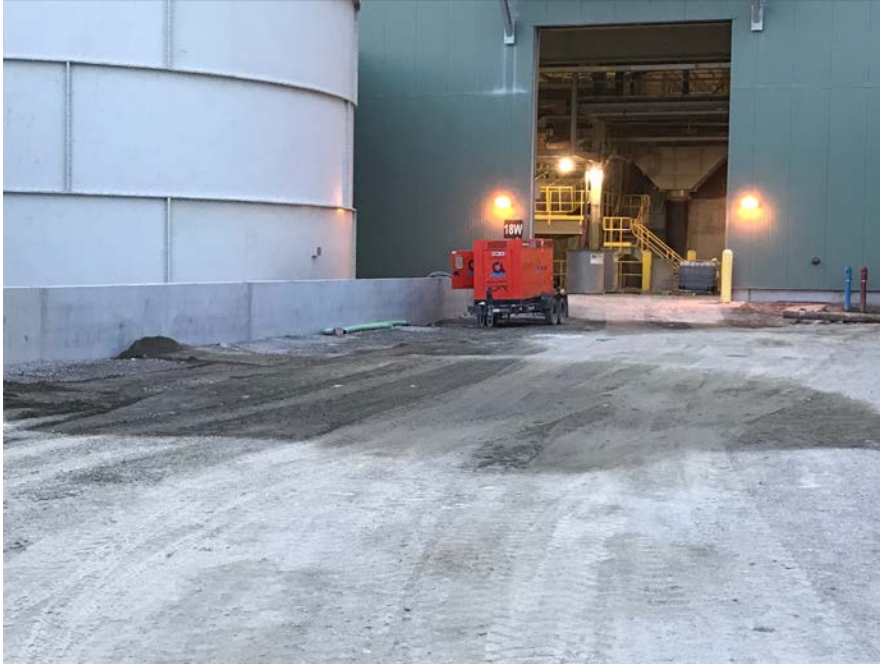
Photo 4. Alleyway of Door 18W showing the area after cleaned up was completed.

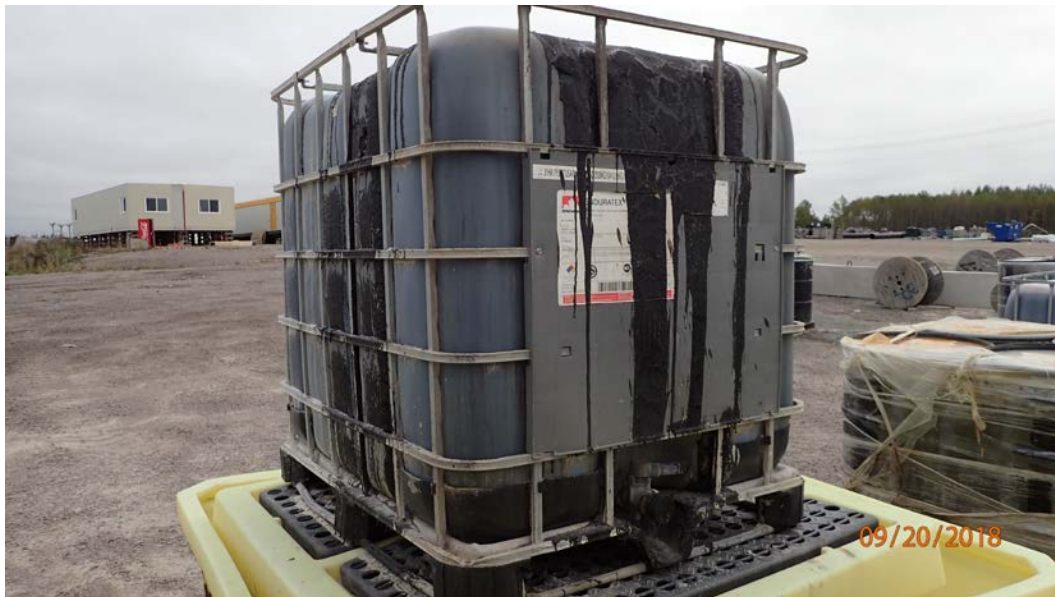
Photo 1. Tote of Vultrex Gear Lubricant supported on secondary containment tub.

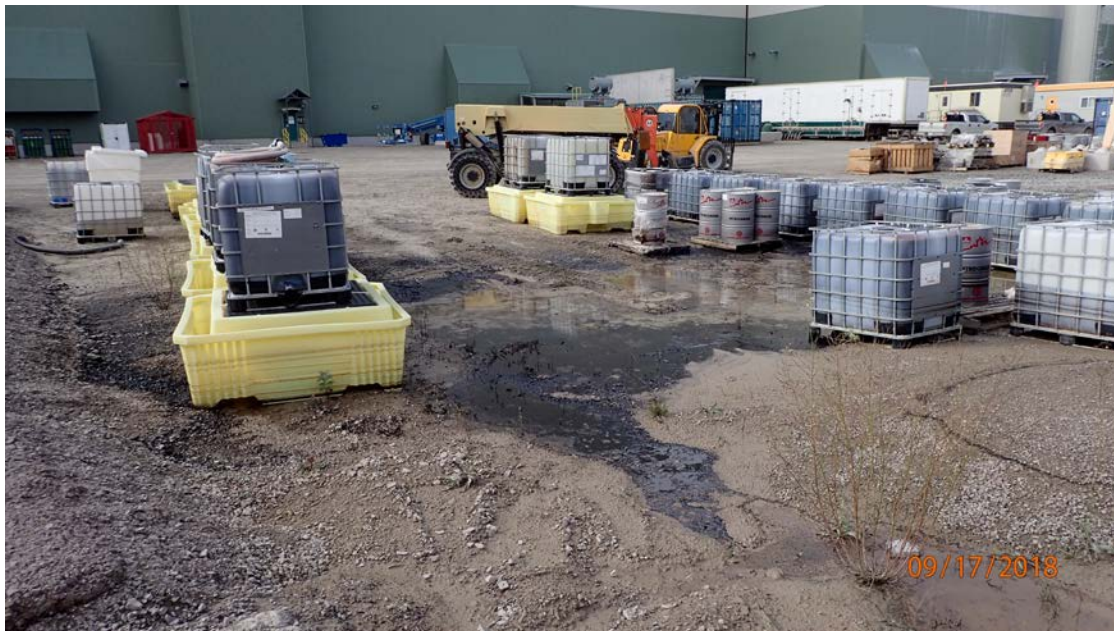
Photo 2. Extent of the gear oil spill into laydown area east of Mill Process building.

The spill occurred approximately 100 m east of mill process building in a laydown area which borders the plant site east drainage ditch system. Runoff water collects in the ditch and is channeled south through the site into the South Pond (Photo 3). All runoff water from the spill area was contained by this internal drainage system the South Pond. Water from the South Pond is used by the mill for processing ore. Any overflow is routed to the Mine Rock Pond via a 20-inch pipeline. New Gold will monitor the South Pond for evidence of hydrocarbon sheen.

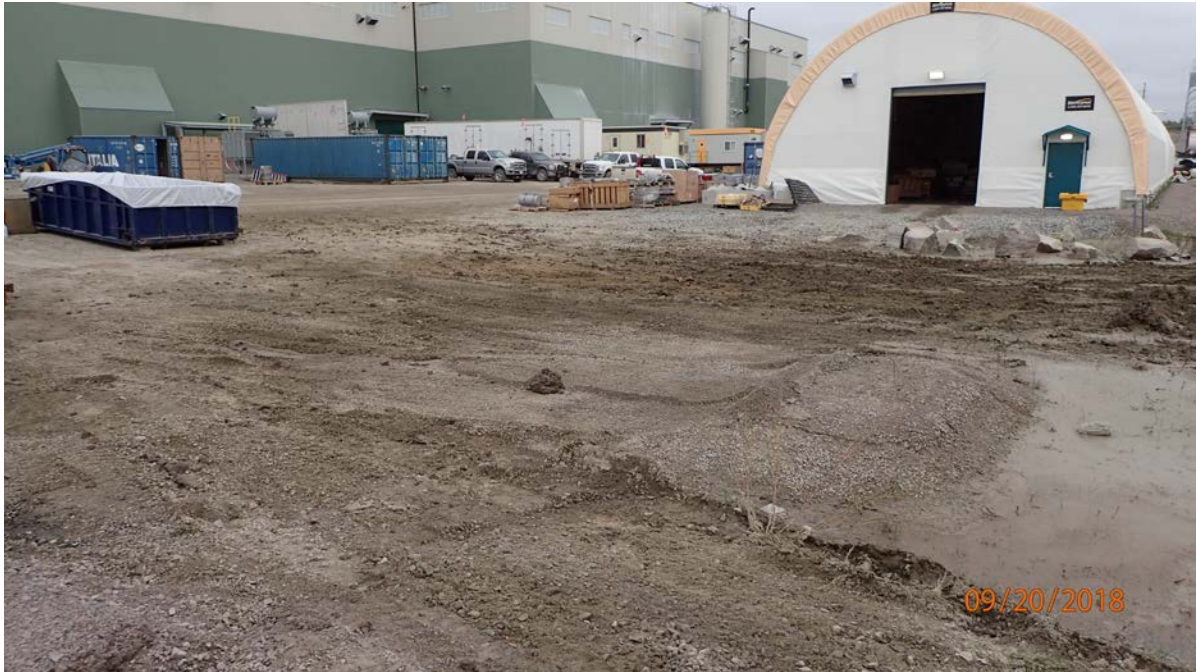
Photo 4. View of area after cleaned up was completed.

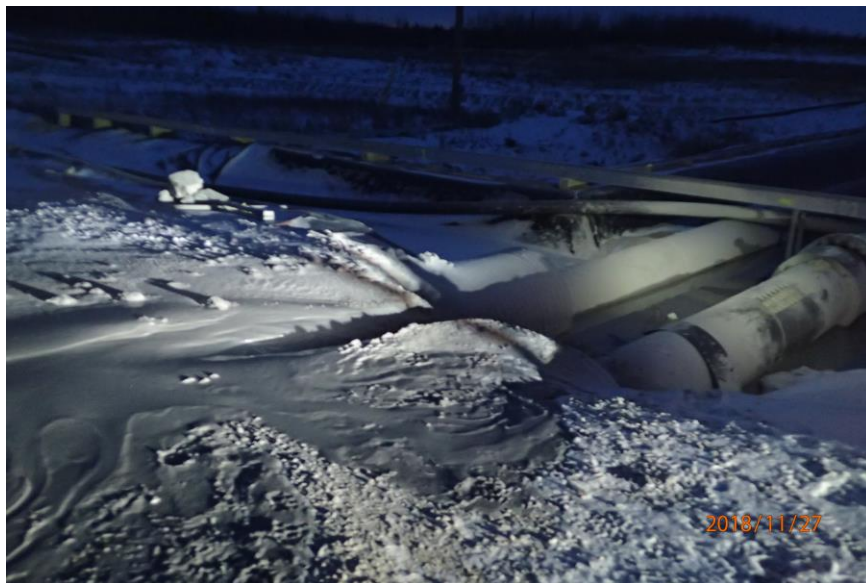
Further to the notification to the Spills Action Center (SAC) Reference # 5504-BFXLNJ, on November 27, 2018 at 16:33, a tailings line corridor inspection at Emergency Dump Pond #6 noted a tailings line leak at a previously patched line of pipe. The mill was contacted, and shutdown began to take place at 16:36. The treated tailings started to spray onto the access road as the mill commenced shutdown.

*Figure 1 shows tailings leak location at 16:50. Tailings spilled onto access road to Emergency Dump Pond 6. Tailings also pooling inside containment due to ice build under WMP reclaim line.*

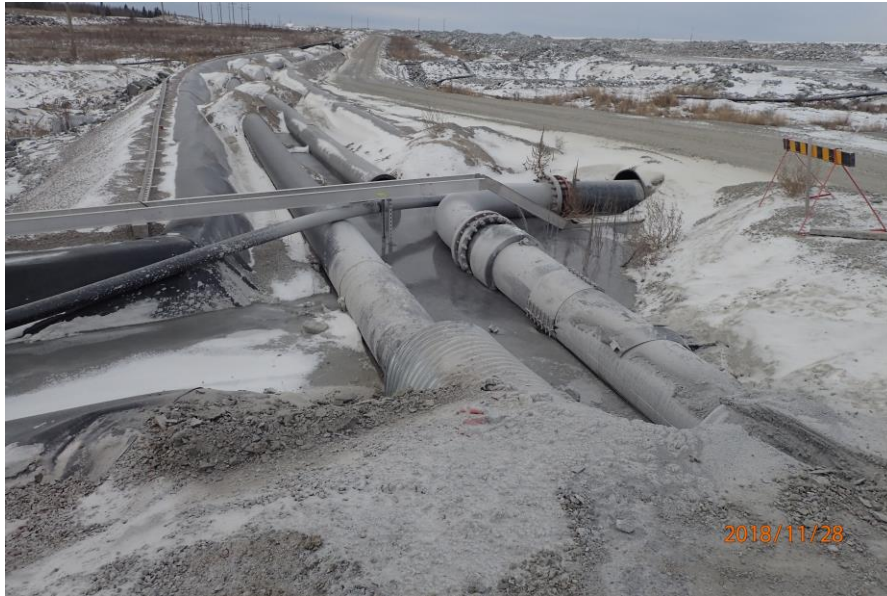
Once the tailings line was depressurized, the previous sleeve patch was inspected, adjusted, and retightened to stop the leak. More spigots were opened to reduce pressure on the tailings line and frequency of inspections increased through out the evening, to ensure the sleeve patch held.

Figure 2 shows where the tailings sprayed out of the sleeve patch (lighter grey area along pipe) and ice build-up within the tailings corridor containment as a result of the spill.

The new tailings pipe section is planned to be installed during a maintenance shutdown for the mill. This portion of pipe will be put together in the maintenance shop and fused during the shutdown. In the interim, a portion of belt will be used to cover the sleeve patch and monitored during dayshift and nightshift. The drain to Emergency Dump Pond #6 will also be maintained free of ice to allow drainage in case of emergency.

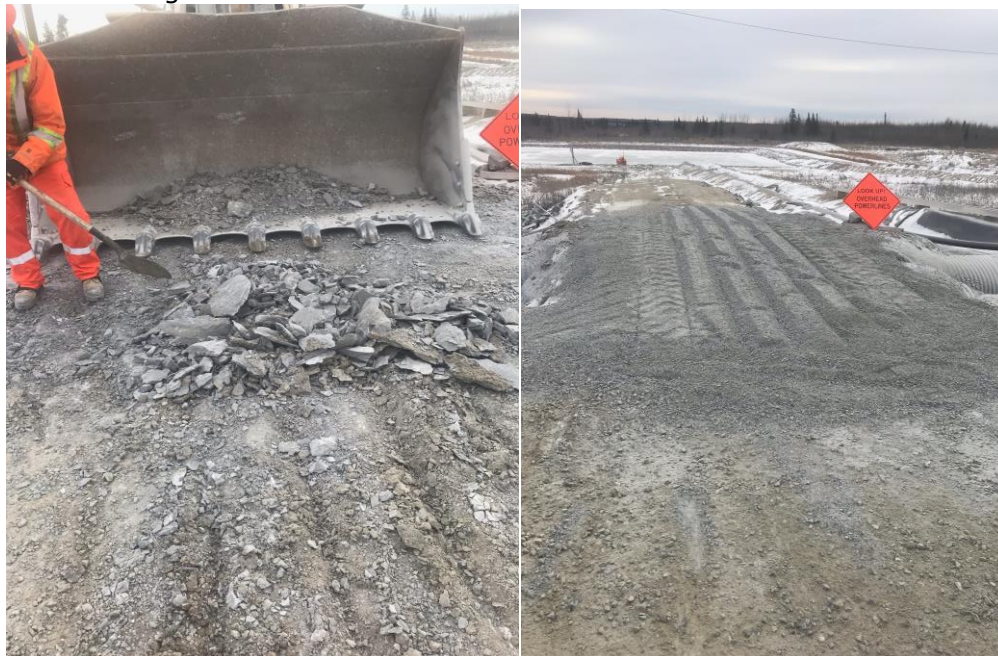
Clean up began the morning of November 28, 2018 once the treated tailings froze. This allowed for the equipment to scrape up the spill without fear of the tailings flowing away from the impacted area. 1m<sup>3</sup> of frozen tailings and contaminated material was removed from the location.

Figure 3 Shows removal of tailings and contaminated material as well as recapped road once clean-up was complete.

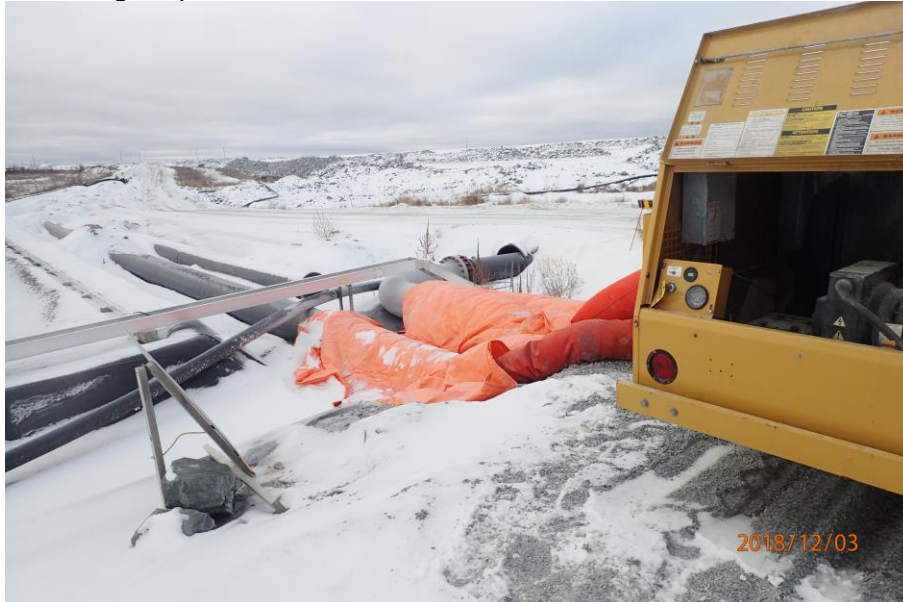
*Figure 4 shows Allmond heater and insulated tarp being used to thaw the frozen tailings from the bottom of the containment as well as thaw ice dam underneath WMP Reclaim line.*

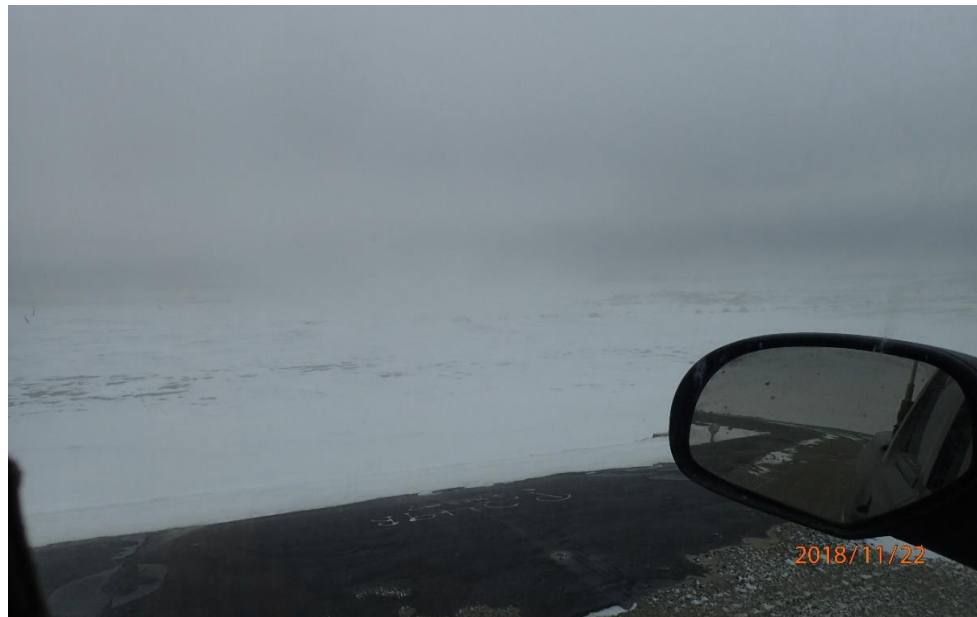
On November 22, 2018 a fugitive dust event was reported coming off of the Cell 1 pond in the Tailings Management Area at approximately 14:00 (See photo 1).

Photo 1: Tailings dust from Cell # 1

Winds were gusting up to 35 km/h out of the south and it was evident at the time that the plume was travelling outside of the Environmentally Sensitive Area (ESA) boundary. Samples of snow were taken from Cell 1 north dam and from the northern most tip of the ESA boundary to assess the level of impact. (See Photo 2).

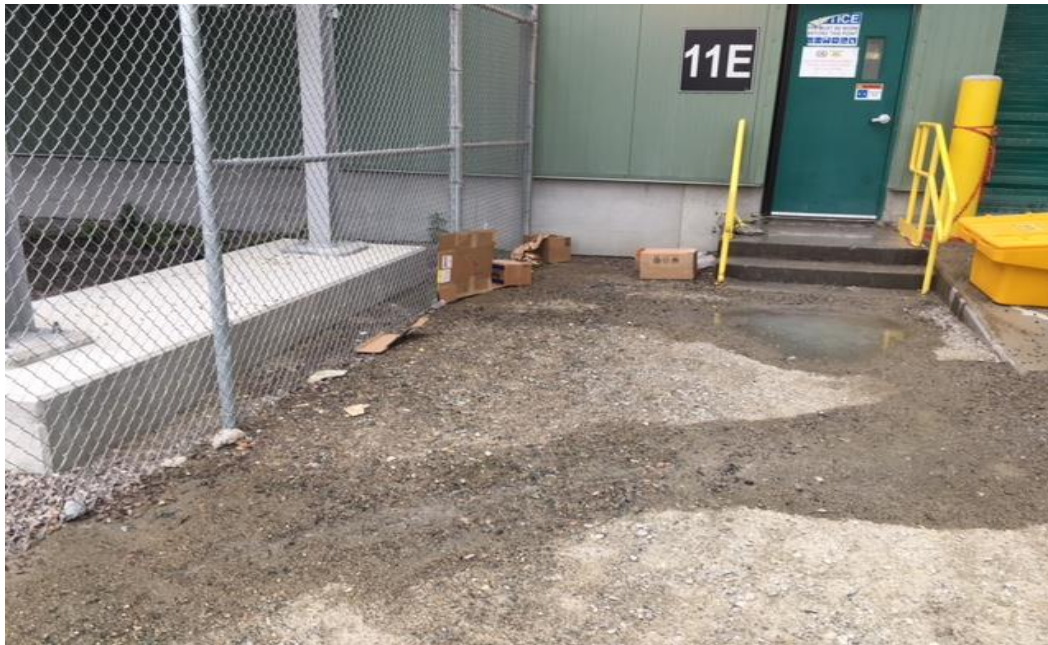
On August 31<sup>st</sup> at approximately 1200, process water was found to be backing up into the Millwright shop from the mill floor. This water was found to have escaped the man door of the Millwright shop and made contact with the ground outside the mill. (See photo below)

The mill was in upset conditions which caused a great deal of process slurry to settle in the works. When the mill was restarted various filter screens, cyclones and sumps were clogged and overtopped onto the mill floor. The process water separated from the slurry and backed up into the Millwright shop then spilled out door 11E. There was no impact to any water body as the process water only migrated about 5 meters outside the door resulting in 20L exiting the mill. This spill was caught quickly by the operators and work ceased. The gravel containing the process water was placed inside the mill and returned into the process, this was completed by the end of the day shift.

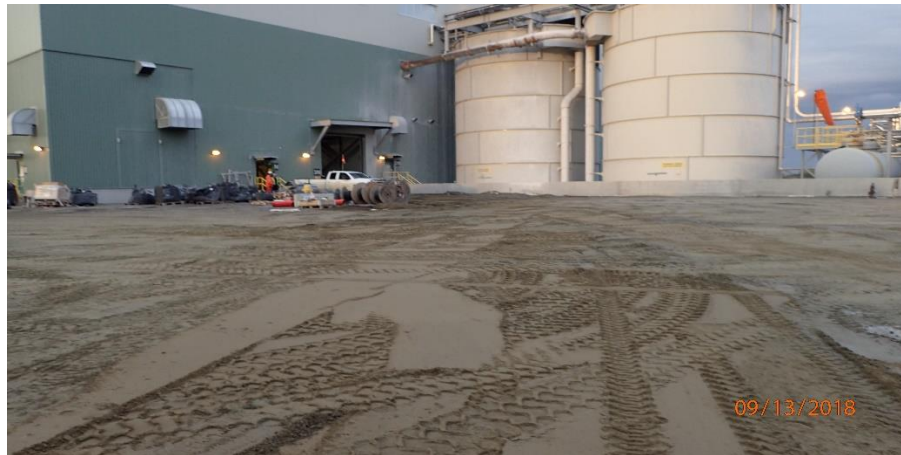
On September 13th at approximately 1215 am, tailings was found to be exiting door 3N from the tailings sump pump box and migrated 55 meters to the northeast. See photo below (clean-up was well underway at time of photo)

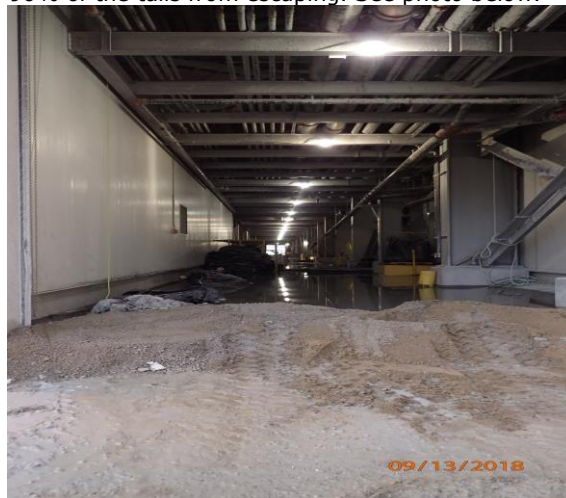
The spill only lasted a few minutes and quick action by the operators placing sand over the existing berm (speed bump) in front of door 3N stopped 80-90% of the tails from escaping. See photo below.

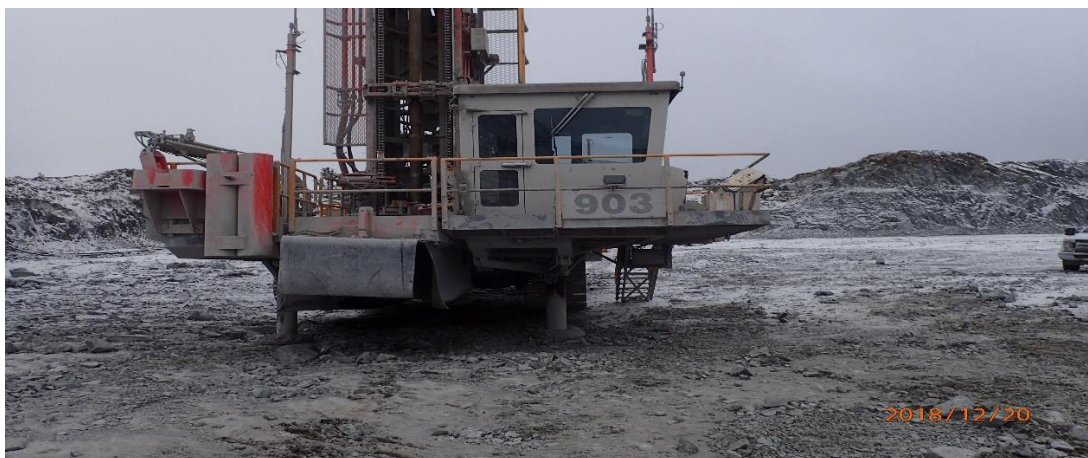
Photo 2: Drill 903

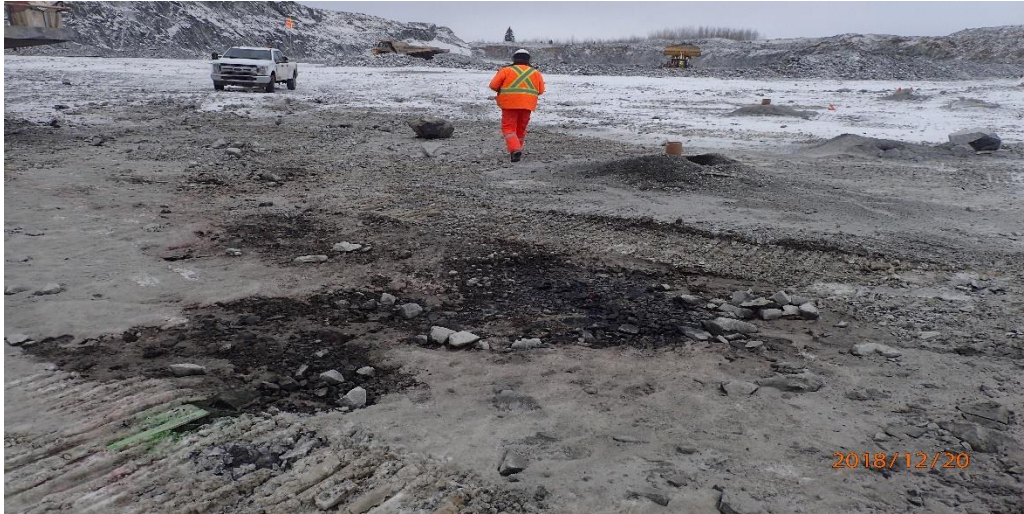
At surface, the spill did not appear to be significant but upon further inspection it was noticed that a large amount of fuel had seeped into the shattered rock (see photos 3 and 4 below). Three drill holes were found to be contaminated with dyed diesel.

Photo 3: Spill site

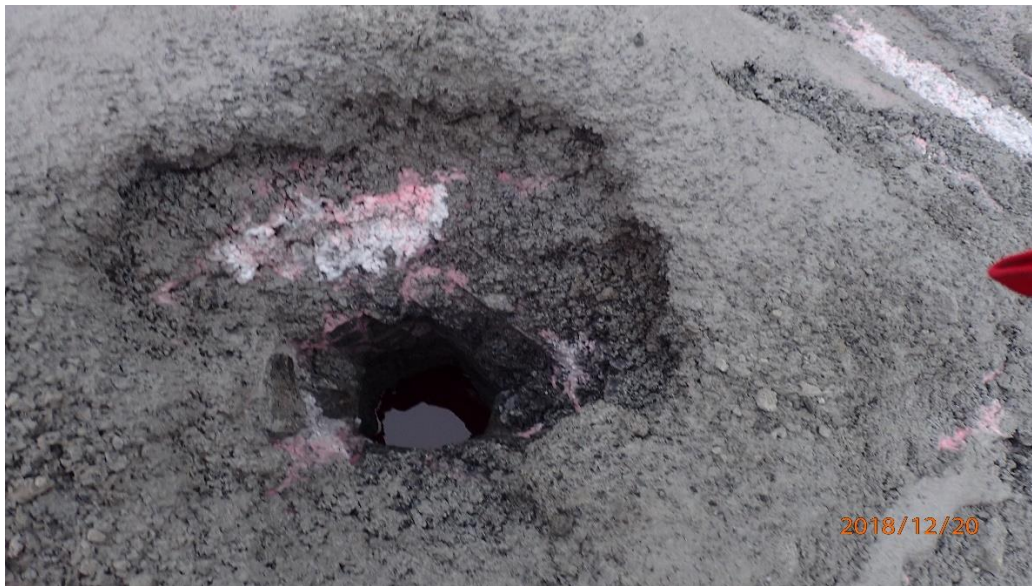
Photo 4: Drill hole

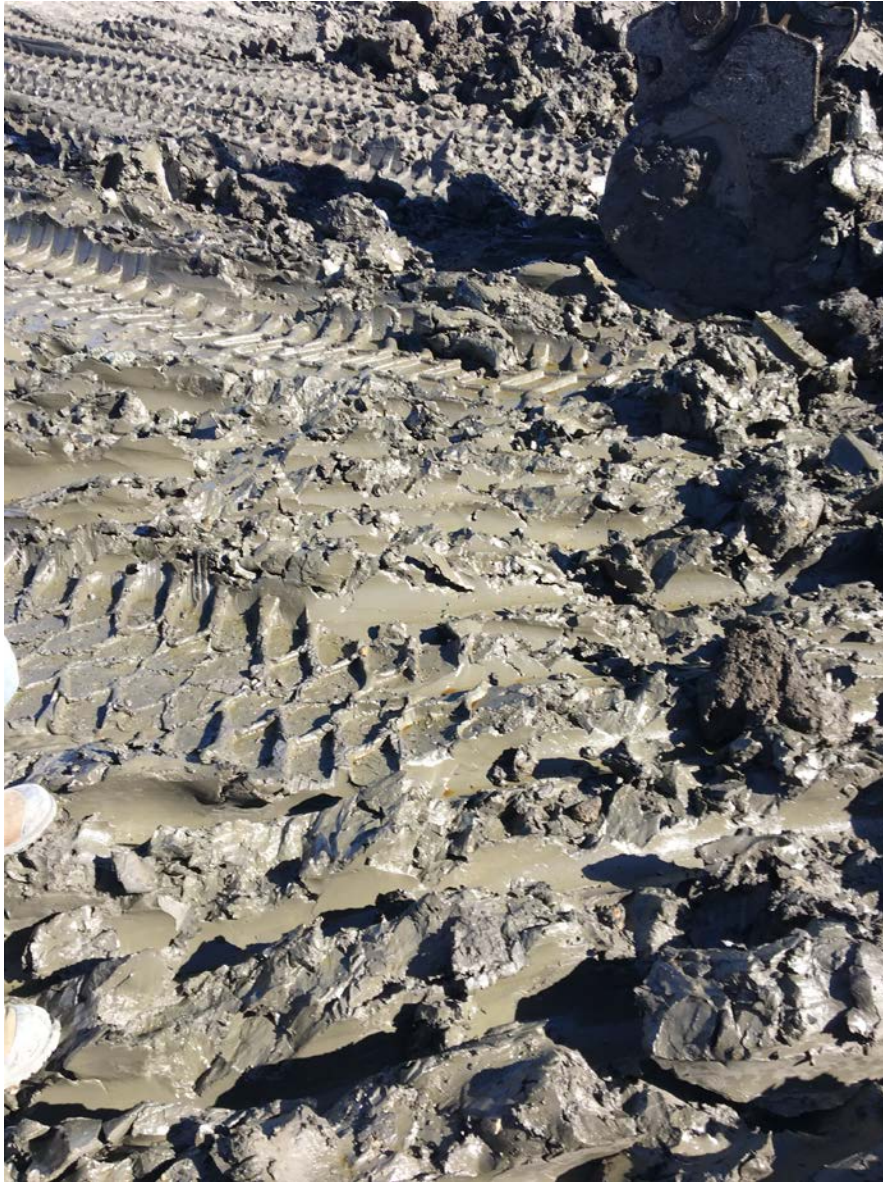
Photo 1 – Clay affected by hydraulic line failure

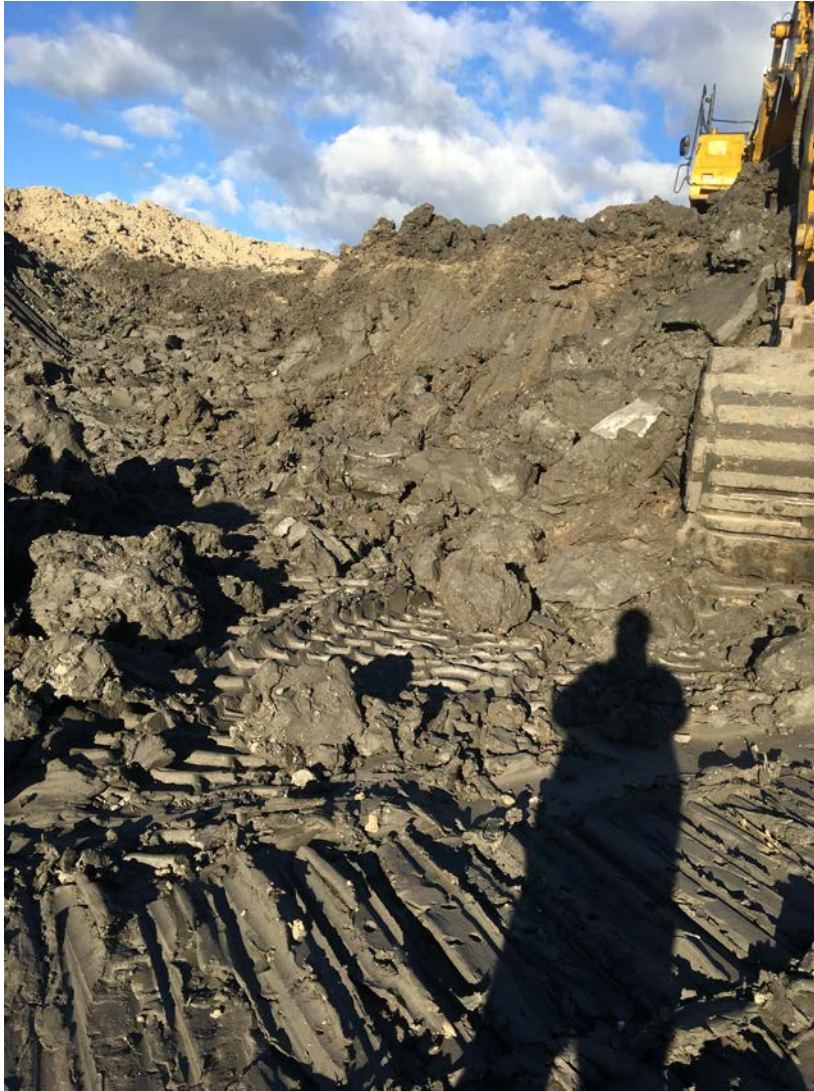
Photo 2 – Spill location after removal of affected clay

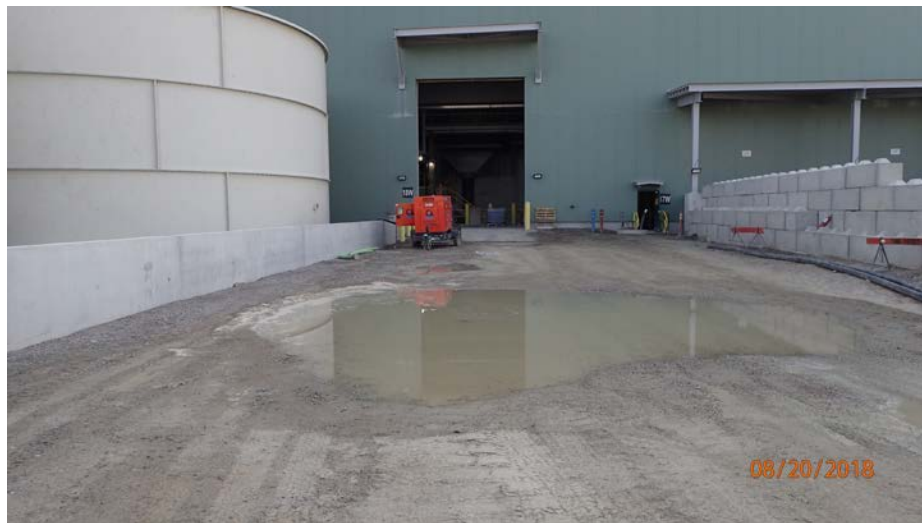
During the early morning hours on August 20, while checking a pump and hose line into the secondary containment area around the thickener and leach tanks, a mill employee discovered the line laying on the ground and process water flowing into the truck alleyway in front of Door 18W (Photo 1). Mill Door 18W is located on the west side of the process building, adjacent to the thickener and leach tank secondary containment area.

Photo 1. Extent of process water spill into truck alleyway of Door 18W.
