**NEW GOLD RAINY RIVER MINE  
APPENDIX L  
WILDLIFE MORTALITY LOG**

**NEW GOLD RAINY RIVER MINE  
APPENDIX M  
EXCEEDANCE LETTER SUBMITTED  
TO MECP**

**RE:1000L Ferrous Sulfate Spill – SAC Reference #2157-B4ZRSU**

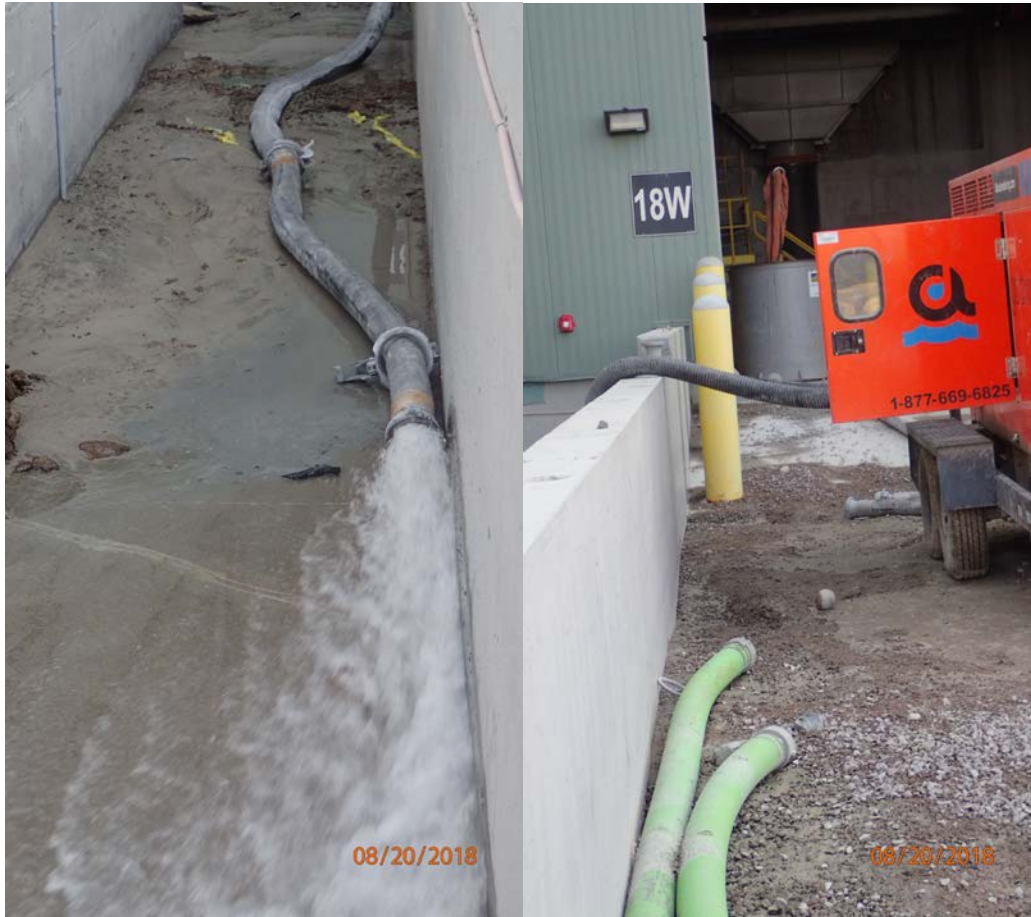
At that time of the event, it was observed that the green hose line connected to the pump and positioned over the wall into the containment area was too short. When the pump surged, the force knocked the line back over the wall and onto the ground surface. The green hose line was replaced with a longer black hose line which reached onto the containment area floor (Photo 3).

Photo 3. Black replacement hose on floor of containment area. Green hose line along containment wall.

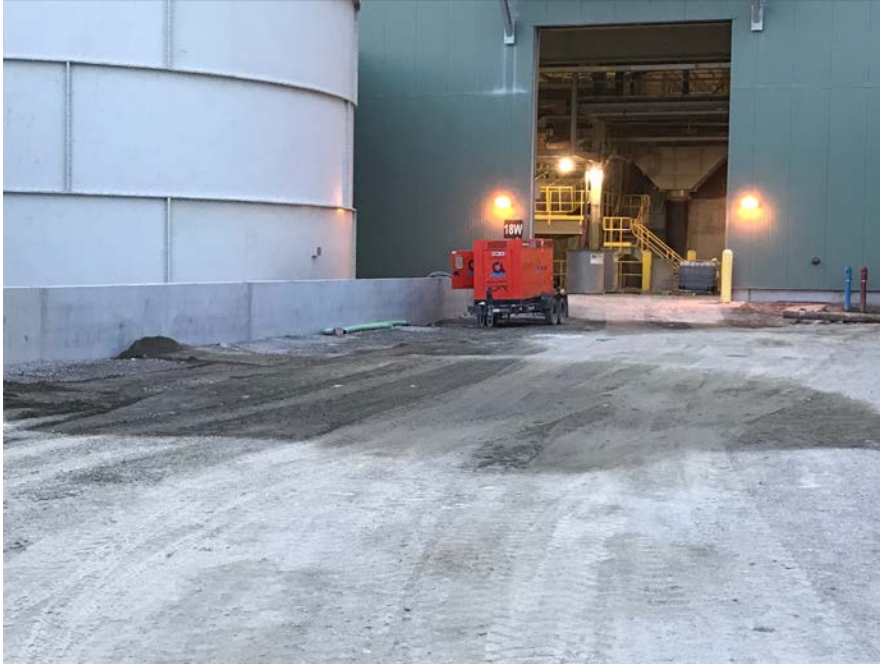
Photo 4. Alleyway of Door 18W showing the area after cleaned up was completed.

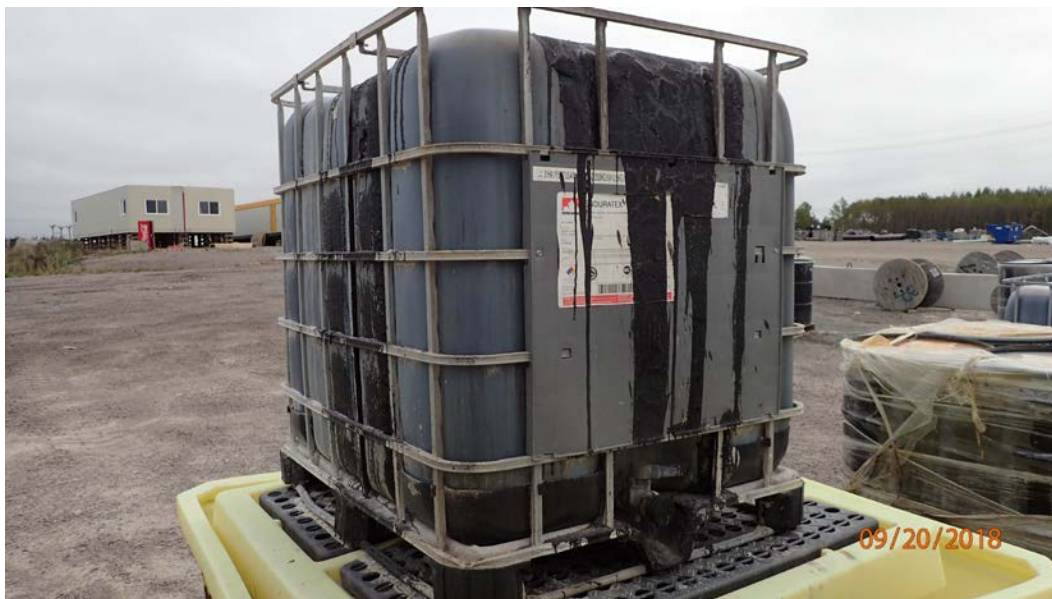
Photo 1. Tote of Vultrex Gear Lubricant supported on secondary containment tub.

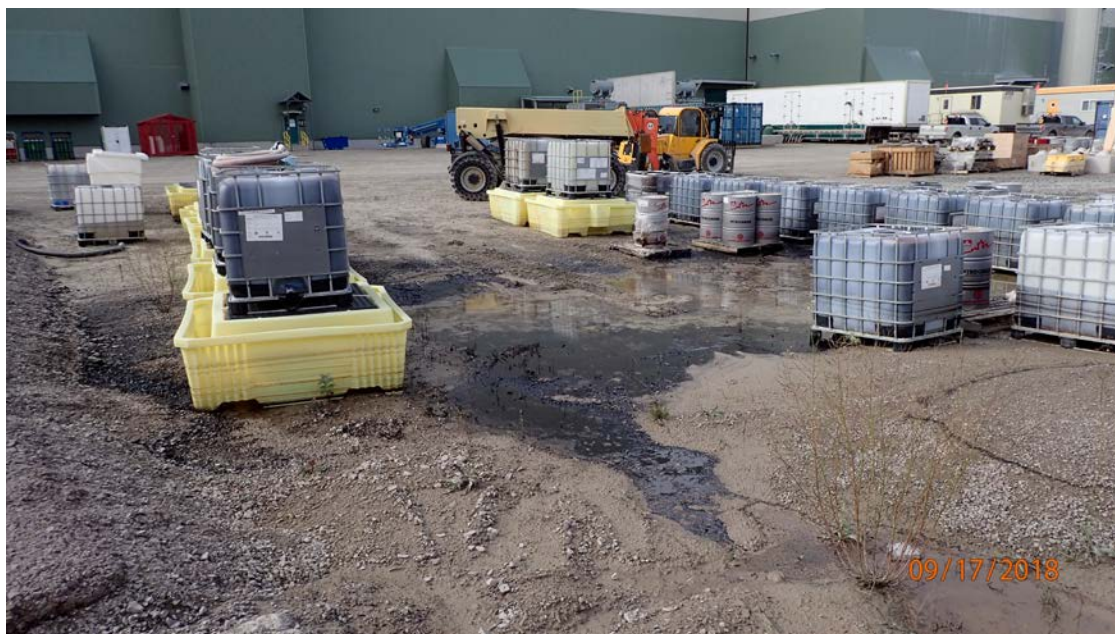
Photo 2. Extent of the gear oil spill into laydown area east of Mill Process building.

The spill occurred approximately 100 m east of mill process building in a laydown area which borders the plant site east drainage ditch system. Runoff water collects in the ditch and is channeled south through the site into the South Pond (Photo 3). All runoff water from the spill area was contained by this internal drainage system the South Pond. Water from the South Pond is used by the mill for processing ore. Any overflow is routed to the Mine Rock Pond via a 20-inch pipeline. New Gold will monitor the South Pond for evidence of hydrocarbon sheen.

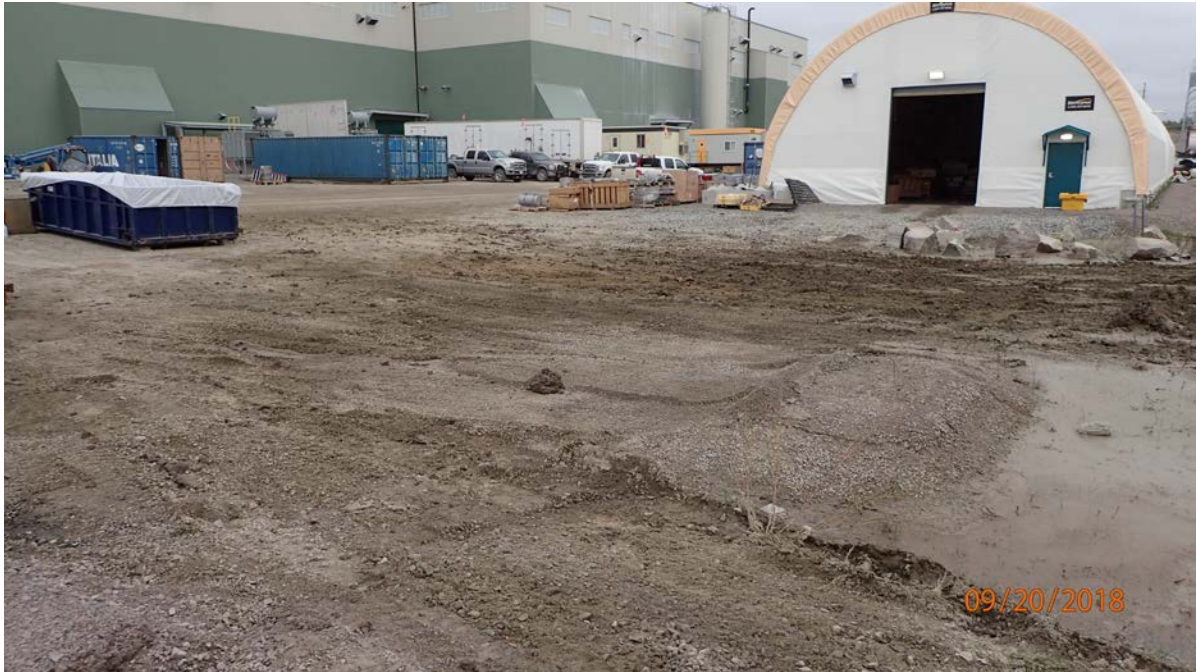
Photo 4. View of area after cleaned up was completed.

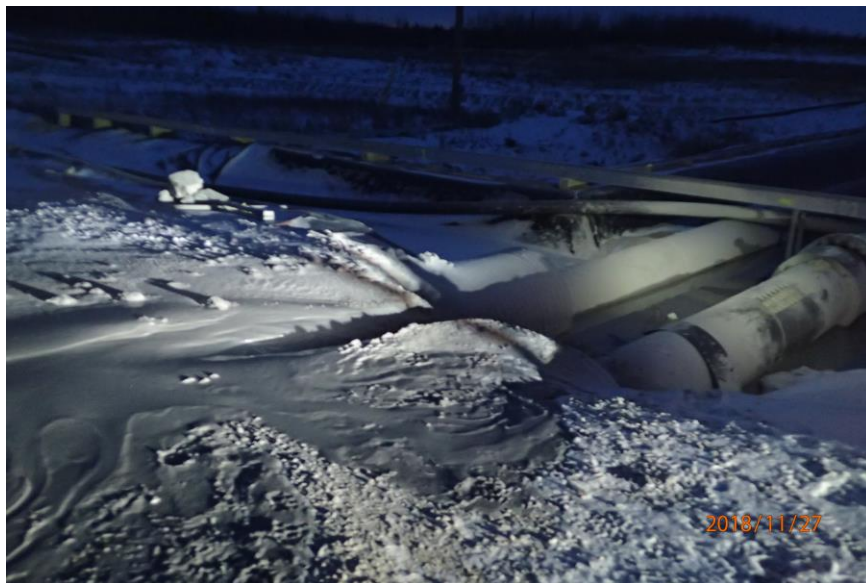
Further to the notification to the Spills Action Center (SAC) Reference # 5504-BFXLNJ, on November 27, 2018 at 16:33, a tailings line corridor inspection at Emergency Dump Pond #6 noted a tailings line leak at a previously patched line of pipe. The mill was contacted, and shutdown began to take place at 16:36. The treated tailings started to spray onto the access road as the mill commenced shutdown.

*Figure 1 shows tailings leak location at 16:50. Tailings spilled onto access road to Emergency Dump Pond 6. Tailings also pooling inside containment due to ice build under WMP reclaim line.*

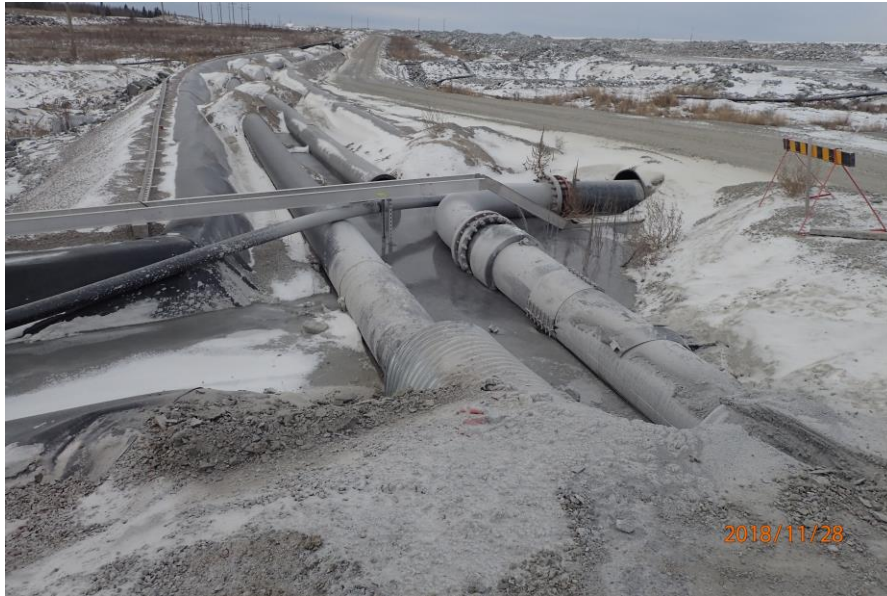
Once the tailings line was depressurized, the previous sleeve patch was inspected, adjusted, and retightened to stop the leak. More spigots were opened to reduce pressure on the tailings line and frequency of inspections increased through out the evening, to ensure the sleeve patch held.

*Figure 2 shows where the tailings sprayed out of the sleeve patch (lighter grey area along pipe) and ice build-up within the tailings corridor containment as a result of the spill.*

The new tailings pipe section is planned to be installed during a maintenance shutdown for the mill. This portion of pipe will be put together in the maintenance shop and fused during the shutdown. In the interim, a portion of belt will be used to cover the sleeve patch and monitored during dayshift and nightshift. The drain to Emergency Dump Pond #6 will also be maintained free of ice to allow drainage in case of emergency.

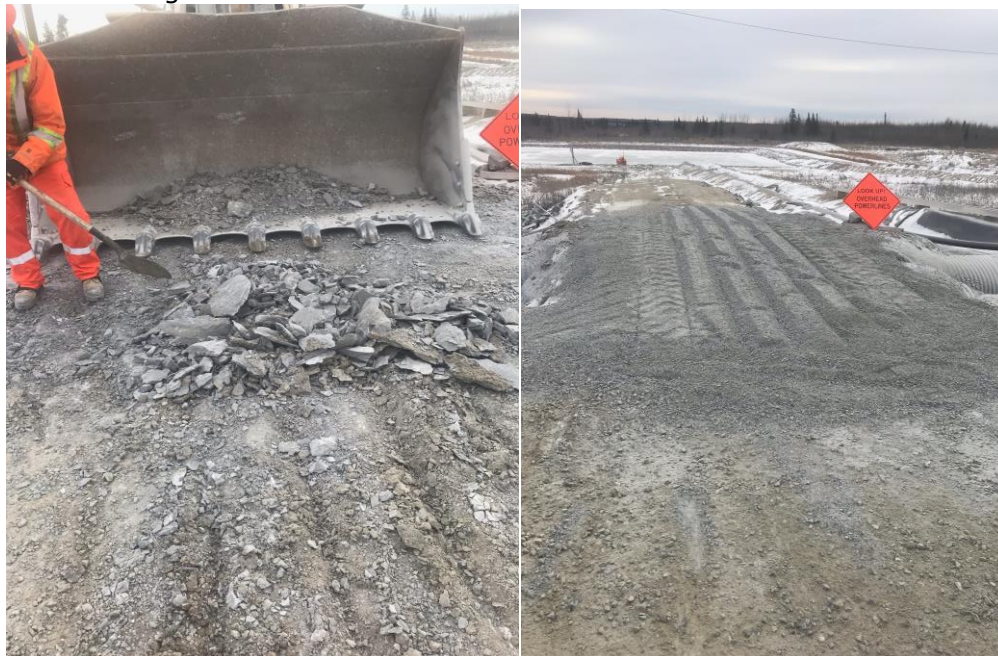
Clean up began the morning of November 28, 2018 once the treated tailings froze. This allowed for the equipment to scrape up the spill without fear of the tailings flowing away from the impacted area. 1m<sup>3</sup> of frozen tailings and contaminated material was removed from the location.

*Figure 3 Shows removal of tailings and contaminated material as well as recapped road once clean-up was complete.*

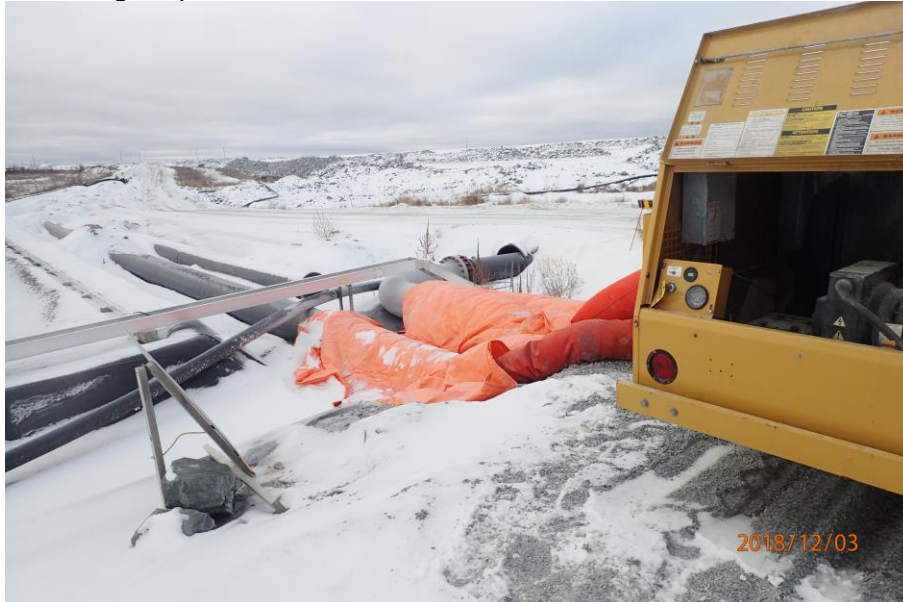
*Figure 4 shows Allmond heater and insulated tarp being used to thaw the frozen tailings from the bottom of the containment as well as thaw ice dam underneath WMP Reclaim line.*

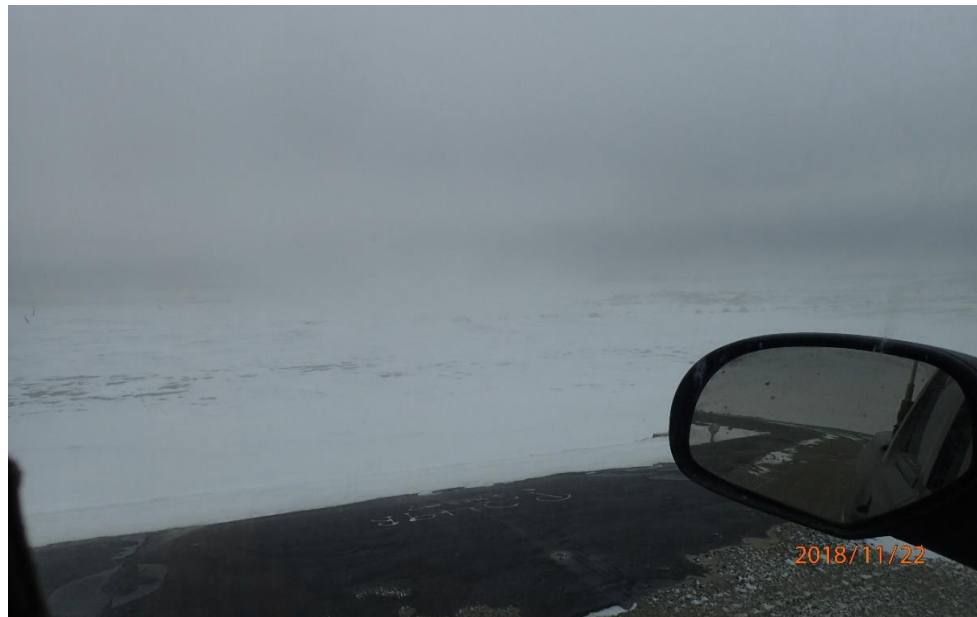
Photo 1: Tailings dust from Cell # 1
