**NEW GOLD RAINY RIVER MINE
APPENDIX N
2018 ANNUAL MONITORING REPORT-
OFFSET PLAN FOR FISHERIES ACT**

2018 Annual Monitoring Report – Offset Plan for Fisheries Act
Section 35(2)(b) Authorization
Emo, Ontario
TC111504

**Re: 2018 Annual Monitoring Report
Offset Plan for Fisheries Act Section 35(2)(b) Authorization, Rainy River Mine
Emo, Ontario**

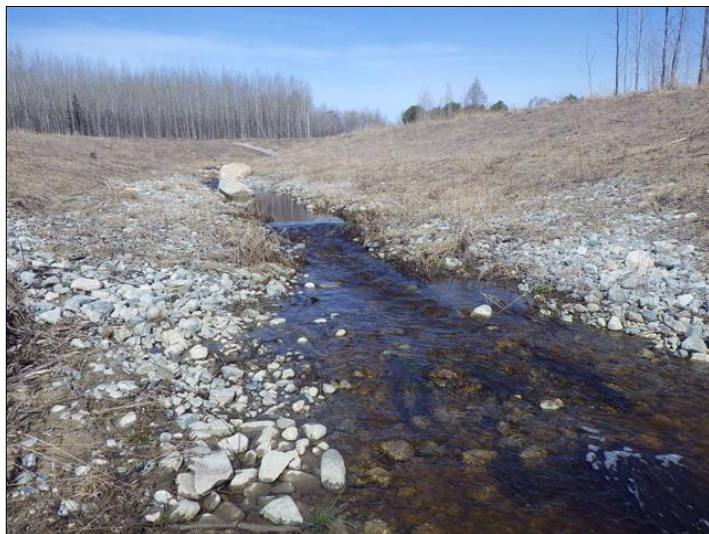
CSS-1, facing upstream during high flow conditions (April 25, 2018)

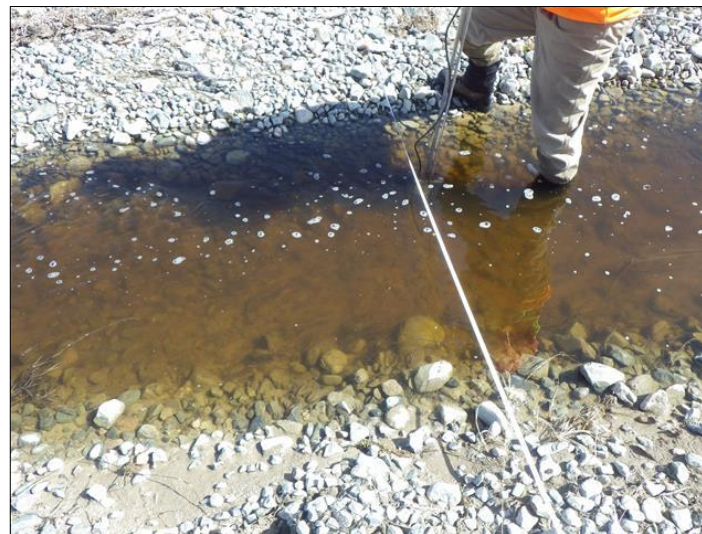
CSS-1 run during high flow conditions (April 25, 2018)

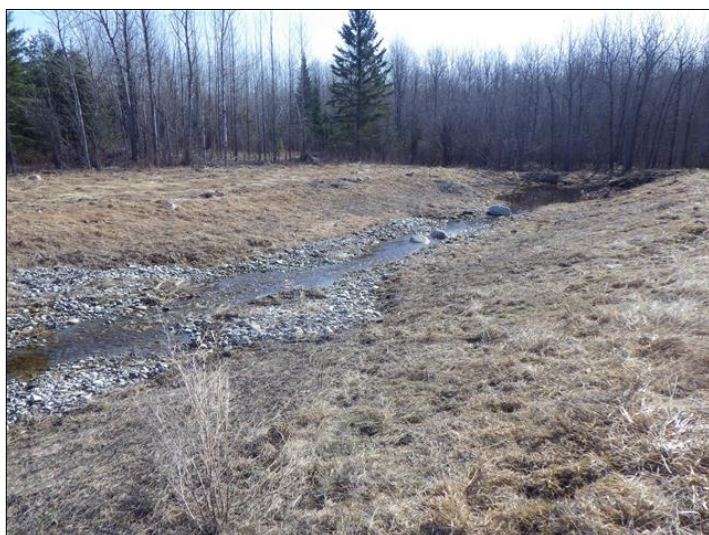
CSS-2, facing downstream toward remnant channel (April 25, 2018)

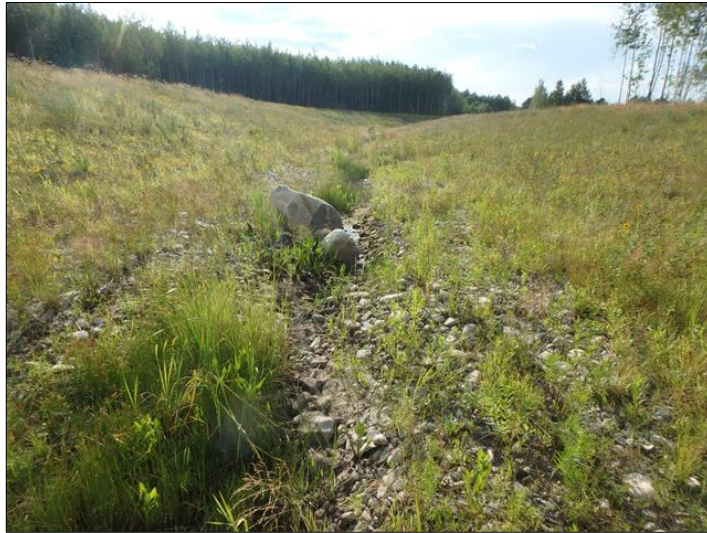
CSS-1, facing upstream during low flow conditions (July 27, 2018)

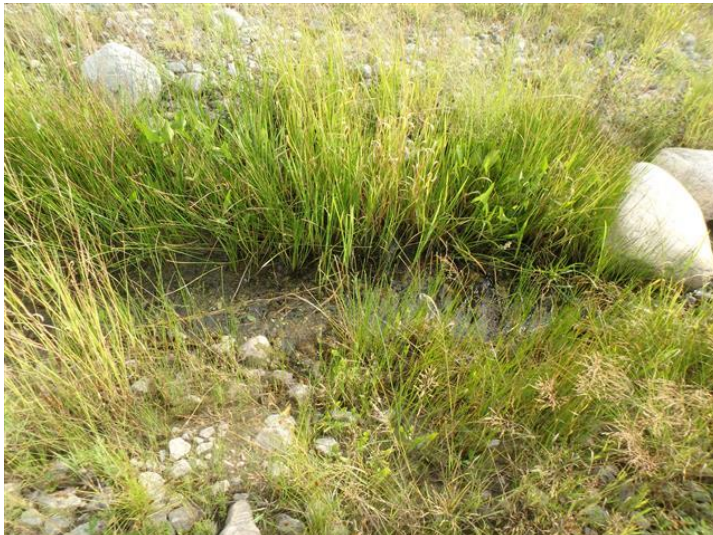
Dry riffle/run in CSS-1 (July 27, 2018)

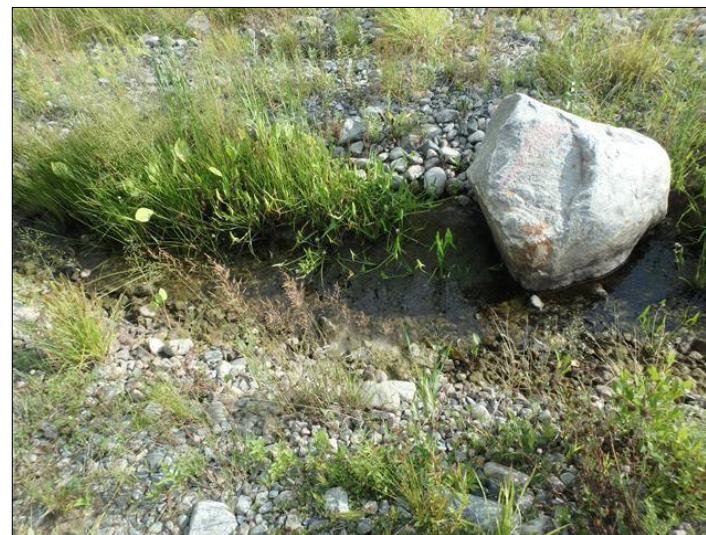
Dry run/pool in CSS-1 (July 27, 2018)

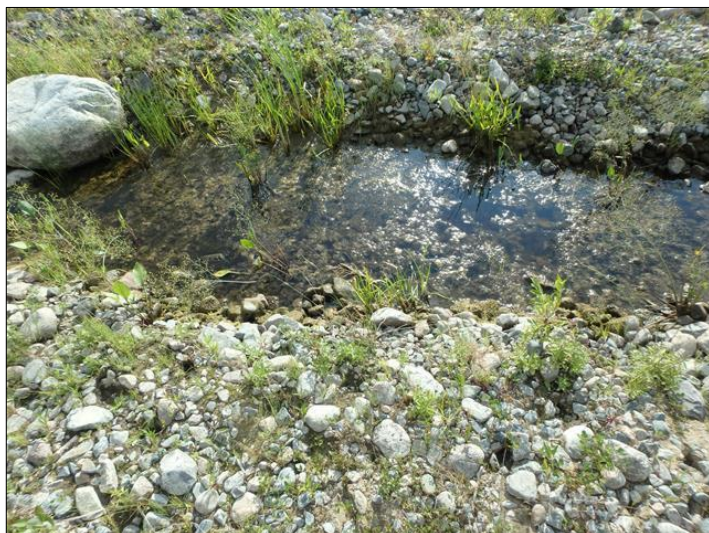
Refuge pool in CSS-2, during low flow conditions (July 27, 2018)

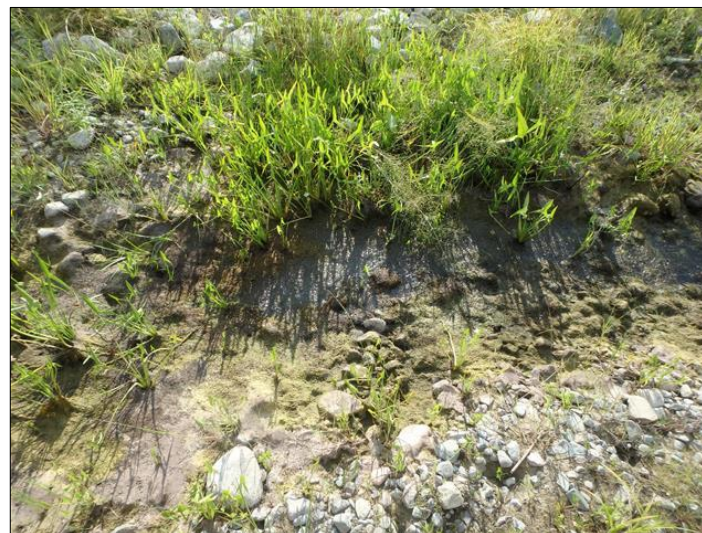
Dry run in CSS-2 (July 27, 2018)

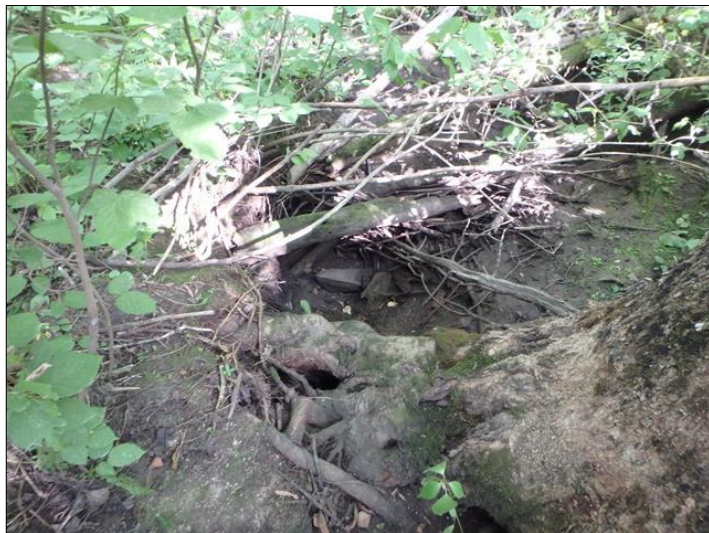
Dry plunge pool in CSS-3 (July 27, 2018)

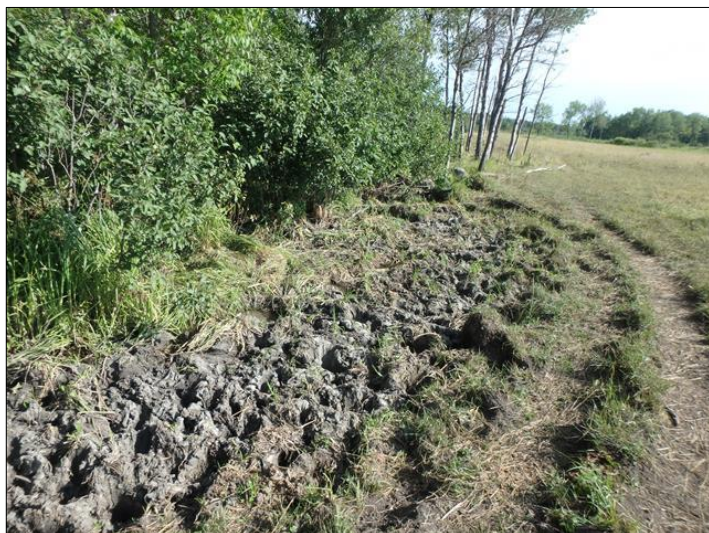
The original Teeple Drain, downstream of Teeple Road, is in an actively used cattle pasture. Consequently, the cattle have destabilized the channel near station P9 and P10 causing severe bank erosion and degradation. The flow path transitions to a broad wet meadow downgradient of this location. Station P10 was located in the wet meadow with surface drainage through the grasses, and no defined central channel. These wet meadow conditions exist further downstream until a channelized flow path enters a woodlot at station P11. No observable channel erosion or instability from the realigned channel flows were noted.

Undefined channel from cattle destabilization; CSS-3 (July 27, 2018)

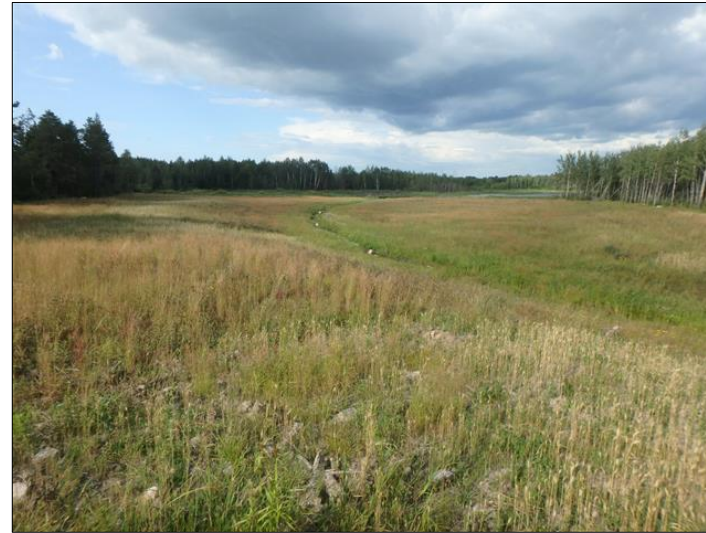
Station P5 facing northeast; note vegetation progress (July 27, 2018)

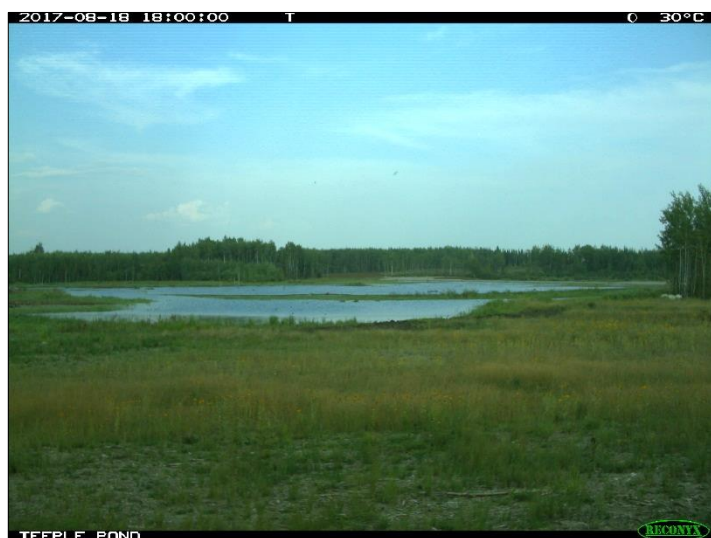
Note debris mound removed; August 18, 2017

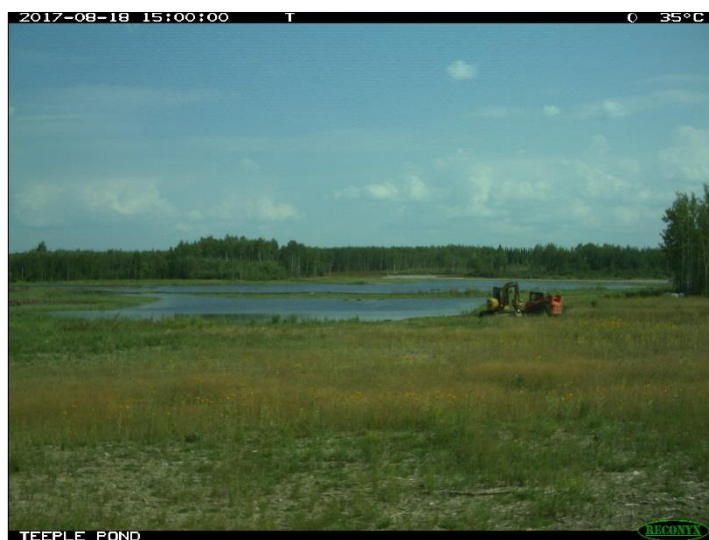
General monitoring events throughout the year were conducted by Wood ESC site staff and aquatic studies field staff. The ESC staff documented some areas of erosion in the low flow channel and inlet fan immediately downstream of the Teeple Pond outlet in 2017 (Amec Foster Wheeler 2017a). Observations from June 1, 2018 showed vegetation establishment had progressed, including areas along the low flow channel which was repaired in the summer/fall of 2017.

Teeple Pond outlet repairs, note machinery; August 18, 2017
