**NEW GOLD RAINY RIVER MINE  
APPENDIX L  
EXCEEDANCE LETTERS SUBMITTED  
TO MECP, CEAA**

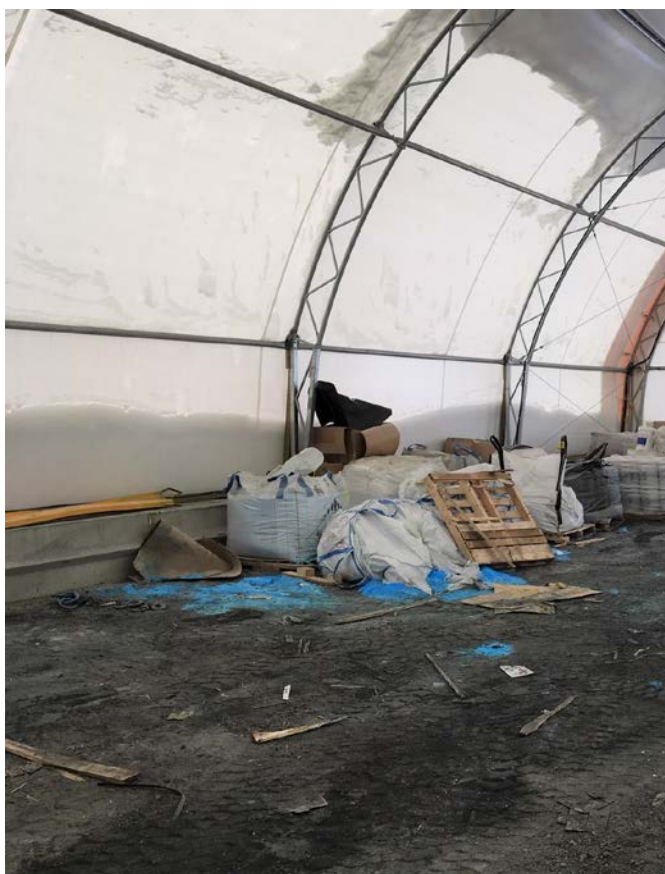
Further to the notification to the Spills Action Center (SAC) Reference # 1661-B8VTYV, on January 29, 2019 at 16:09, a copper sulfate spill was noted on the earthen floor of the covered chemical cold storage area east of the Mill on January 29, 2019 at 13:10. The original volume estimate was 25kg, but it has since been corrected to approximately 40kg.

Figure 1: Location of copper sulfate spill inside the covered chemical cold storage building east of the Mill

To prevent future occurrences, shelving has been ordered for the covered chemical cold storage building to be installed in the spring, which will eliminate the practice of stacking copper sulfate totes. It is also planned to pour a concrete pad for the building to be placed on, which will provide spill containment.

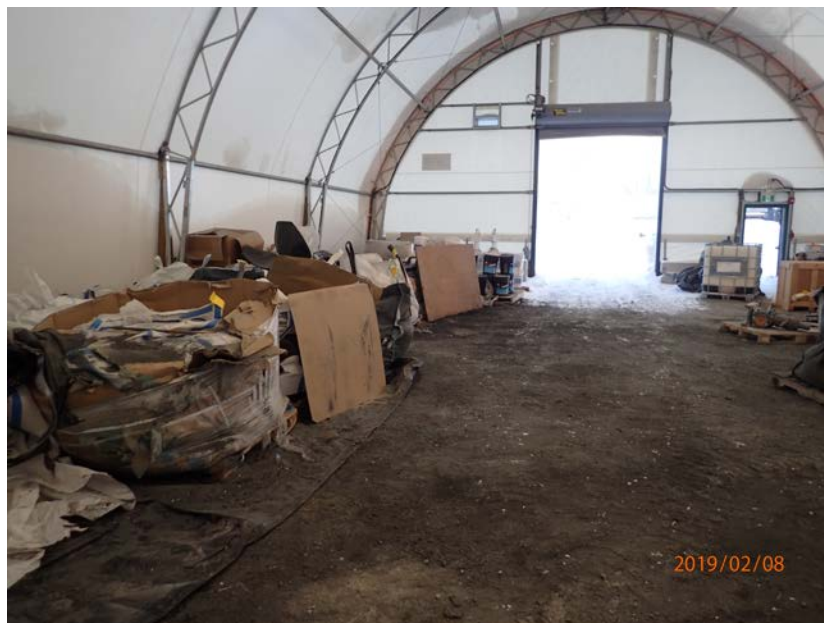
Figure 3: Cleaned up copper sulfate spill inside the covered chemical cold storage building east of the Mill. Damaged totes placed on fold out spill containment.

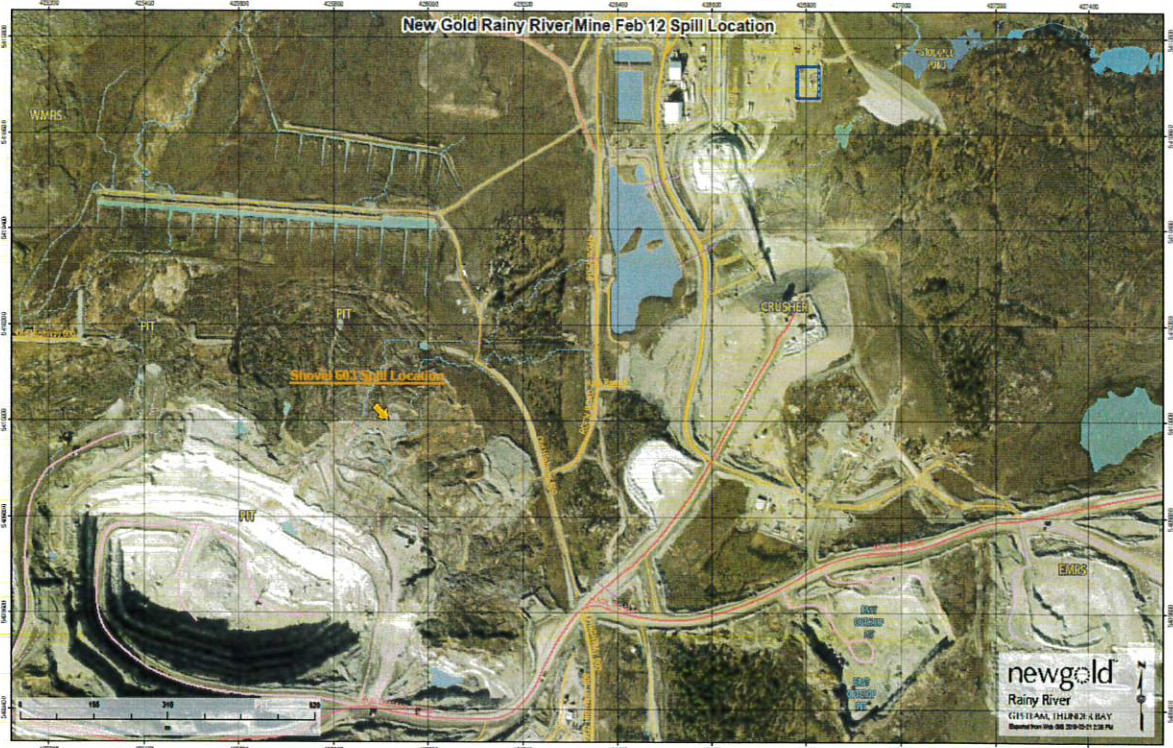
During the afternoon of February 12, while loading haul trucks on the 300 bench (photo 1) in phase 2 of the open pit, the Komatsu PC 8000 hydraulic shovel unit# 603 suffered a fracture of the main return line.

Photo 1. GIS image of Phase 2 of the Open Pit in relation to the plant and mine site. Yellow arrow indicates location of shovel and hydraulic fluid spill.

Corrective actions include continuing with a regular preventative maintenance program, which is designed to identify and replace defective equipment before failures occur.

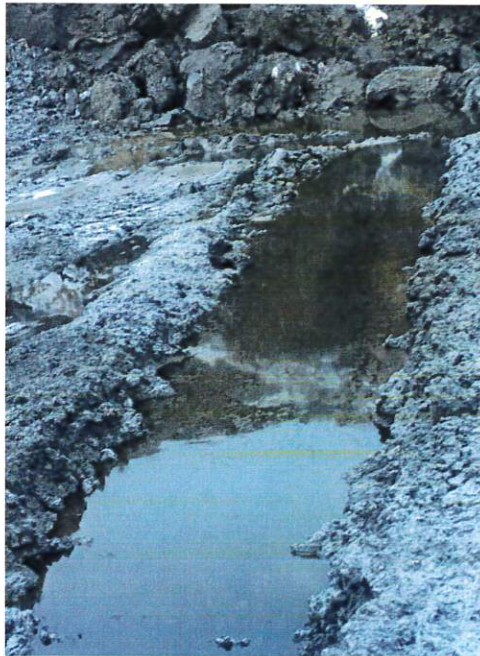
Ponding hydraulic fluid was contained within a berm area (Photo 3). Mine Maintenance used a lubricant and service truck to collect the pooled hydraulic fluid and disposed of it in a used oil tank located on the plant site.

Photo 3. Hydraulic fluid collected in a berm area on floor of 300 bench.

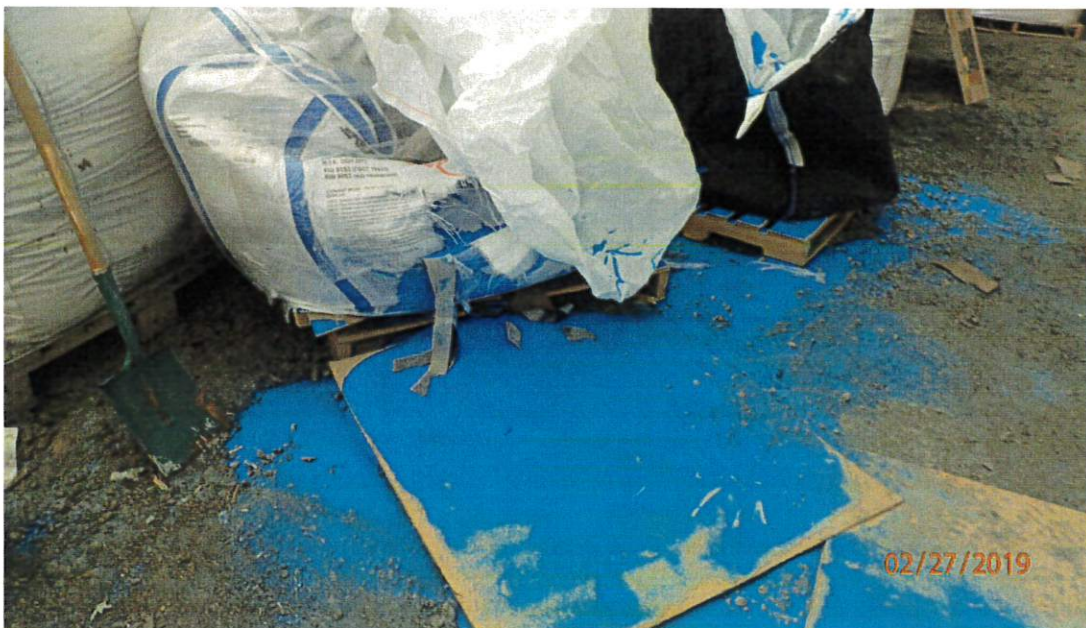
It was determined that during movement of a tote bag of copper sulphate, a forklift contacted an adjacent bag, and tore it open (Figure 2). The spilled copper sulphate was collected and placed into another tote. Granular copper sulphate did not migrate from the spillage area and was contained inside the covered building.

Figure 2. Copper sulphate tote bag with tear and spillage onto cold storage tent floor.

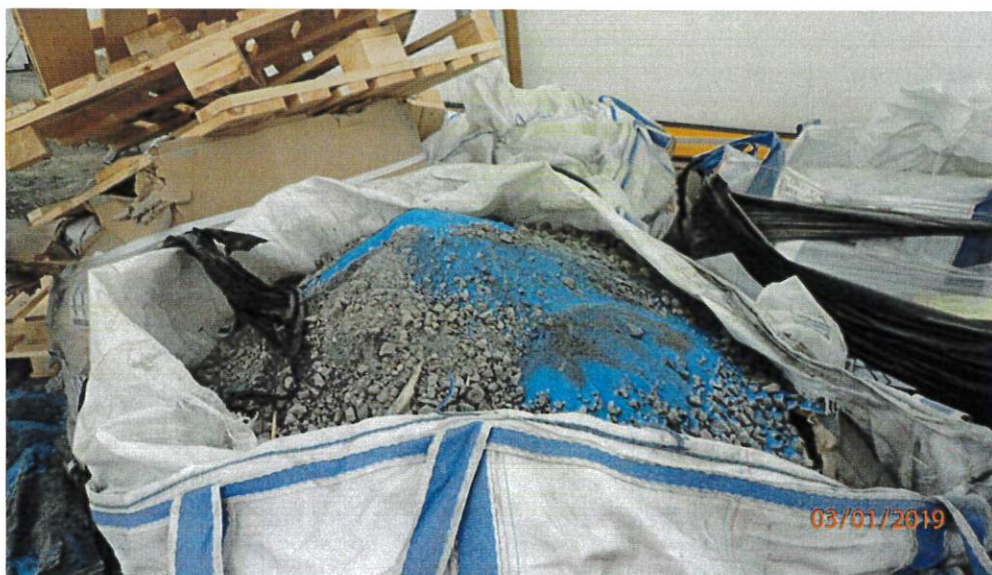
The mill was contacted, and spill cleanup completed by the end of the next day. Gravel, clay and wood particles mixed in with the spillage, prevented the mill from using the copper sulphate in the process. The contaminated mixture will be added into the Cyanide Destruction (CND) circuit and consumed. Disposal is planned for the spring of 2019.

Figure 3. Spillage bag containing materials removed from the cold storage tent floor. Bag contains mixture of granular copper sulphate, gravel, clays and wood.

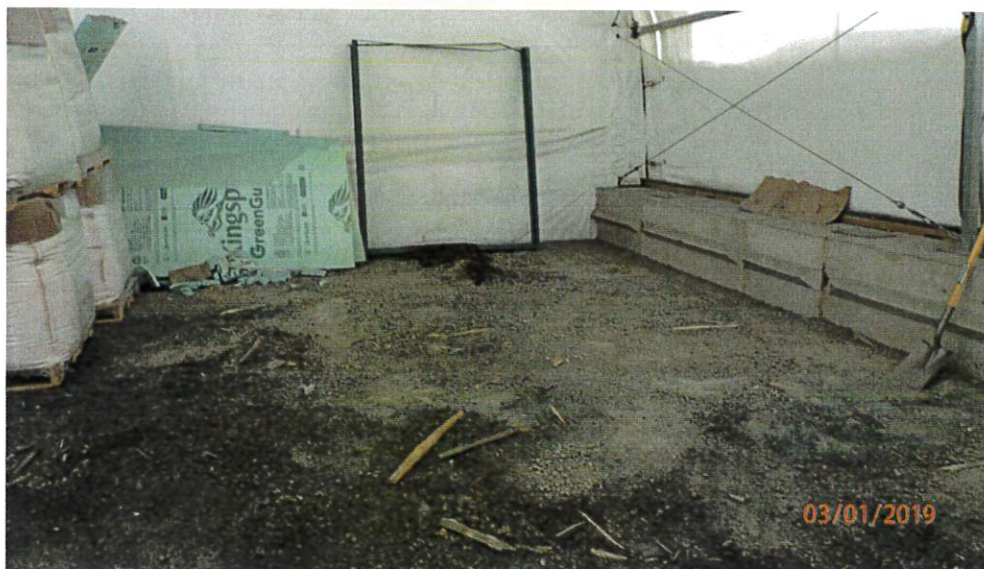
Remaining copper sulphate tote bags were removed from the cold storage tent (Figure 4) and placed in the Mill building. Photograph of the location of the spill after cleanup is provided as Figure 5. To prevent future occurrences, copper sulphate totes will be stored in the mill building until a suitable structure, with secondary containment, is constructed.

Figure 4. South end of cold storage tent where copper sulphate tote bags were previously stored.

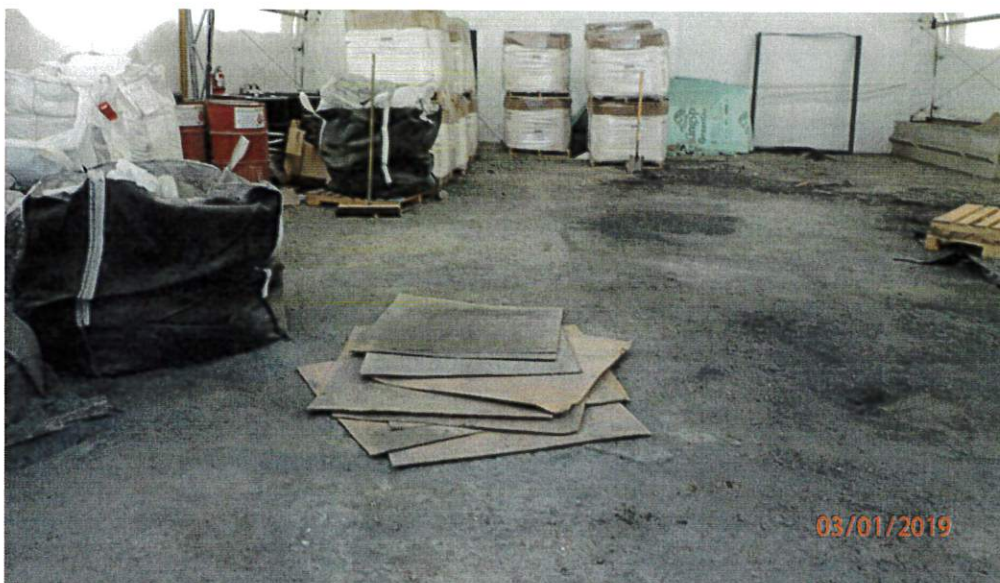
Figure 5. Floor of cold storage tent showing successful clean-up of copper sulphate spillage.

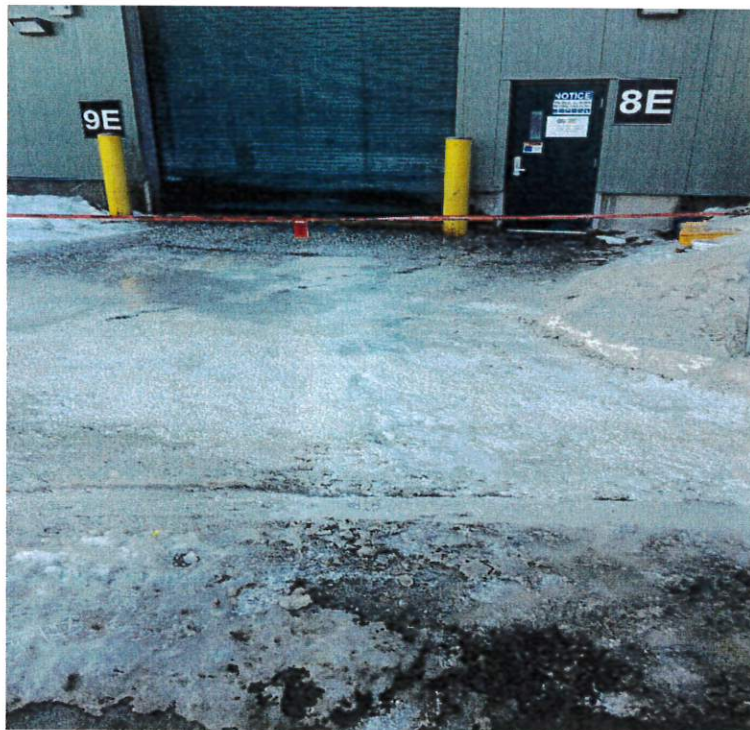
At 17:30 hours on March 12th the mill was receiving a shipment of high calcium quick lime from a transport truck directly into the lime silo. The transfer hose became obstructed due to damp conditions and kinking. When the transport truck operator uncoupled the transfer hose pressure had built up in the line causing approximately 25 kilograms of lime to be spilled. See photo below (lighter areas are snow).

To prevent another similar event from occurring in future, modifications will be made to the lime silo. The loading pipe will be raised to prevent kinks from forming in the transfer hose which is suspected to have contributed to the blockage.

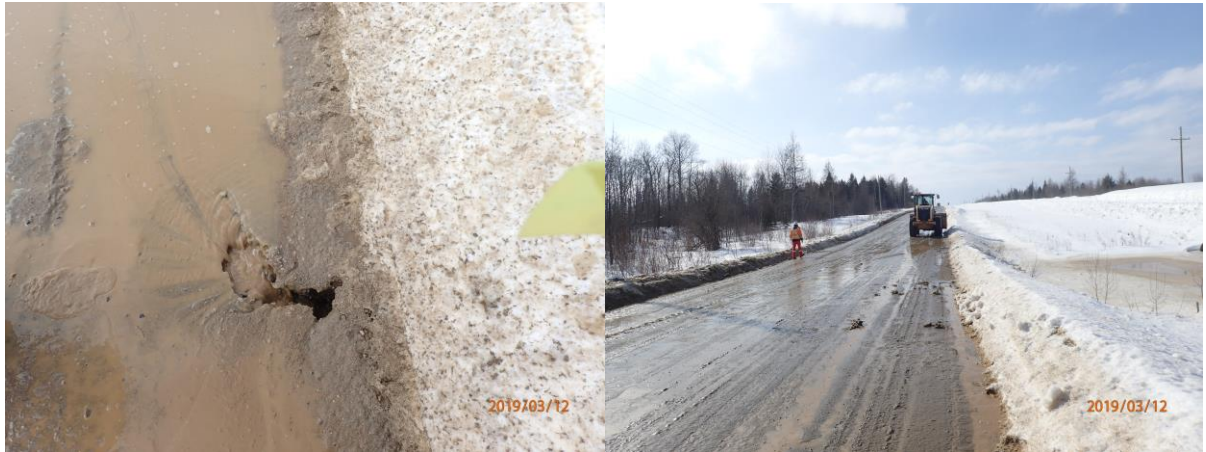
The water flowing through the culvert appeared to be picking up sediment from road material that had thawed, eroded holes through the road bed and entered the watercourse at the upstream end of the culvert. Upon discovery of the turbid water, an in-field turbidity analyses was completed which determined the turbidity to be 77.9 NTU. Another sample was collected that was sent to a licensed external laboratory for total suspended solids and turbidity analyses which were determined to be 24.0 mg/L and 78.3 NTU, respectively.

Figure 2. Eroded hole in Roen Road allowing turbid water from road to enter West Creek (left). Condition of road when mitigation measures were being installed by loader (right).

Water Management General Foreman was contacted and dispatched a loader and supervisor to install mitigation measures. Clean crushed rock was dumped and packed into the eroded holes by hand. This was then reinforced with sand and packed in with the loader. The loader continued to clean up the road by creating three punch outs on the north side and three punch outs on the south side of Roen Road. Small swales were built with shovels to promote water relay to ditches.

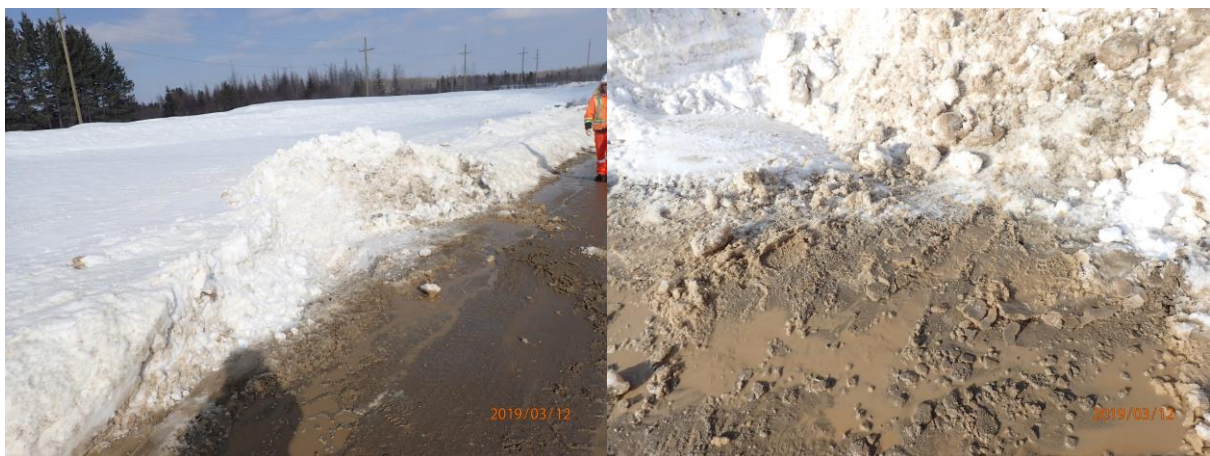
Figure 3. Punch out created on north side of Roen Road (left). Small swale made with shovel to help promote water-shedding from Roen Road (right).

The punch-outs created during this event will be inspected and maintained through the freshet. A site wide inspection will also occur to identify other locations that may require punch-outs to be installed. This will help mitigate any future total suspended solid exceedances from site roadways.

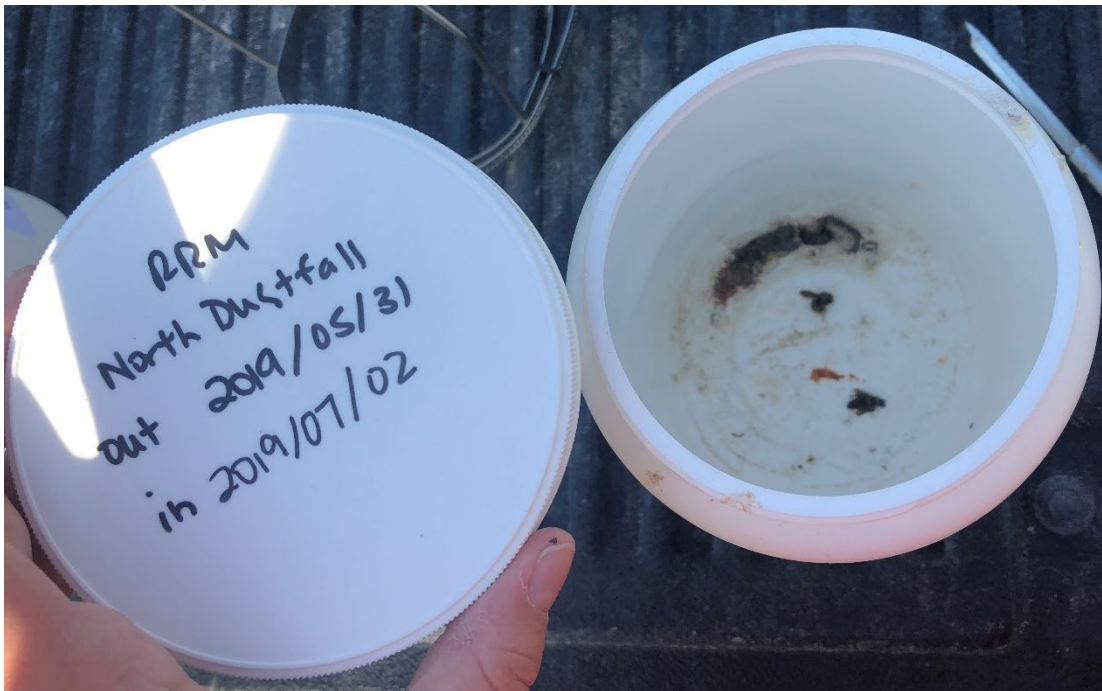
Upon further analysis of the laboratory results, I determined that 9.99 g/m<sup>2</sup>/30-day of the total dustfall was volatile (organic) matter. Tables 1, 2 & 3 outline the laboratory results for this sample. As you can see in Figure 1, the dustfall jar for the month of June collected at least two insects, as well as bird droppings. The elevated total dustfall result is likely caused by these organic sources.

**Figure 1. June Dustfall Jar illustrating organic influences.**

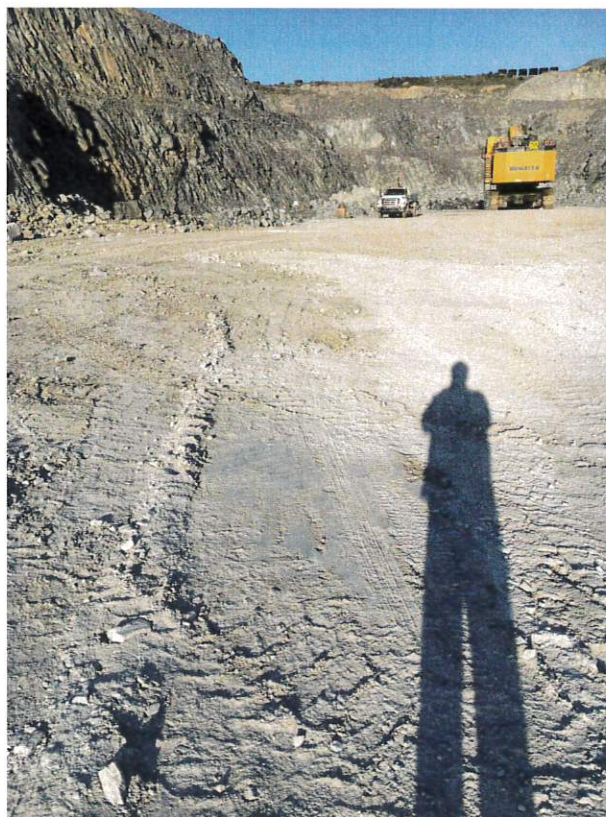
Approximately 5 yards of contaminated gravel was collected and placed in a contaminated soil bin for removal offsite by a certified hazardous waste hauler. See below photos of the spill area cleaned up. The area was returned to the original grade.

Figure 2. Location of spill after cleanup.

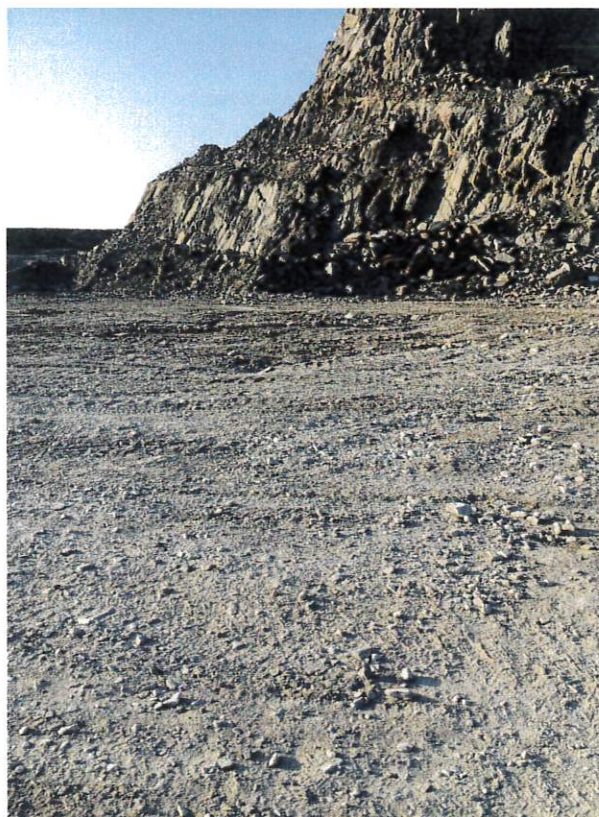
Figure 3. Location of spill after cleanup.

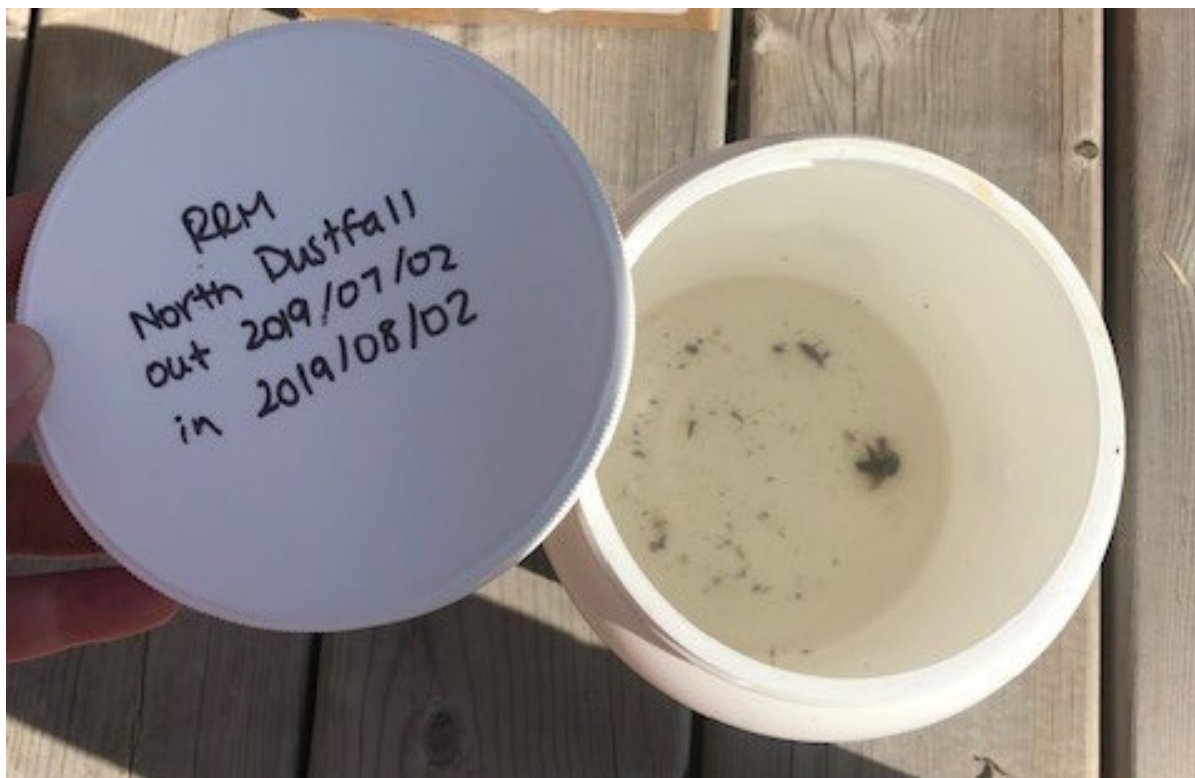
Upon further analysis of the laboratory results, it was determined that 7.05 g/m<sup>2</sup>/30-day of the total dustfall was volatile (organic) matter. Tables 1, 2 & 3 outline the laboratory results for this sample. As seen in Figure 1, the dustfall jar for the month of July collected at least one large intact insect as well as other organic influences. As a result, the elevated total dustfall is likely caused by these organic sources.

**Figure 1. July Dustfall Jar illustrating organic influences.**

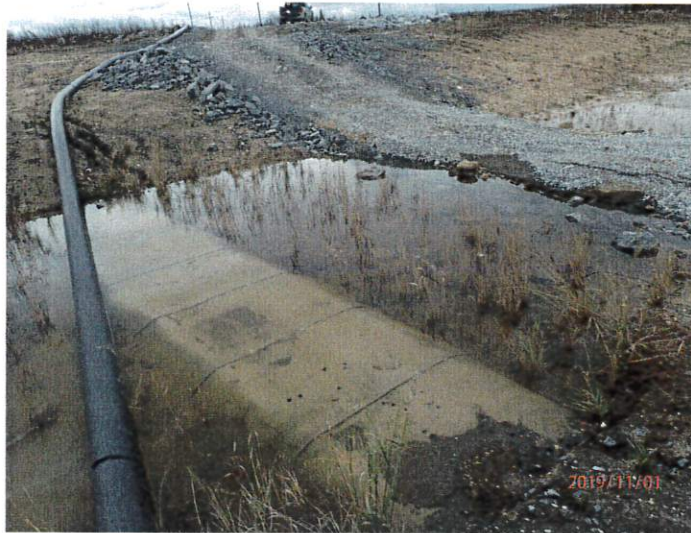
Further to the notification to the Spills Action Center (SAC) Reference # 0476-BHHRKC, on November 1, 2019 at 11:30 am, it was noticed that the spillway at the Water Discharge Pond (WDP) had been triggered, resulting in an unplanned effluent release from the Water Discharge Pond into Lower Loslo Creek via land (Figure 1).

Figure 1 shows water flowing over sill in WDP Spillway and headed to remnant Loslo Creek.

The spillway was triggered at the WDP due to an error in operational conditions.

Mitigation measures to prevent this type of error in the future include daily survey of water levels when water level is close to the maximum operating water level (MOWL) and weekly surveying of water levels thereafter.

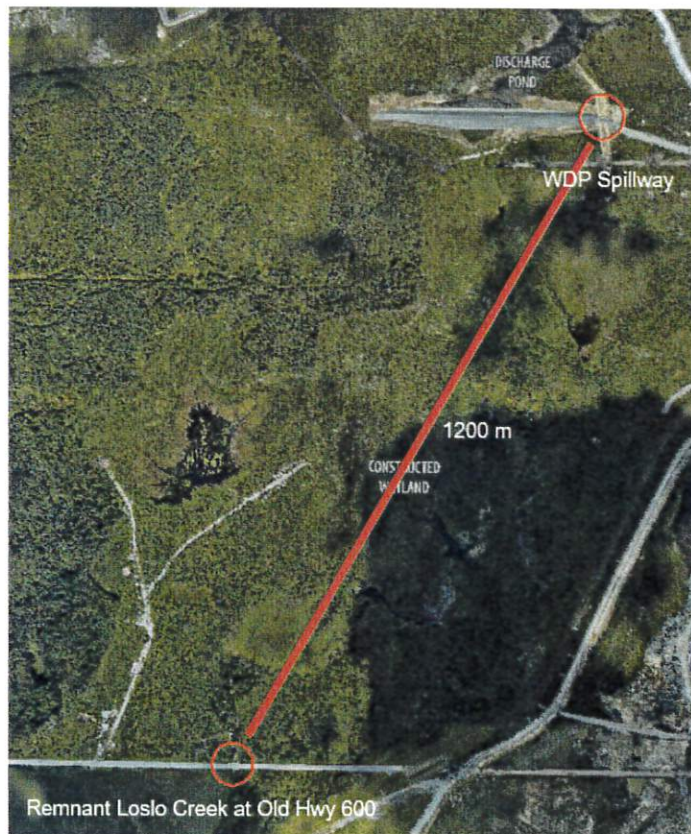
Figure 2 Red circles show where samples were collected at WDP Spillway and remnant Loslo Creek at old Hwy 600. Water travelled approximately 1200 m through the remnant creek with multiple beaver dams and thick vegetation.

The water level in the WDP decreased significantly by Friday, November 1. Water flowing over the sill froze. However, a 25 cm section of the 3 m wide sill remained open. The pond level reduced further over the course of the day causing water to stop flowing over the sill by 2 pm on Saturday, November 2<sup>nd</sup>. Water travelled through heavily vegetated undulatory remnant creek bed with numerous beaver dams before reaching Loslo Creek below Hwy 600 (Figure 2).
