**NEW GOLD RAINY RIVER MINE
APPENDIX K
EXCEEDANCE LETTERS
SUBMITTED TO MECP**

SUBJECT: NORTHWEST STATION AMBIENT AIR QUALITY EXCEEDANCE OF 24-HOUR TOTAL SUSPENDED PARTICULATE MONITORING LIMITS

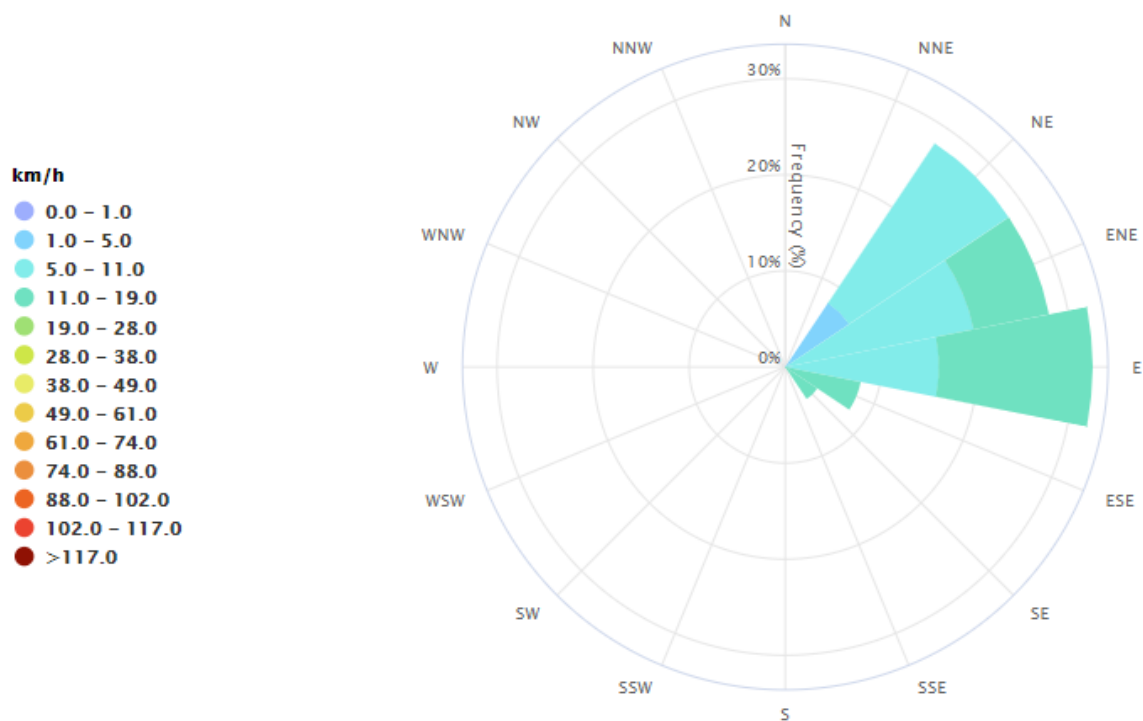
TSP samples were collected during a 24-hr period on January 28, 2021 as per Rainy River Project Ambient Air Quality Monitoring Plan, accepted by MECP on November 9th, 2016. During this 24-hour period, predominant wind direction was from the east to northeast (Figure 2). With these wind directions, the preliminary investigation identified the source of the dust would likely be from the Rainy River Mine Site TMA activities.

Figure 2: Windrose from January 28, 202 at Barron Weather Station

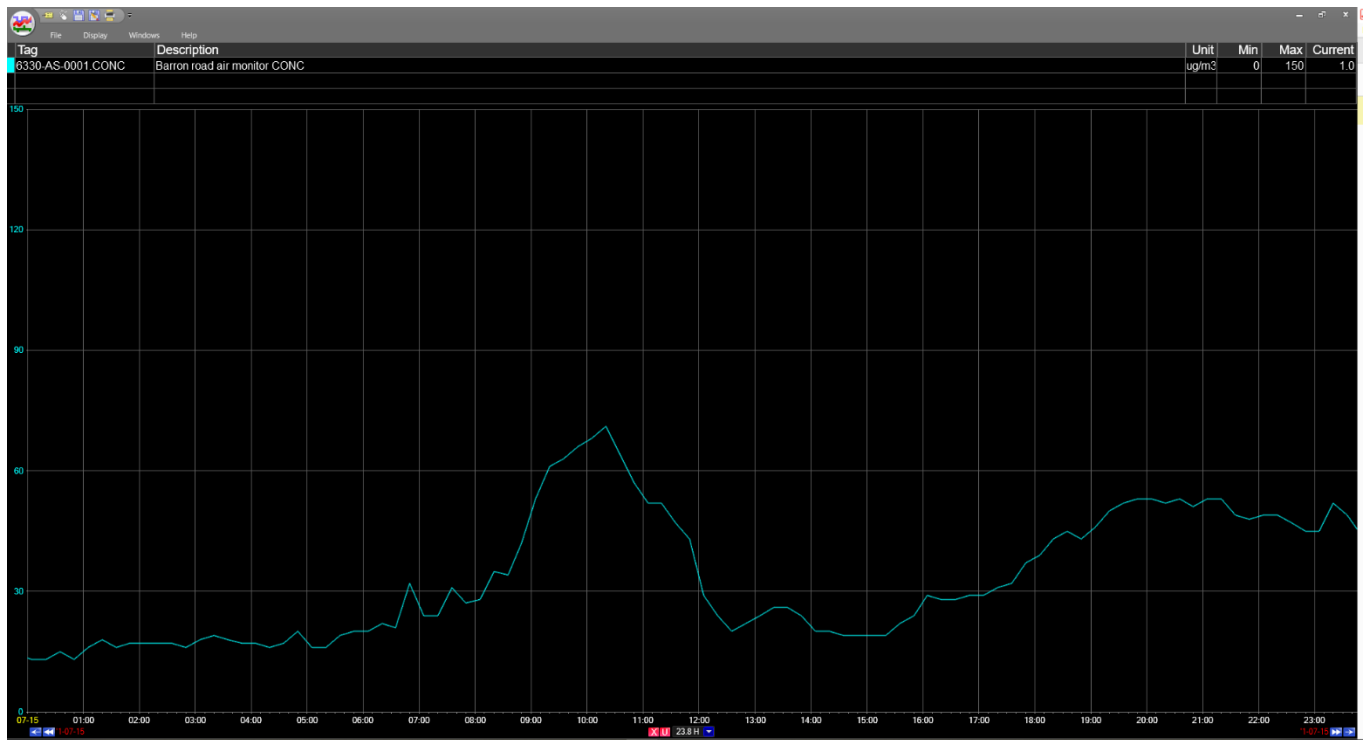
The cause of the exceedance is due to the increased smoke in the area from local wildfires. The other two PQ200 units at RRM also measured very high readings that day (97% and 99%). Below I have also attached the E-Sampler readings for the day which show consistently elevated total suspended particulate readings over the 24 hours from July 15, 2021.

Figure 1 Barron Site E-Sampler readings for July 15, 2021 (ug/m3)

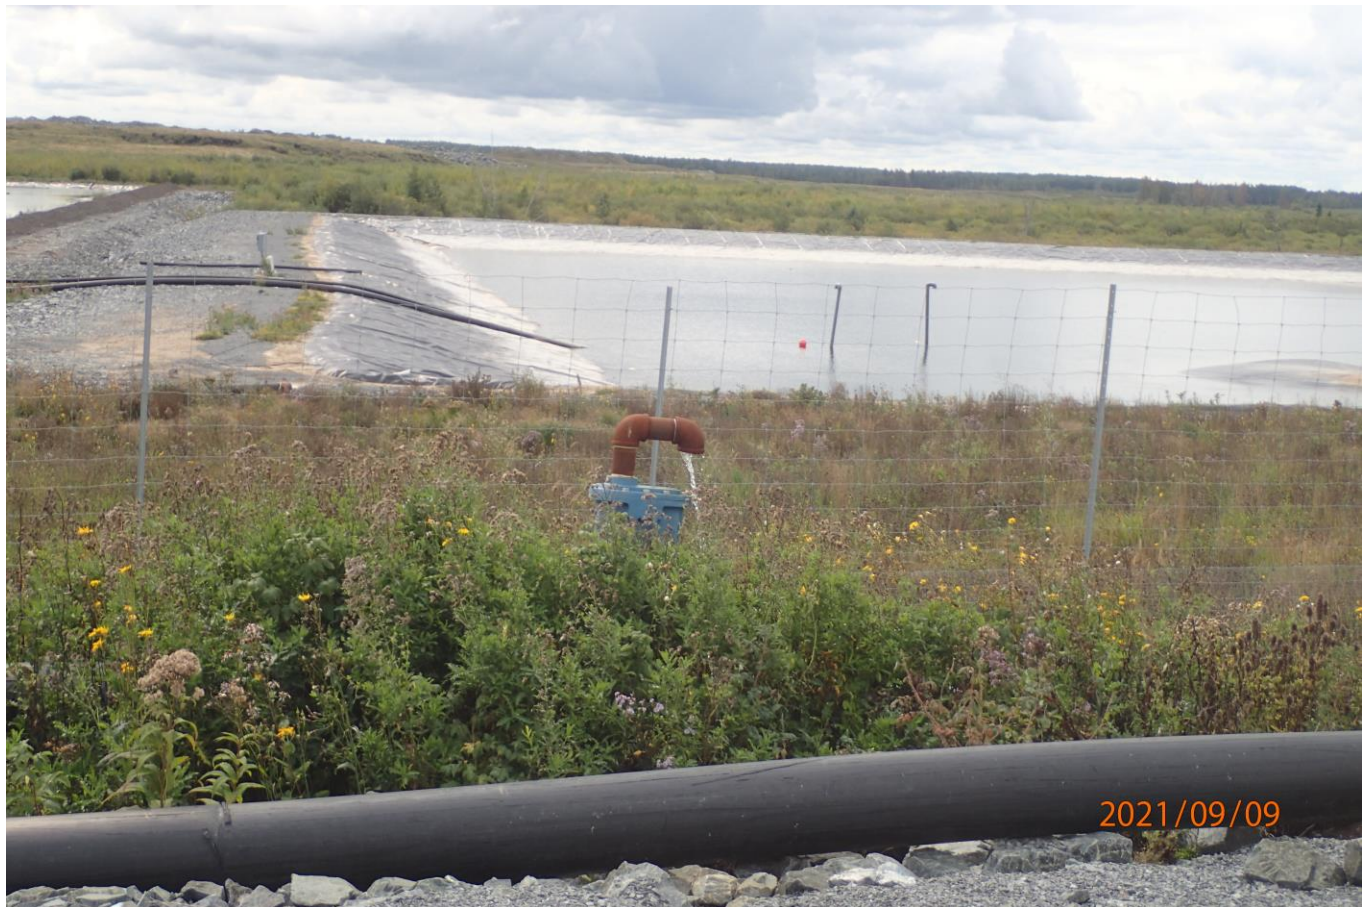
Photo 1: Leaking valve.

The bucket test indicated a total loss of 33.6 m³ of water, if we assume the leak started immediately after the valve was last observed functioning at 10 am, the previous day, by New Gold Environment staff during water level checks. Given the

distance to fish bearing waters from this point (1.4 km), the volume of water lost and the extreme dry conditions of the year is it unlikely that this water reached fish bearing waters.

No cleanup was attempted for this event as it would have caused more harm than good to the surrounding environment. To prevent this from reoccurring a different style of valve will be selected or an isolation valve will be added.

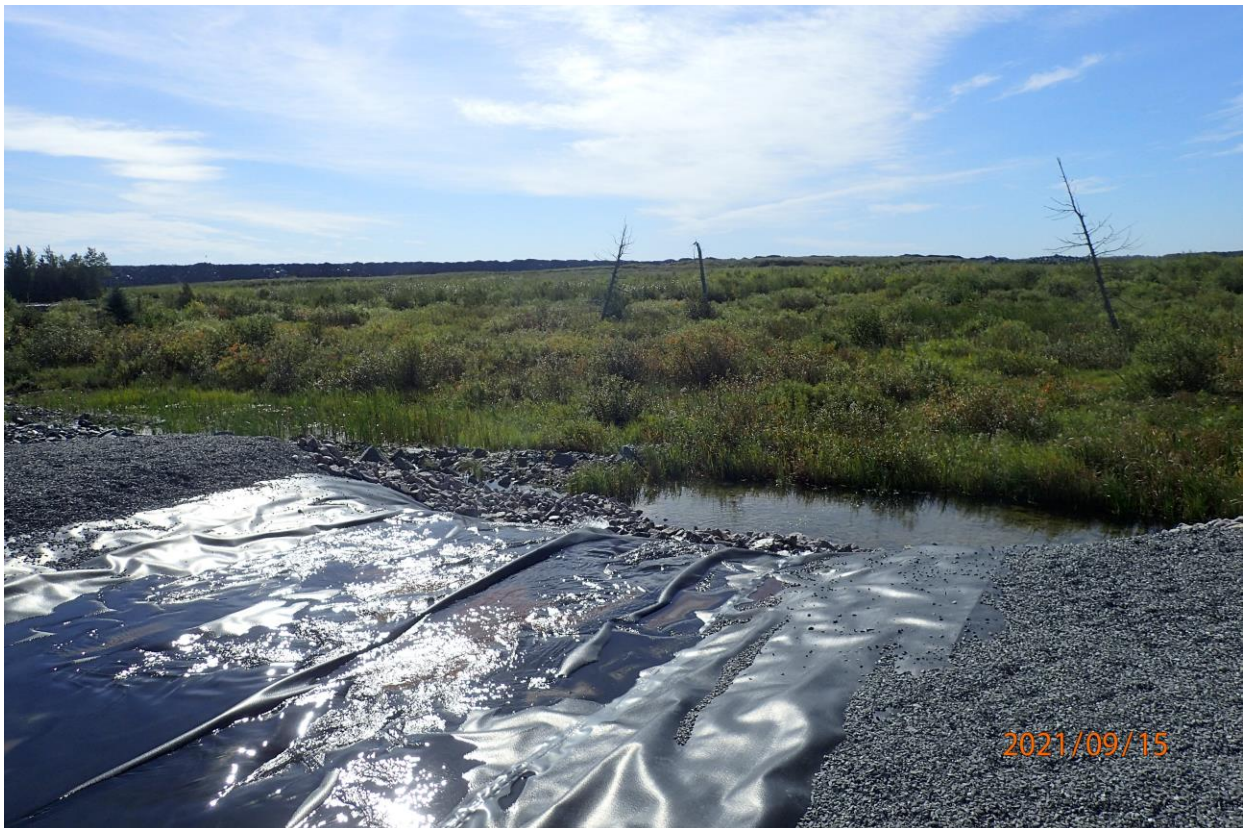
Photo 1: Outflow Basin emergency spillway active.

The volume of water lost is estimated to be 21,000 m³ of treated mine effluent and would have made it to fish bearing waters in Loslo Creek and the Pinewood River. The primary reasons for this occurrence are that the pump sending water from OB to WMP lost prime and the level indicator for OB was not calibrated correctly. Please refer to the screen shot below from PARCView for greater detail and timeline.

As mentioned in the table above, sensors have been recalibrated, additional personnel are being assigned responsibility, the requirement for visual observations and documentation has been made clear and cameras will be added in this location in an effort to ensure this does not reoccur.

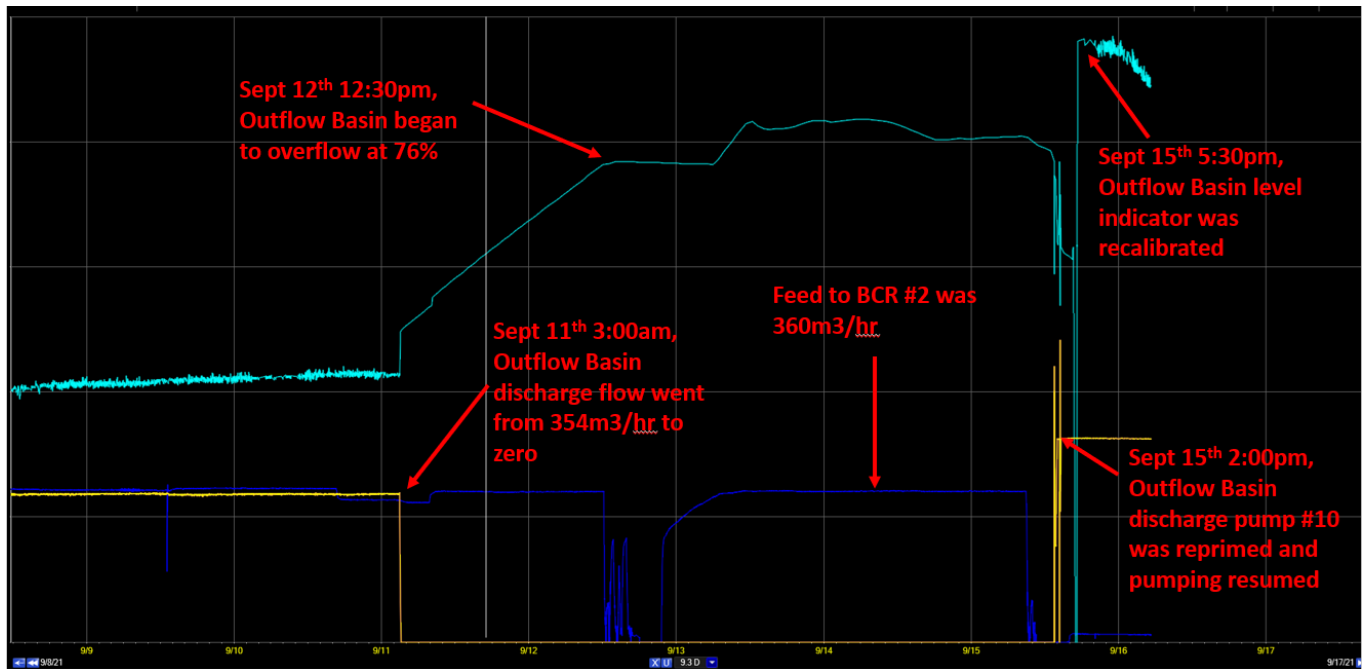
PARCView screen shot.
