**NEW GOLD RAINY RIVER MINE
APPENDIX B
EMRS RECORD OF CONSTRUCTION**

2022 EMRS Progressive Reclamation Record of Construction

1003-223-001

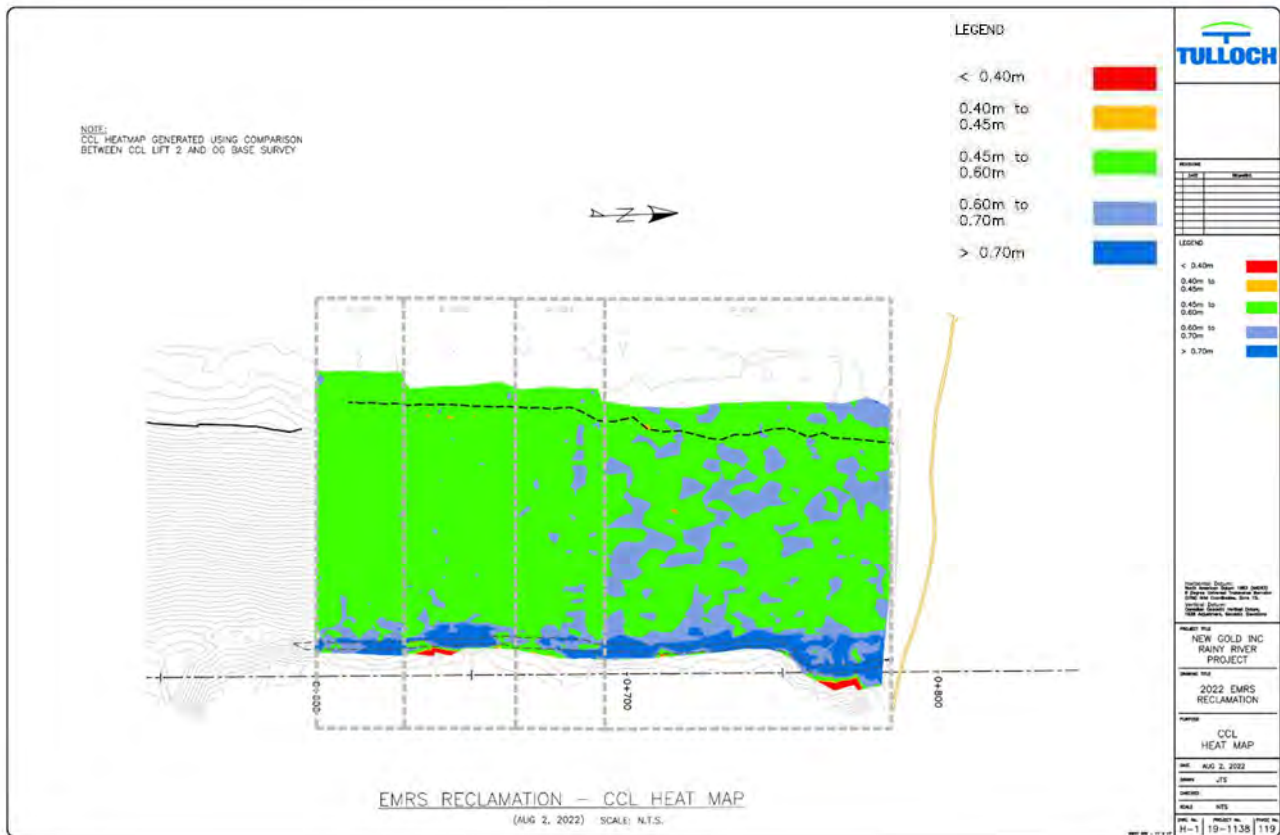
Figure 4.2: EMRS 2022 CCL thickness heat map (from Tulloch, 2022b).

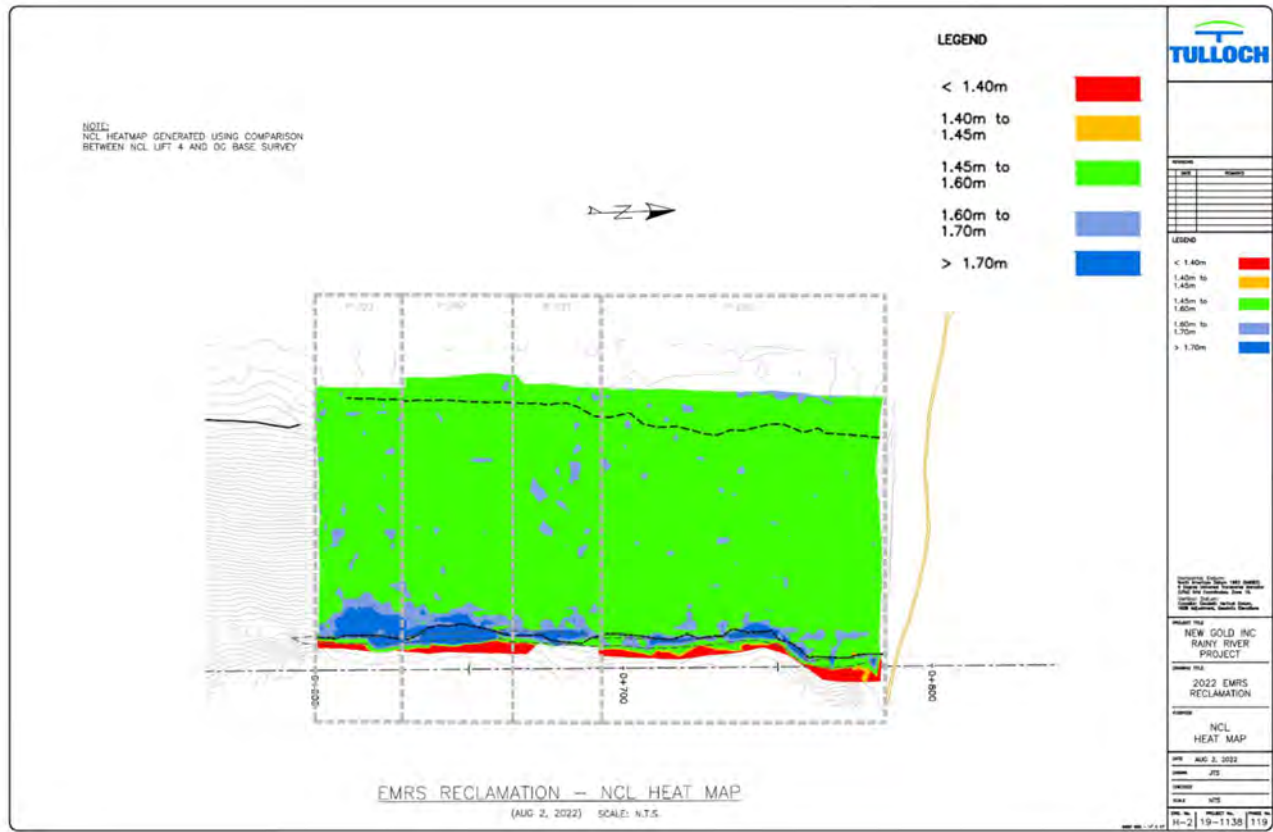
Figure 4.3: EMRS 2022 NCL thickness heat map (from Tulloch, 2022c)

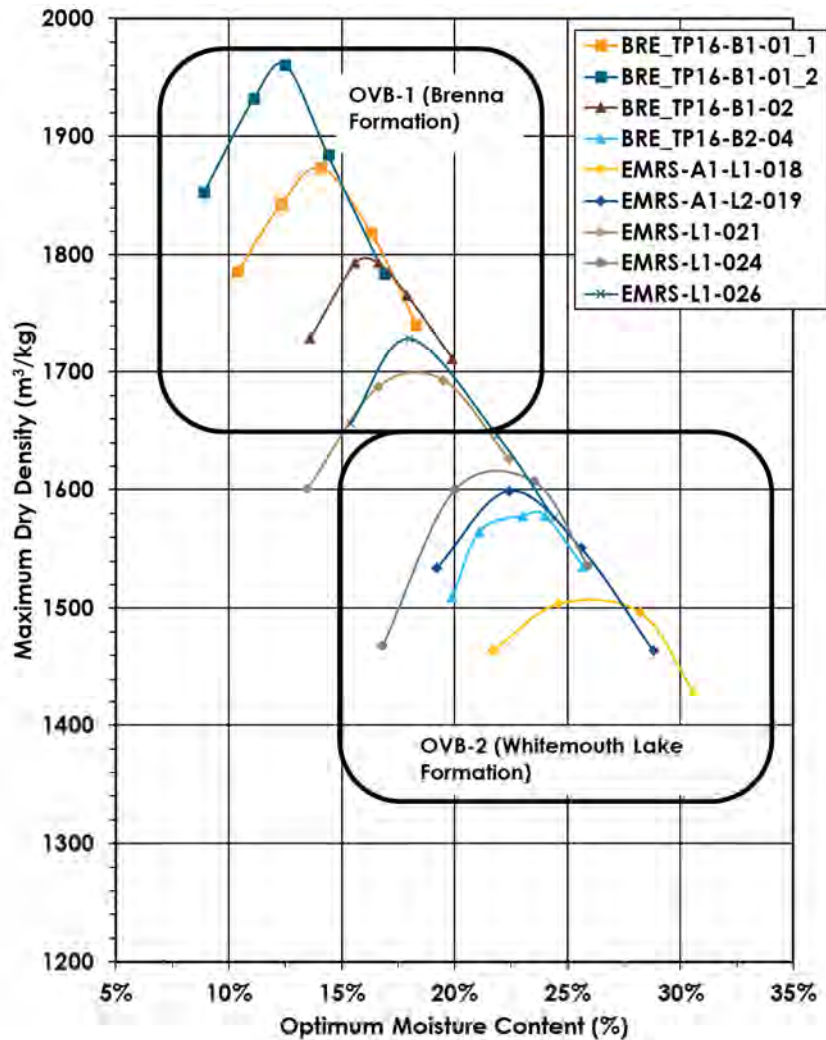
Figure 5.1: Compaction curves from field testing program

Samples EMRS-A1-L1-018, EMRS-A1-L2-019, and EMRS-L1-021 were in situ CCL material. This material comprised a higher proportion of clay sized particles, a higher plasticity index, and compaction characteristics more characteristic of WML. The difference in optimum water

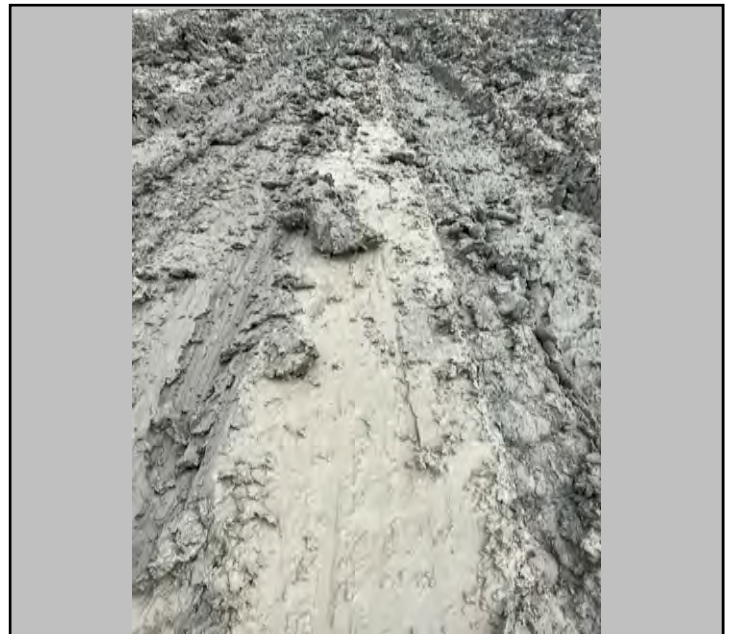
Photo #: 4

L3 conditions after heavy rainfall

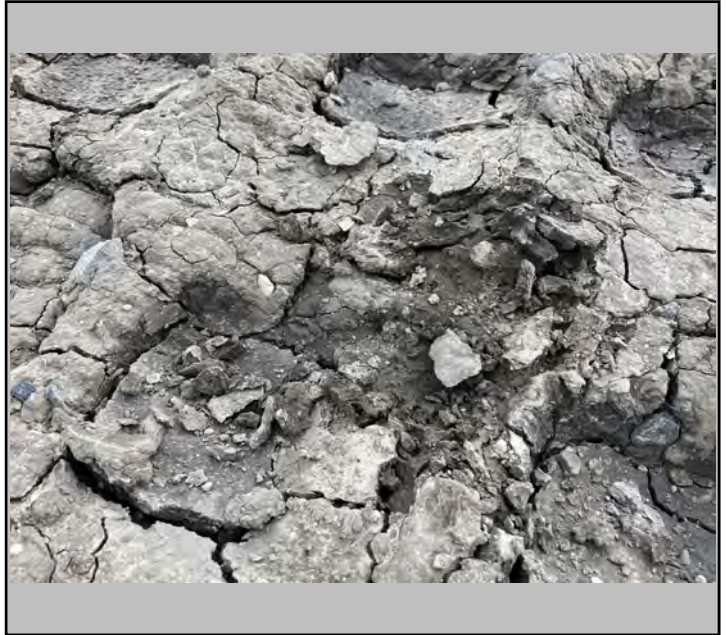
Photo #: 2

P30 L2 showing some surface drying at top of
sheepsfoot roller near end of day

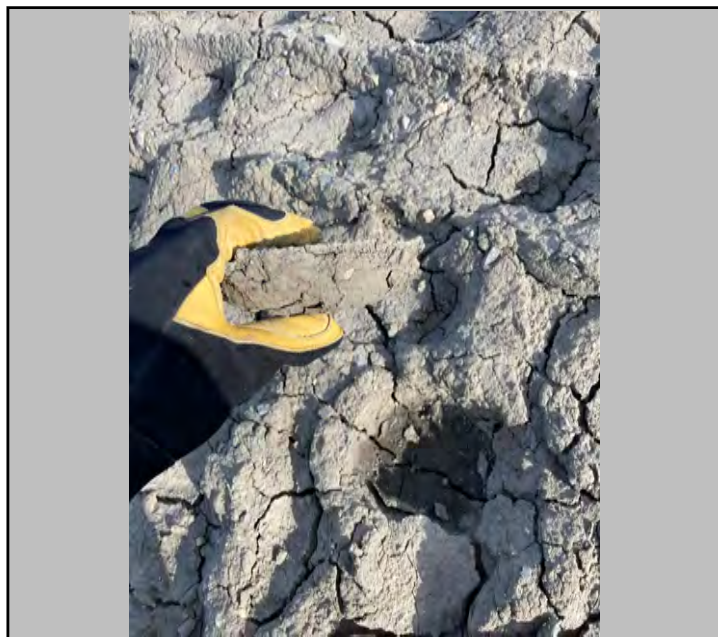
Photo #: 1

P30 L2 desiccation continues

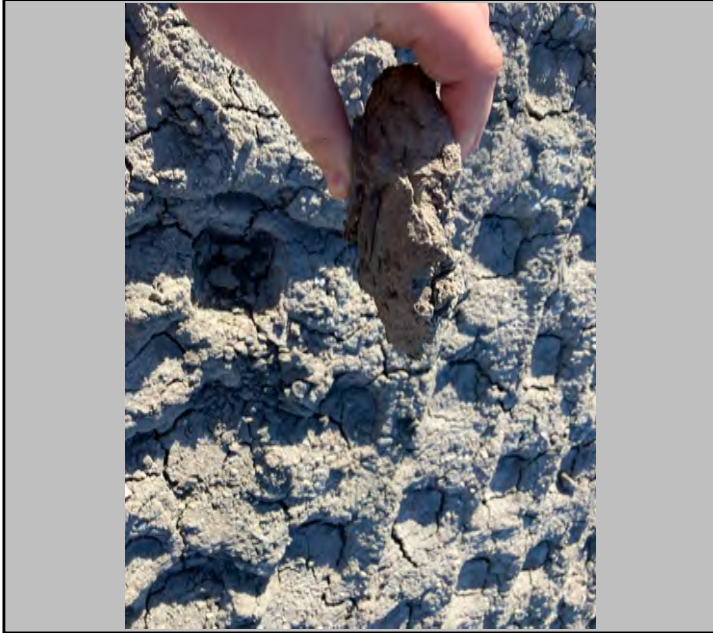
Photo #: 1

P30 L2 desiccation continues

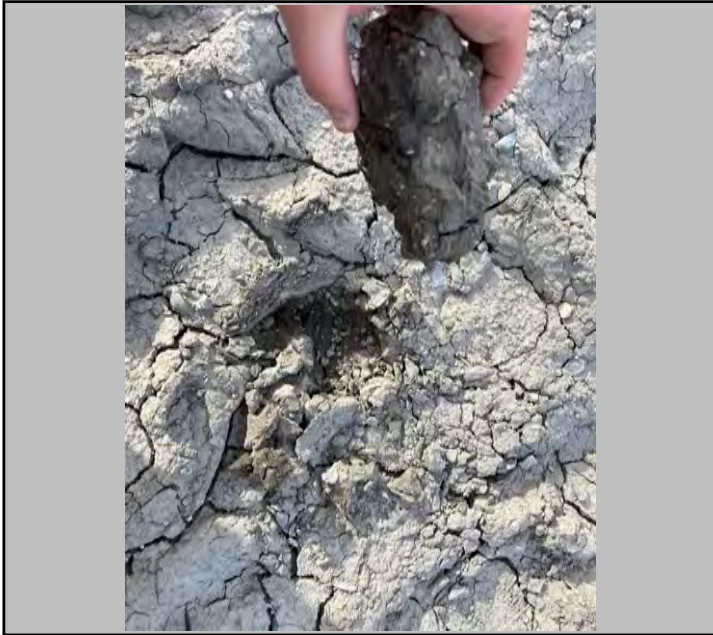
Photo #: 1

P30 L2 desiccation continues

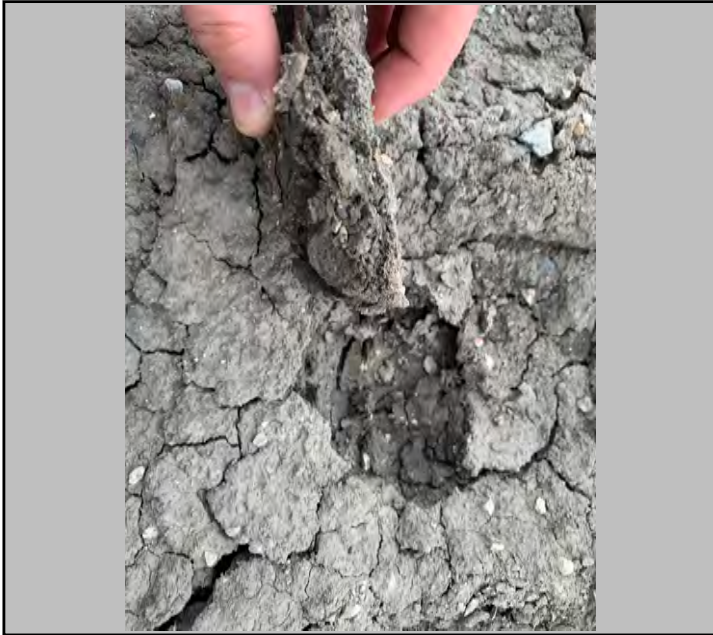
Photo #: 1

Minimal crusting on P30 L2

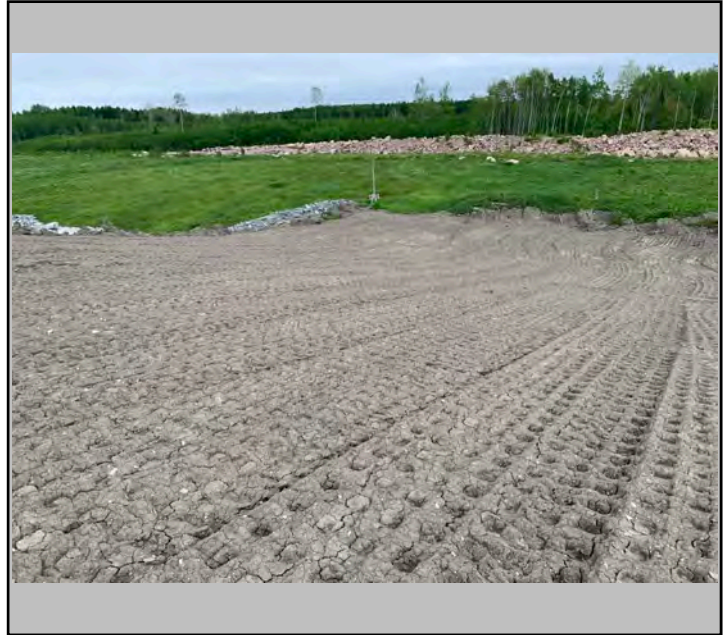
Photo #: 2

P30 L2 cracking present

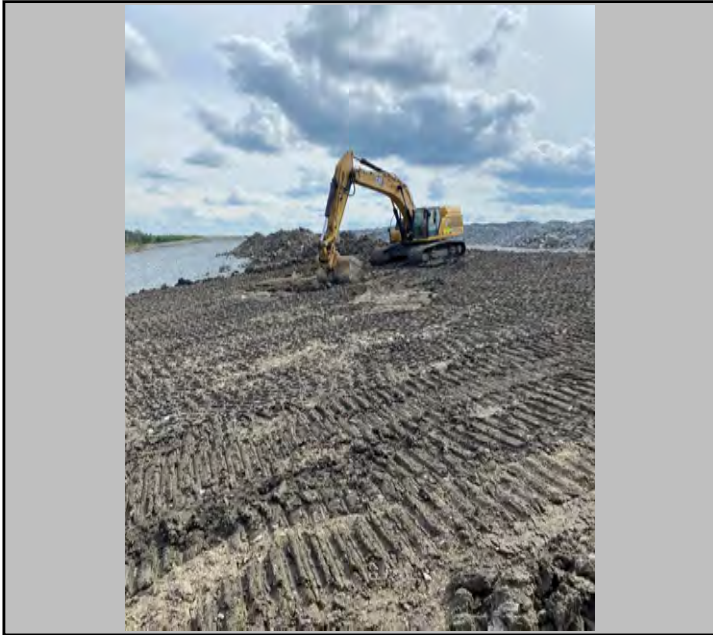
Photo #: 5

Excavator replacing dry patches with moist material following over size stone removal

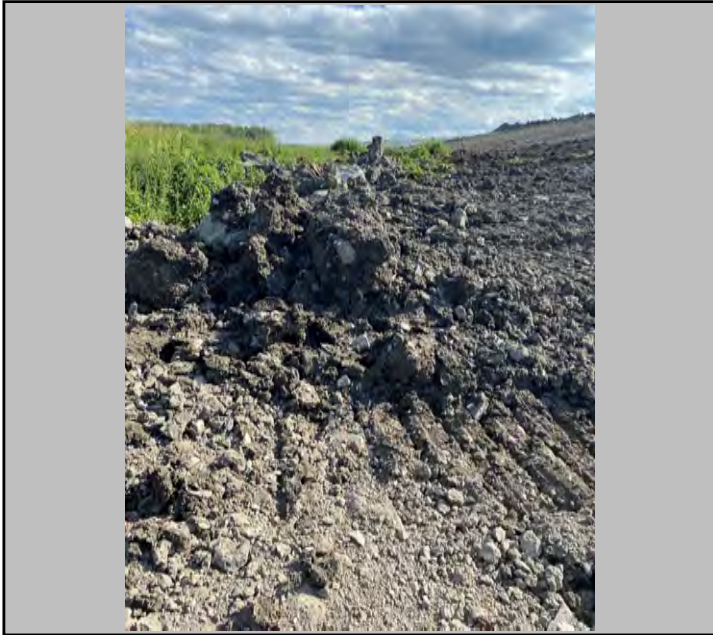
Photo #: 5

Raised material noted at P30 toe

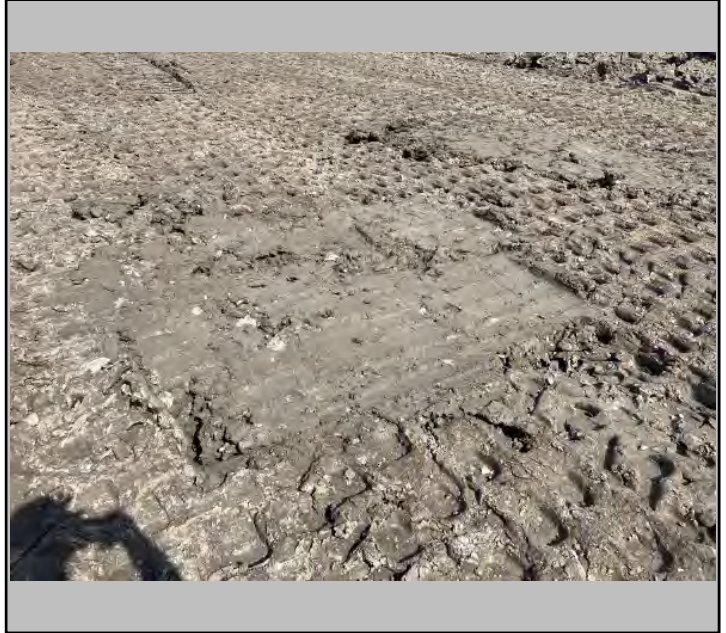
Photo #: 2

Repair following oversize rock removal from P32,
L1

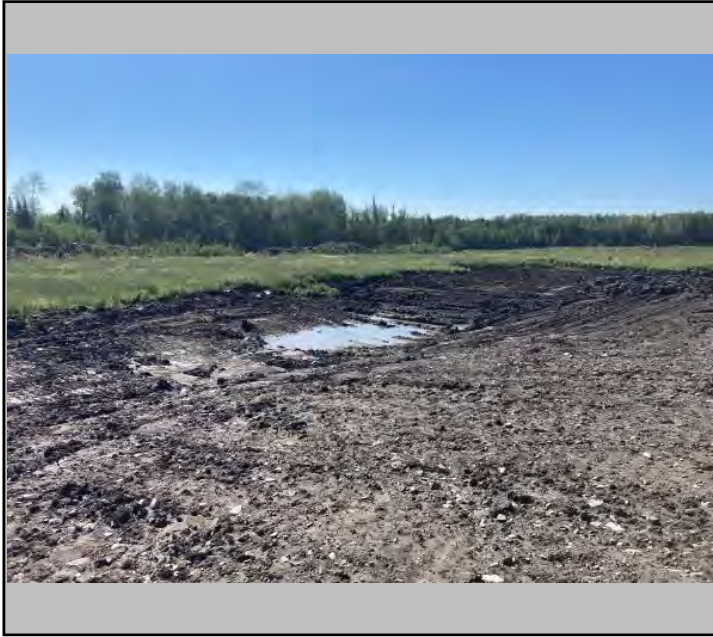
Photo #: 1

Standing water at toe of P30

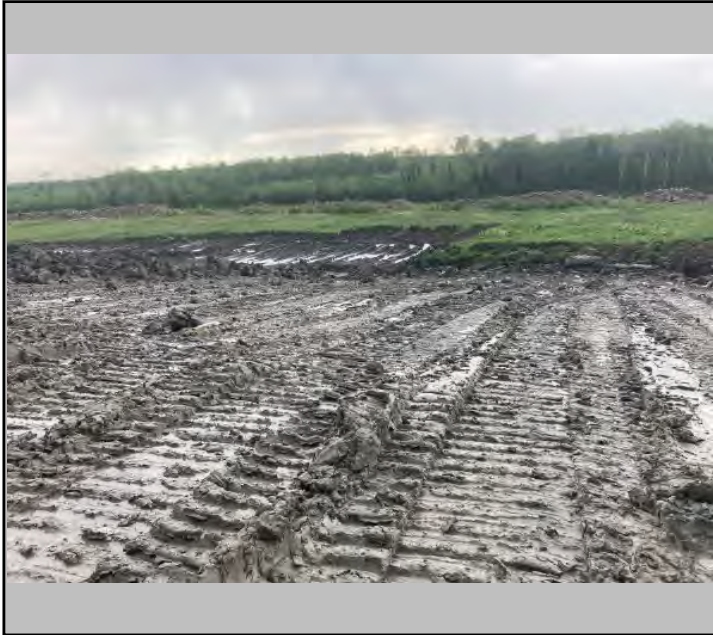
Photo #: 1

Very wet P33, L1 material, with standing water at toe of P32, L3

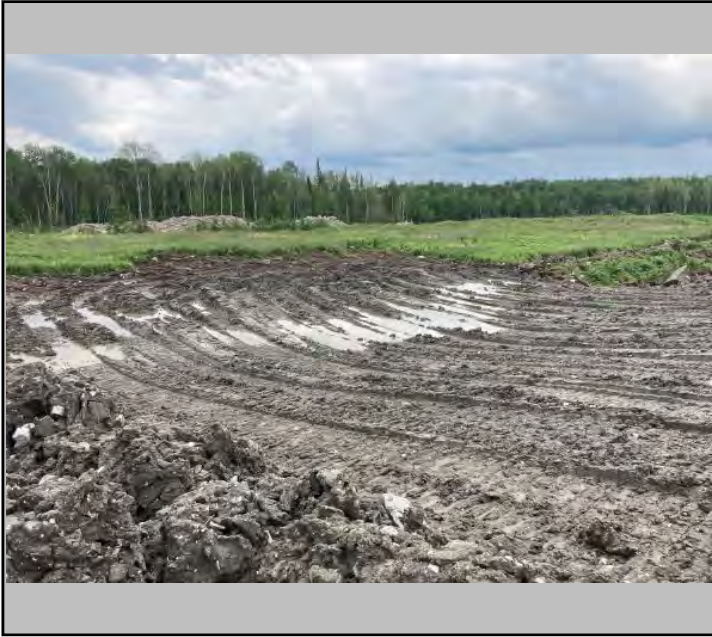
Photo #: 1

Standing water at toe of P32, L3

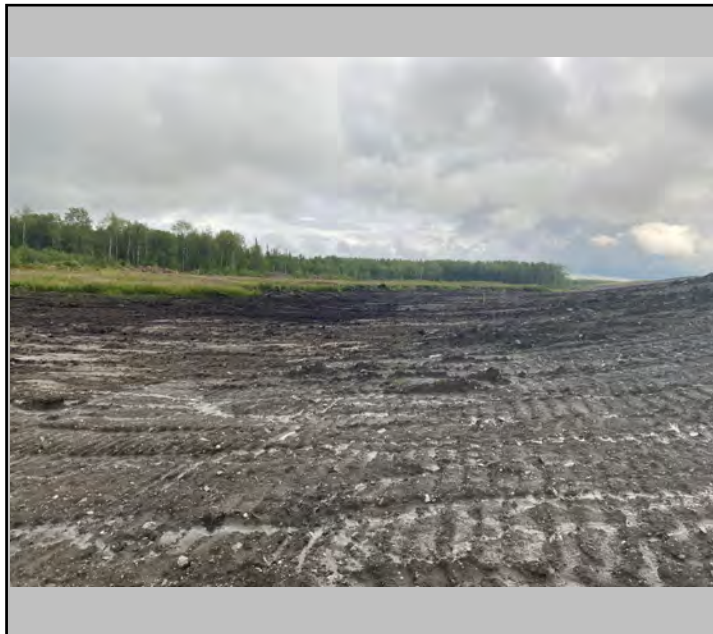
Photo #: 7

P30 toe following rework
