**NEW GOLD RAINY RIVER MINE
APPENDIX K
EXCEEDANCE LETTERS
SUBMITTED TO MECP**

RE: Overpressure Exceedance

APRIL 11, 2022 TOTAL SUSPENDED SOLIDS EXCEEDANCE AT WEST CREEK AND MARR DIVERSION CONFLUENCE

**Re: Emergency Dump Pond #3 and North Dam Seepage Collection Pond #3
Unplanned Effluent Release – SAC Reference #1 - 1RWVOG**

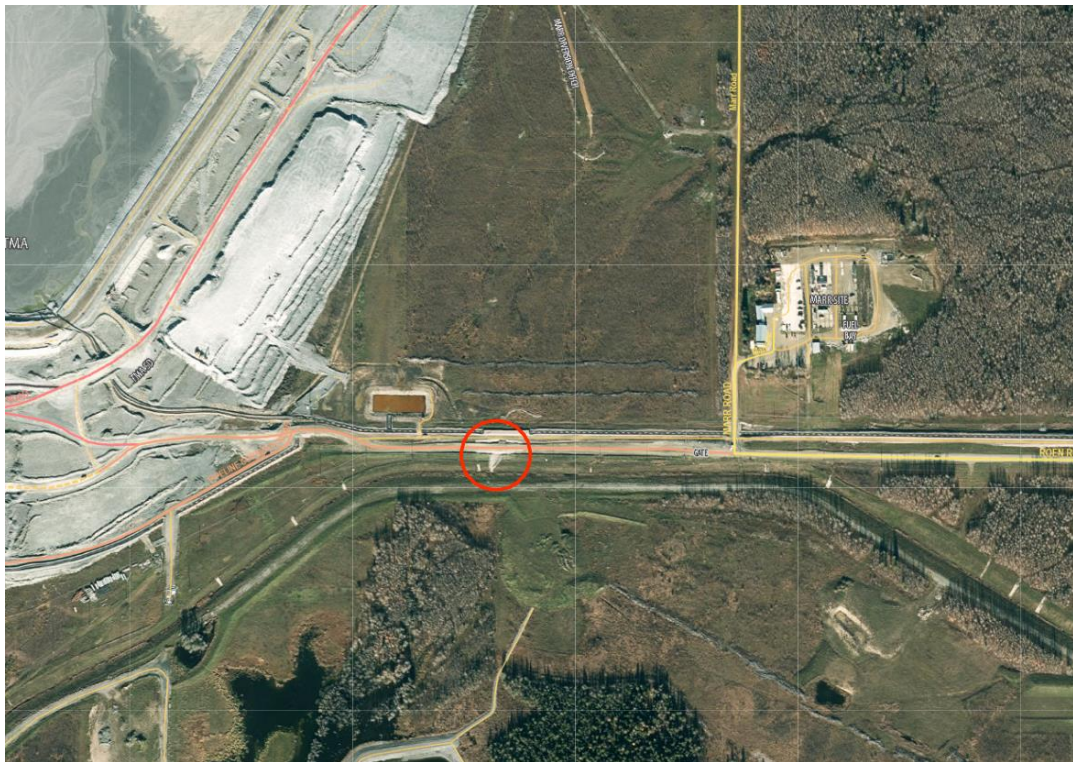
At 16:00 on April 11, 2022, Rainy River Mine Environmental Technician and Monitor observed turbid water mobilizing through Marr Diversion culverts under Roen Road and into West Creek Diversion. A turbidity reading of 45.0 NTU taken, and a total suspended solids (TSS) sample collected per the TSS/Turbidity Monitoring Plan.

Figure 1 Location of turbid water observed travelling through culverts under Roen Road into West Creek Diversion.

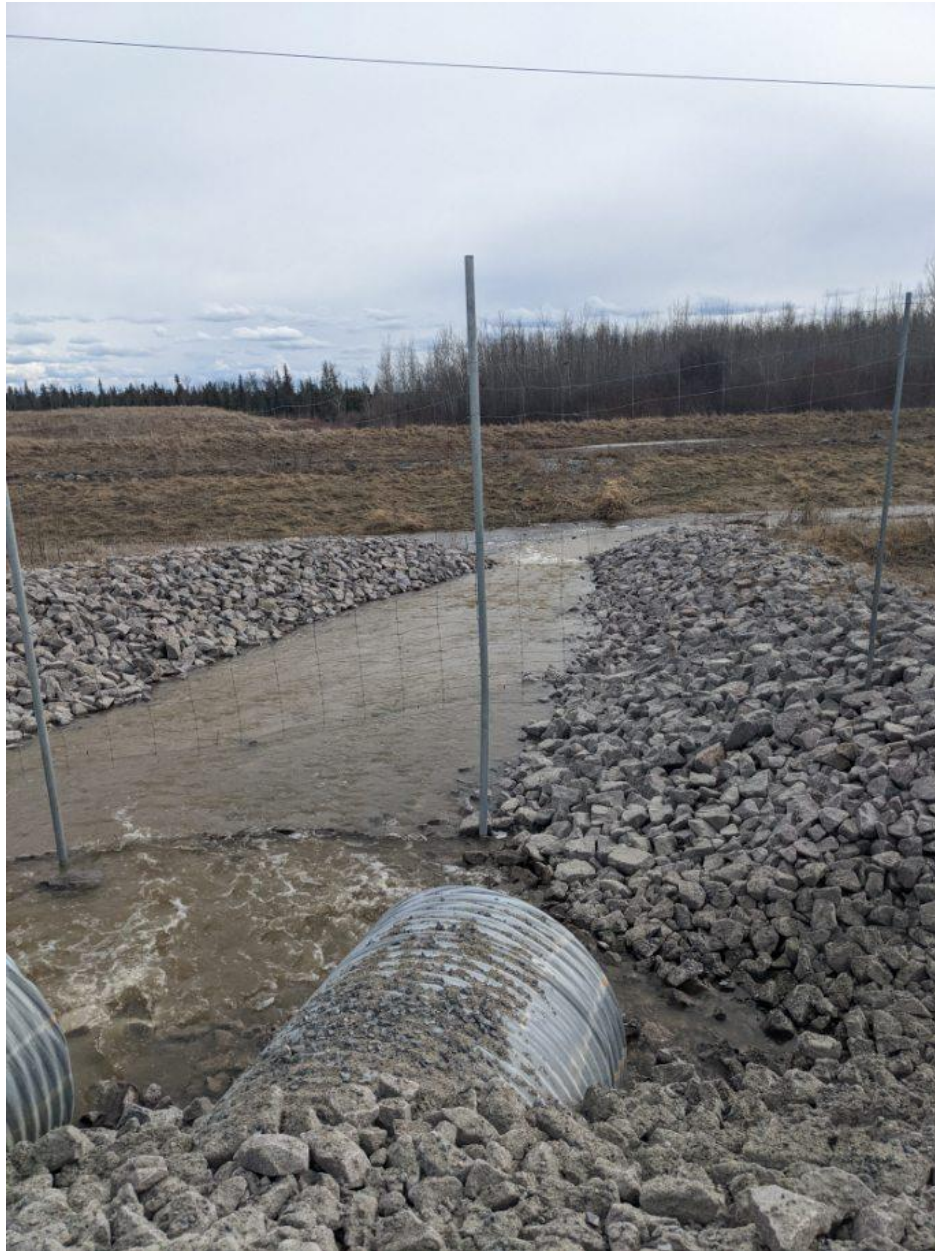
Figure 2 Turbid water observed travelling under Roan Road into West Creek Diversion.

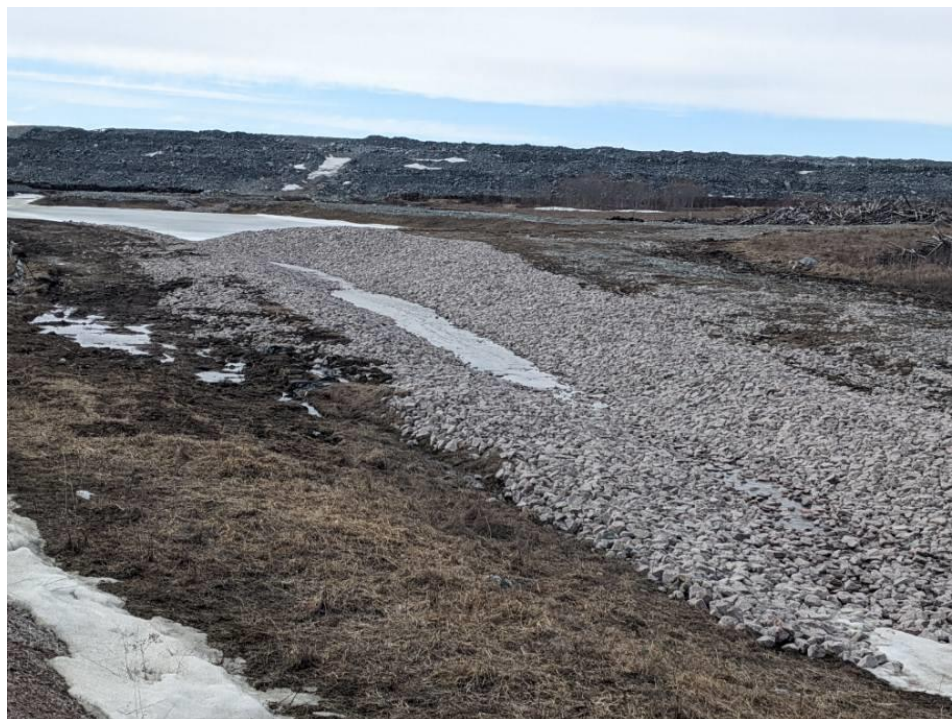
Figure 4 TMA seepage pond spillway activated.

Once it was observed that the recently constructed TMA seepage sump spillway had been activated, a discharge monitoring sample kit was used to collect a sample at Marr Diversion and West Creek Diversion confluence.

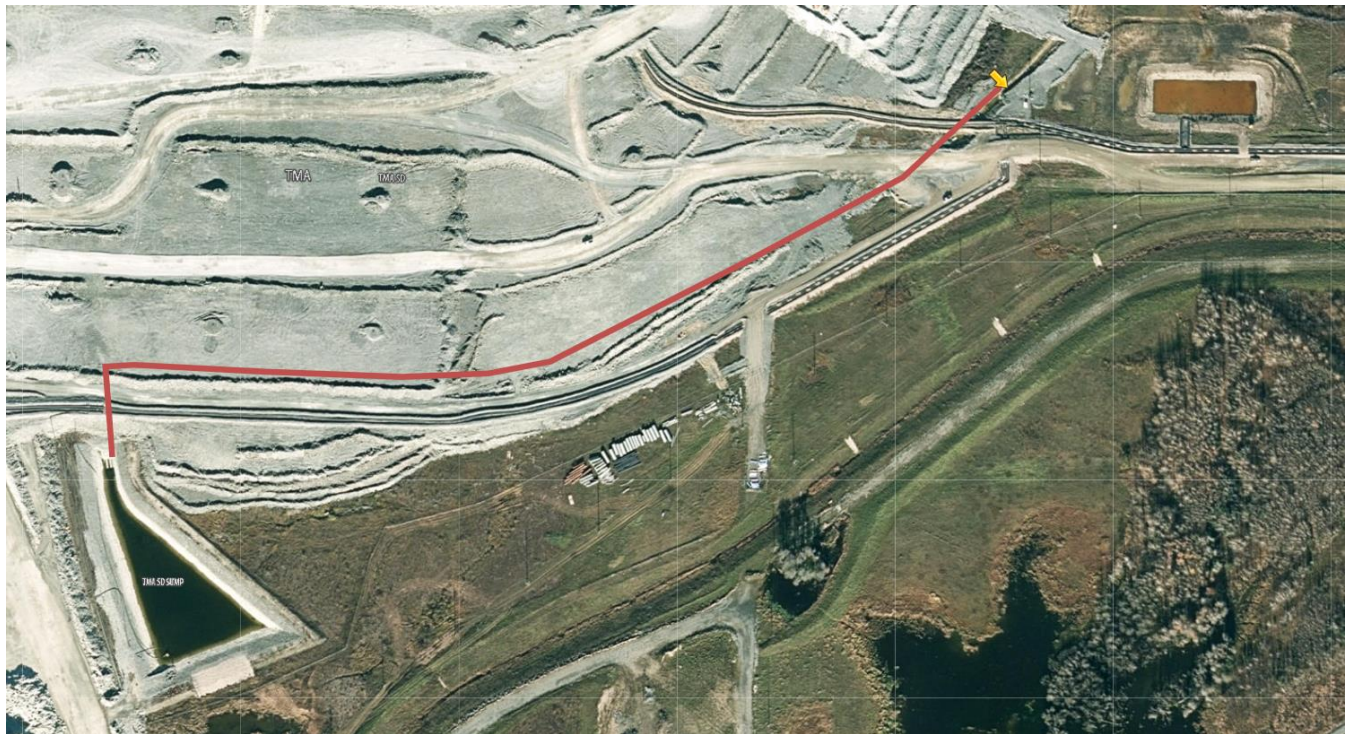
Further investigation found that the Site Services team were currently dewatering the TMA seepage sump into the South Dam seepage ditch that was a French drain to drain it to the downstream South Dam seepage sump. It was observed that the French drain was not conveying the pumped volume and was draining back into the original sump activating the spillway. Site Services was made aware of the situation and mobilized a High-Volume pump to tie straight into the tailings line and pump the additional water to the TMA. The water from this TMA seepage sump stopped spilling through the spillway at approximately 04:00 April 12, 2022.

Figure 5 Red line delineates approximate path of South Dam seepage collection ditch French drain. Yellow arrow delineates approximate discharge location of dewatering pump.

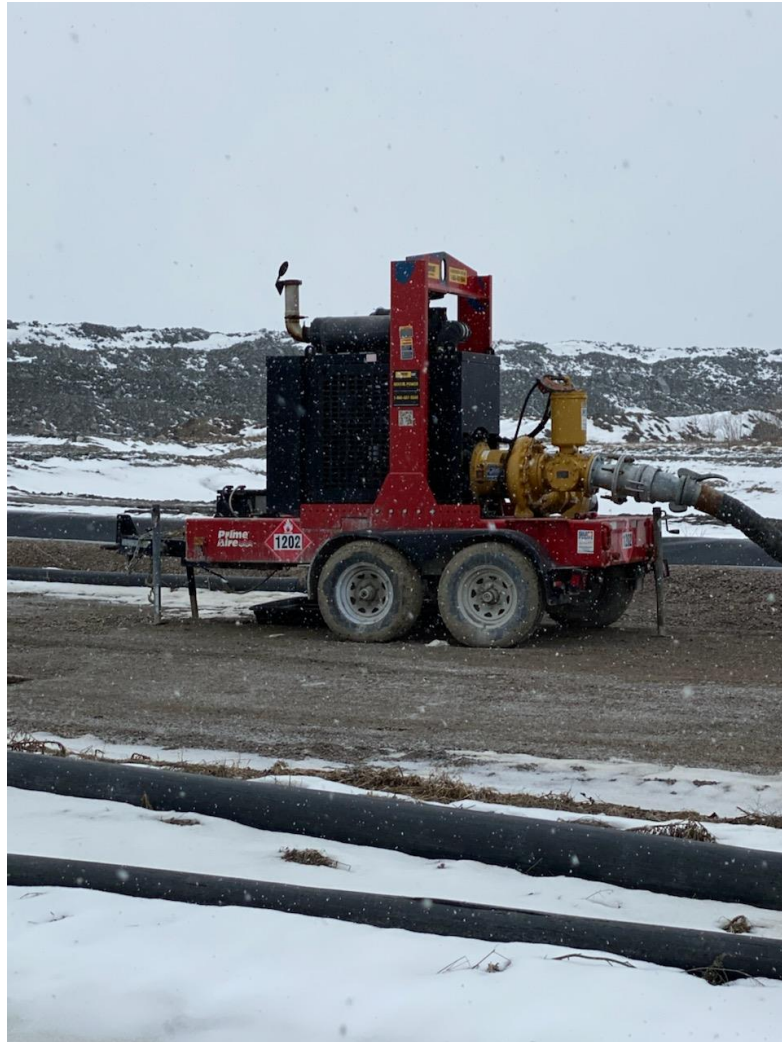
Figure 6 High-Volume pump installed to discharge water straight into tailings line and into the TMA.

to deal with the excess water experienced during this incident. High-Volume pump used during the incident will remain in place until second electric pump is installed.

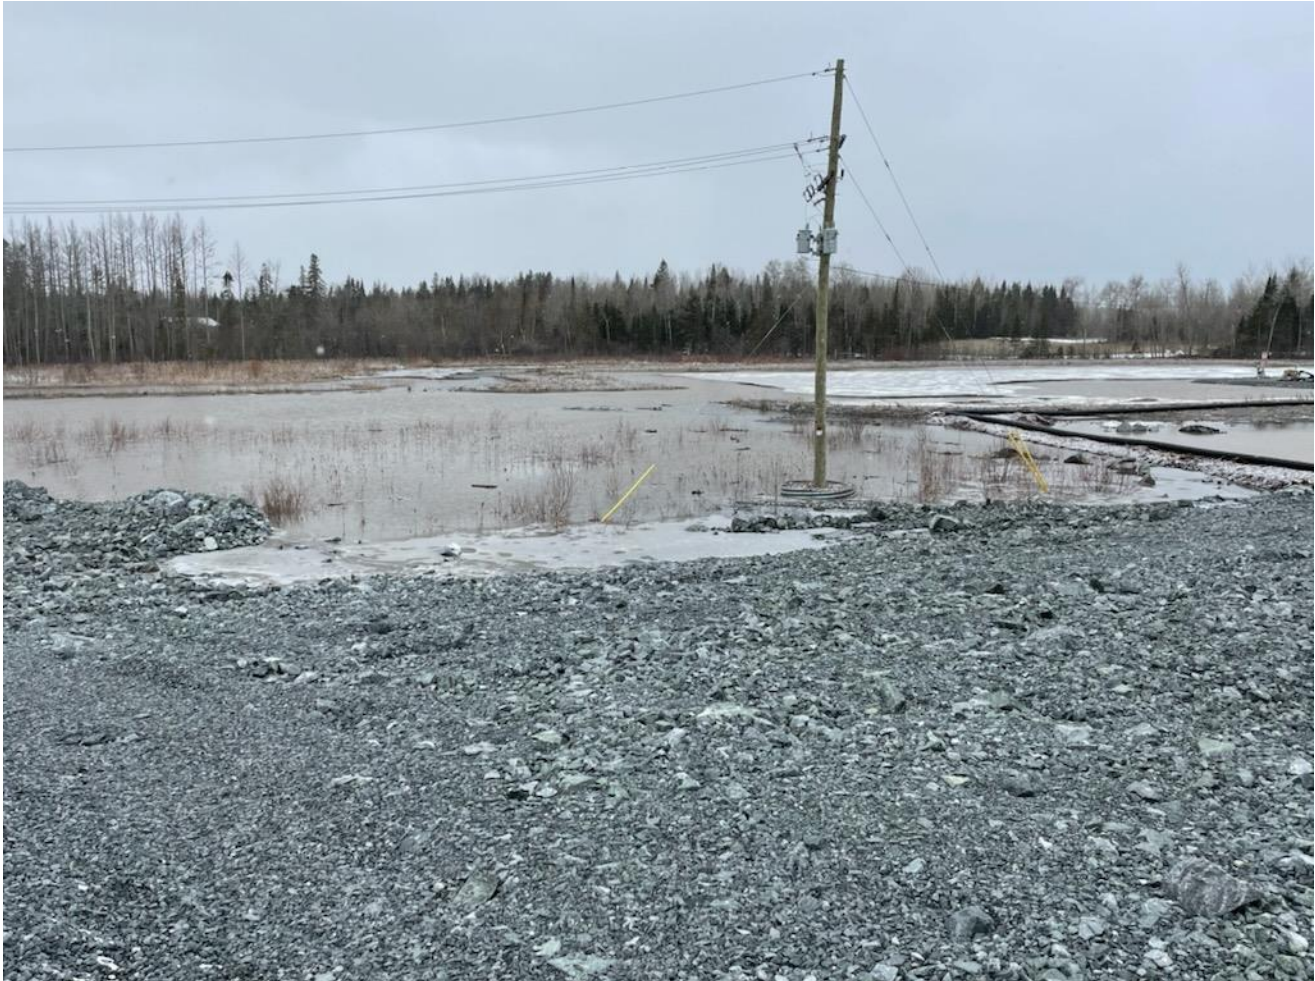
It should be noted that this estimate is an overestimation. Due to the high precipitation during that month, the local topography outside of the engineered catchment area for Seepage3 was oversaturated and flooded the area including the pond.

Figure 1 April 25, 2022 water build up around Seepage3.

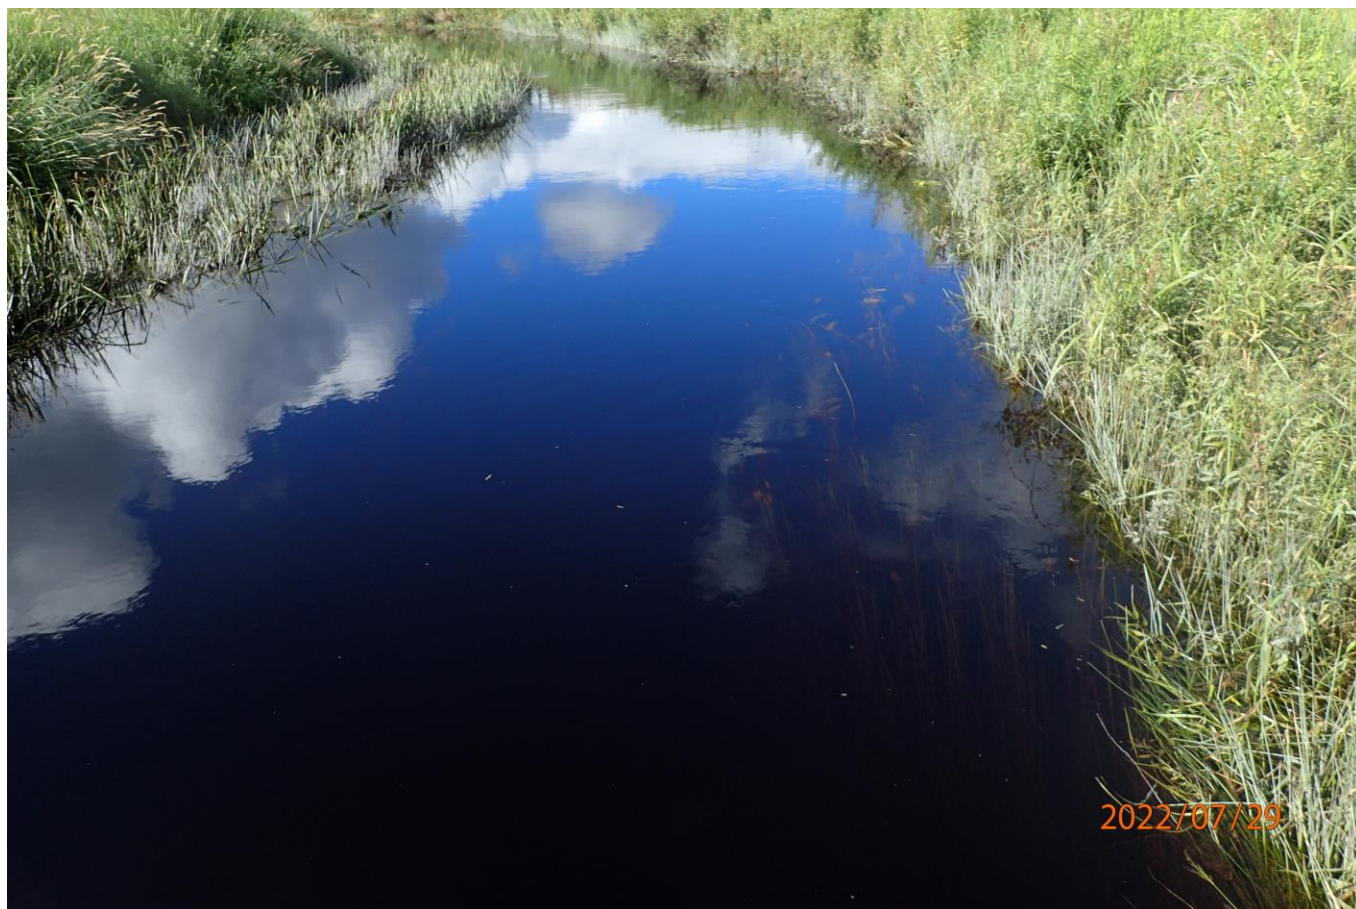
At 0830 on July 29th, the New Gold Environmental Department was made aware that Pump #11 had been turned on in error. Pump #11 discharges Outflow Basin to EDL2 which is a permitted discharge point in the Pinewood River. This discharge occurred from 2000 hours on 2022-07-28 to 0600 hours 2022-07-29 discharging 3502 m³ of mine effluent to the Pinewood River. Water samples, including acute toxicity, were collected and the Pinewood River was observed in two locations downstream for evidence of adverse effects such as fish kill, no adverse effects were observed.

Photo 1: Pinewood River downstream of EDL2 at Surface Water location 22a.

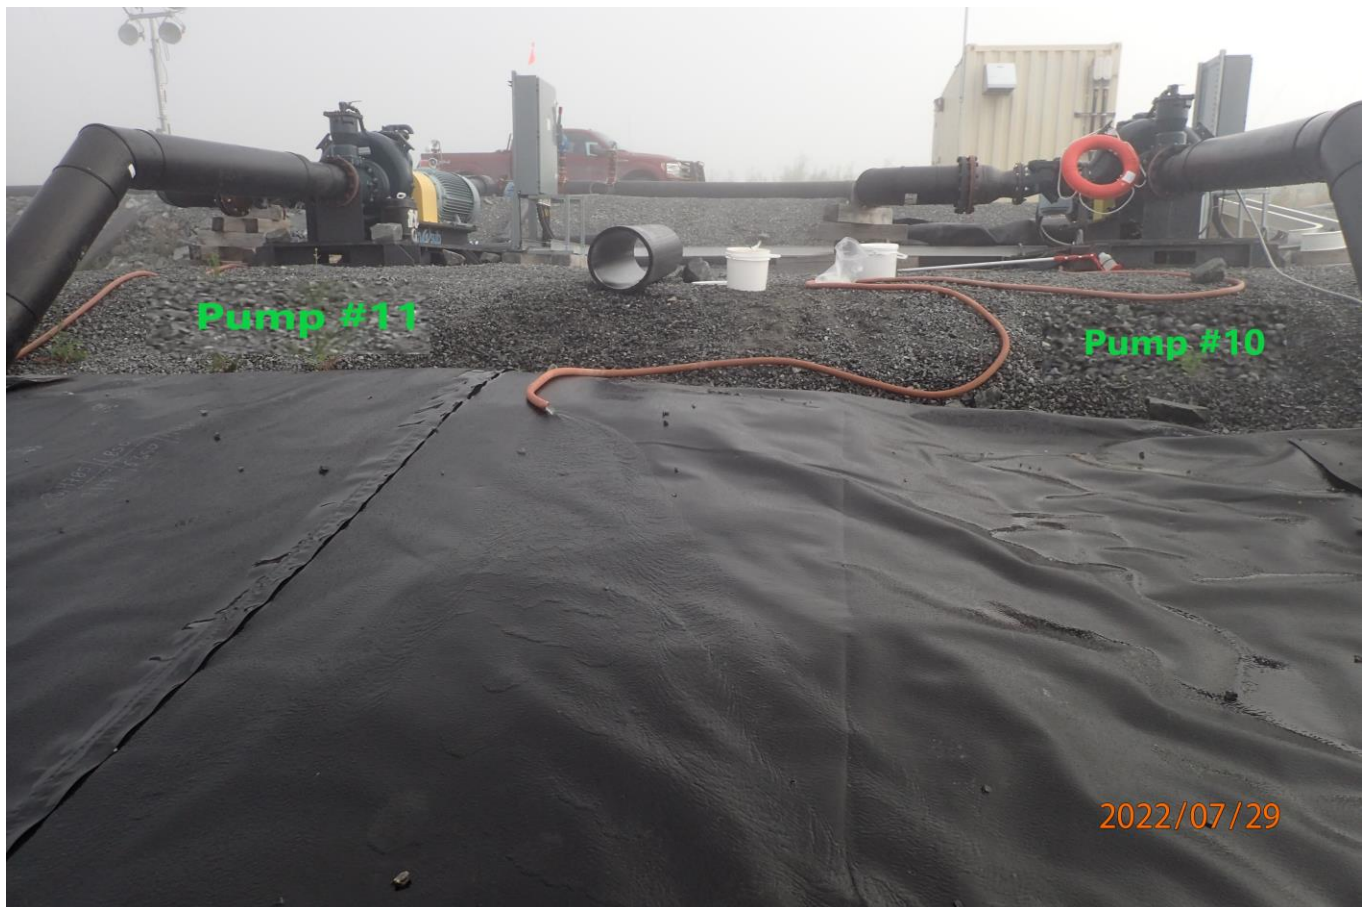
Photo 2: Outflow Basin Pumps

The decision was made on 2022-07-28 to resume discharge of water from Sediment Pond 2 and EDL1. (see attached email) After shift change Mill Nightshift operations staff turned on Pump #11 believing this pump reported to EDL1 not EDL2. Pump #11 is in the Outflow Basin and beside Pump #10 which can report to EDL1, Pump #10 was in use pumping Outflow Basin to TMA as part of a trial to treat Mine Rock Pond water with Biochemical Reactor #2 and Outflow Basin. Since Pump #10 was in use Pump #11 was turned on.

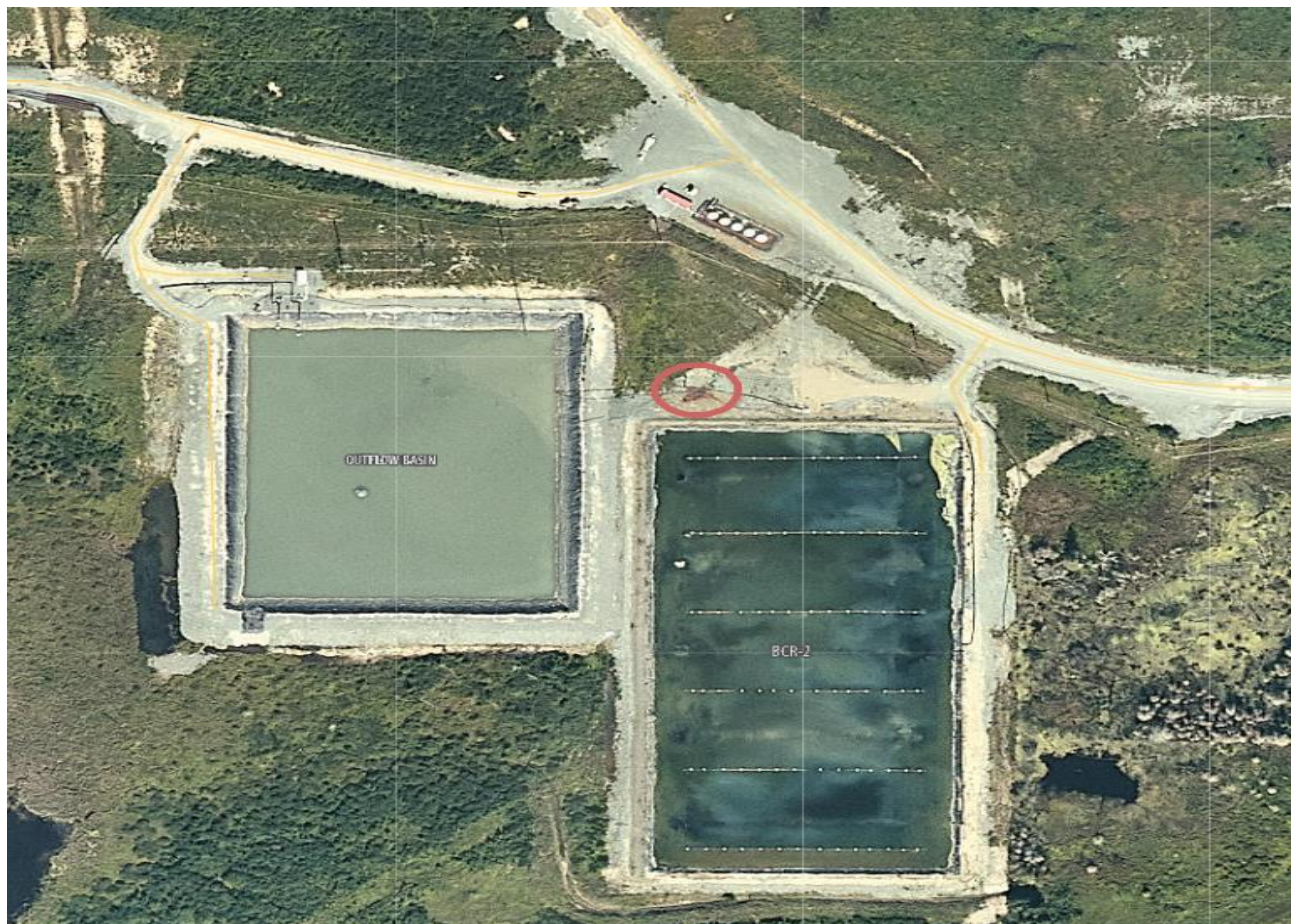
On September 20th, a new GIS image was posted on the New Gold GIS viewer for the Rainy River Mine Site. During a review of this image by Environmental Department staff, a discoloration was noted on the ground north of Biochemical Reactor 2 (BCR2).

Photo 1: location of spill.

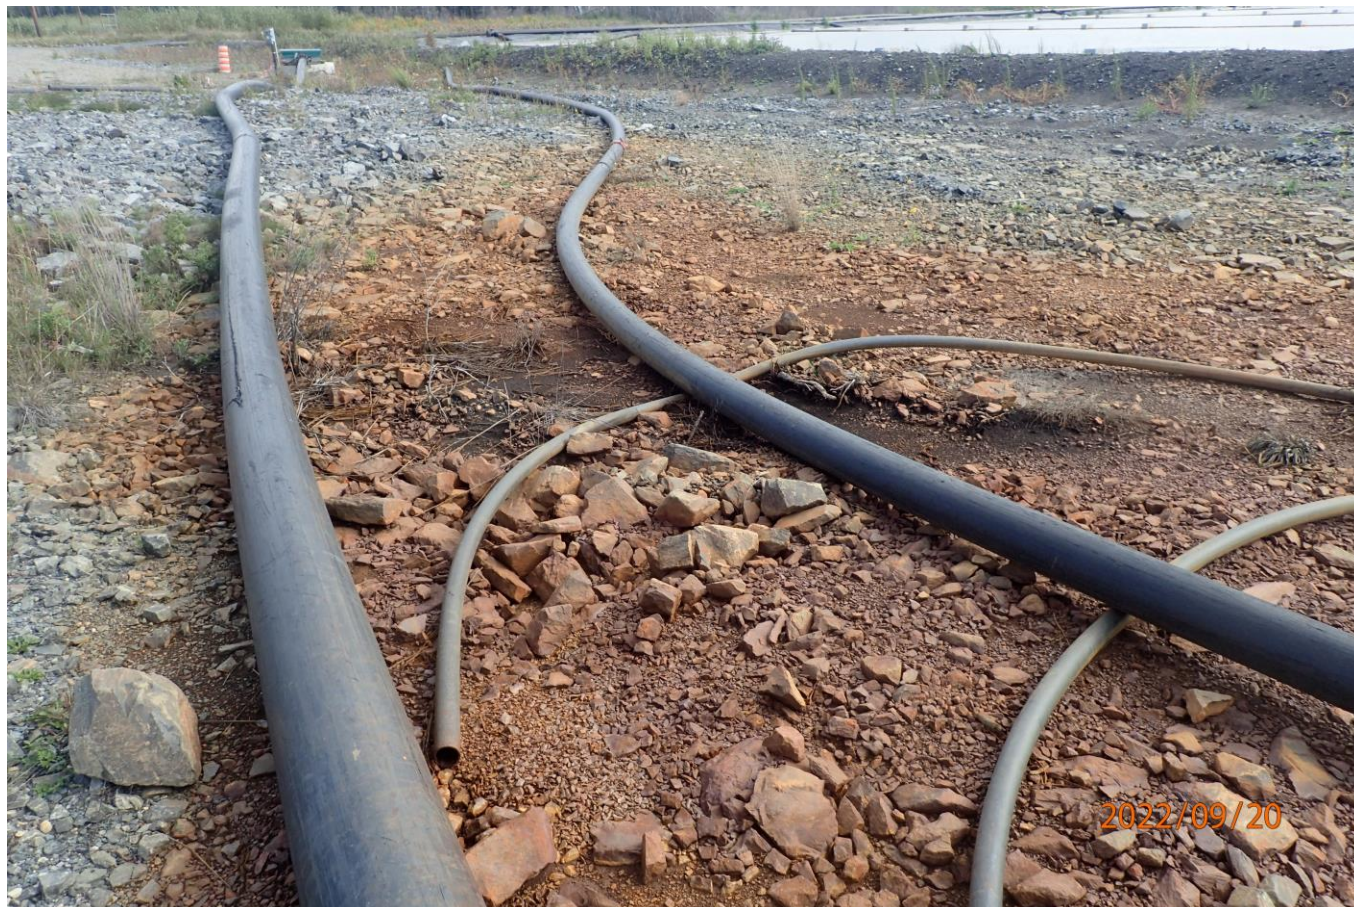
Upon field inspection this was found to be caused by a drain line misplaced for the BCR2 reagent tank secondary containment. There is a drain line that is intended to be placed directly into to BCR2 from this secondary containment so that any leaks or water captured by the containment can be pumped out.

Photo 2: spill impact

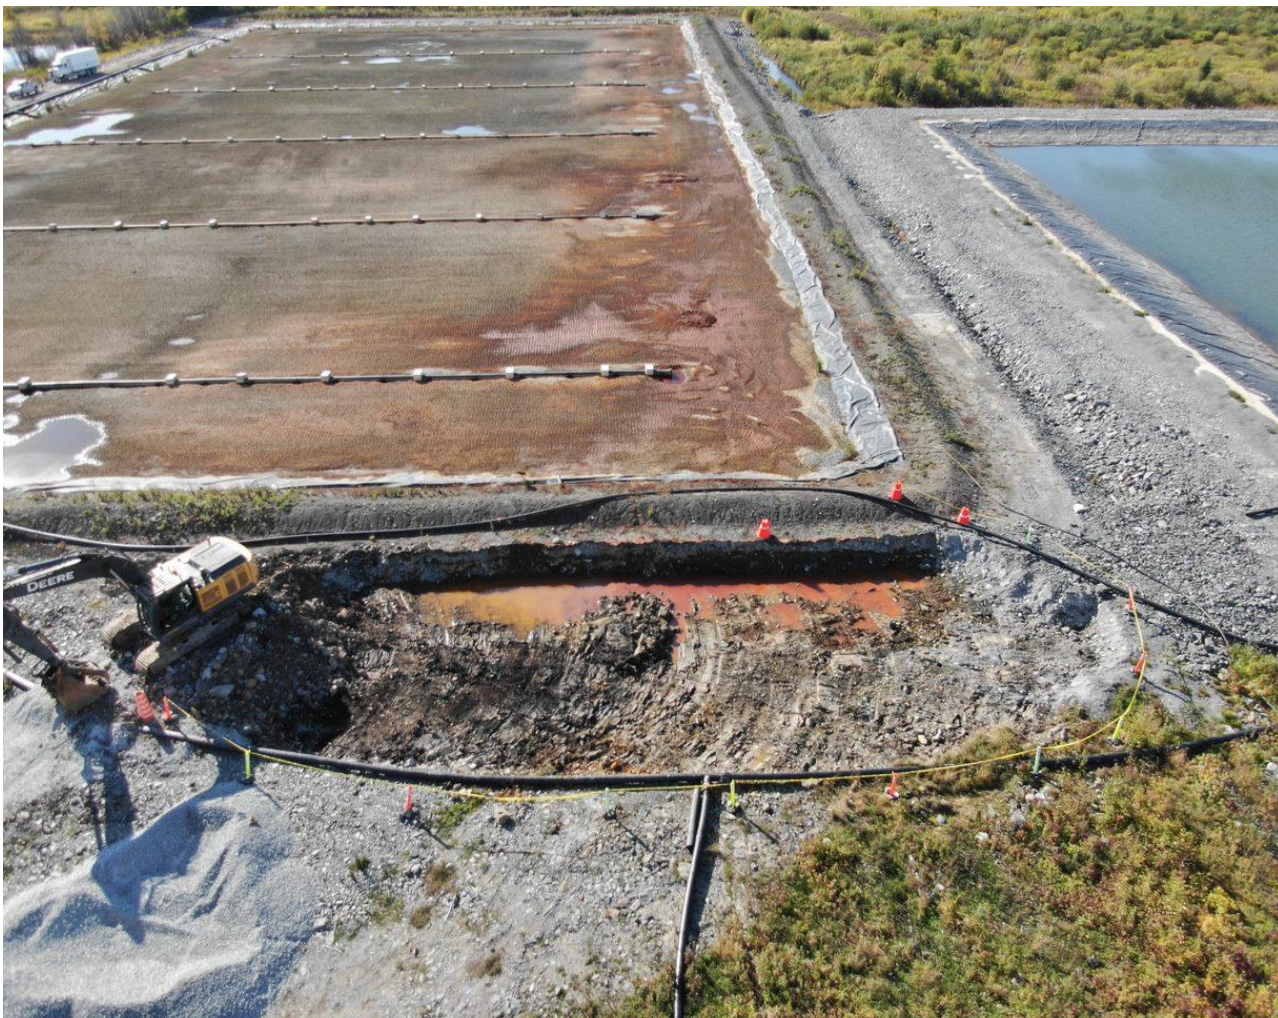
Clean up remains ongoing for this event as staining appears to have mobilized down the ditch between the Outflow Basin and BCR2. Options for containing this entire area with a pump back system are being explored and will be implemented once identified.

Photo 4: current state of clean up as of 2022-09-29.

At the time of required reporting clean up remains ongoing and permanent solutions are still being identified, updates will be provided regularly until this issue is resolved.

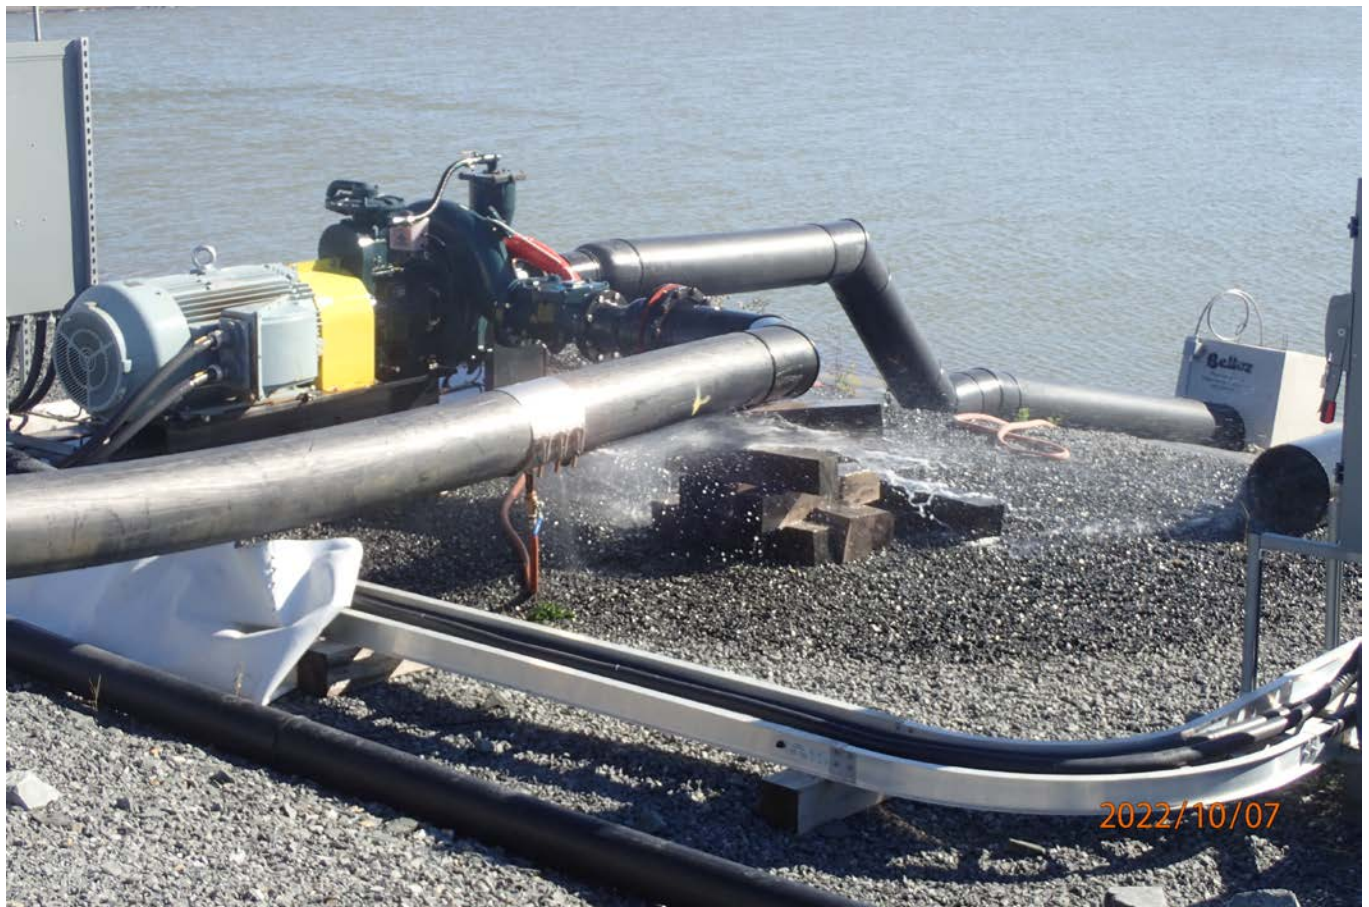
At 1430 on October 7th, during routine water sampling of Outflow Basin (OB) a hugger clamp for a drain valve on the pipeline supplying water to Water Management Pond (WMP) from OB was found leaking. Water samples including acute toxicity were collected, but a bucket test could not be performed to estimate the volume of water lost due to the high pressure of the leak. Mill Operations was called immediately upon discovery and the pump was shut down from the control room. This pump was turning on at 1130 that day so the duration of the spill is estimated to be 3 hours at the most.

Photo 1: Leaking hugger clamp.

Water sample results indicate that only Total Zinc exceeded its monthly average discharge limit of 0.174 mg/L with a laboratory result of 0.203 mg/L. Acute Toxicity testing passed with no issue.

A new fused valve will be installed instead of the hugger style and lining of the pump pad is being reviewed to ensure any future mechanical failures that result in leaks are captured and report to OB.

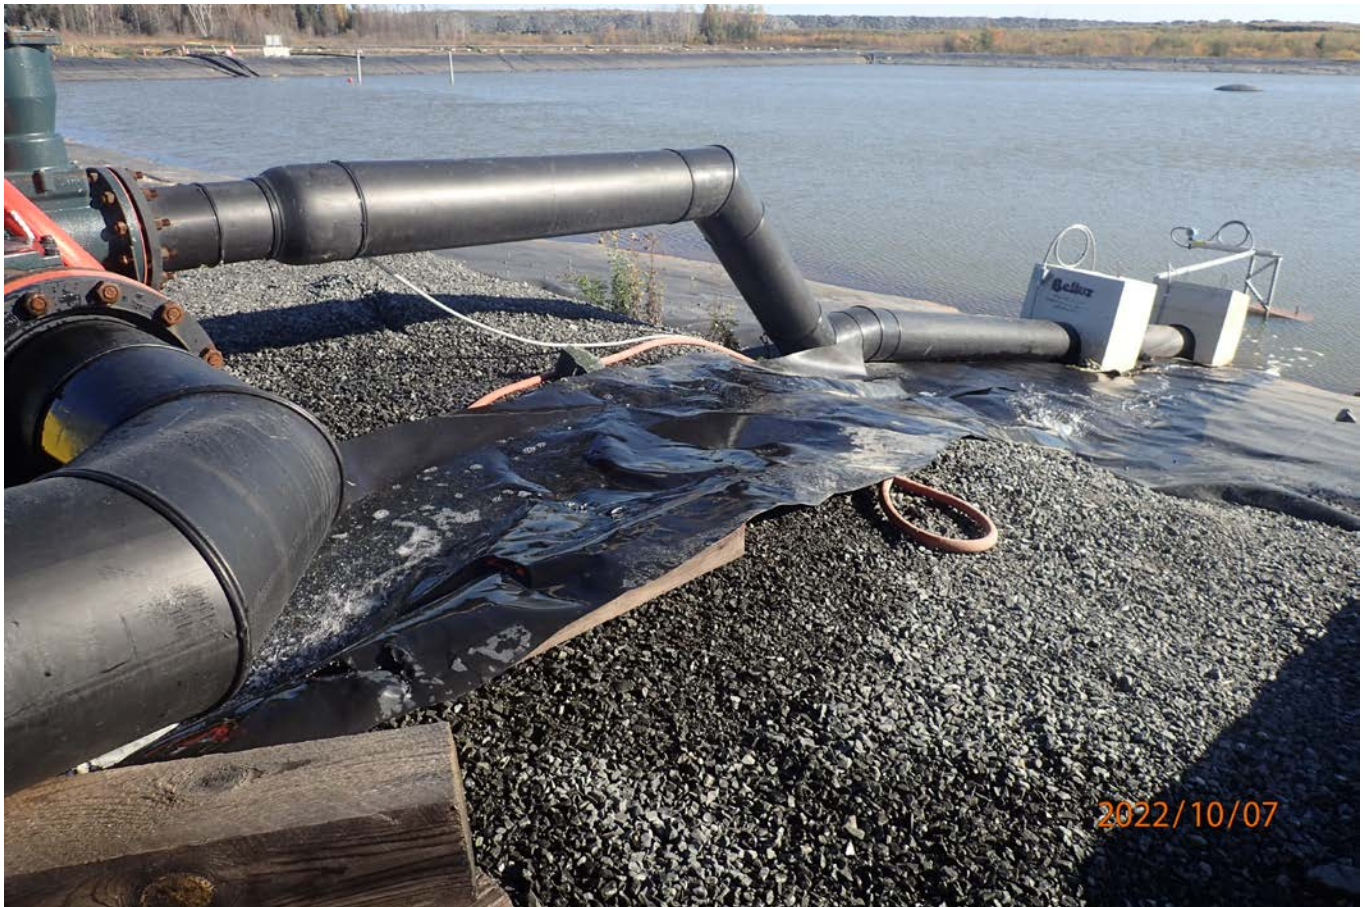
Once the pump was turned off and the line began depressurizing, some scrap liner found nearby was used to direct the water onto the liner of the OB, so the bulk of the water reported to OB mitigating the spill as much as possible.

Photo 2; Scrap liner used to catch spill.

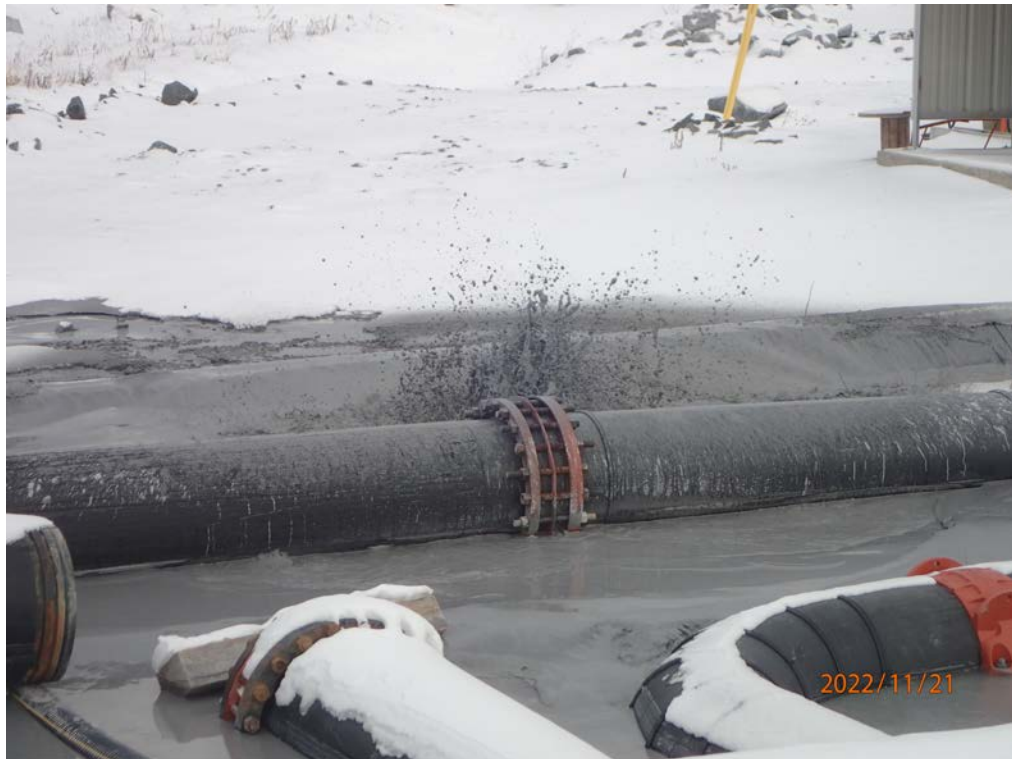
At 11:18 on November 21st, the New Gold Environment Department was made aware of a connection failure along the tailings pipeline just west of the Marr gate. As soon as the event was reported the mill shut down and tailings continued to exit out of the connection as the pressure was reduced. The majority of the material was captured inside the liner and traveled east into the sump as designed. A pump and secondary line were then utilized by site services to pump from the sump to the tailings pond to avoid an increase of water level within the sump.

Photo 1: Leak at pipe connection

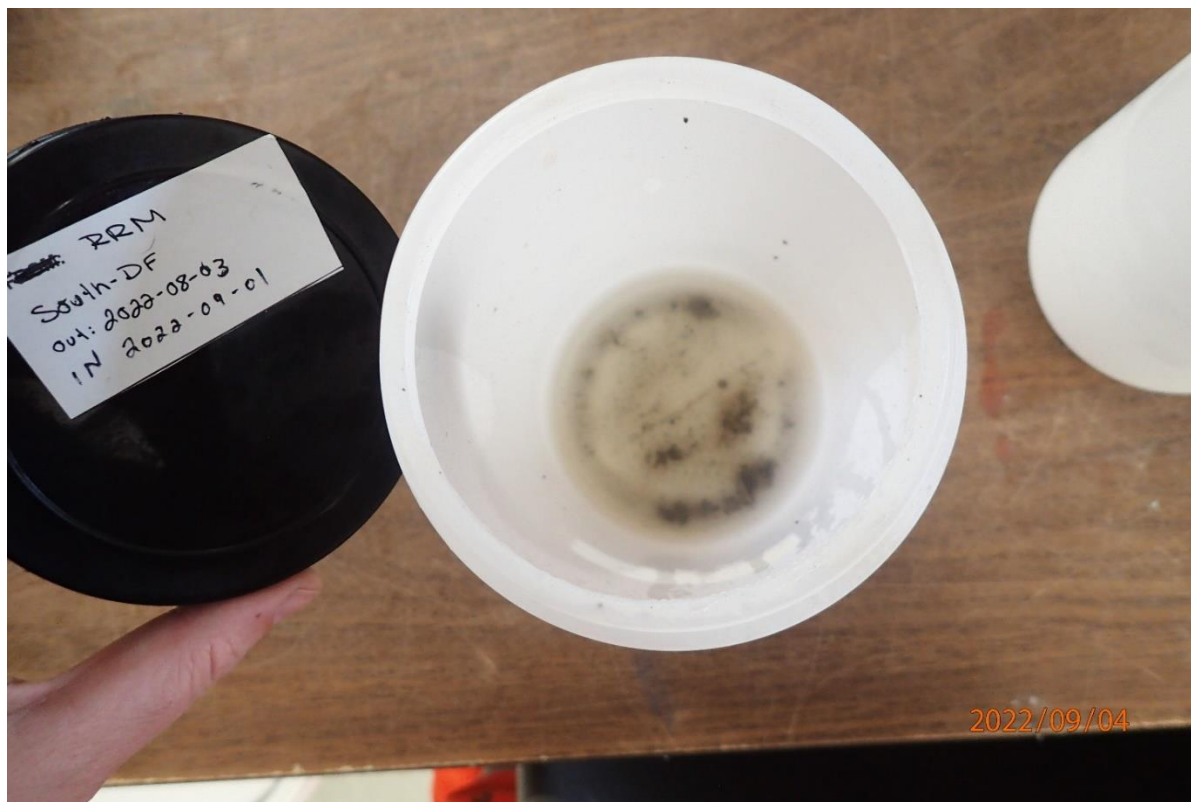
This dustfall exceedance was mostly due to high organics in the canister. Once organics were removed, the fixed dustfall concentration was 8.1 g/m³/30 days, 115.71% of the AAQC limit.

Figure 1: August 2022 South Air Quality Station dustfall canister before shipment to certified laboratory.

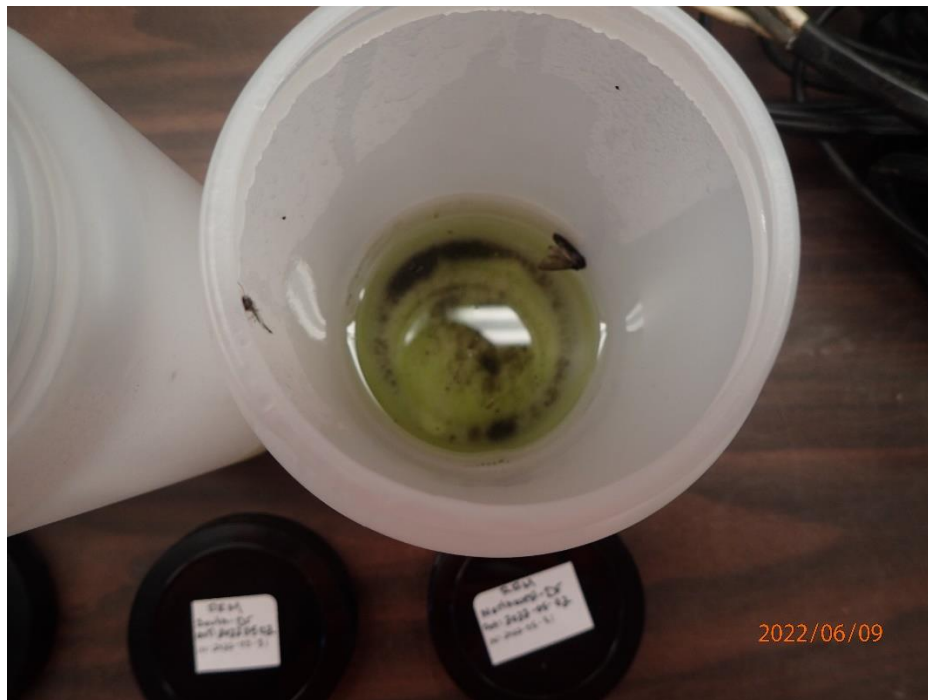
Figure 3 shows May 2022 Northwest Air Quality Station dustfall canister before shipment to certified laboratory.

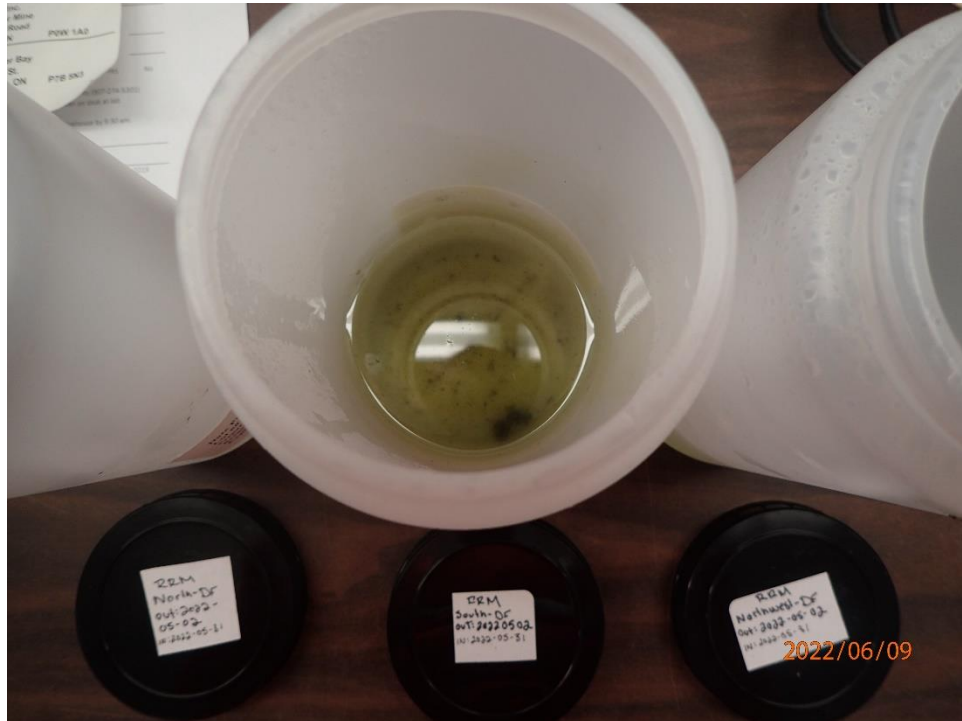
The dustfall exceedance from South Air Quality Station in May 2022 and dustfall exceedances in June 2022 from both North and Northwest Air Quality Stations were due to high organics in the dustfall canister.

Figure 4 shows May 2022 South Air Quality Station dustfall canister before shipment to certified laboratory.
