**NEW GOLD RAINY RIVER MINE
APPENDIX H
EXCEEDANCE LETTERS
SUBMITTED TO MECP**

RE: EDL1 Daily and Monthly Average Copper Limit and Daily Free Cyanide Limit Exceedances

RE: Southern Pit Ring Road Ditch Failure SAC Reference #1-7ON9RQ

RE: Unauthorized Deposit of Treated Mine Effluent SAC Reference #1-EYQHAV

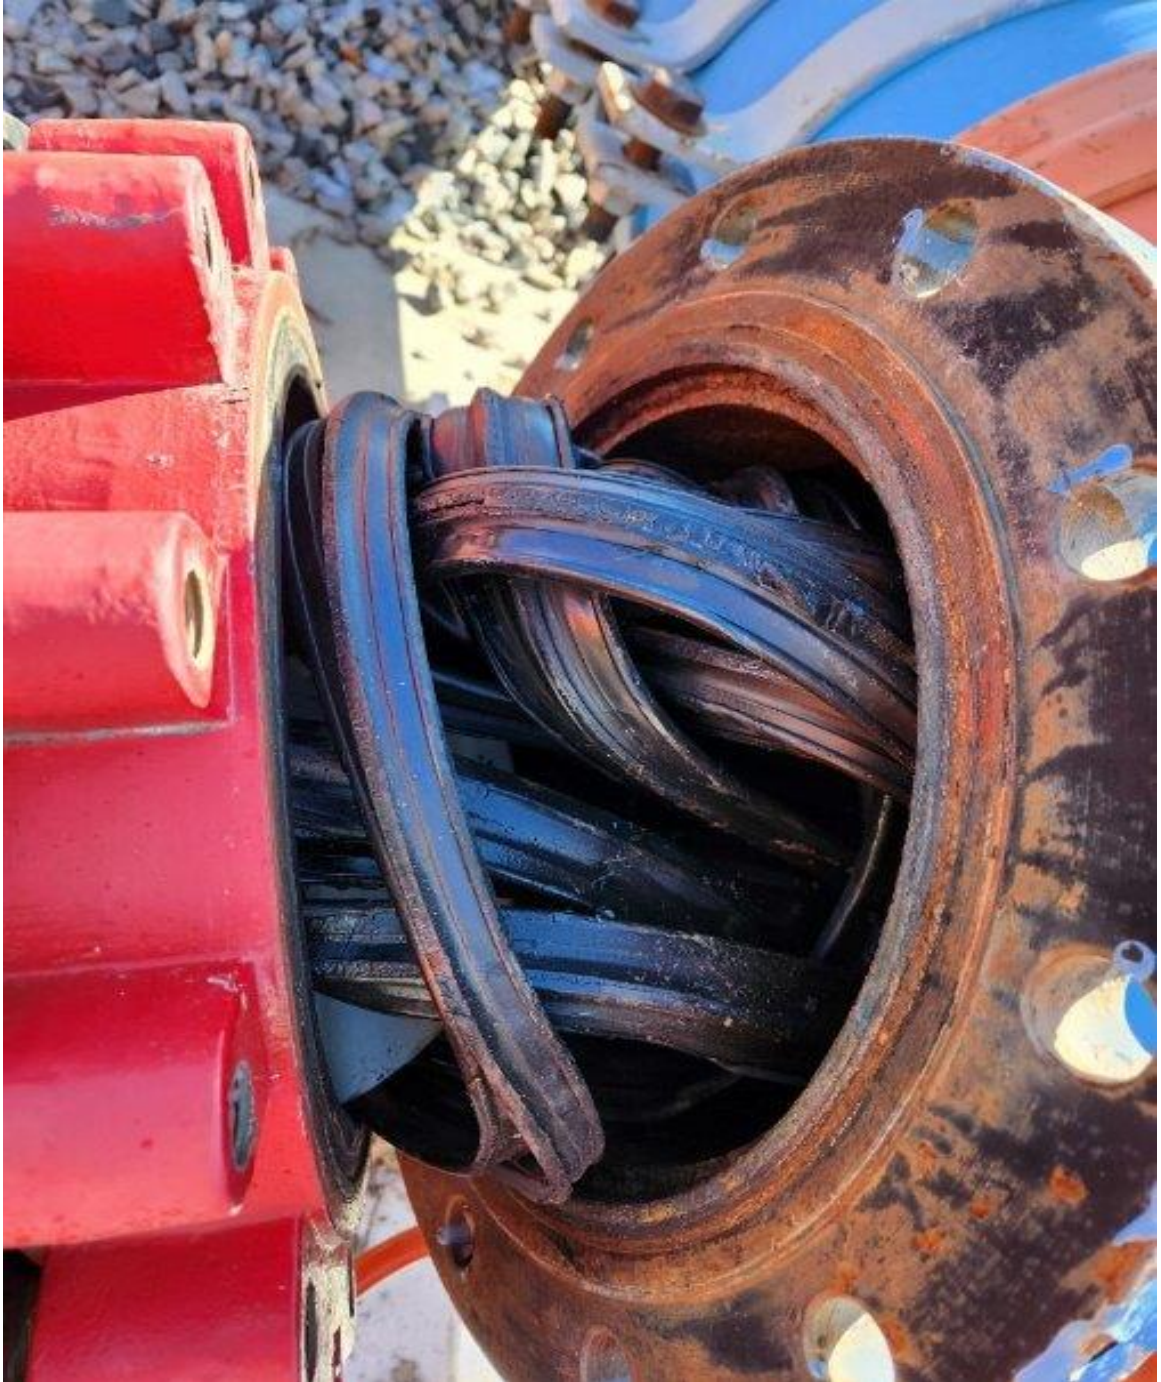
The most probable cause for this exceedance is maintenance work done 2 days prior to the sample collection on April 22nd. Beading from the fused HDPE discharge line was discovered balled up in the pipeline just upstream from the EDL1 sample port. See photo 1. When the metal portion of the pipeline was opened to remove the pipe beading there was some corrosion in the pipeline, it is suspected that when the valve was opened to collect the sample there was still some corrosion in the sample valve. The pipeline is under very high pressure when discharging, so valves are not opened to 100% for safety reasons and ease of sampling. During the investigation evidence of corrosion was discovered when the valve was opened 100% on May 3rd. See photo 2.

Photo 1: Beading from the fused HDPE discharge line

Cyanide can bond to copper, and copper sulfate is used as a reagent in the cyanide destruct process that New Gold employs during milling operations. Some copper cyanide complexes may have been associated with this corrosion and once the valve was purged the contaminants were no longer detectable. EDL2 was also discharging from the same source of water (WMP) during this time and no elevated copper or cyanide was detected at EDL2 when sampled on April 22nd but other metals/analytes were as similar as a duplicate sample should be. This supports the theory of maintenance work contaminating the sample valve. To further mitigate the potential for recurrence all brass fittings on sample valves will be removed, as brass contains copper nickel lead and zinc, and replaced with stainless steel.

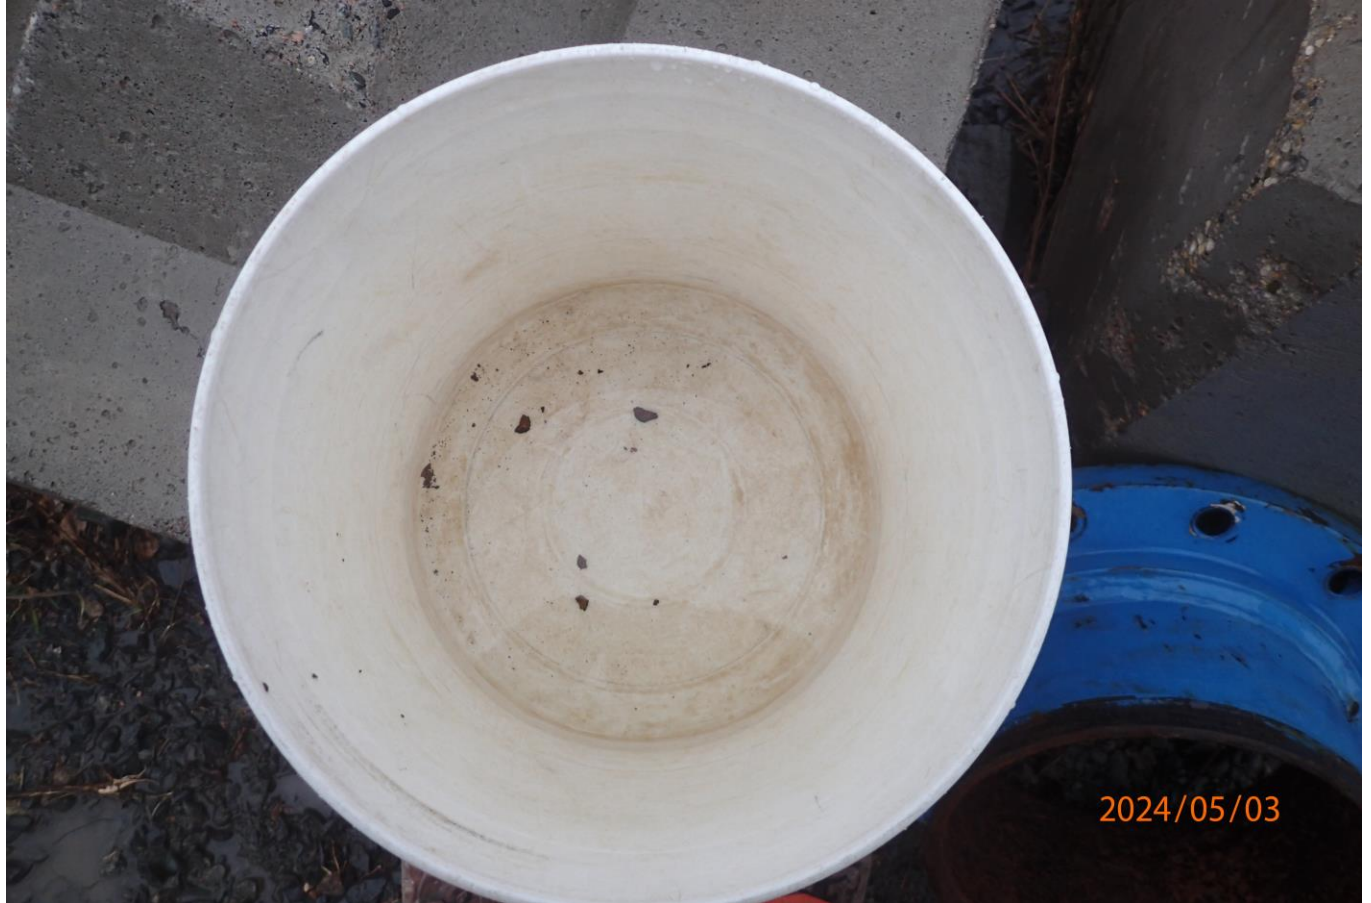
Photo 2: Evidence of corrosion in EDL1 discharge sample collection valve

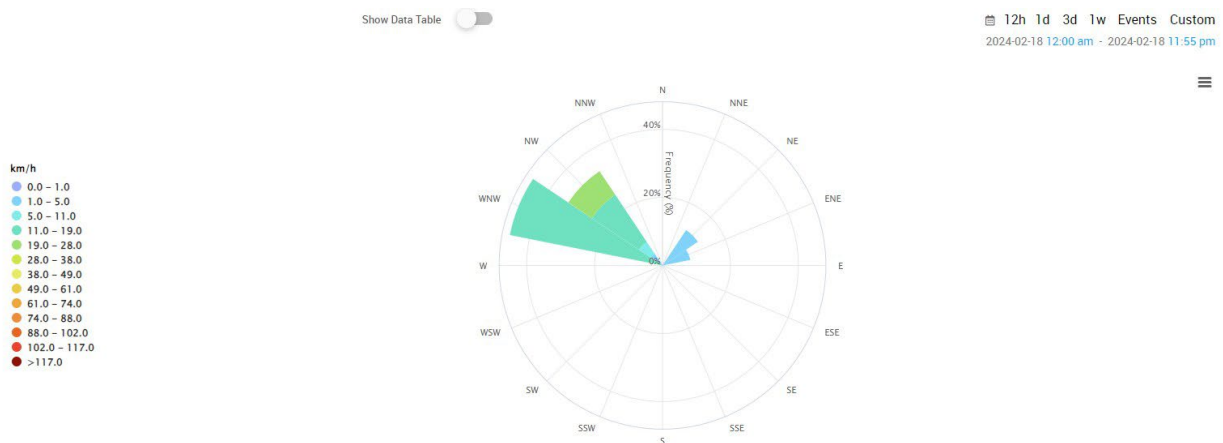
Figure 1: Wind Rose for February 18, 2024, at the Barron Weather Station

It is believed that dust produced within the TMA migrated offsite and caused the exceedance. No inspection of the TMA occurred on February 18, 2024 but inspections occurred on February 15th and February 19th and did not show any sign of TMA dust migration offsite (Appendix A).

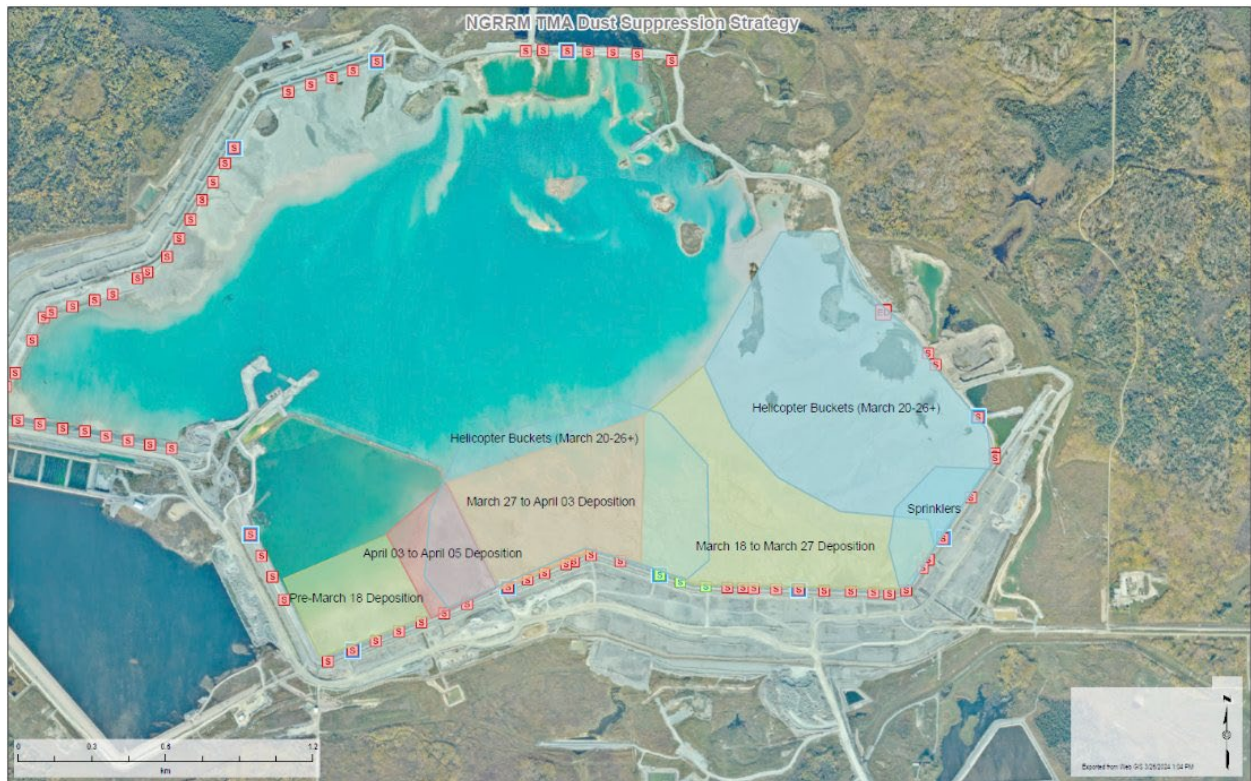
Figure 2: Shows short-term TMA dust mitigation strategies implemented in March 2024.

1. Sprinklers to re-wet dry tailings along Southeast Dam. Overall concept to start water ponding on top of tailings (Started March 8th to April 5th)
2. Tailings spigotting along South Dam to re-wet dry tailings (March 18th to April 5th)
3. Helicopter water bucketing (March 20th to March 27th)

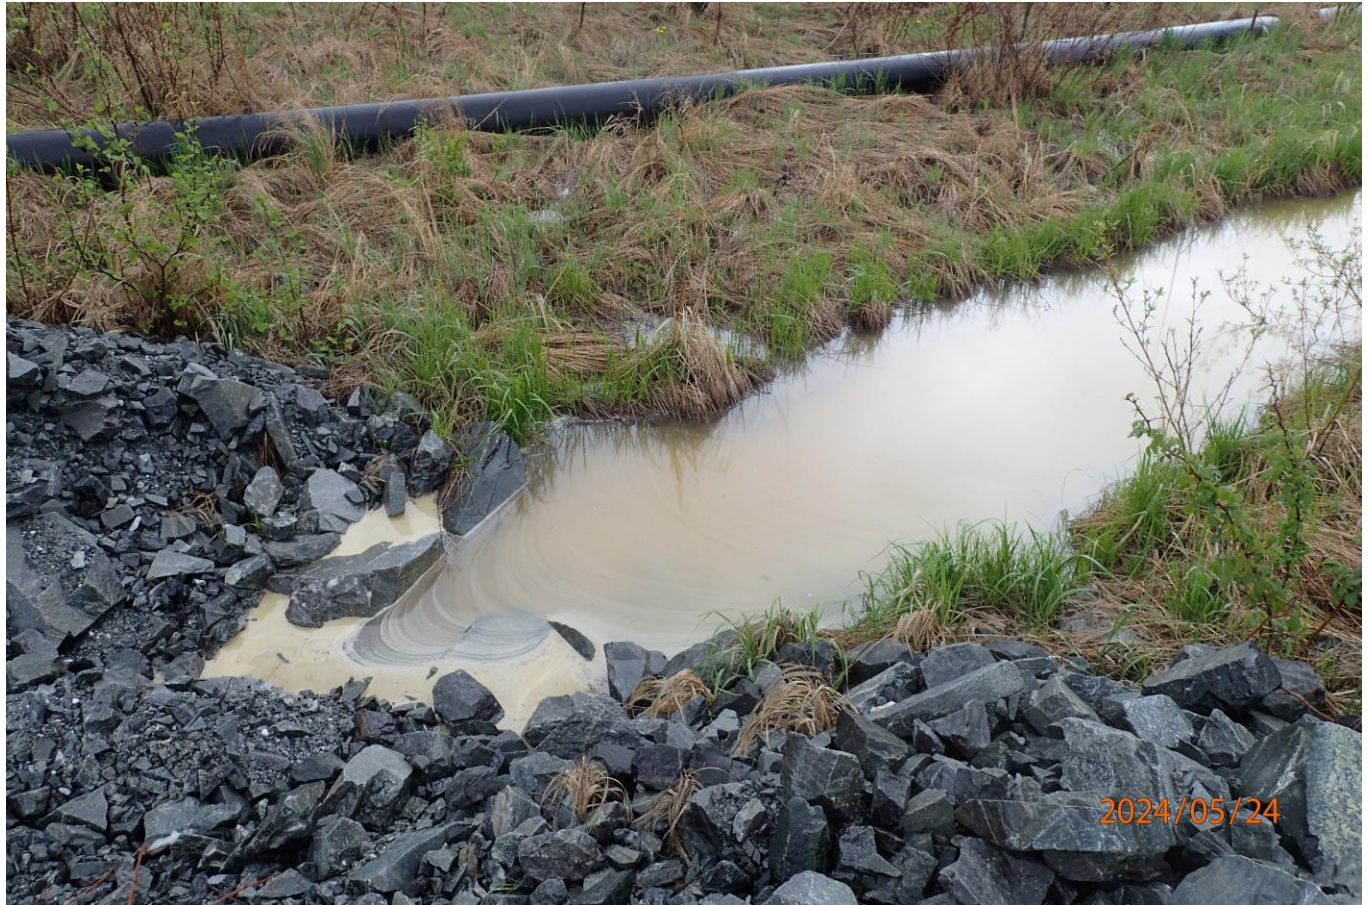
During a routine inspection of exploration drilling operations, south of New Gold's Open Pit, sediment laden water was discovered escaping a ditch and spilling into the environment. See Figure 1 and 2.

It would appear the water level in the ditch reached such a level to allow water to pass through or under the road thus leaving site containment and not being conveyed to Sump 2 at all.

Figure 1: Sediment Laden Water in Ditch

To mitigate this issue the drilling operation was authorized to dewater their sumps to the Open Pit. This water will then be pumped into the MRP or South Pond then to the Mill for use as process water.

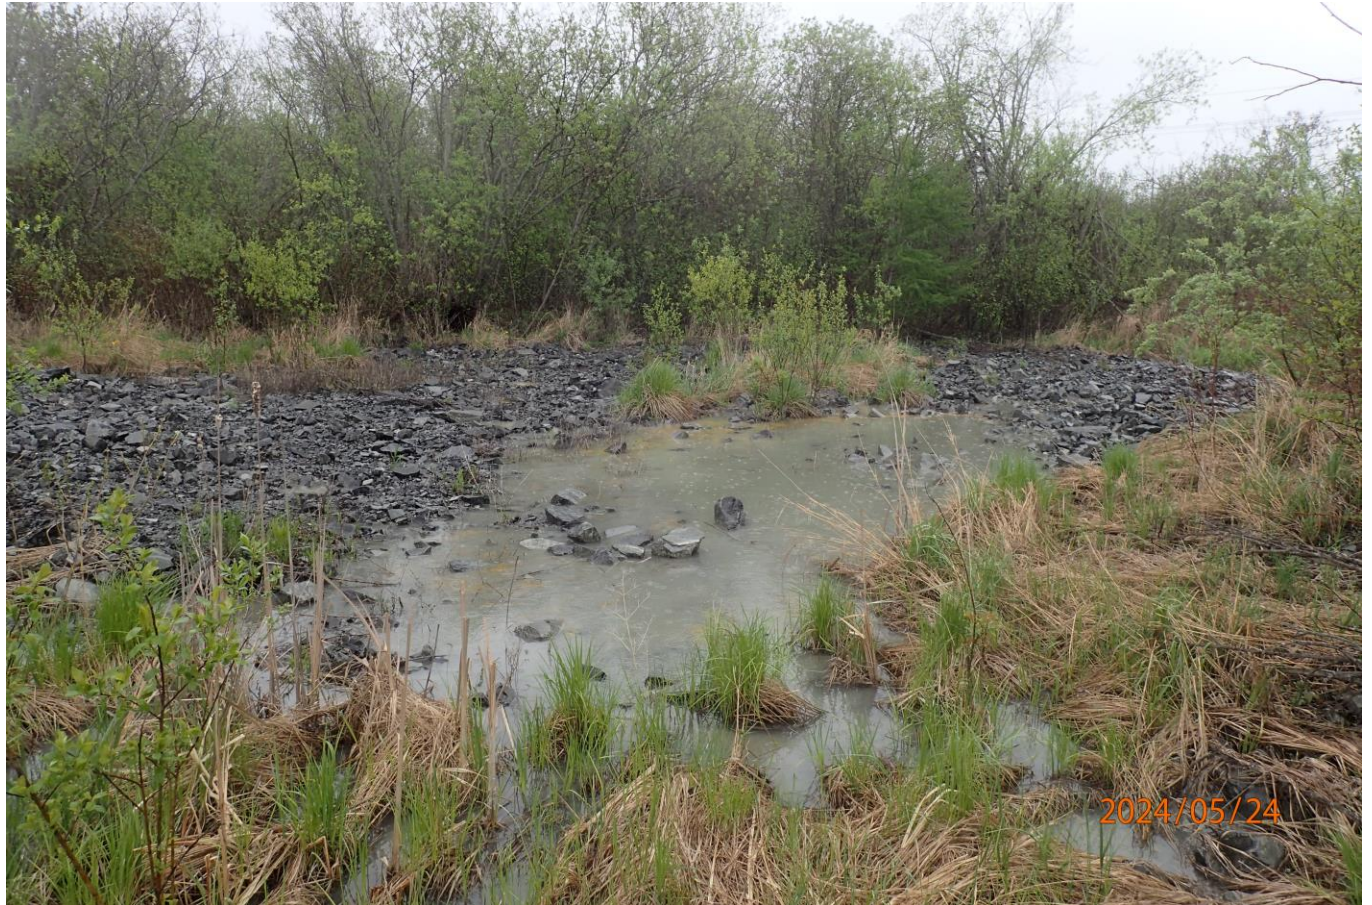
Figure 2: Sediment Laden Water Outside of Site Containment

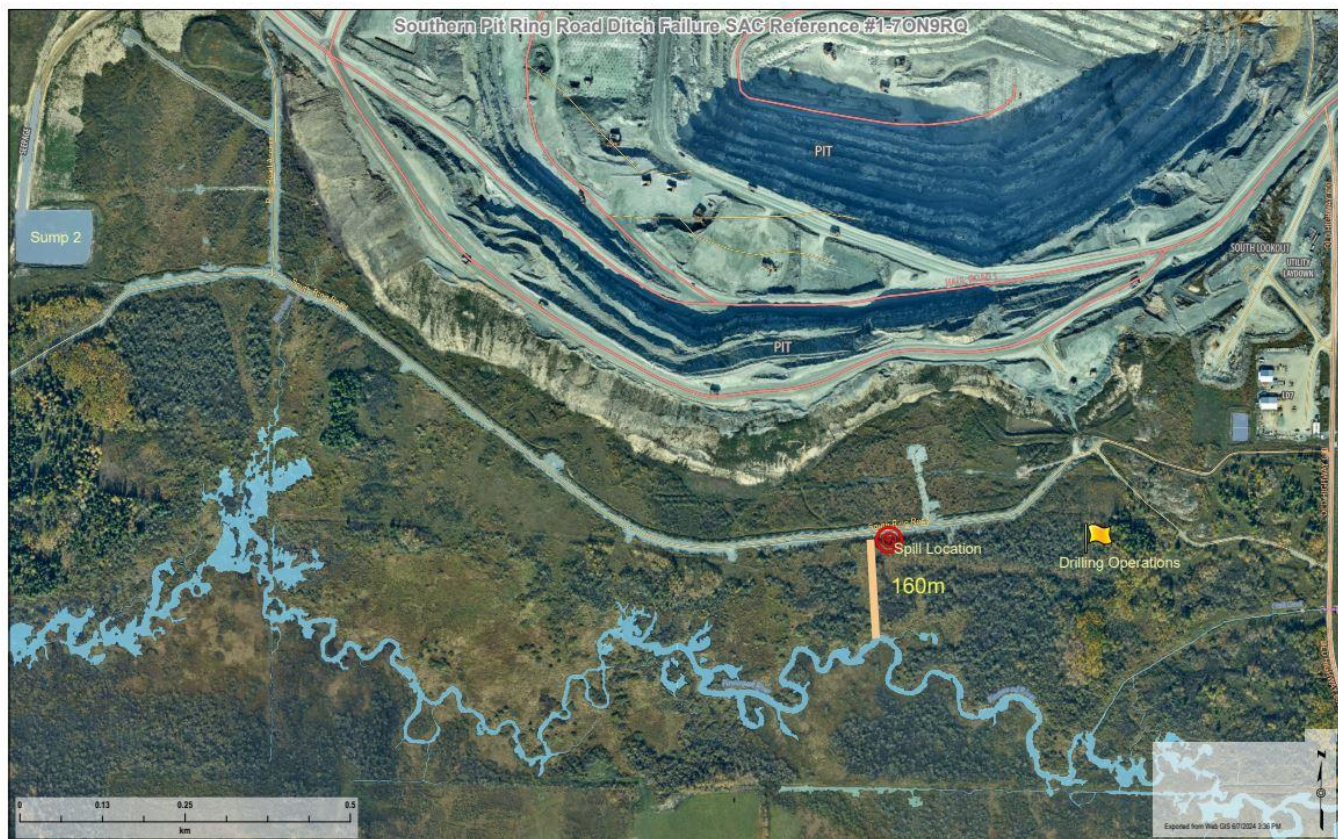
Due to the nature of the generally undisturbed ground in this location, no clean-up was attempted as it potentially would have caused more harm than good. This spill would have to travel 160 m over land to reach the Pinewood River. See Figure 3 for details.

Figure 3 Incident Location Overview.

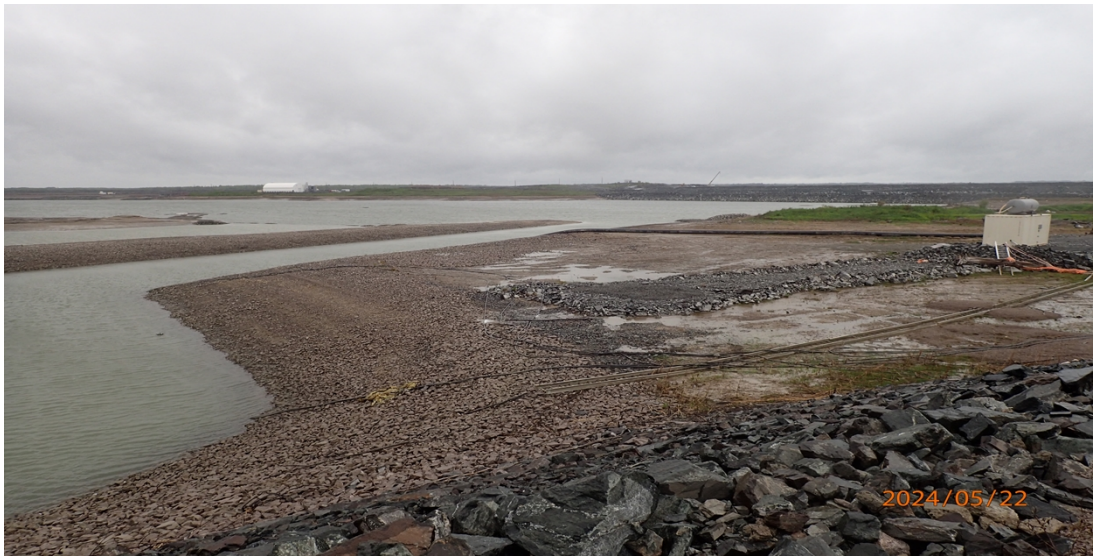
Total Suspended Solids (TSS) was also found to be at 15.7 mg/L at EDL2 for this sample. As New Gold has no to plans to resume discharge for the month of June, this will be a monthly average exceedance of TSS for EDL2. The cause for this heightened TSS level is due to low water levels within the WMP, high winds and rainfall. Figure 4 depicts WMP at low water levels. WMP has clay walls and is susceptible to sediment mobilization during times of low water especially during storm events. To mitigate this issue New Gold is exploring sediment control methods that are either permanent or can be deployed during the above-mentioned conditions.

Figure 4, WMP at low water level

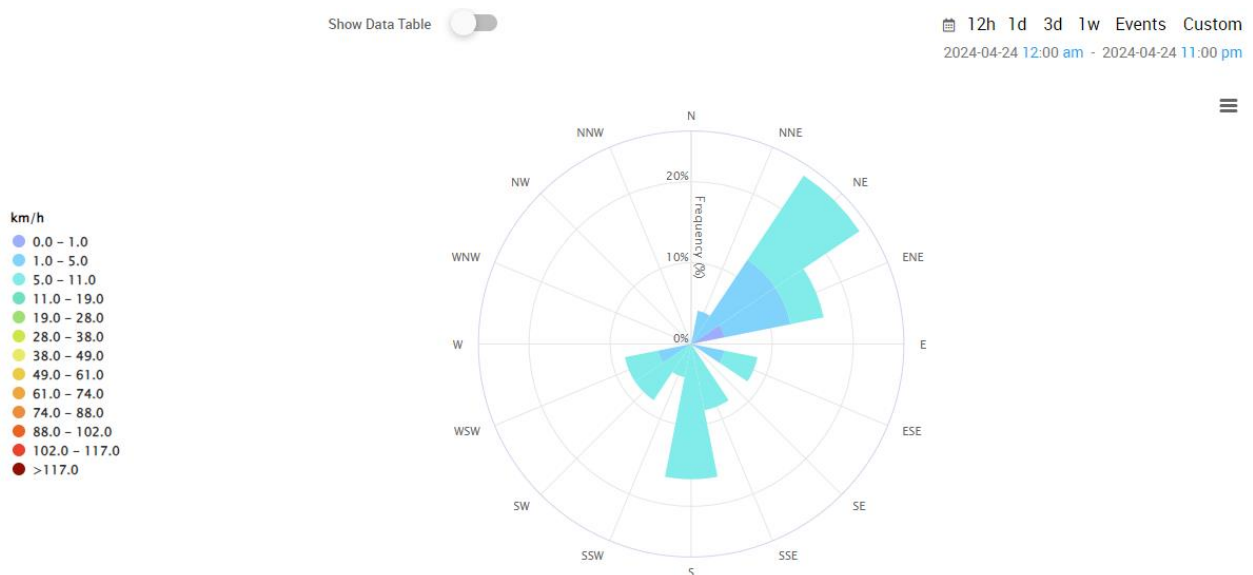
During the review of the April air quality results, it was noted that on April 24, 2024, the concentration of iron at the Northwest Station was $4.04 \mu\text{g}/\text{m}^3$, exceeding the ministry approved limit of $4.00 \mu\text{g}/\text{m}^3$. The wind rose from the Barron Weather Station shows the wind direction varied over the day, with wind coming from the Northeast and South. This indicates a combination of dust originating from the Tailings Management Area (TMA) and road dust from Highway 600 containing a high proportion of iron.

Figure 1: Barron weather station wind rose from April 24, 2024.

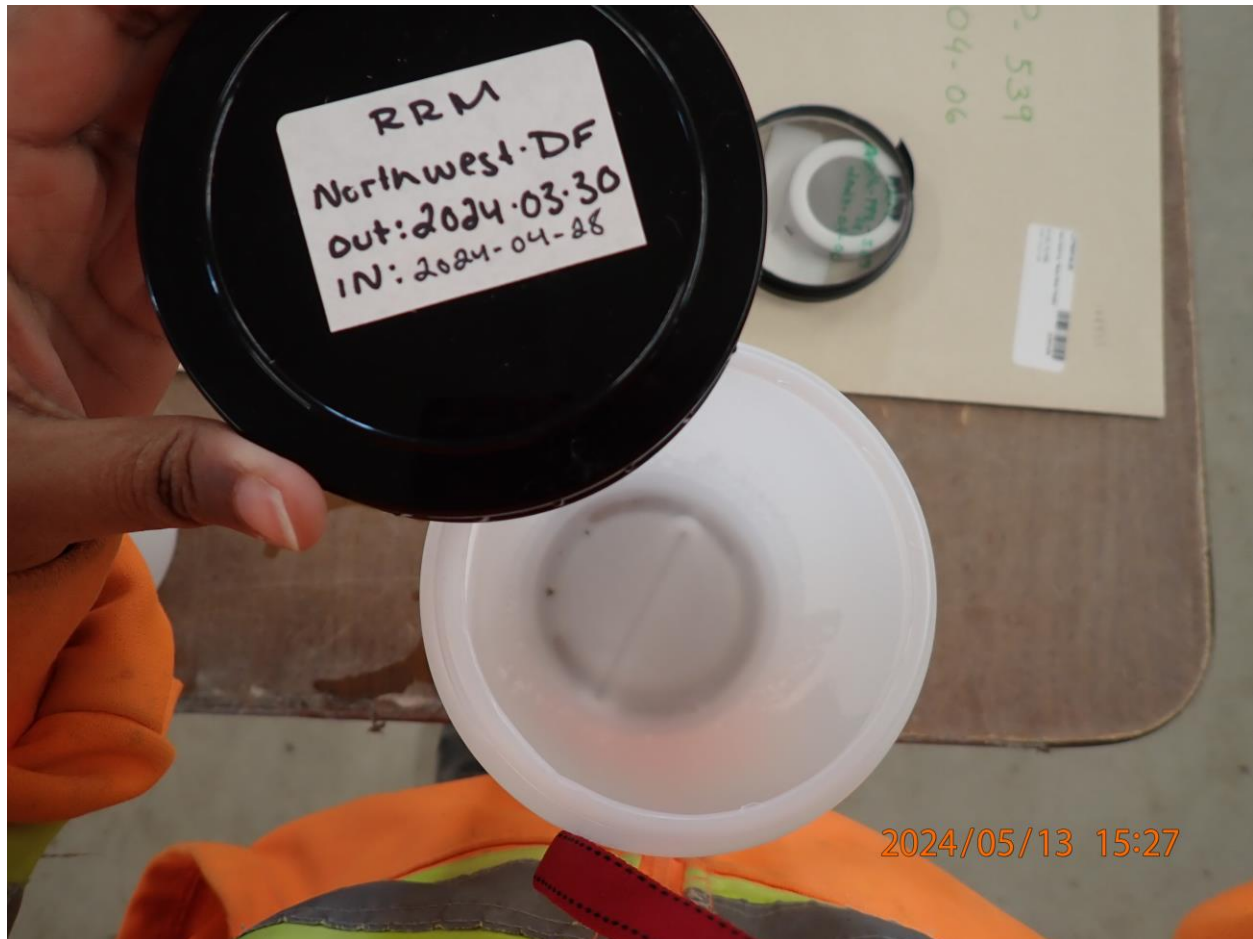
ug/m³, and there was contamination from organic matter in the sample (Figure 2), indicating the high particulate concentration in this sample was not due to activities at the mine site.

Figure 2: Contents of North Station Dustfall Jar collected on April 28, 2024, contaminated with organic matter.

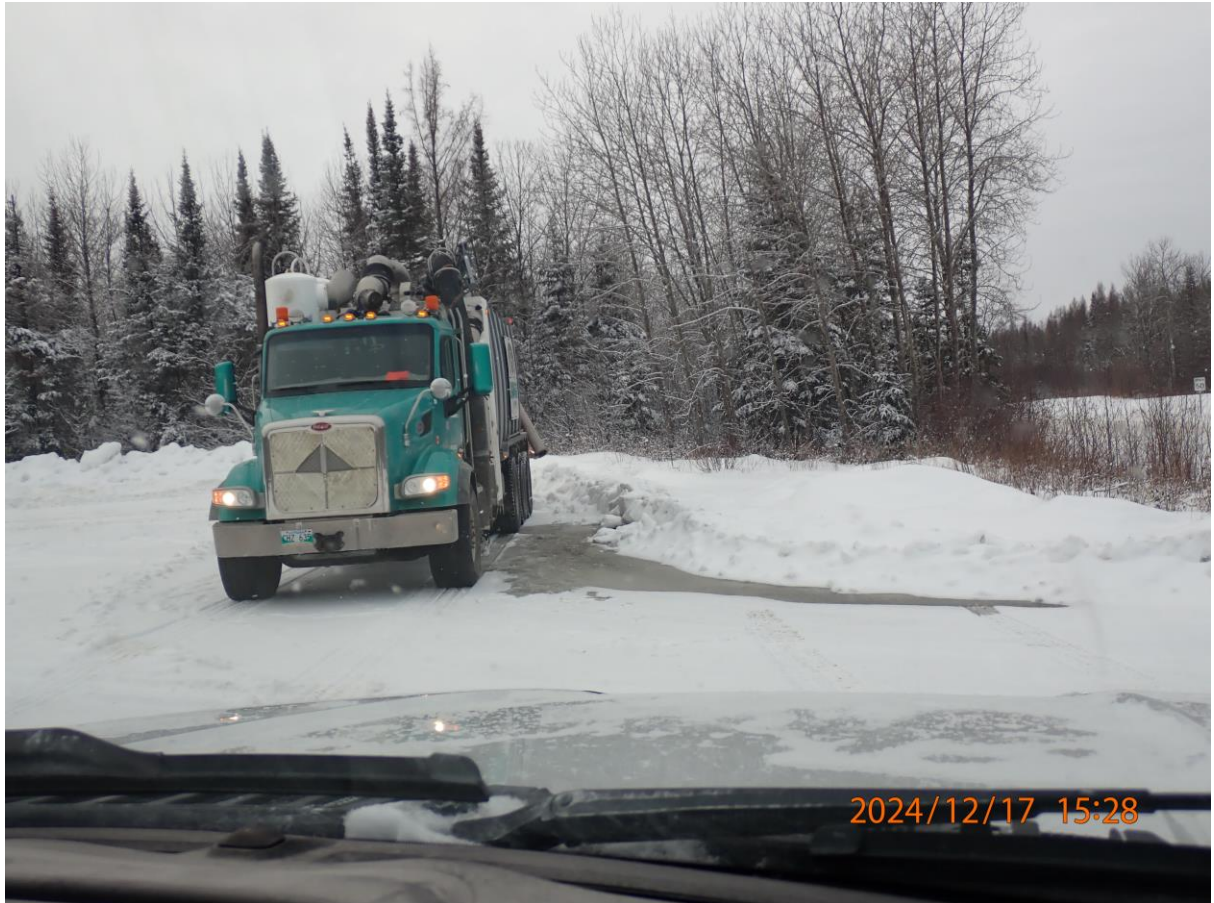
On Tuesday 17th December 2024, a hydrovac truck was observed discharging unused water at Korpi laydown which is outside our site containment. At the time of discovery, the water being discharged by the hydrovac truck was assumed to be from the Water Management Pond (WMP) via the truck wash. The amount of water discharged from the hydrovac truck was estimated to be 100L (figure 1).

Figure 1: Spill location

To mitigate this issue, the hydrovac truck operator was directed to clean up the spill immediately using the same truck. An estimated 70 percent of the spill was vacuumed into the truck as the spill was on icy ground leaving about 30 percent frozen. Furthermore, the location of the spill is about 180m away from the closest fish bearing waterway (as shown in figure 4). Therefore, there is little chance this remaining water will reach fish habitat.

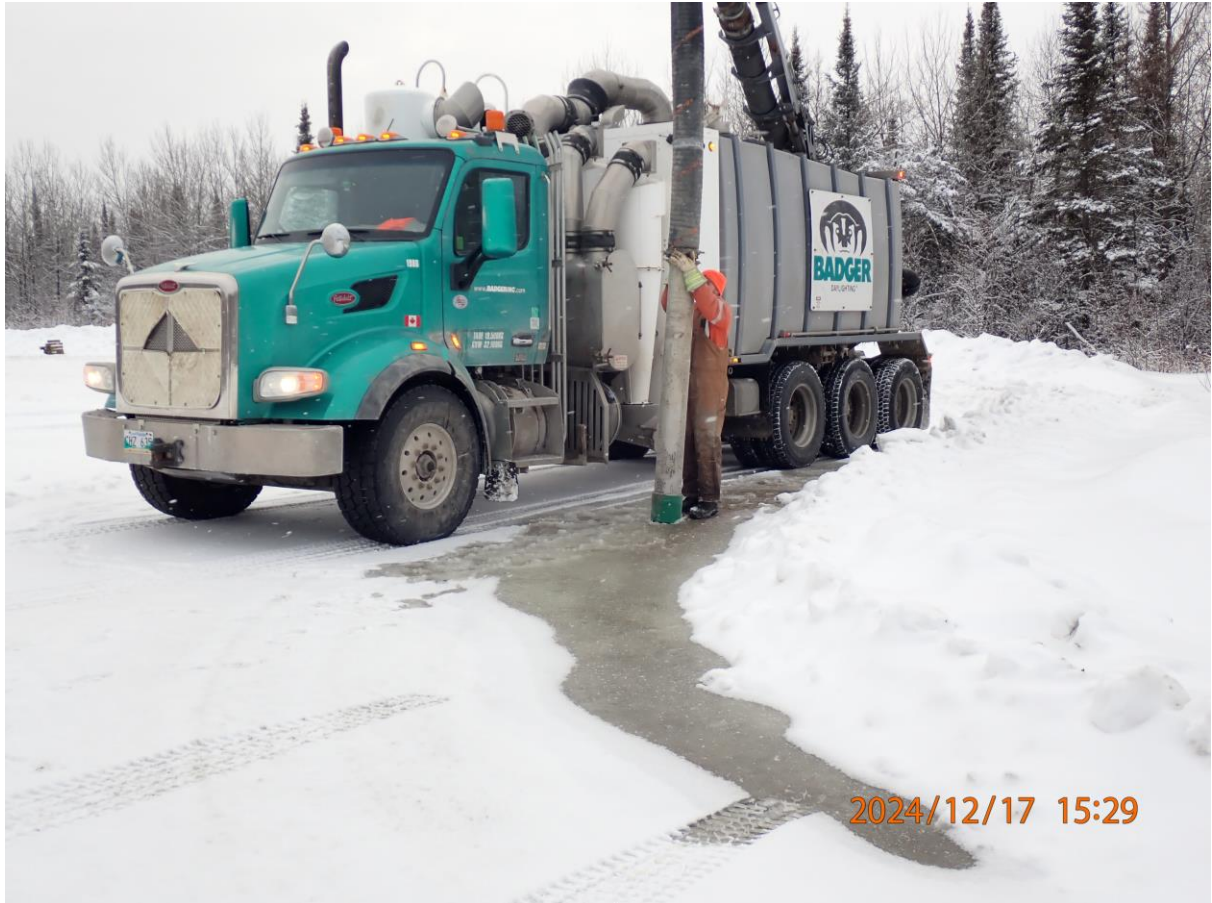
Figure 2: Spill cleanup process

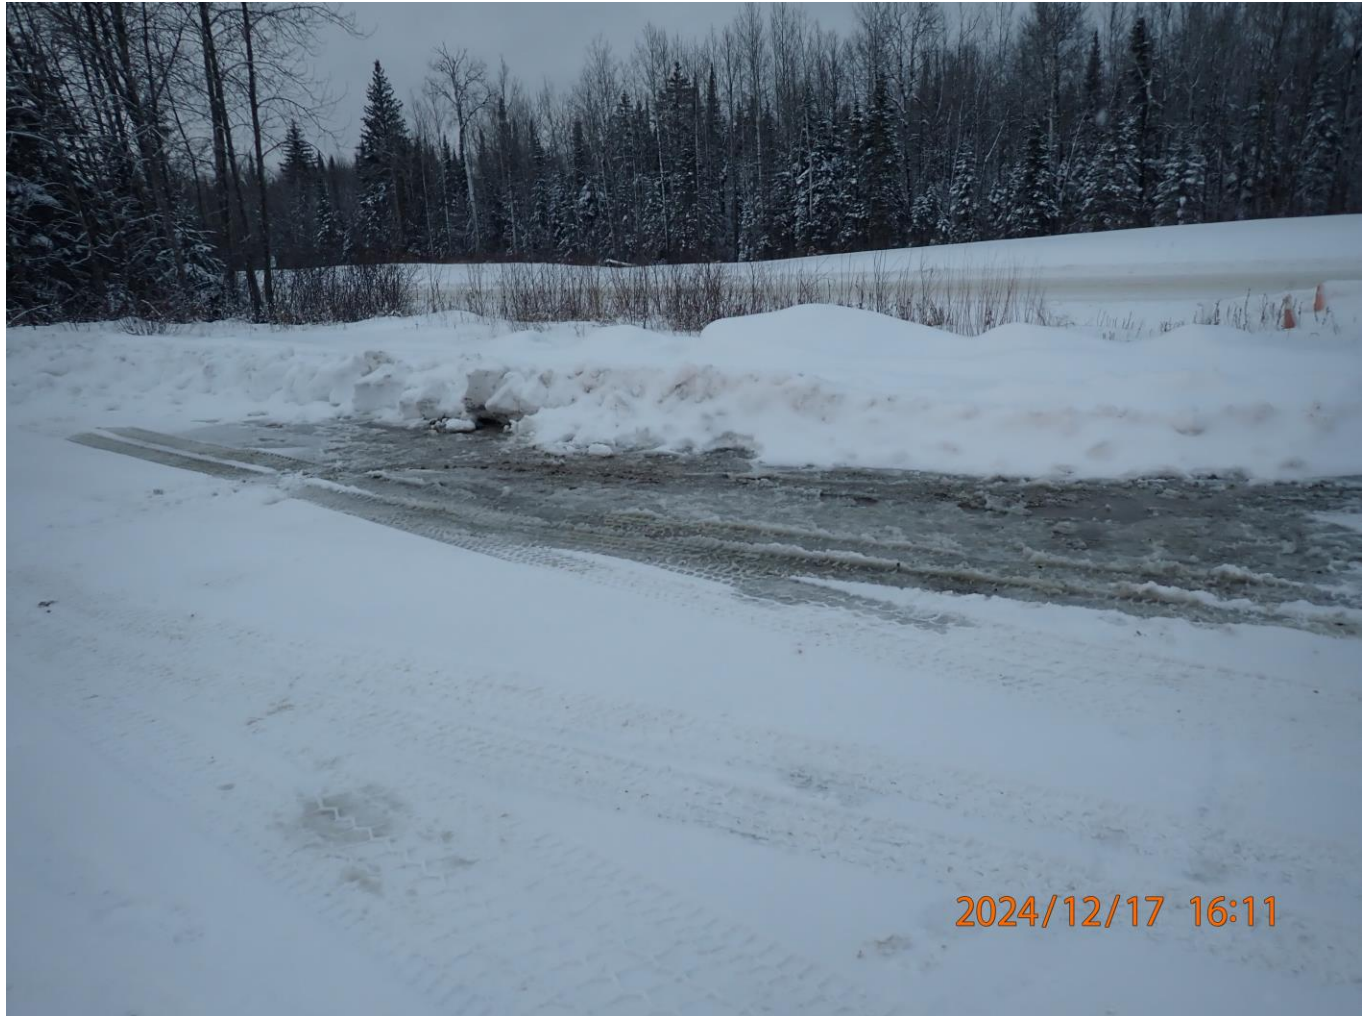
Figure 3: Spill location after cleanup

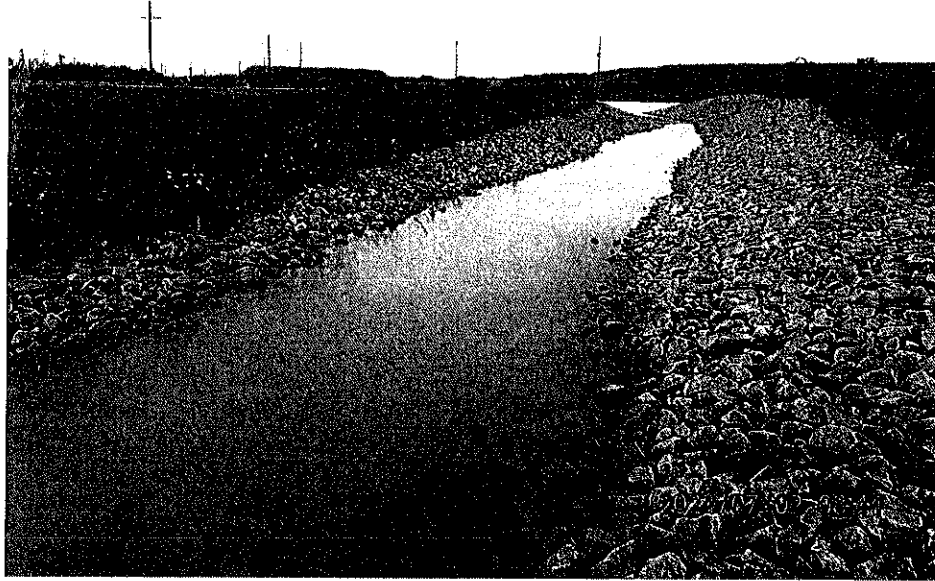
At approximately 08:40, July 2, 2024, the New Gold Environmental team was dispatched and confirmed that the spillway was active. Once the water crossed the rock ridge it moved through the culverts under Roen Road, mixing with Marr Diversion freshwater and into the West Creek Diversion. The effluent was further mixed with water coming from upstream West Creek Diversion. See Figure 1, 2, and 3.

Figure 1 Activated spill way from the South Dam Seep Collection Sump 2 pond.

To mitigate future incidents of this nature at this sump, a larger electric pump capable of pumping water at a minimum of 600 m³/hr over the Life-of-Mine dam height is being sourced to replace the current pump. Additionally, all other seepage ponds around the Tailings Management Area will have their pumping rates reviewed against Life-of-Mine dam height to ensure they align with the 25-year return period, 24-hour storm event condition in ECA 2290-CAVKGN.

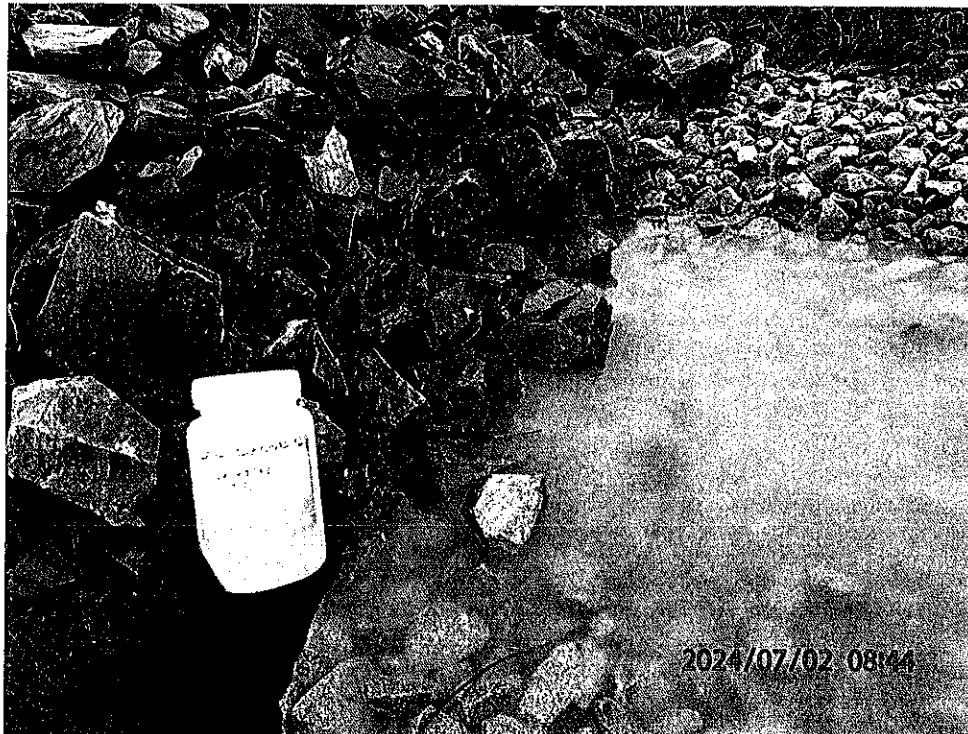
Figure 2 Water passing through the rock ridge at the end of the spill way.

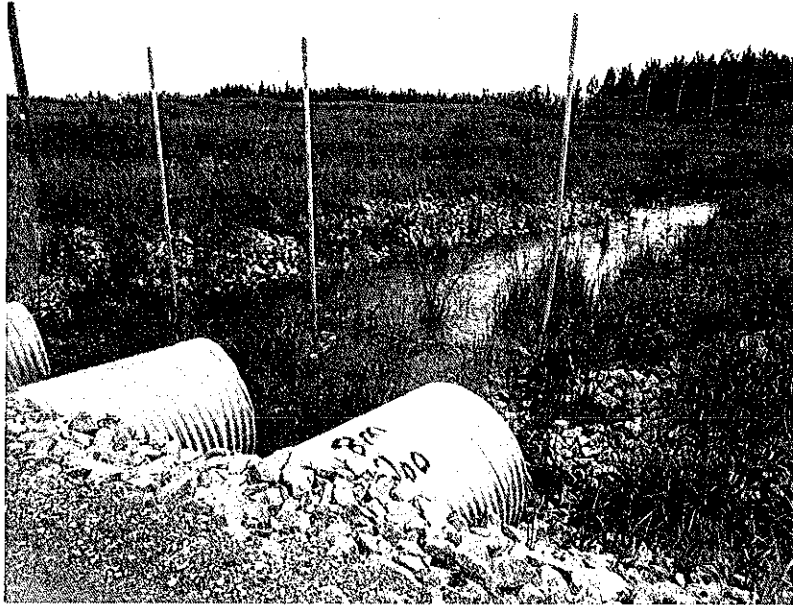
Figure 3 Water passing through the Marr Diversion culverts entering the West Creak Diversion.

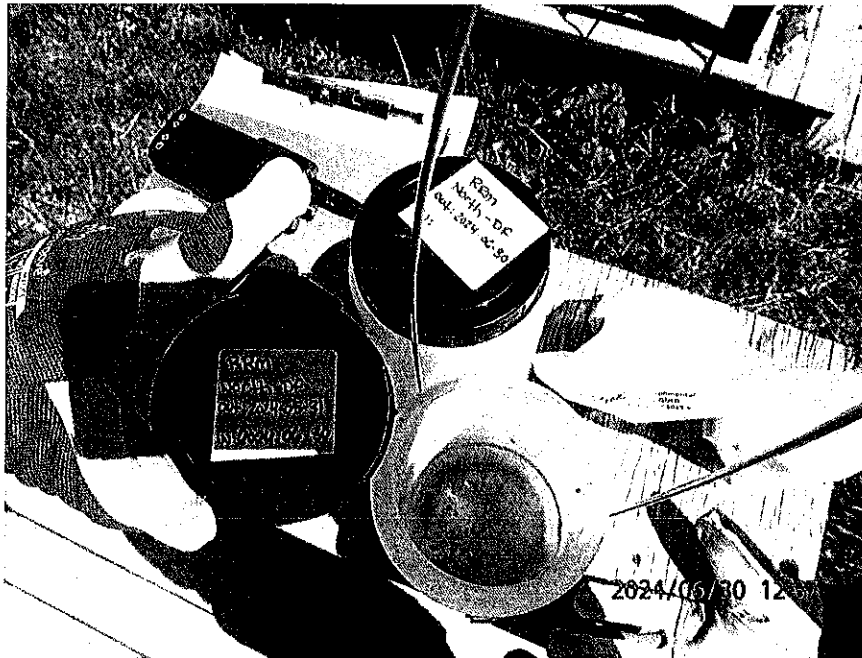
During the review of the June air quality results, it was noted that for the month of June, 2024, the total concentration of dustfall at the North Station was $11.16 \mu\text{g}/\text{m}^3$, and the total concentration of dustfall at the South Station was $8.31 \mu\text{g}/\text{m}^3$, exceeding the ministry approved limit of $7.00 \mu\text{g}/\text{m}^3$. Photos from time of collection (Figure 1 and Figure 2) show that the samples were contaminated with organics (bird dropping, bugs, etc.), biasing the results. The proportion of fixed dustfall for North and South Stations were $3.00 \mu\text{g}/\text{m}^3$ and $3.51 \mu\text{g}/\text{m}^3$ respectively.

Figure 1: North Station Dustfall jar, collected on June 30, 2024.

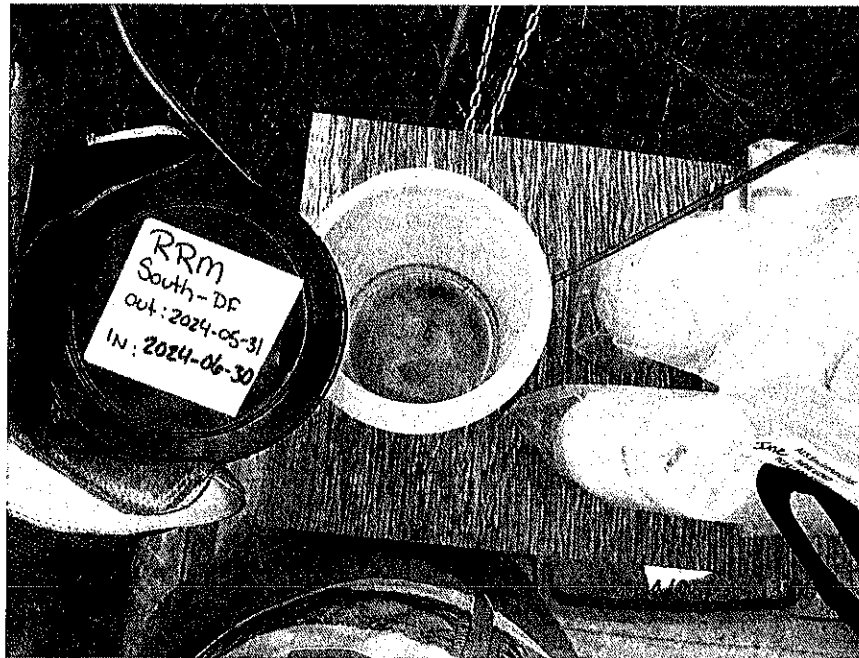
Figure 2: South Station Dustfall Jar, collected on June 30, 2024.

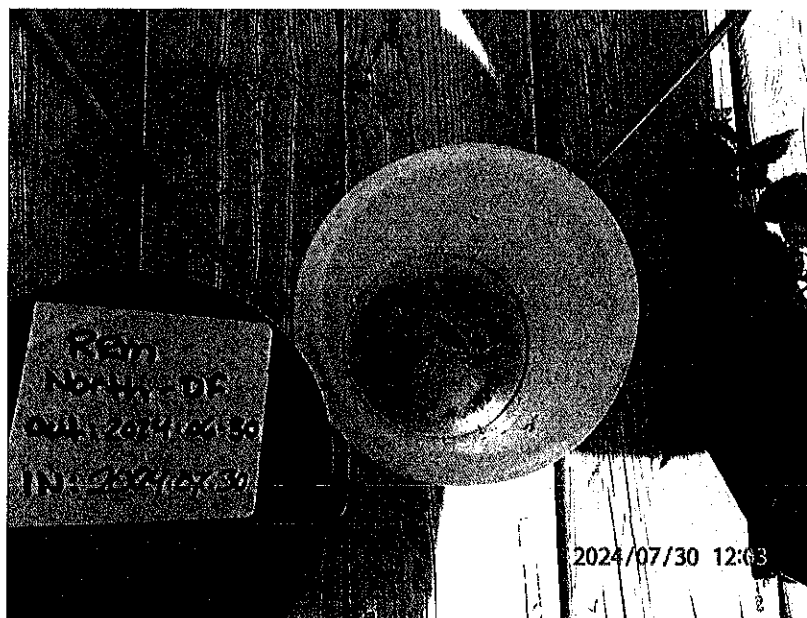
Photos from time of collection (Figure 1 and Figure 2) show that the samples were contaminated with organics (bird dropping, bugs, etc.), biasing the results. The proportion of fixed dustfall for North and South Stations were $3.18 \mu\text{g}/\text{m}^3$ and $2.67 \mu\text{g}/\text{m}^3$ respectively.

Figure 1: North Station Dustfall jar, collected on July 30, 2024.

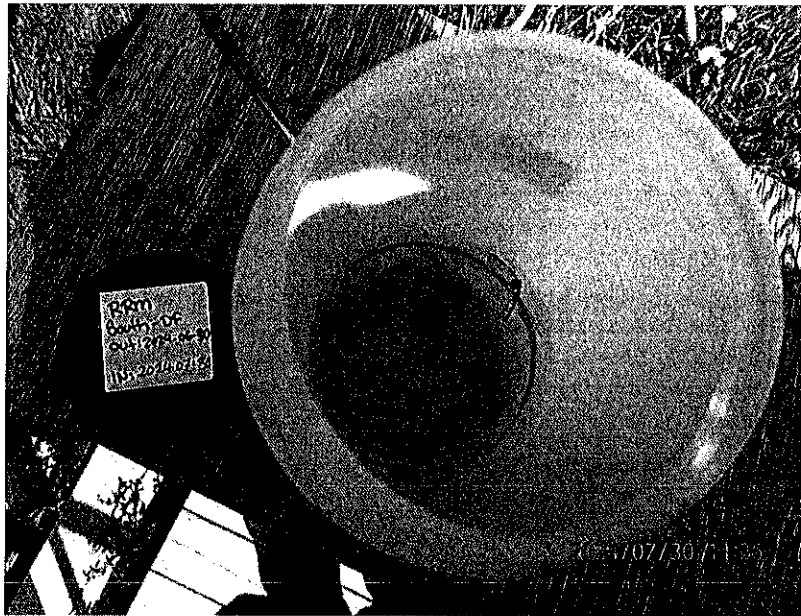
Figure 2: South Station Dustfall Jar, collected on July 30, 2024.
