**NEW GOLD RAINY RIVER MINE
APPENDIX K
EXCEEDANCE LETTERS
SUBMITTED TO MECP**

newgoldTM Rainy River

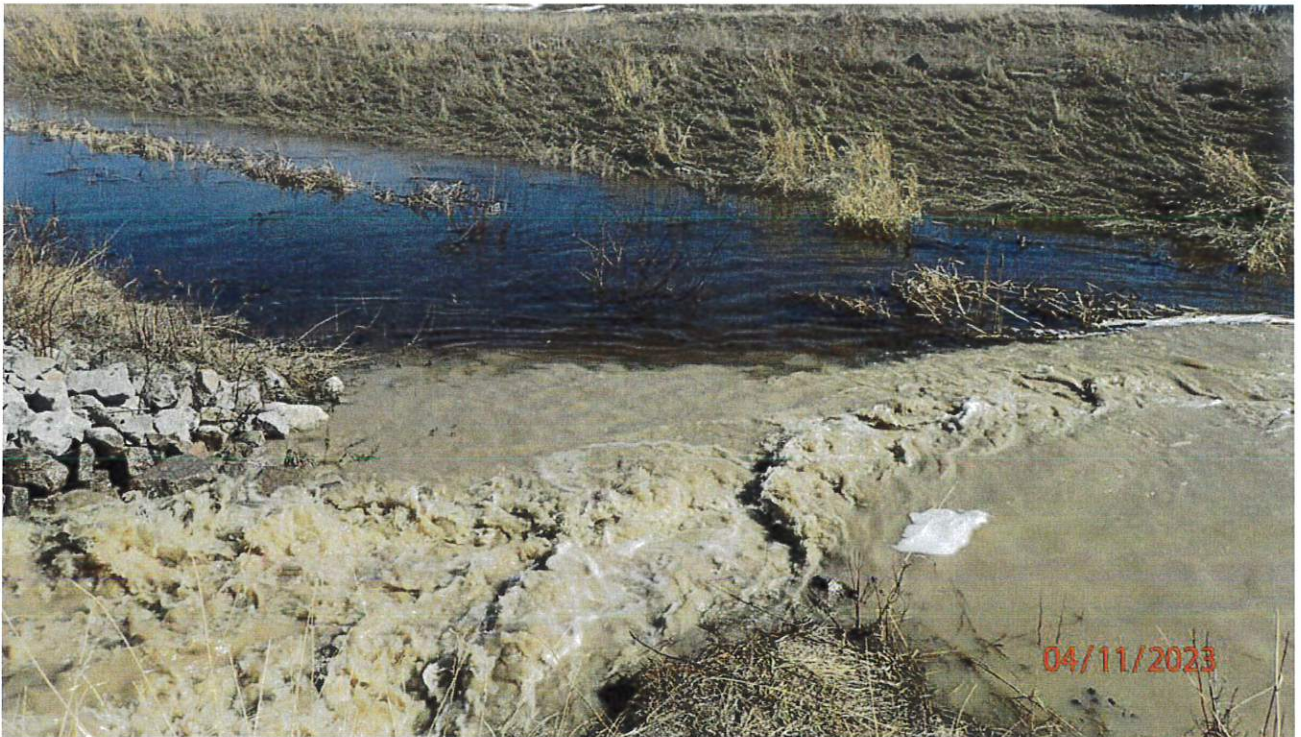
At 1400 on April 11th, New Gold Environment Staff noticed sediment laden water entering the West Creek Diversion (WCD) from the Marr Ditch (MD) culverts under Roen Road .

Photo 1: Sediment laden water from MD entering WCD

Total Suspended Solids (TSS) samples were collected along with field NTU samples at MD and at Surface Water Sample Site #25 (SW25). At the time MD was found to be at an NTU of 505.7 and a TSS of 710 mg/L, WCD at SW25 was at an NTU of 74.1 and a TSS of 104 mg/L.

1. Dewatering for remnant Marr and Loslo creeks was occurring to keep clean water out of the Tailings Management Area at 800 m³ per hour. Not all lines were discharging onto rock splash pads but onto disturbed ground.
2. New dam extension and seepage collection ditch cut off MD without a proper tie-in for overland flow to enter the MD.
3. Grubbing had occurred in winter without proper sediment and erosion control measures for spring in place.
4. A berm was constructed along the seepage collection ditch of Breana clay without geotextile liner or rock armor to keep overland flow from entering the seepage collection ditch.
5. Spring freshet occurred.

1. Dewatering lines have been extended as needed and placed on rock splash pads to reduce the energy of the pumped water. **Complete.**
2. Dewatering is halted or adjusted during times of downstream work or TSS is observed in excess of 30 mg/L. **On-going.**
3. Where MD now receives overland flow from Marr and Loslo, rock armoring of MD has occurred. New rock check dams have been installed along MD. **Complete.**
4. Where overland flow interacts with the seepage collection berm rock armoring has been added. **Complete.**
5. After observing the path of water as it interacts with grubbing rock, check dams have been added. **Complete.**
6. Freshet continues and monitoring will be on-going into summer for this newly disturbed location. When conditions improve as the ground dries, more sediment and erosion controls will be added as well as revegetation efforts where needed.

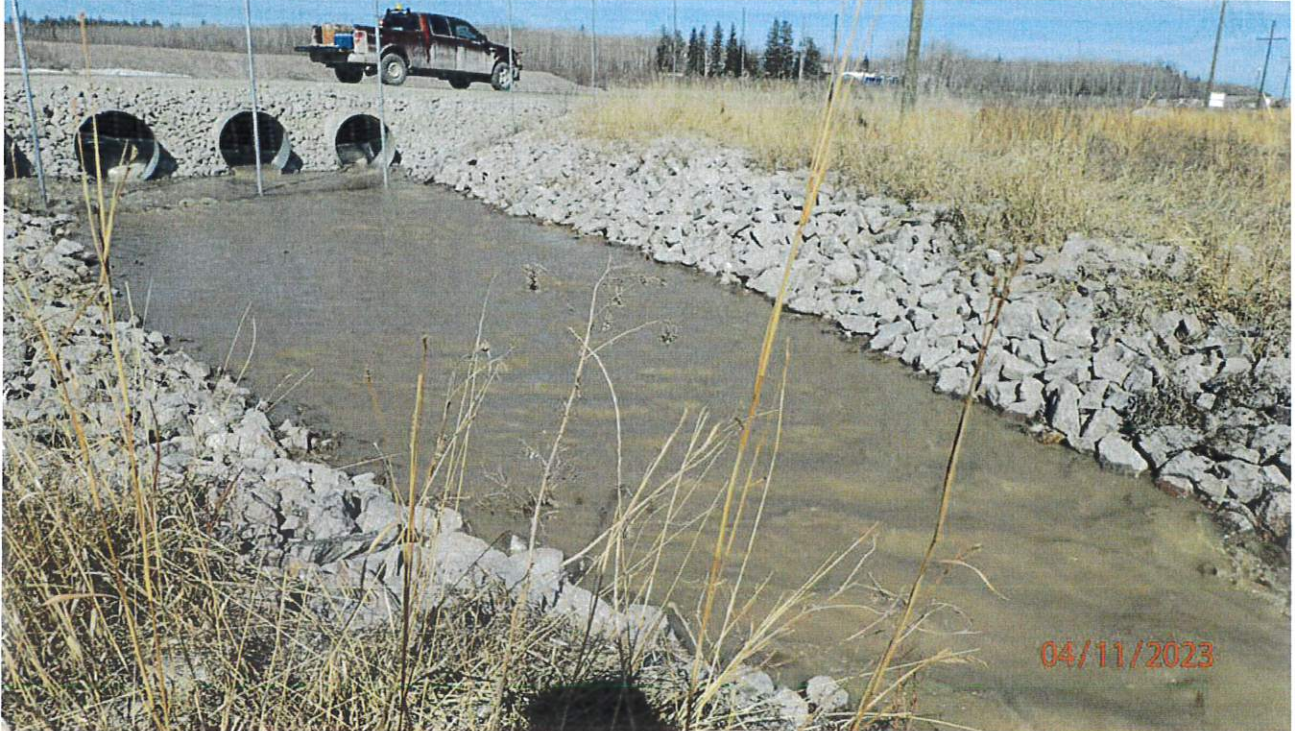
Photo 2: MD culverts

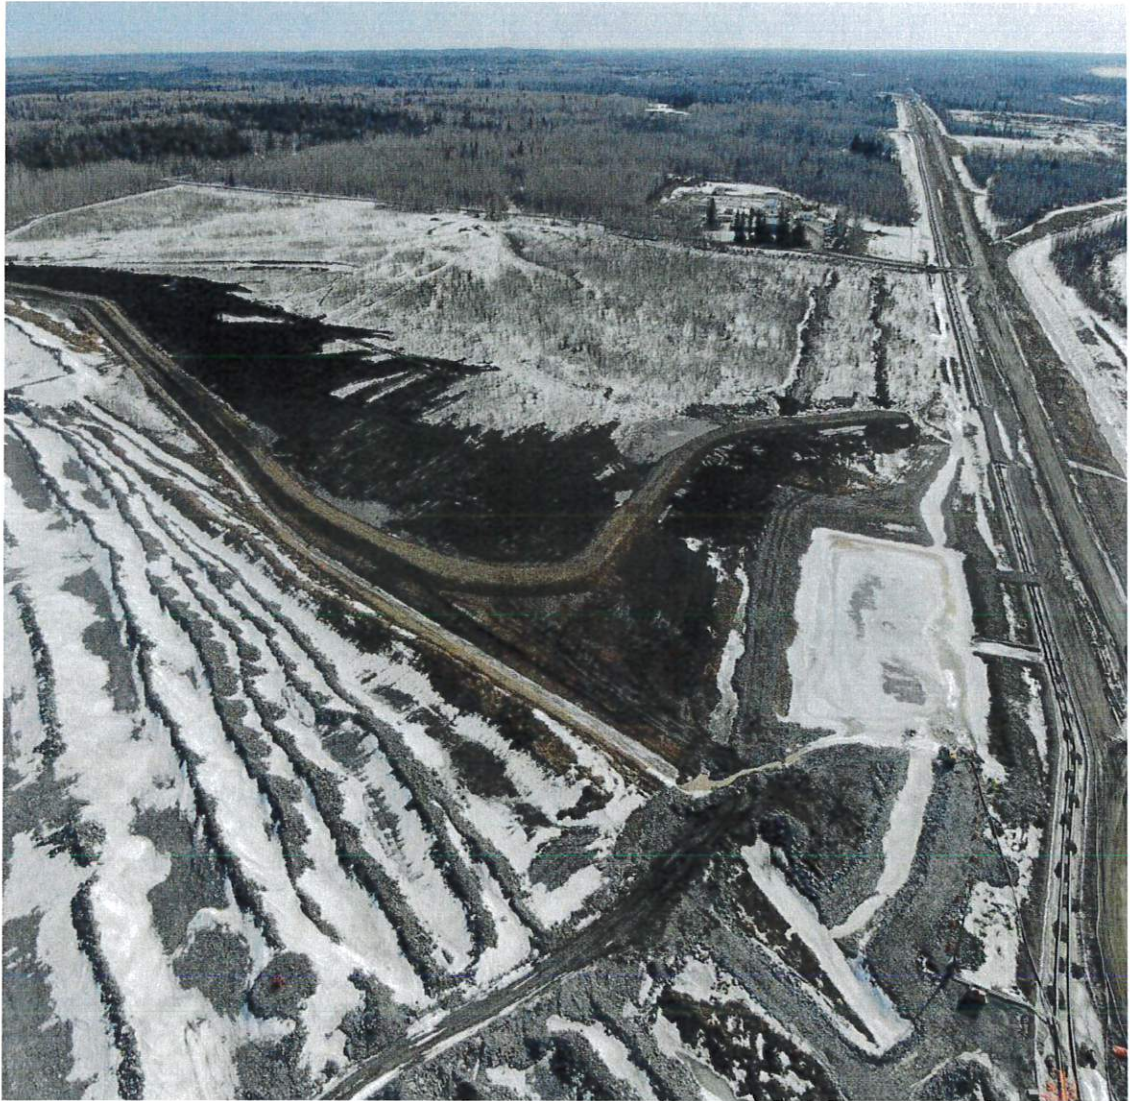
Photo 3: Area of event

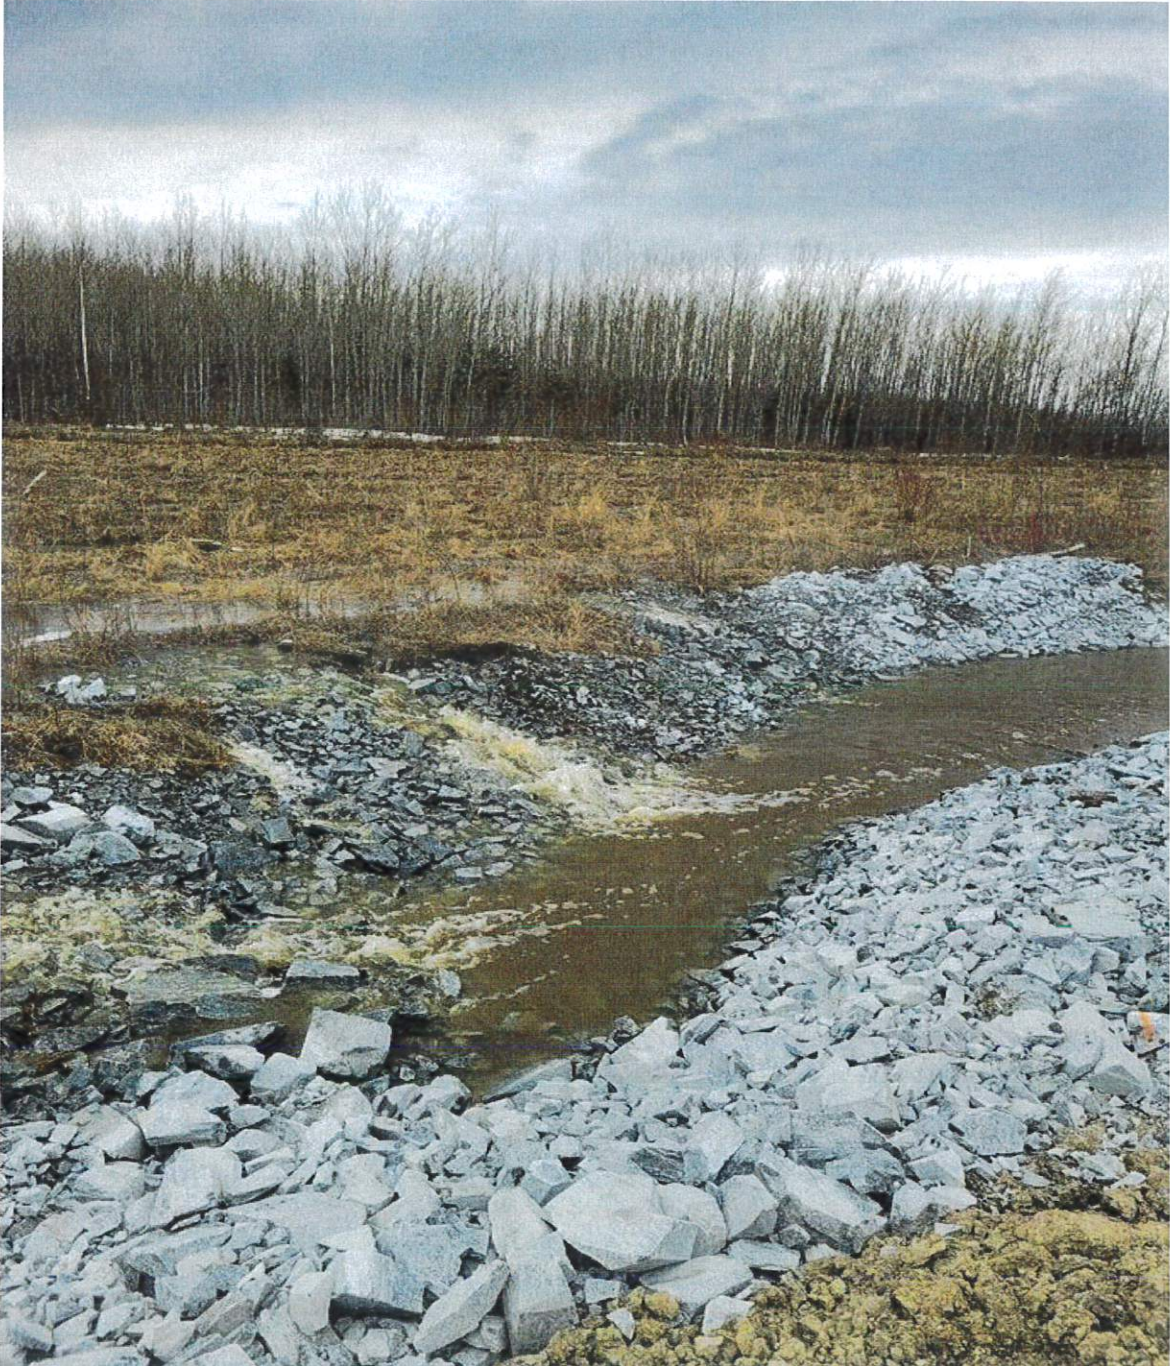
Photo 4: Marr tie-in repair

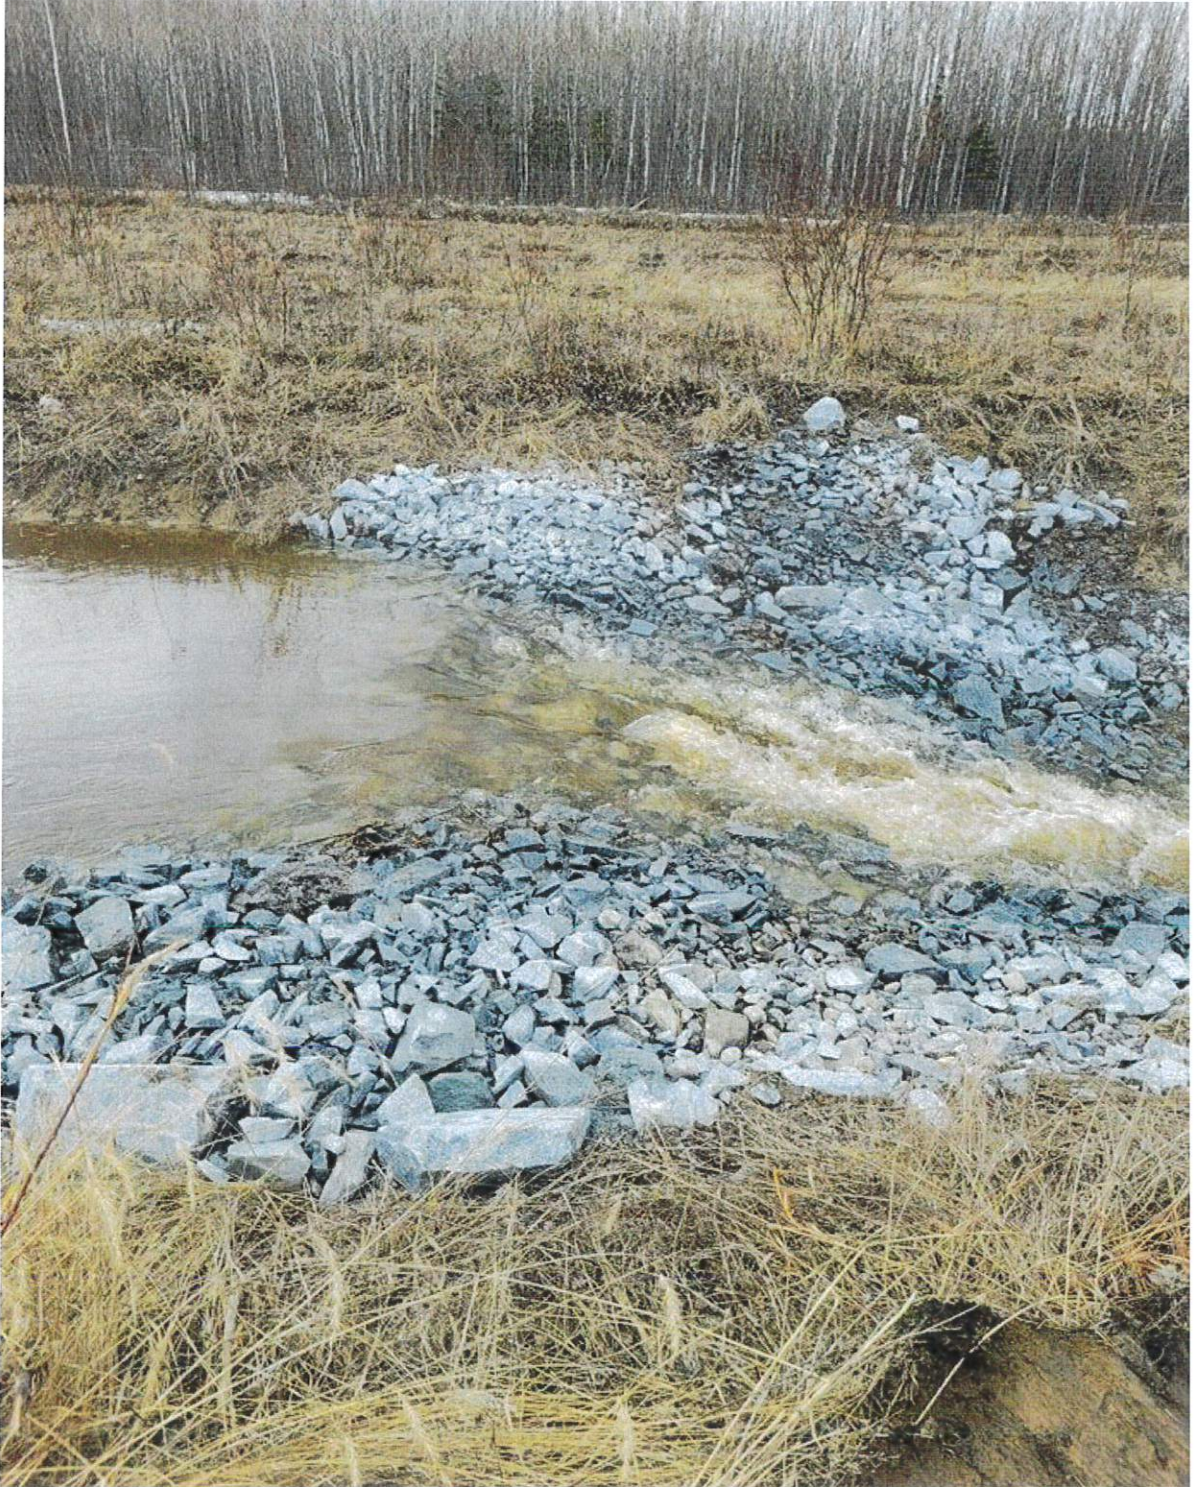
Photo 5: New rock check dam

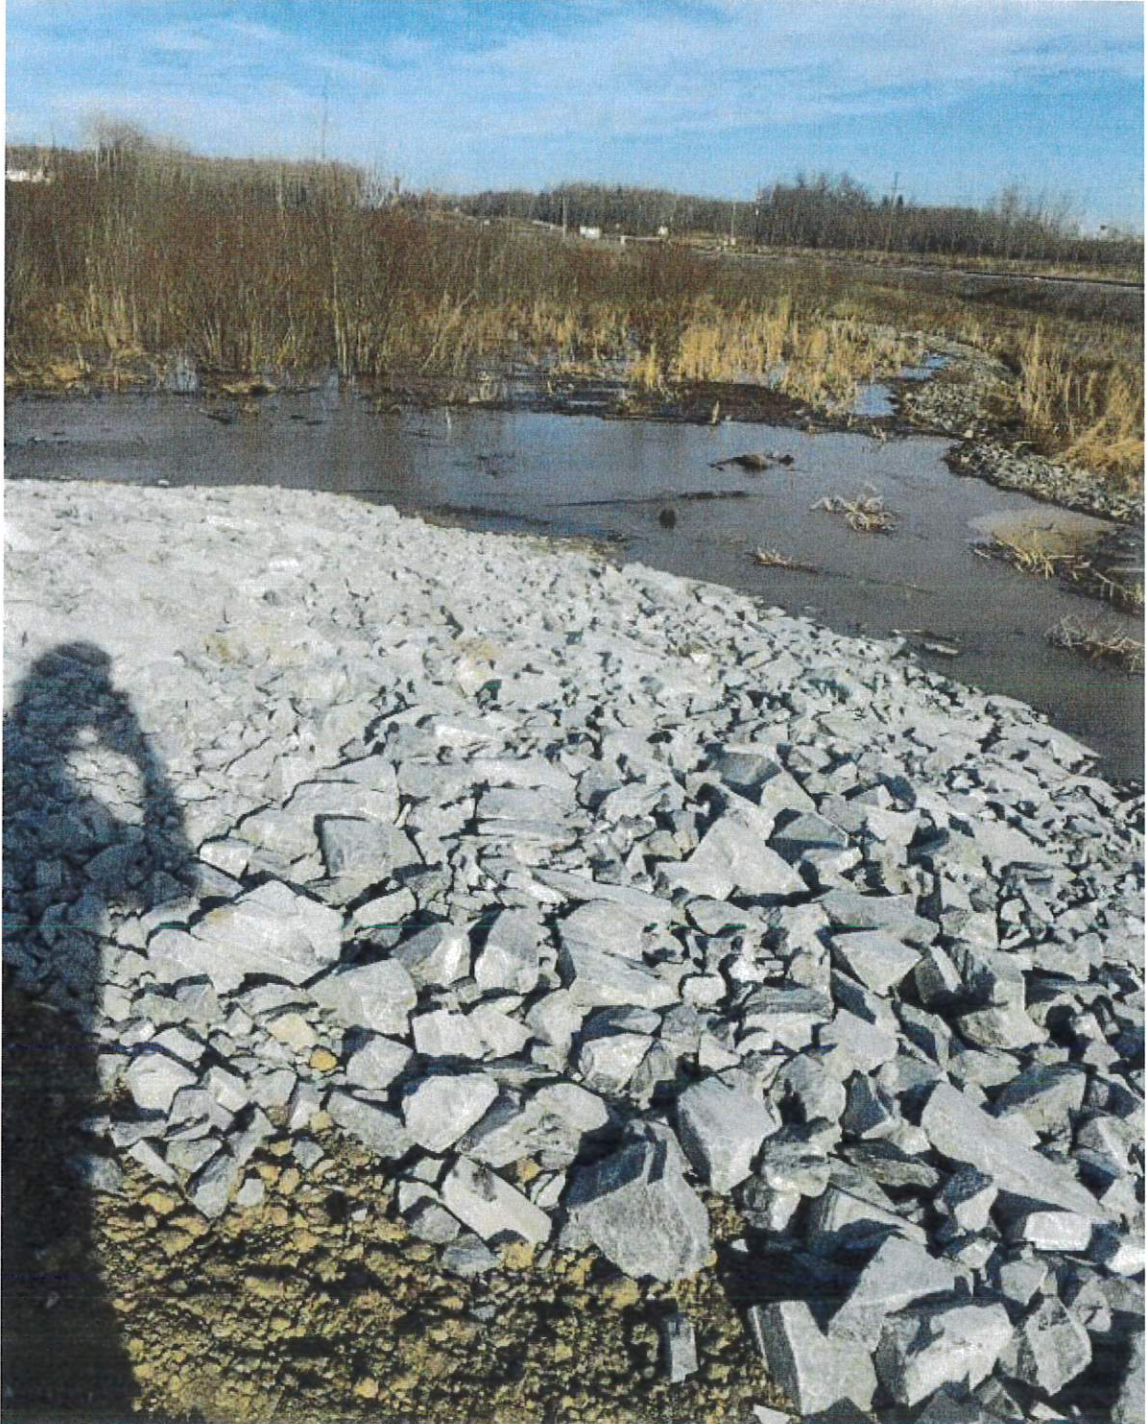
Photo 6: Berm armoring.

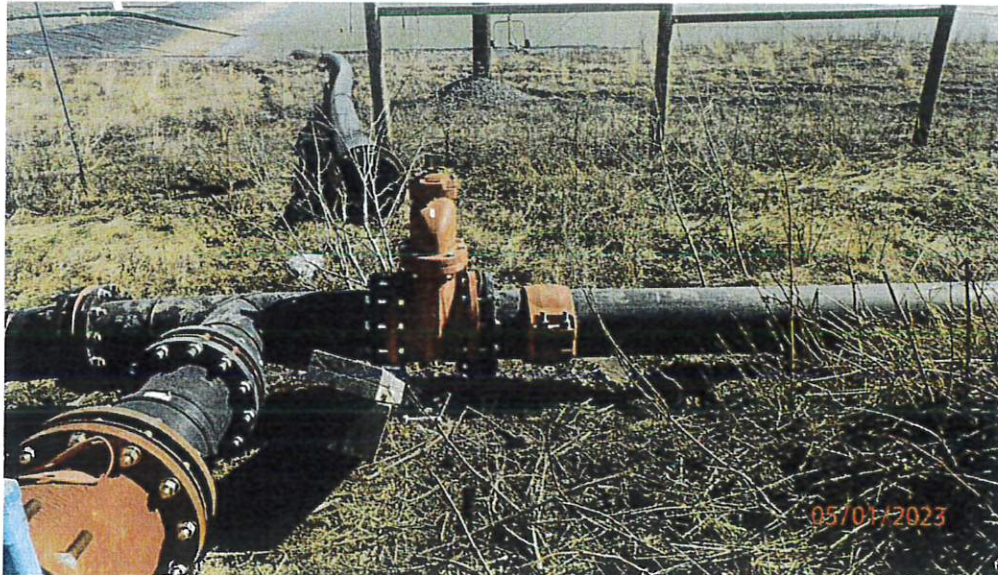
At 11:55 on May 01, a pipeline pumping water from the Water Discharge Pond (WDP) to Water Management Pond (WMP) was found leaking. Site Services was called upon discovery, and the pump was shut off at 13:00 for repairs to be completed. It was determined that a gasket failure caused the spill. The pipe was not leaking during a routine check by Site Services at 04:00 that morning, so the duration of the spill is estimated to be 9 hours in a worst-case scenario. Based on the flow rate of the spill, it is estimated that 0.78m³ of water was lost. Water samples taken from the source included discharge monitoring kits and acute toxicity.

There is no evidence that the spill will reach fish bearing water. No cleanup was undertaken due to the low risk of environmental damage, and concerns with sediment and erosion control during a cleanup. Water from this spill is expected to report to the outflow basin. The gasket has been replaced, and the fittings were tightened to prevent further spills of this nature.

Photo 1: Repaired pipe, outflow basin in the background.

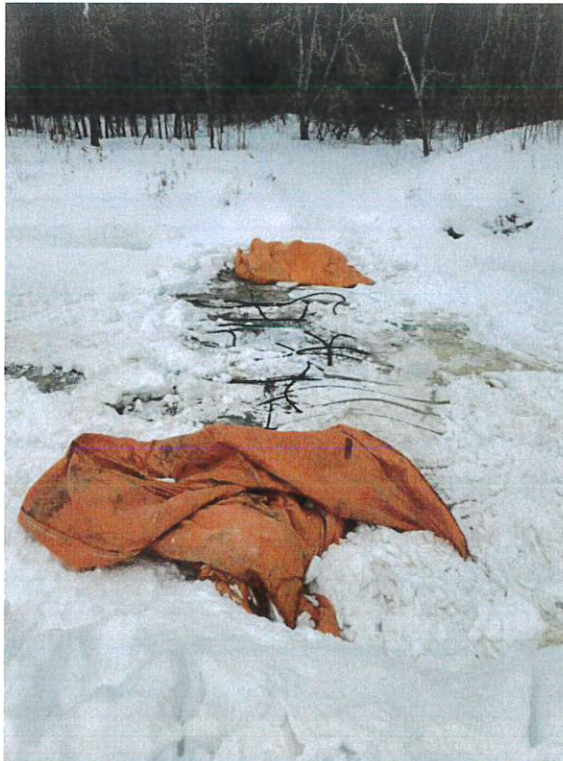
At approximately 8:00 on February 27, 2023, during an inspection of the Heat King glycol heater that was being used to thaw the ice at Effluent Discharge Location #1 (EDL1), it was noted that the glycol heater had automatically turned off sometime in the night due to a low-level alarm. Upon further investigation it was noticed that the glycol line had small tooth-like punctures in multiple areas along the glycol line that leaked approximately 110L of glycol into the Pinewood River. The glycol heater was expected to have shut off sometime overnight which left the glycol line frozen in the Pinewood River. The glycol heater was disconnected from the line and removed from the site for repairs. The glycol line was first attempted to be recovered with manual tools (ie. sledge hammer, chisels, etc.) but due to the hardness of the ice and safety concerns, an additional glycol heater was mobilized to thaw the ice and extract the remaining trapped glycol line.

Photo 1: Chewed glycol line trapped in ice morning of February 27, 2023.

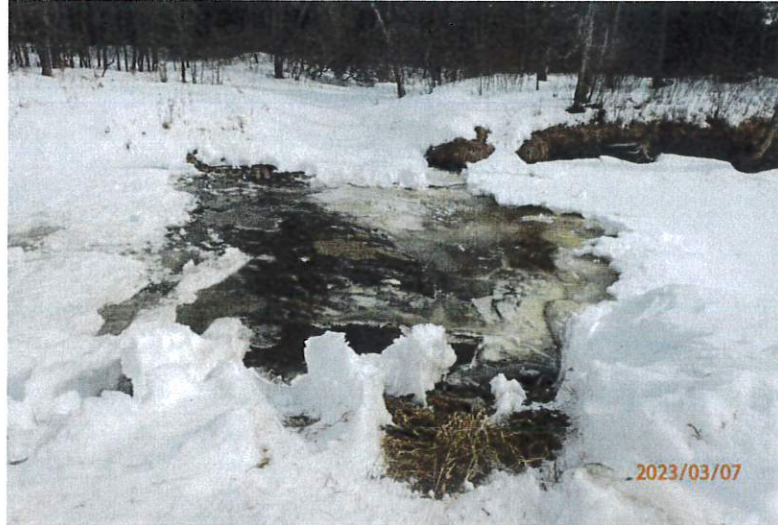
Photo 2: Clean-up of spill location with thawing of ice and removal of glycol line and insulated tarps.

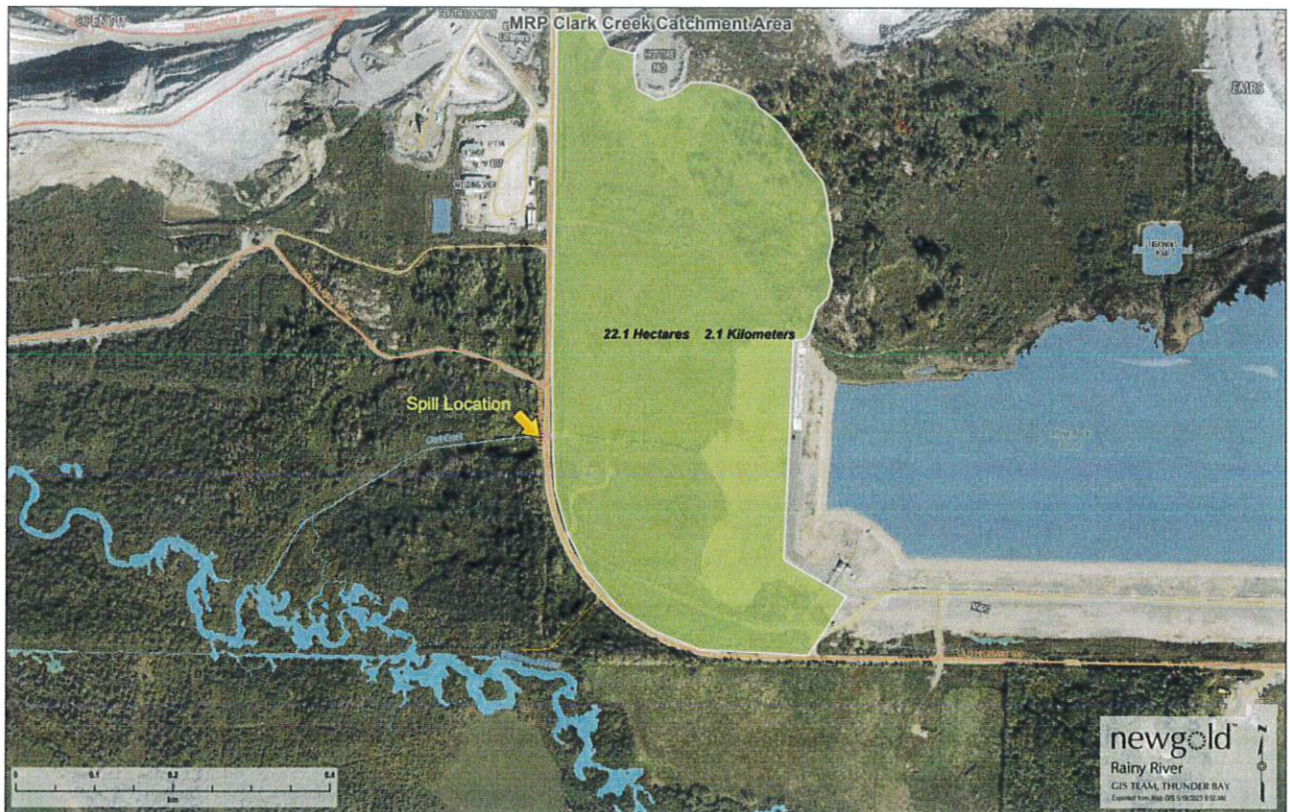
At 1200 on May 11th, the New Gold Environment Department discovered the catchment that collects contact water and other run-off from the downstream side of the Mine Rock Pond (MRP) dam and surrounding area was overflowing. Water samples including acute toxicity were collected, as well as an instream flow measure to estimate volume lost to the environment. There is a pump back system set up at this location to collect this water in the MRP, however the pump installed malfunctioned repeatedly and during repairs the volume of water exceeded the pumps ability to capture the water and the catchments ability to hold it.

Figure 1: Catchment area (green/white boarder) and spill location (arrow).

There is a plan in place to install an electric pump with a float to keep this catchment dewatered. Currently the estimated installation target is early 2024.

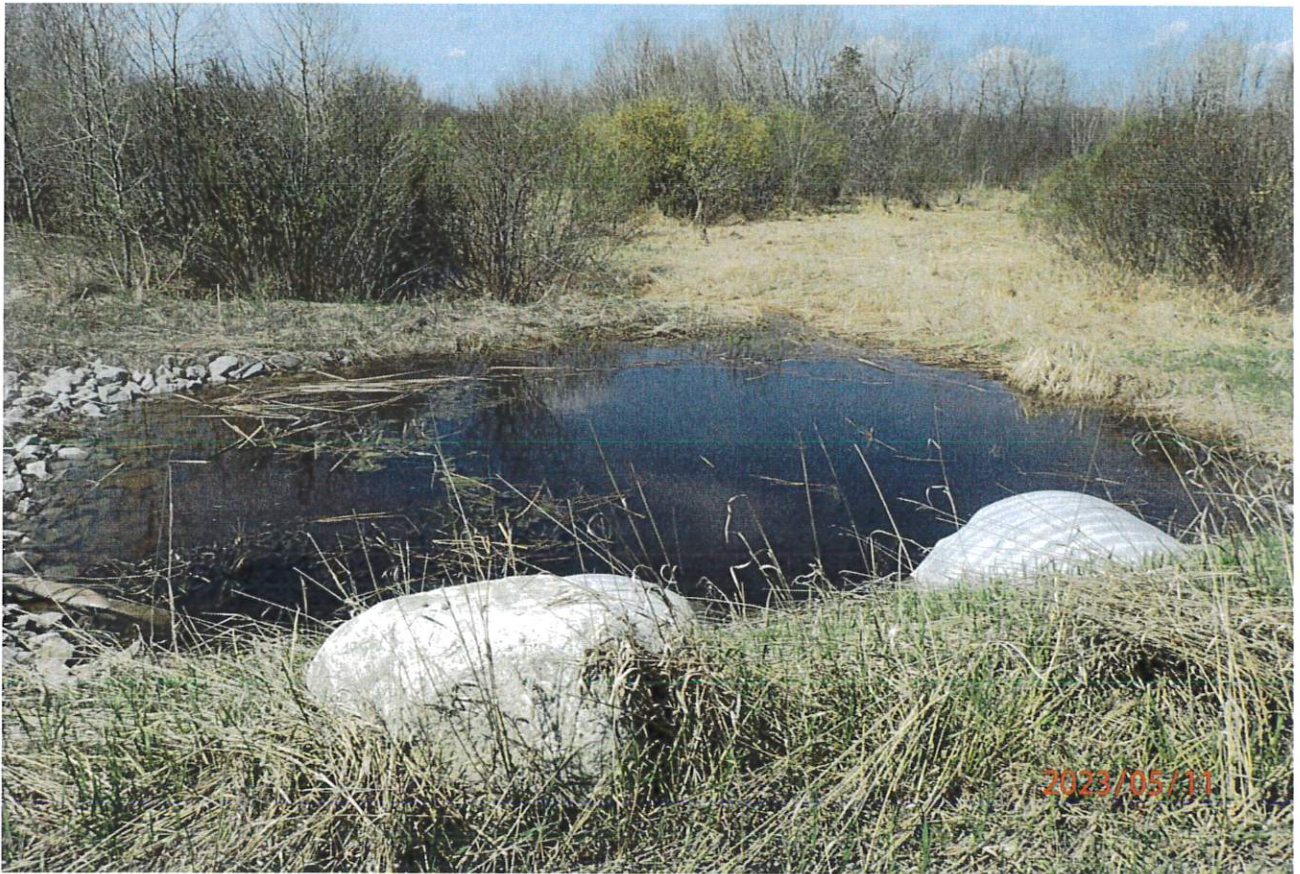
Photo 1; Spill location at time of discovery.

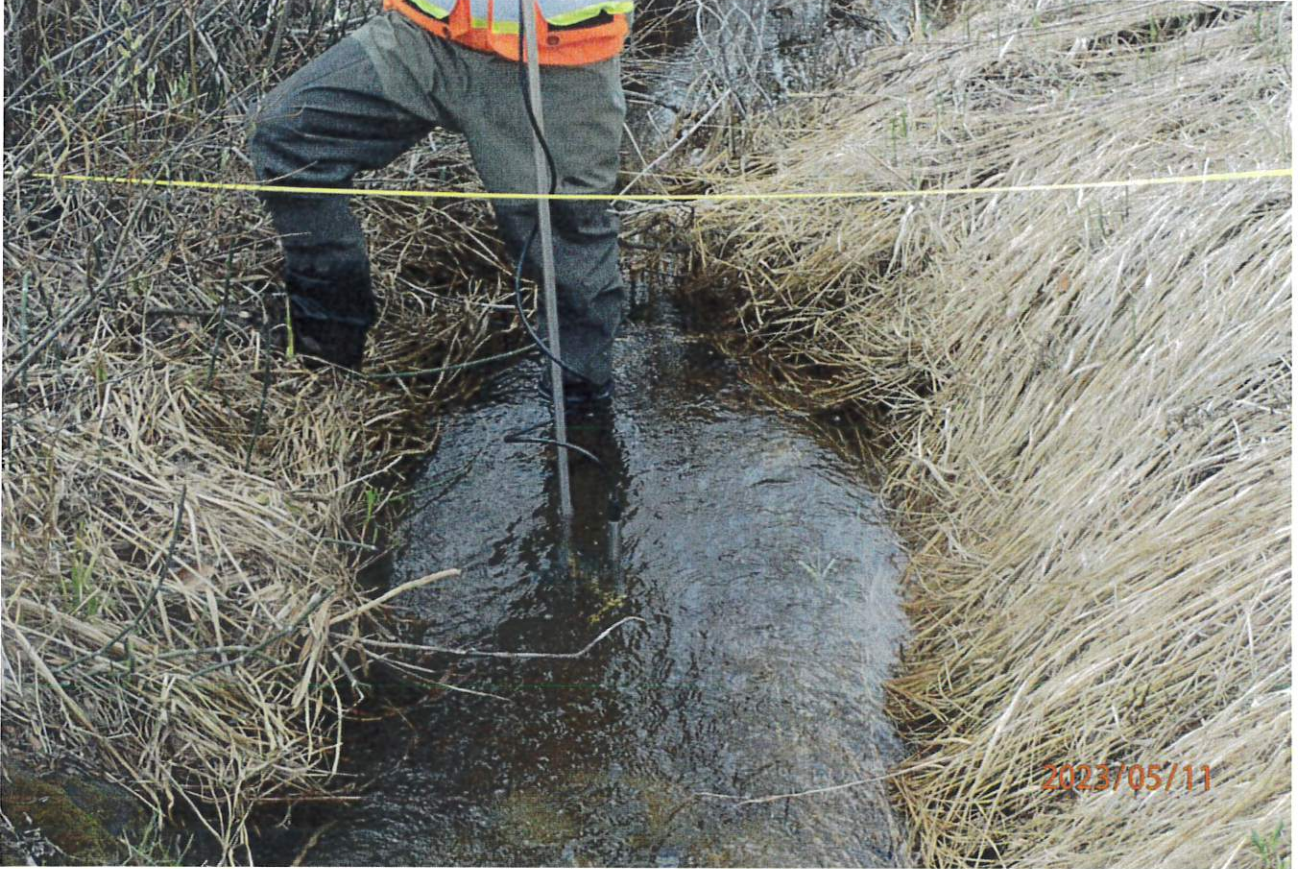
An instream flow measurement was taken to estimate the volume lost to the environment and fish bearing waters immediately downstream of the spill location. This measurement came to 16 L/s and reviewing weather station data for when the storm event began (0200 2023-05-11) and when the spill was observed to have stopped (1500 2023-05-11) an

estimated 748.8 m³ was lost from this catchment as a worst-case scenario. This assumes the catchment was 100% full at the time of storm beginning and that the pump did not run at all until noticed by the Environmental Department and the flow remained at 16 L/s during this entire time. We do not believe this to be the case, but we have no way of proving it was not at this time.

Photo 2; Flow measurement.

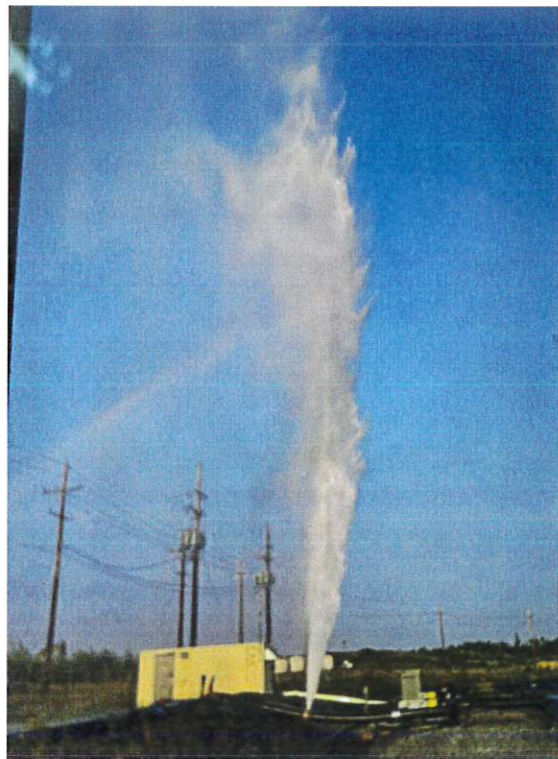
At 18:35 on August 18th, the New Gold Capital Projects Construction crew noticed a stream of water going straight up from beside the Outflow Basin pumps. Site Services was contacted immediately and quickly mobilized to the area. The control room was contacted, and the pumps were powered down at 18:50. The line continued to gradually leak for 54 minutes as the pressure reduced from 122 kPa to 0 kPa. A temporary fix was completed on August 18th at 20:45 and pumps restarted shortly after. Permanent parts were ordered August 21st and repairs planned to be completed the week of August 28th. Water volume loss is estimated at 4,797 L using the total spill duration and gradual pressure reduction within the line.

Figure 1 shows the Outflow Basin spill when Site Services arrived to shut down the pumps.

A call to Spills Action Center occurred on August 21st at 09:06 as the incident was not reported internally until August 20th at 18:43. To mitigate delayed reporting in the future, a side-wide reminder was distributed to ensure internal procedures are followed to report all environmental incidents within 24 hours.

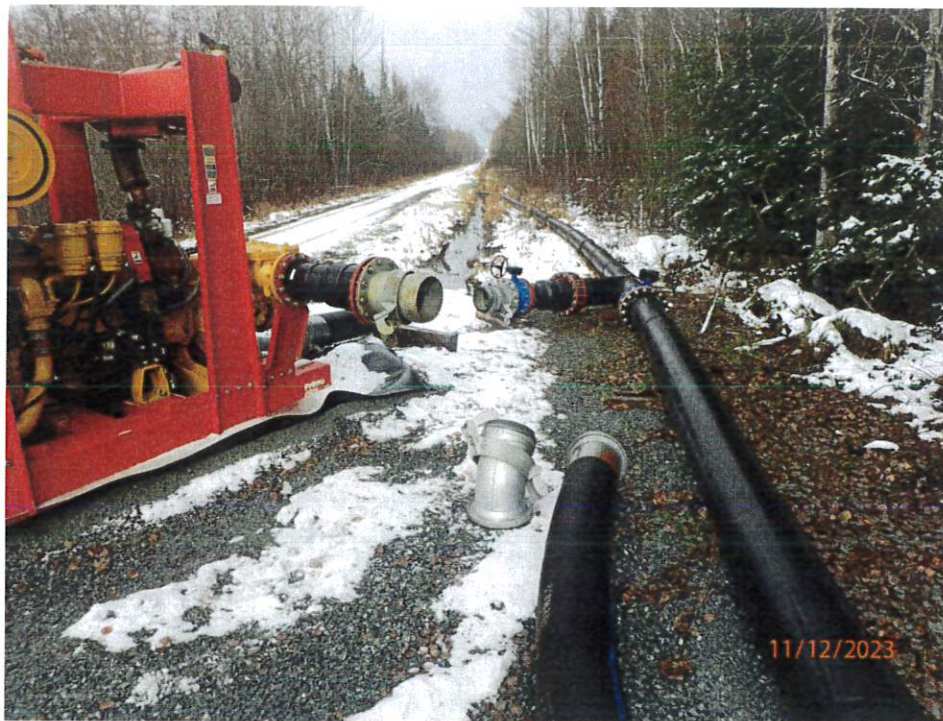
At 10:00 on November 11, a spill of effluent bound to a final discharge point occurred at the EDL2 booster pump on old Loslo road, 400m Northeast of the final discharge point. This occurred during commissioning of the booster pump, when an increase in feed pressure caused the discharge line to disconnect from the crimped end of the pump. The spill duration was 5 minutes, 45 seconds. The volume lost was calculated using the recorded flow rate of 942m³/h and assuming 100% of effluent from the pipeline spilled during the timeframe, the volume lost would be 75.575 m³ in a worst-case scenario. The effluent entered the ditch beside the road and is expected to have migrated towards the Pinewood River.

Figure 1: EDL2 Booster Pump and spilled effluent water in the ditch beside old Loslo Road.

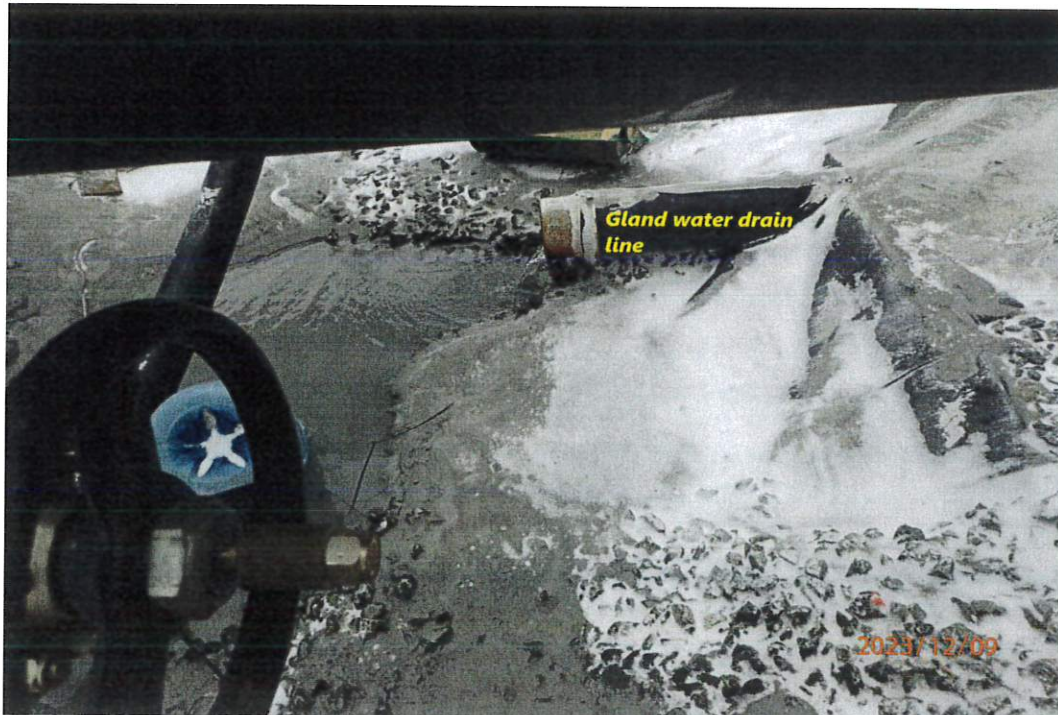
During the investigation into this seep's increase in flow and the presence of cyanide, New Gold has determined the most likely cause to be a leak in the TMA Booster Station's emergency dump pond liner. The booster station has never been run in winter before and it appears a pump designed to maintain the water level in the dump pond failed. This resulted in higher-than-normal water levels within the emergency dump pond. The pond itself does not show any signs of overtopping but New Gold suspects a gland water drain line that goes through the liner is not well sealed (Figure 1) allowing water from the dump pond to leach through the blast rock laydown and mix with the existing seep.

Figure 1: Gland water drain line and Booster Station.

Permanent solutions to this area are being investigated with the TMA Engineer-of-Record which will include secondary containment. We are also reviewing additional alarm mitigation measures for the Booster Station.

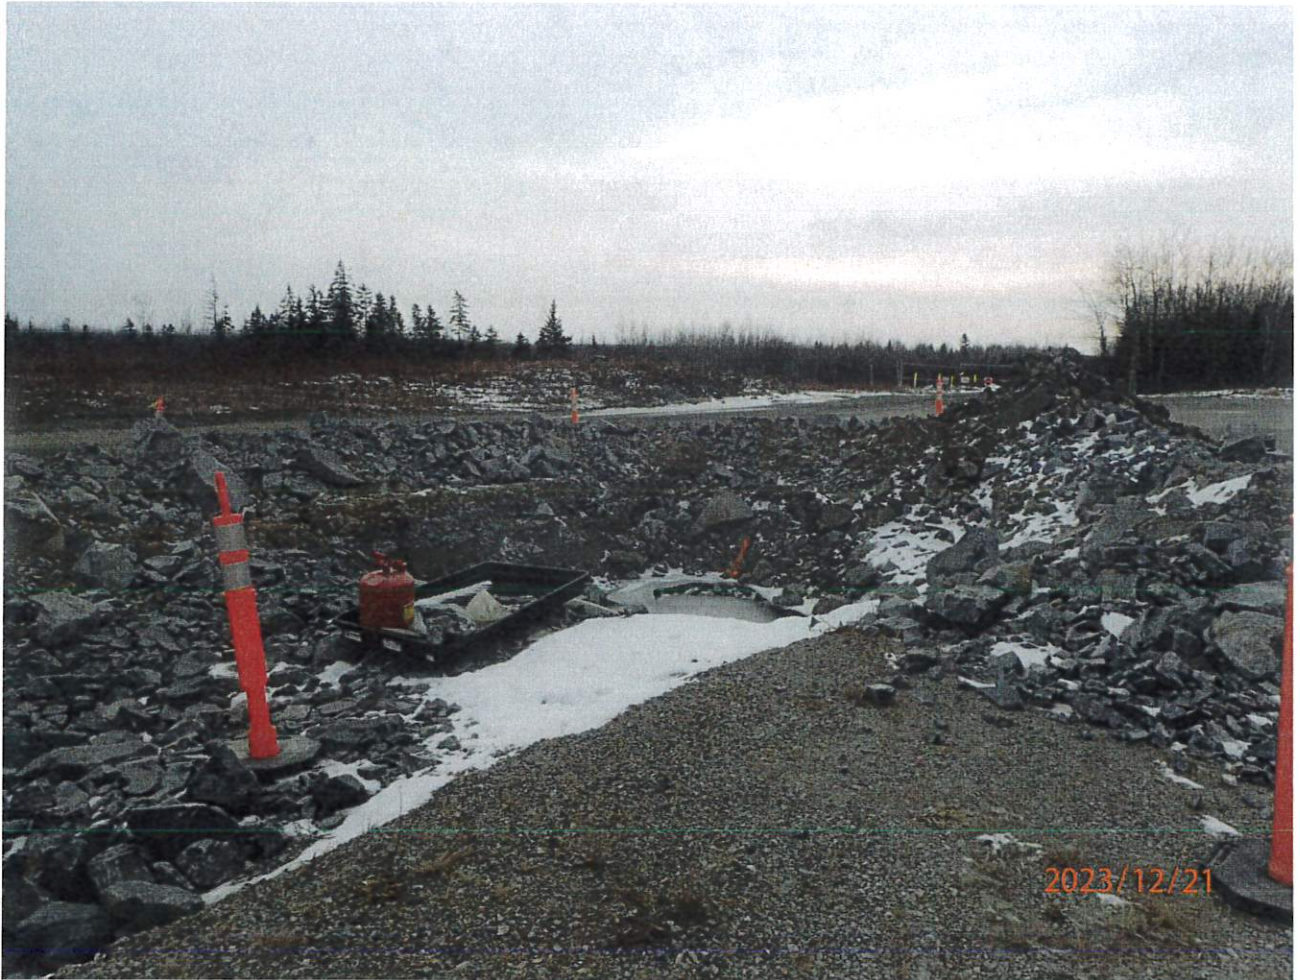
Figure 2: Collection sump constructed at seep location.

To mitigate the release to environment a small sump (Figure 2) was dug to capture the seep on 2023-12-10. The booster station emergency dump pond was also pumped down as much as possible and will remain in a near dry state going forward until repairs can be completed.

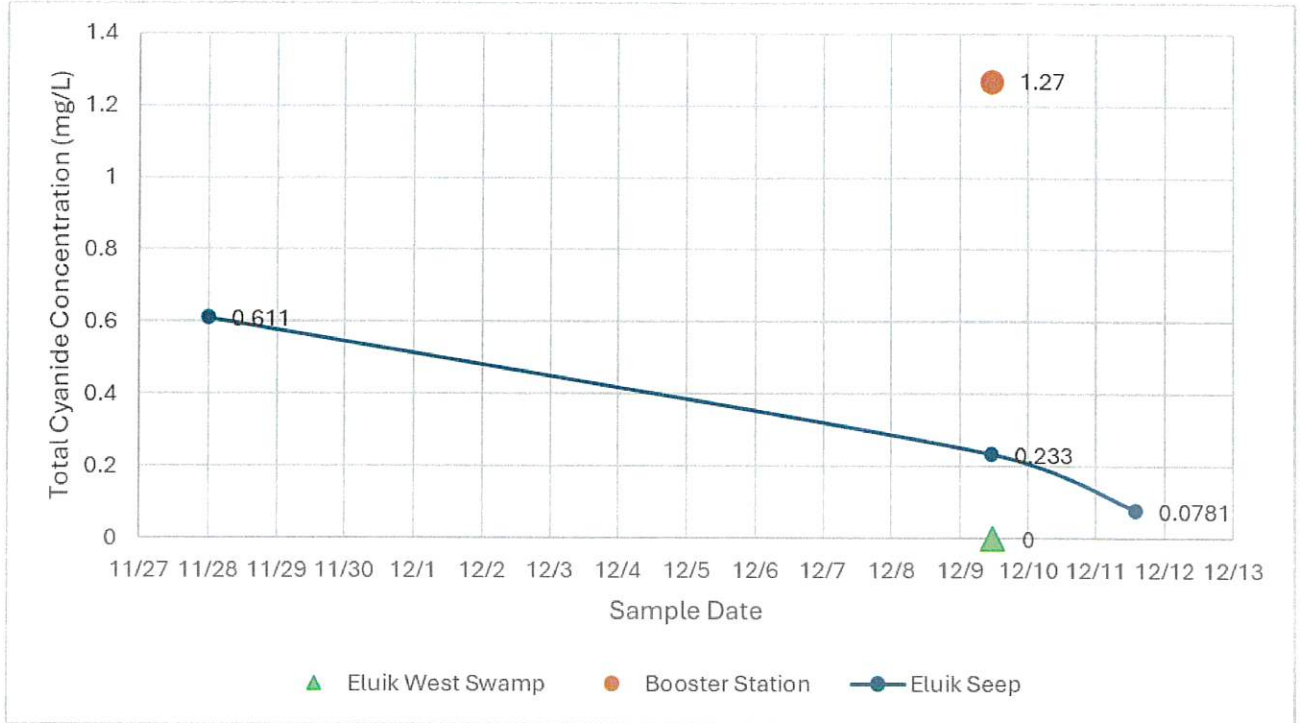
To date, weekly water quality monitoring of the newly created sump has shown a decreasing trend in cyanide levels (Figure 3). Monitoring will continue at this frequency until baseline cyanide levels return to normal (below detection limit). Freezing conditions have played a factor in the seeps flow rate and sampling may not be possible over winter of this new sump. Once low to no cyanide is detected in the sump, monitoring will follow quarterly monitoring frequency of the TMA seepage monitoring program.

Figure 3 – Total Cyanide concentration over time.
