NEW GOLD RAINY RIVER MINE APPENDIX K WILDLIFE MORTALITY LOG

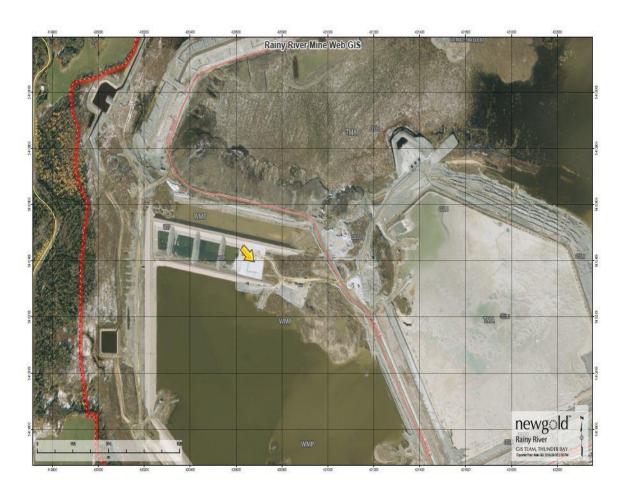
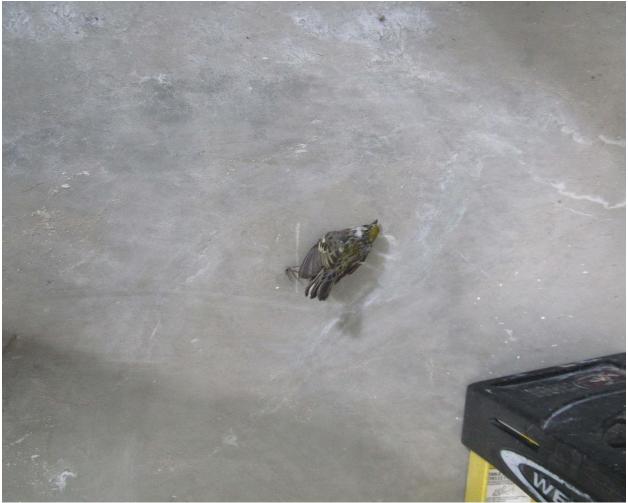
On June 2, 2019 at 1749 a deceased Chestnut-sided Warbler was discovered within the Water Treatment Plant which is currently under construction at the Tailings Management Area. (See photos below)

A contractor discovered the bird laying dead on the floor of the building and an assumption was made that it contacted some fans running on the ceiling. The doors of the building were open as construction is on going at the Water Treatment Plant but are closed whenever possible.

3.3. Description of Incident and Outcome	A Chestnut sided Warbler was found on the floor behind the polymer tanks.							
	No one witnessed what happened to the bird however the building fans were running							
	It is suspected that the bird flew into the fan at some point.

3.4. Could the Incident Have Been Avoided? (If yes, describe how)	Yes ⊠ No □	_						
	If fan caused the mortality it could have been prevented by having them turned off							
	and having the doors closed. Fans were turned off and will remain off if the doors							
	Need to be oper	ned during const	ruction

4. Additional Comments								
Personnel were reminded to keep the doors closed when not required to be open and to leave fans off unless they								
Are absolutely needed.

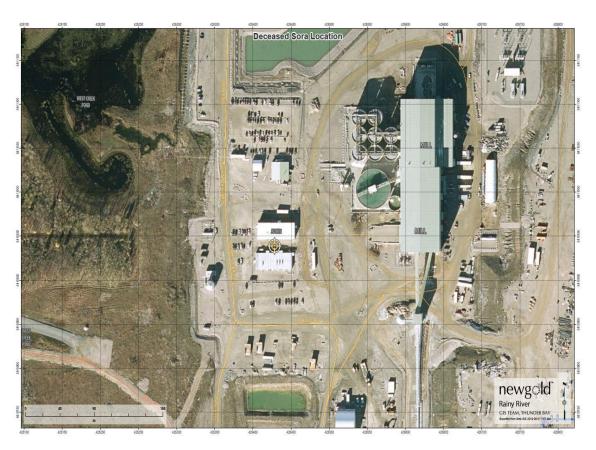
Photo 1. Site image with location marked out by bulls eye.

On June 18, 2019 at 0830 a deceased Sora was discovered in the parking lot between the Mine dry and the Admin building. (See on photo 1)

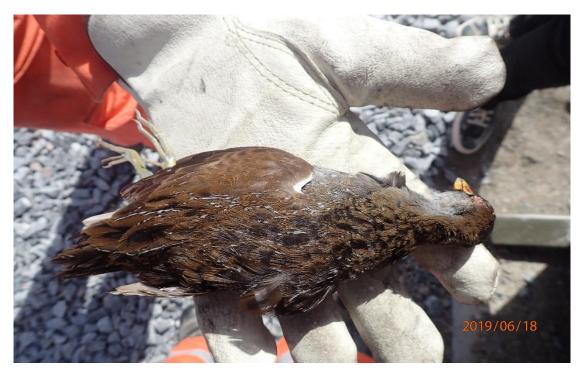
Photo 2. Deceased Sora with damage to head and neck.

A Sora was found dead in the parking lot with damage to its head and neck (Photo 2). The incident report stated that it is suspected the bird collided with a vehicle near the West Creek Pond and when the vehicle stopped the bird dropped off the vehicle.

We are not certain this incident occurred on the mine site as a Sora has never been observed on site, but it's habitat is nearby. The speed limit for the area around the Admin building is 20 km/h, indicating that this may not have happened at West Creek Pond. No one reported hitting a bird and no vehicle was nearby when the bird was discovered.

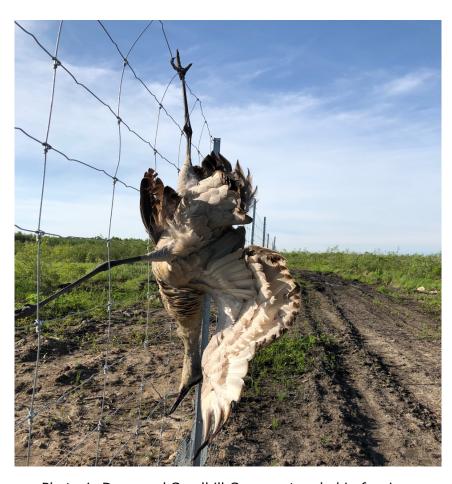
On June 21, 2019 at 0815 a Sandhill Crane was discovered deceased and entangled in the Wildlife Exclusion Fence (See photo 1).

Photo 1. Deceased Sandhill Crane entangled in fencing.

3.1. Location		Wildlife Exclusion Fe	ence	UTMs E:		N:		
3.2. Species		Sandhill Crane		Number of An	nimals: 1			
3.3. Description of Incident and Outcome	A Sandhill Crane was discovered entangled in the Wildlife Exclusion Fence some time							
	Between June 7 th and June 21 st and likely died of exhaustion.

To summarize, a Sandhill Crane was found entangled and deceased in the Wildlife Exclusion Fence. It is unknown how this happened as Sandhill Cranes are not often observed attempting to roost on a fence, possibly wind was a factor.

4. Additional Comments								
The Wildlife Exclusion Fence is basically an 8 foot high page wire fence and is patrolled at least twice a month.						a month.		
If further incidents occur m	itigation efforts	s will be made, s	uch as the inst	allation of reflec	tive tape or	long the top of		
the fence.

We will continue to patrol the fence and if other similar incidents occur, mitigation efforts will be explored.

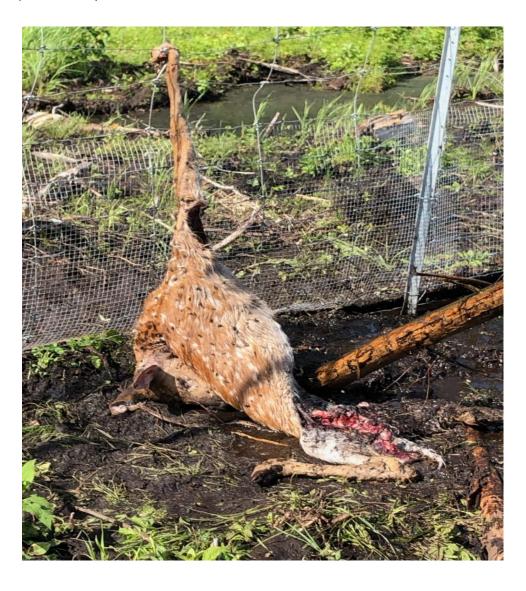
On July 12th, 2019 at 0705 a deceased White-tailed Deer Fawn was discovered entangled in the Wildlife Exclusion Fence. (See photo 1 below)

The Wildlife Exclusion Fence is over 14 kilometers long and not visible along its entirety. The services of a trapper are retained by New Gold. As part of his normal duties he patrols the fence to keep incidents like this from happening and ensure the fence is in good repair. His assessment of the tracks in the area led to the conclusion that a black bear had chased the fawn into and through the fence, which caused it to become entangled and die of exhaustion.

3.2. Species		Deer		Number of Anima	als: 1		
3.3. Description of Incident and Outcome	A Deer fawn was discovered entangled in the Wildlife Exclusion Fence and likely died of						
	exhaustion. The tracks in the mud around the area lead the trapper to come the						
	conclusion that a bear chased the fawn from the outside into the fence where it became						
	entangled.

It was built out of standard gap page wire and stands 8 feet in height with 2 feet of reptile barrier along to bottom. It is not uncommon for White-tailed deer to become entangled in this type of fencing when used to control livestock.

Should further incidents occur patrols may be increased and other options may also be explored.
