### NEW GOLD RAINY RIVER MINE APPENDIX K EXCEEDANCE LETTERS SUBMITTED TO MECP AND REGULATORY REPORTING TABLE

### NEW GOLD RAINY RIVER MINE APPENDIX K.1 EXCEEDANCE LETTERS SUBMITTED TO MECP

#### SUBJECT: NORTH STATION AMBIENT AIR QUALITY EXCEEDANCES OF 24-HOUR TOTAL SUSPENDED PARTICULATE-MONITORING LIMITS - SAC REFERENCE #8876-BPJS8Z

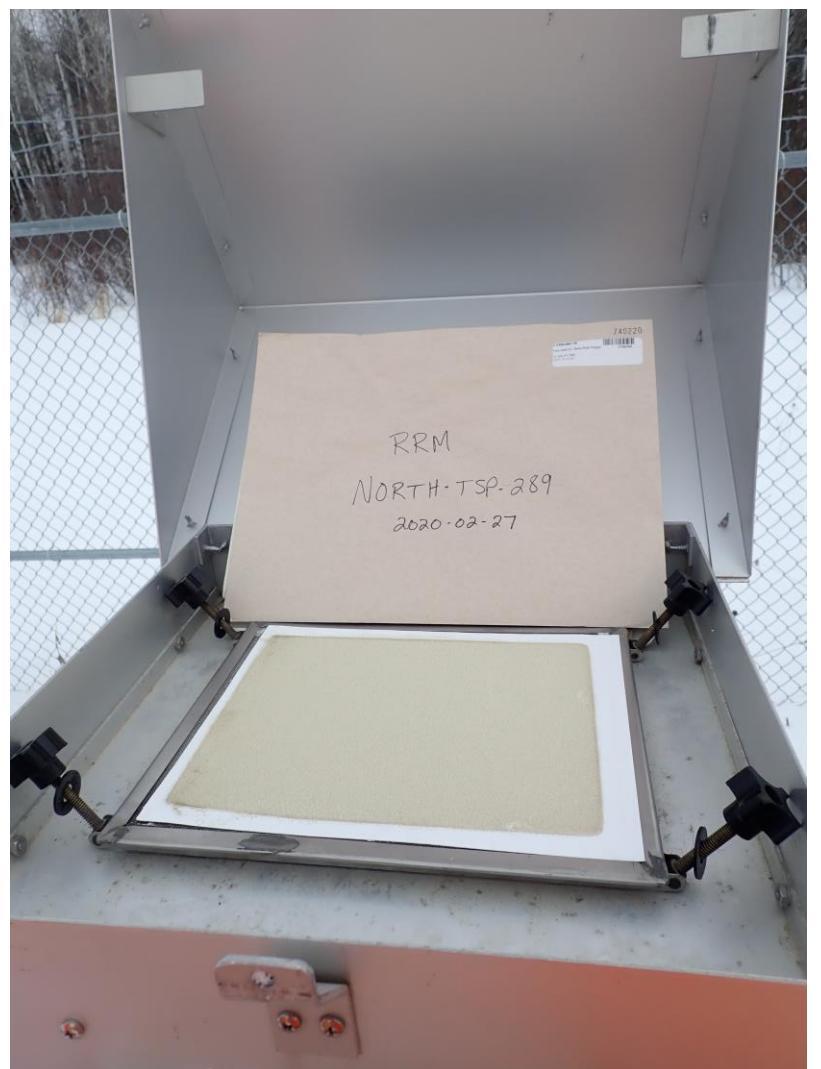
It was noted that on February 27, 2020, the Total Suspended Particulates (TSP) concentration and iron concentration exceedances at Gallinger Ambient Air Quality Monitoring Station and Tait Ambient Air Quality Monitoring Station were invalidated. As described in the Rainy River Q1 Ambient Air Quality Monitoring Report, the data for this samples was invalidated. The data for both stations was invalid because of the flow calculation exceeded the theoretical flow limit described in the Operations Manual for Air Quality Monitoring in Ontario. The operations manual theoretical total volume limit is 1794 m<sup>3</sup>. On February 27, 2020, the Gallinger and Tait Ambient Air Quality Monitoring Stations had a total volume of 1829.65 m<sup>3</sup> and 2095.44 m<sup>3</sup> respectively.

After reviewing the sampling notes for both monitoring stations, no error was seen in the operation of the equipment or sampling procedure. The lab results were also reviewed. No QAQC issues were found with the analyses. The error in setting the equipment to a higher cubic feet per minute resulted in the exceeded theoretical flow limit. Figure 1 and Figure 2 are photos of the filters from the February 27, 2020 samples. Figure 3 and Figure 4 are photos of samples taken February 3, 2020 both of which had very similar flows to February 27 samples. By comparing these photos there is a visual difference between the amount of dust collected on the February 27, 2020 and the dust collected on February 3, 2020. Therefore, the data was invalidated but we still believe the February 27, 2020 samples were exceedances.

Figure 1: Photo of the North Station TSP Filter sampled on February 27, 2020

New Gold will continue to apply the mitigation measures as described in the previous letter sent on May 13, 2020, and is actively working on improving our sampling and maintenance procedures of ambient air quality monitoring equipment to allow for faster reaction time on errors. In addition, New Gold will be providing more training for New Gold employees on equipment maintenance and calibration.

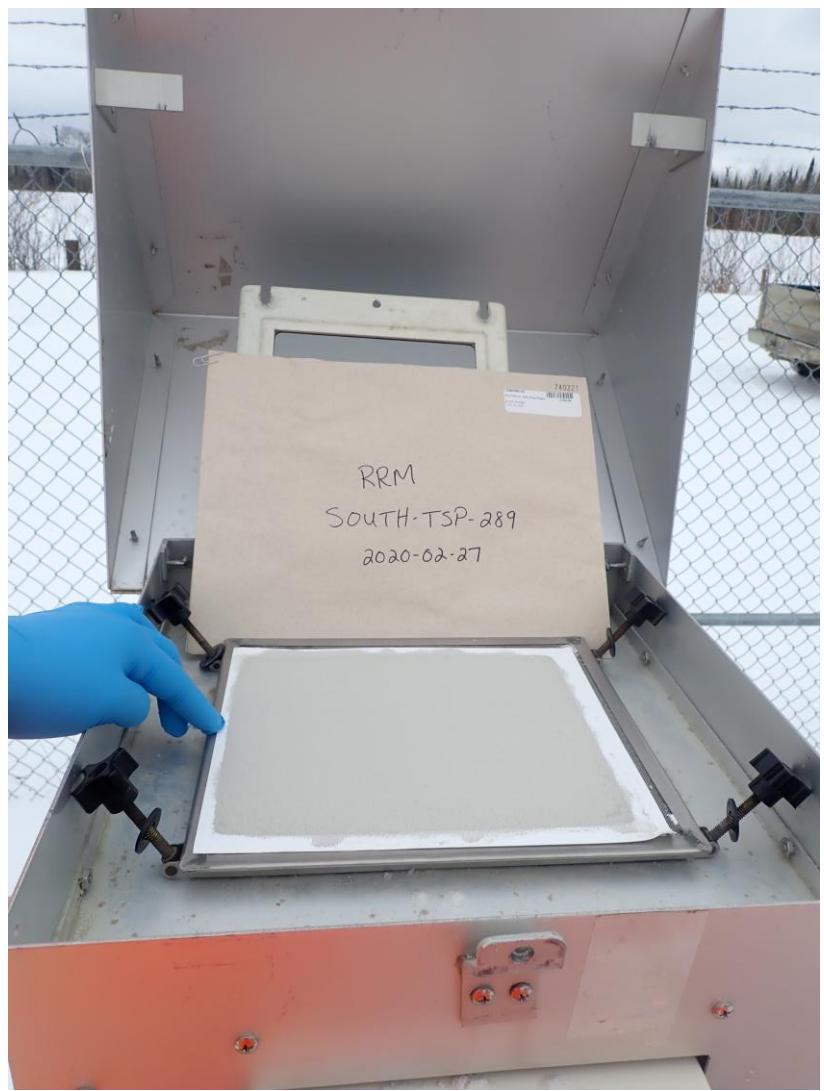
Figure 2: Photo of the South Station TSP Filter sampled on February 27, 2020

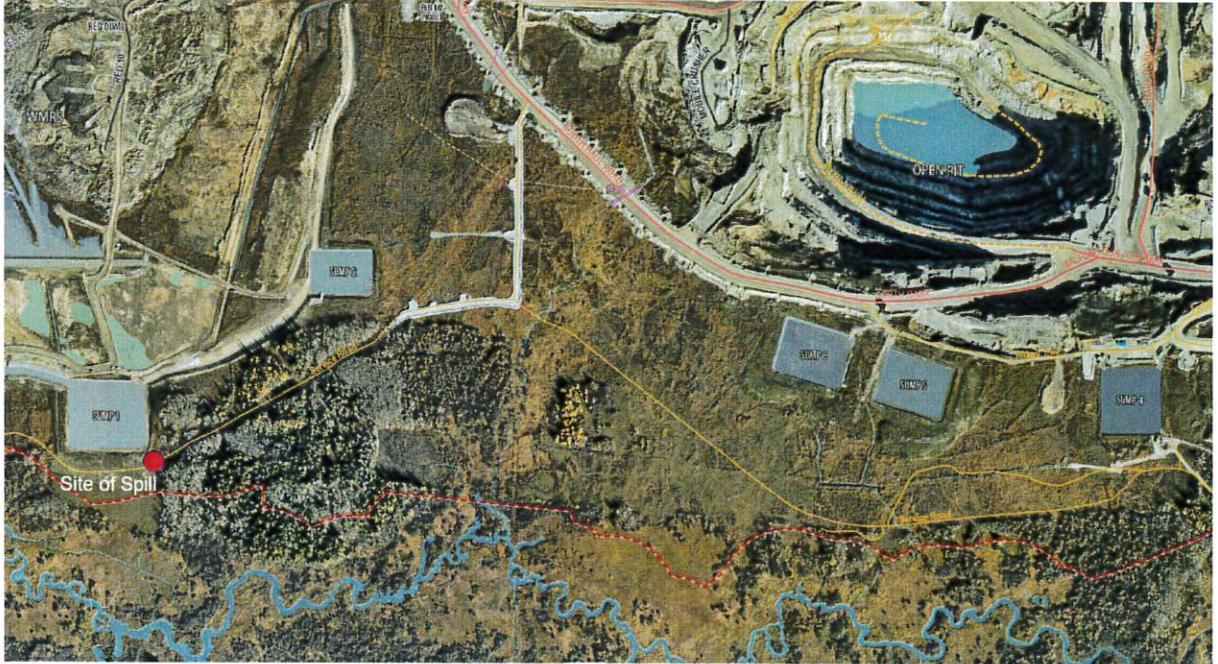
Further to the notification to the Spills Action Center (SAC) Reference # 4400-BNHQXJ: On April 9, 2020, at 0800 hours, open pit effluent was sighted flowing out of a ruptured pipeline at zone 15U N5409024.6416 E424059.2277. This pipeline connects Sump 4 to the Tailings Management Area. Site services were contacted and the pump moving the water from Sump 4 was shut off at 0834 hours. It was estimated approximately 75 m<sup>3</sup> of open pit effluent was released to the environment. This estimate was calculated from the rate at which the pump was running, the size of the line, and the size of the puncture.

Figure 1 Location of where spill occurred (Southeast of Sump 1)

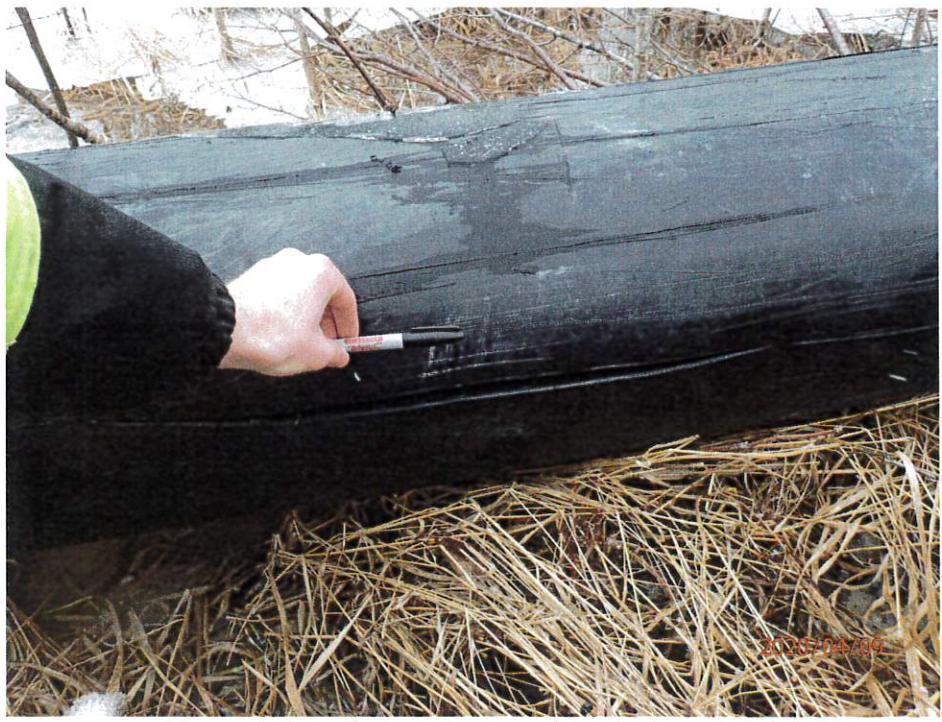
The spill originated from a gouge that was made in the pipe during its realignment. A 2" trash pump was put in place to pump the pooled effluent on the south side of the pipeline road to Sump 1 nearby. After the flow was stopped, no effluent was observed entering the Pinewood River however it could not be confirmed if any flowed there during the incident.

Figure 2 Size of gouge in pipe where leak occurred.

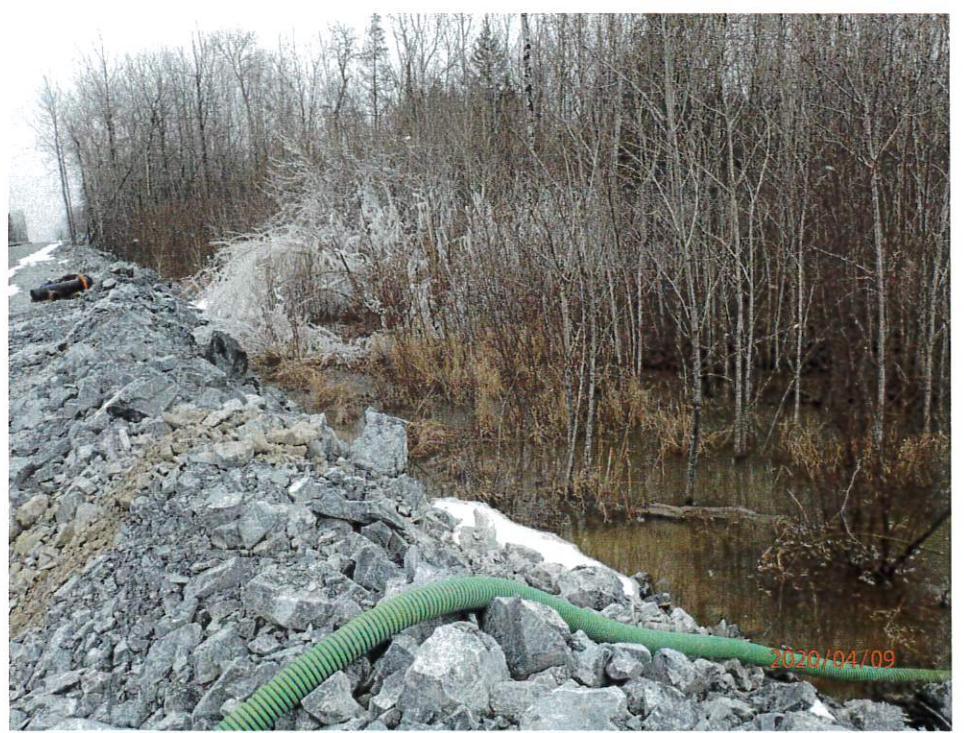
Figure 3 Spray from pipeline leak into trees and pooling effluent south of pipeline access road.

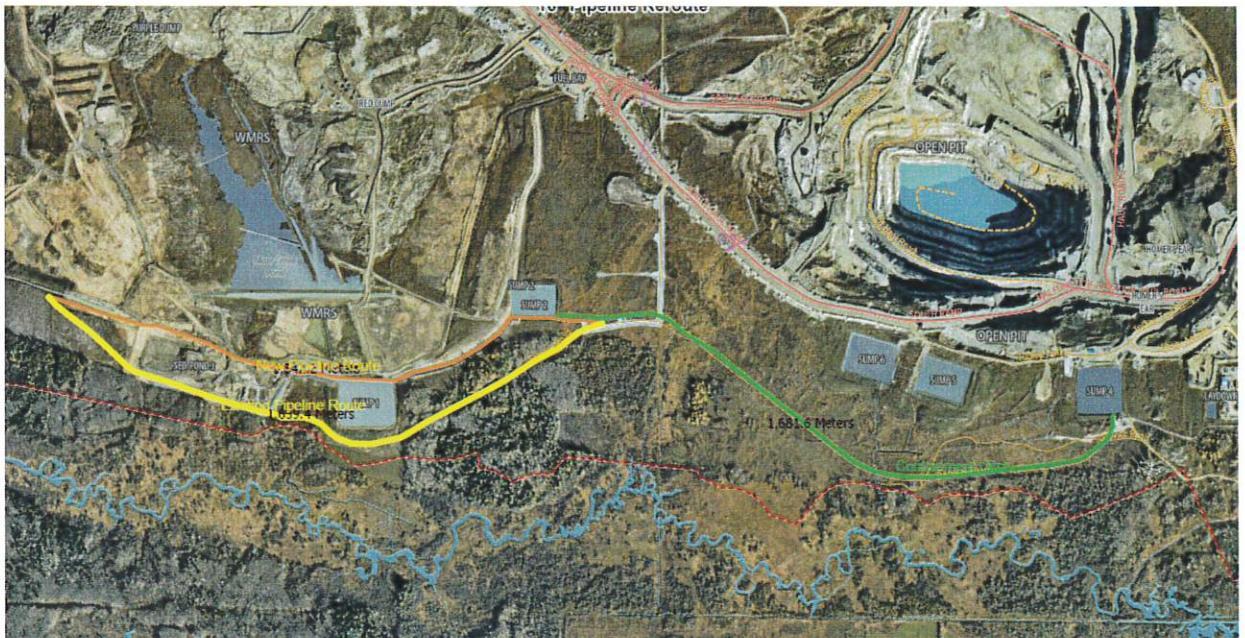
Figure 4 Yellow shows the old alignment of the pipeline. Green and orange is the realigned route of the pipeline with green being the newly constructed containment ditch.

The mitigation measures implemented were a realignment of the pipeline to the north with the construction of a containment ditch between Sump 4 and West Mine Rock Stockpile ditching. The pipeline will be moved within this ditch and continue to travel this ditch to Sediment Pond 2.

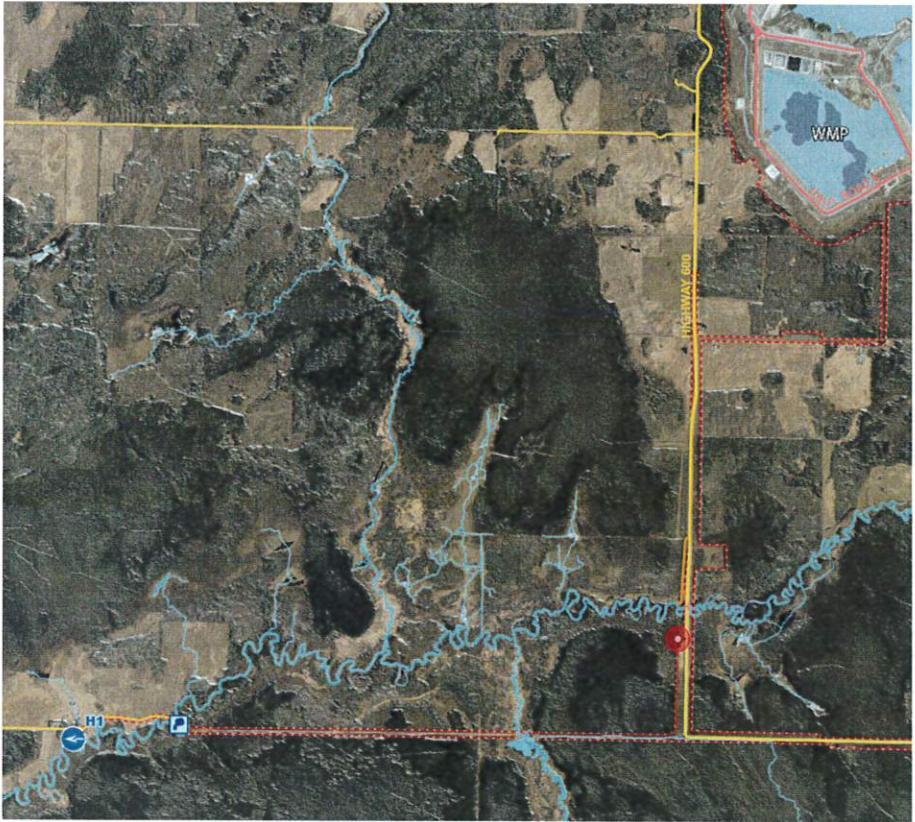
Further to the notification to the Spills Action Center (SAC) Reference # 1682-BPLJZ3: On May 13, 2020, at approximately 09:00, a New Gold employee notified the Environment Department that they had seen water leaking from the Water Discharge Pipeline on the morning of Saturday, May 9, 2020 along new Highway 600. The leak was determined to be as a result of a failed pressure gauge located at approximately Zone 15U 419552.49 E 5407824.45 N. The Water Discharge Pipeline was actively discharging to EDL1 located on the Pinewood River downstream of McCallum Creek at the former Pinewood Pumphouse. Site services were contacted, and the pump was shut off at 10:45 to change the failed pressure gauge was removed, causing a spray into the air. It was estimated approximately 5.9 m<sup>3</sup> of treated effluent was released to the environment. This estimate was calculated from the rate at which the failed pressure gauge was leaking at the time of report for the time period of Saturday morning to Wednesday morning (4 days) and an estimate of the volume sprayed for 15 minutes while the line depressurized.

Figure 1 Location of the leak on the Water Discharge Pipeline along new Highway 600

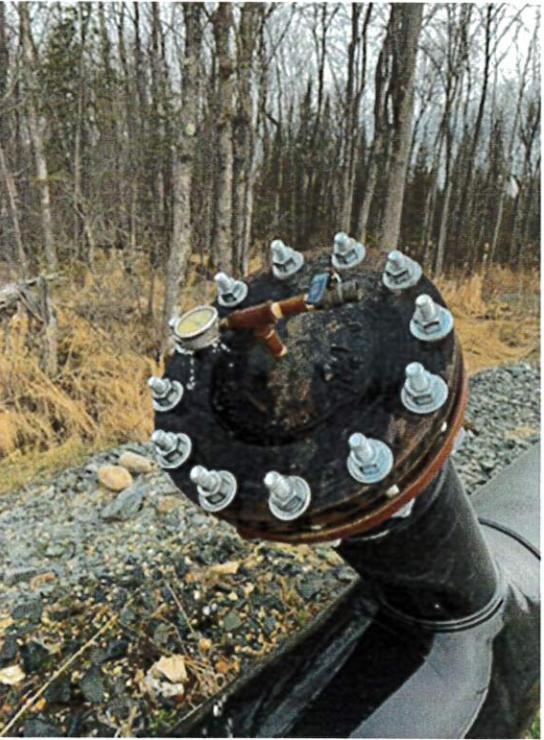
The leak originated from a failed pressure gauge. The location of the leak was accessible by road however the location and slow rate of the leak may not have raised alarm during a pipeline inspection as the wet area was located on the far side of the pipeline away from the road. A discharge sample was collected at the end of pipeline on May 13, 2020 at 09:45. An acute toxicity sample was not collected on May 13, 2020 however the results from a May 6, 2020 acute toxicity sample taken at the end of pipe for EDL1 were non-acutely lethal for both Rainbow Trout and *Daphnia magna*.

Figure 2 Failed pressure gauge leaking

The mitigation measures implemented include a daily inspection of the Water Discharge Pipeline by UTV during day shift while the pipeline is active. The pipeline will be kept clear of brush and shrubs to ensure leaks can be visually detected. A weekly drone flight of an approximately 2.5 km section of the pipeline that cannot be accessed by UTV will be arranged weather permitting while the pipeline is active.

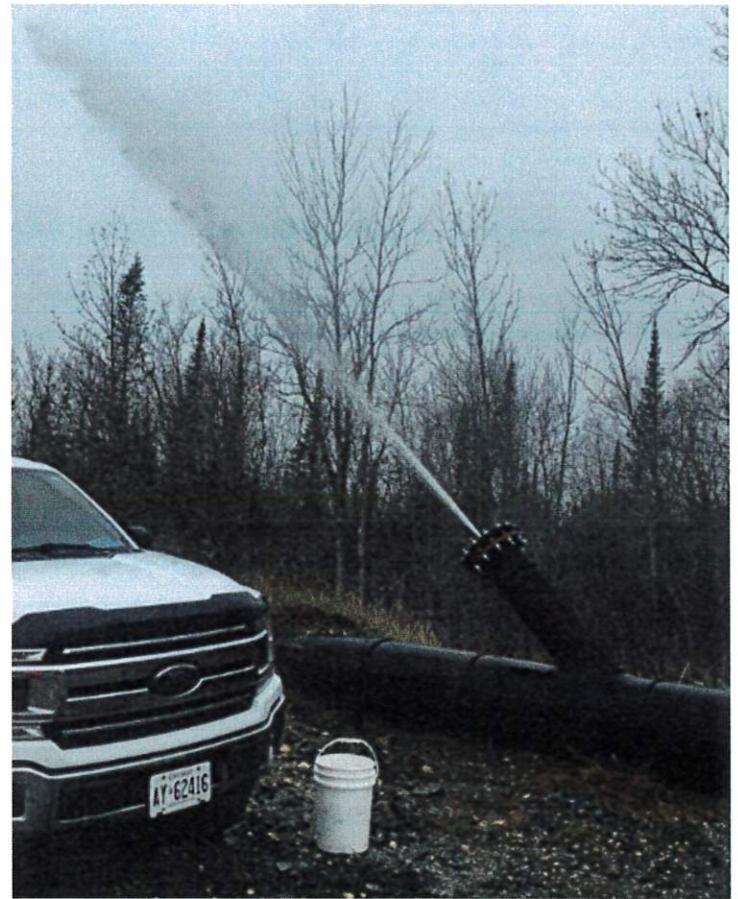
Figure 3 Spray from pipeline during depressurization to replace failed pressure gauge, note it was also raining at the time of pressure gauge replacement

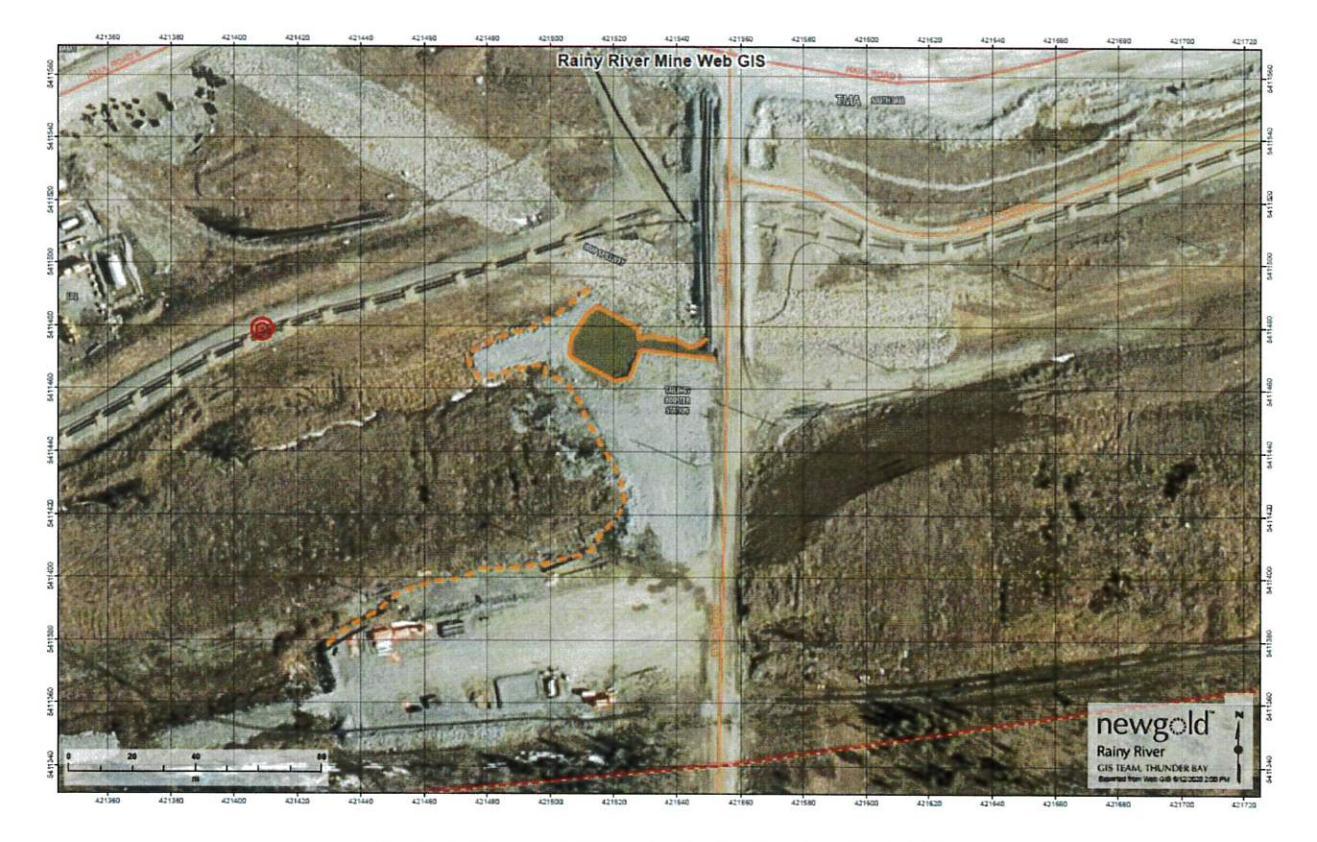
At 1100 on June 9<sup>th</sup>, 2020, it was brought to the attention of the New Gold Environmental Department that a valve was leaking on the Water Management Pond (WMP) reclaim pipeline. Once the leaking valve was located, a call was made to Site Services Department and after estimating the discharge rate of the leak, the valve was isolated and the line drained. A sample was collected that included all discharge parameters including acute toxicity of the water drained from the pipe into the Water Discharge Pond (WDP) via the WMP spill way. Laboratory results are still pending regarding this incident and will be provided when finalized. Please note acute toxicity testing did not show any mortality or stress in test subjects. Draft results for all parameters show two discharge criteria for this sample exceeded ECA limits, un-ionized ammonia at 0.339 mg/L and copper at 0.0689 mg/L.

Photo 1: Map depicting failed valve location (red dot).

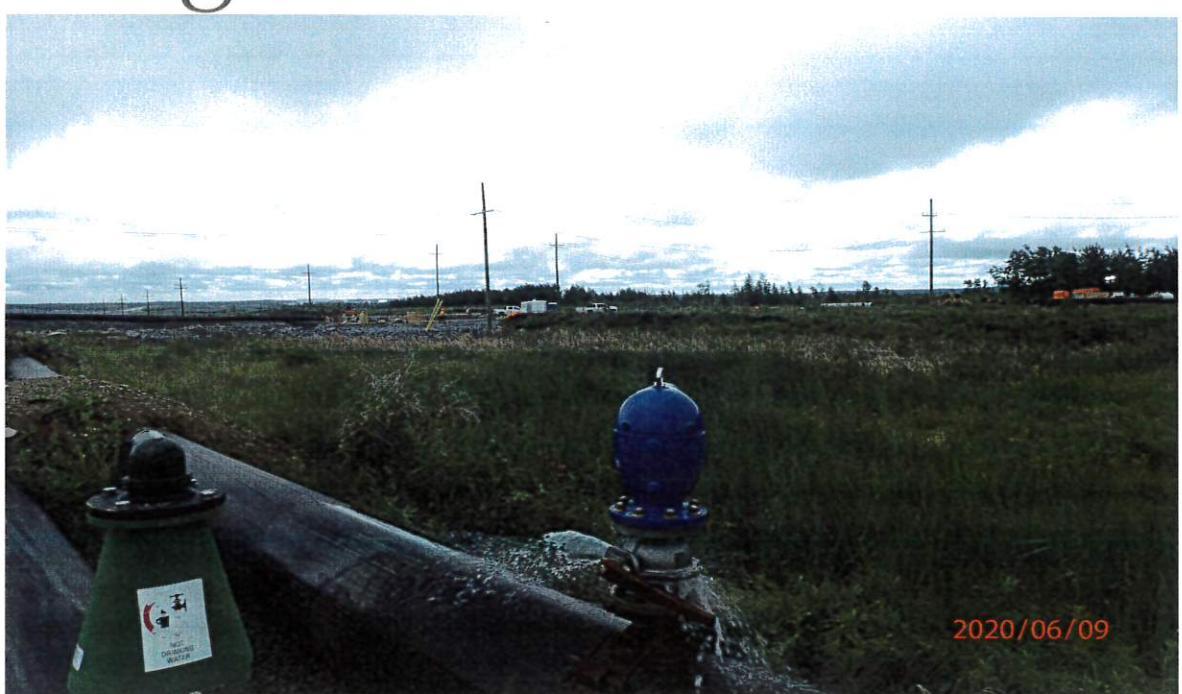
An estimated 152.5  $m^3$  of mine effluent is assumed to be spilled with this event. The failed valve is located in an isolated location without regular access and can only be seen at a distance. The line was also not in service at the time of the incident. The amount of spilled effluent was estimated by performing a "bucket test" on the leaking valve (filling a vessel with a known volume and recording the amount of time it takes to fill) and assuming the leak started after the valve was last known to be in working order, which was 3.5 days prior.

Photo 3: Failed Valve on WMP reclaim line.

The pipeline on which the valve failed is used to supply the Mill with water for processing ore from either the WMP or Tailings Management Area (TMA). Approximately 3.5 days before the valve malfunctioned, work was performed on the source pump in Cell 2 and the pipeline was left pressurized with the valve closed. The reason the line was left pressurized was so the water source could be changed remotely without affecting the Mill's process.

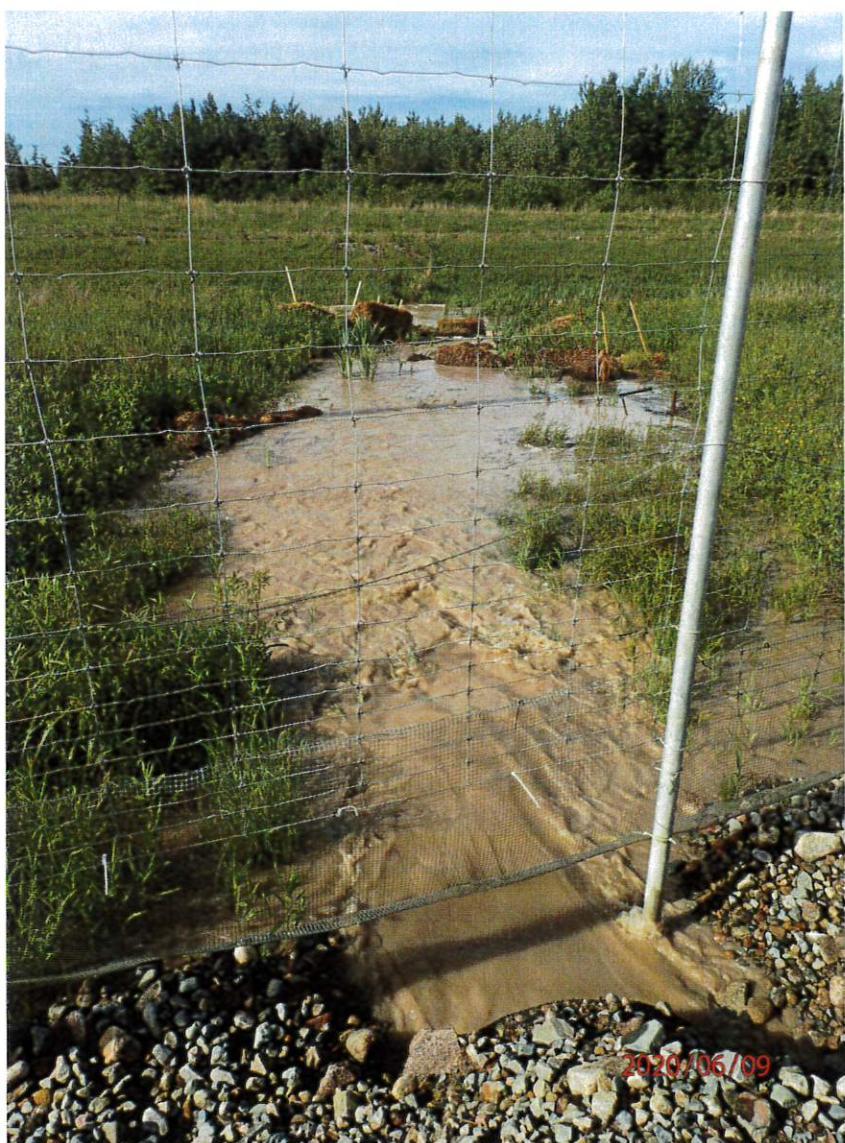
The water flowing through the culvert appeared to be sediment-laden water originating from Marr Diversion upstream the culvert. Upon discovery of the turbid water, a total suspended solids sampled was collected and Site

Figure 2. Highly turbid water entering the riffle into West Creek Diversion. Turbidity at time of photo was 855.1 NTU.

Site Services was able to activate the pump within the Marr Diversion sump and started to redirect water to the South Dam seepage collection system at 08:45. This seepage collection system is pumped back into the Tailings Management Area.

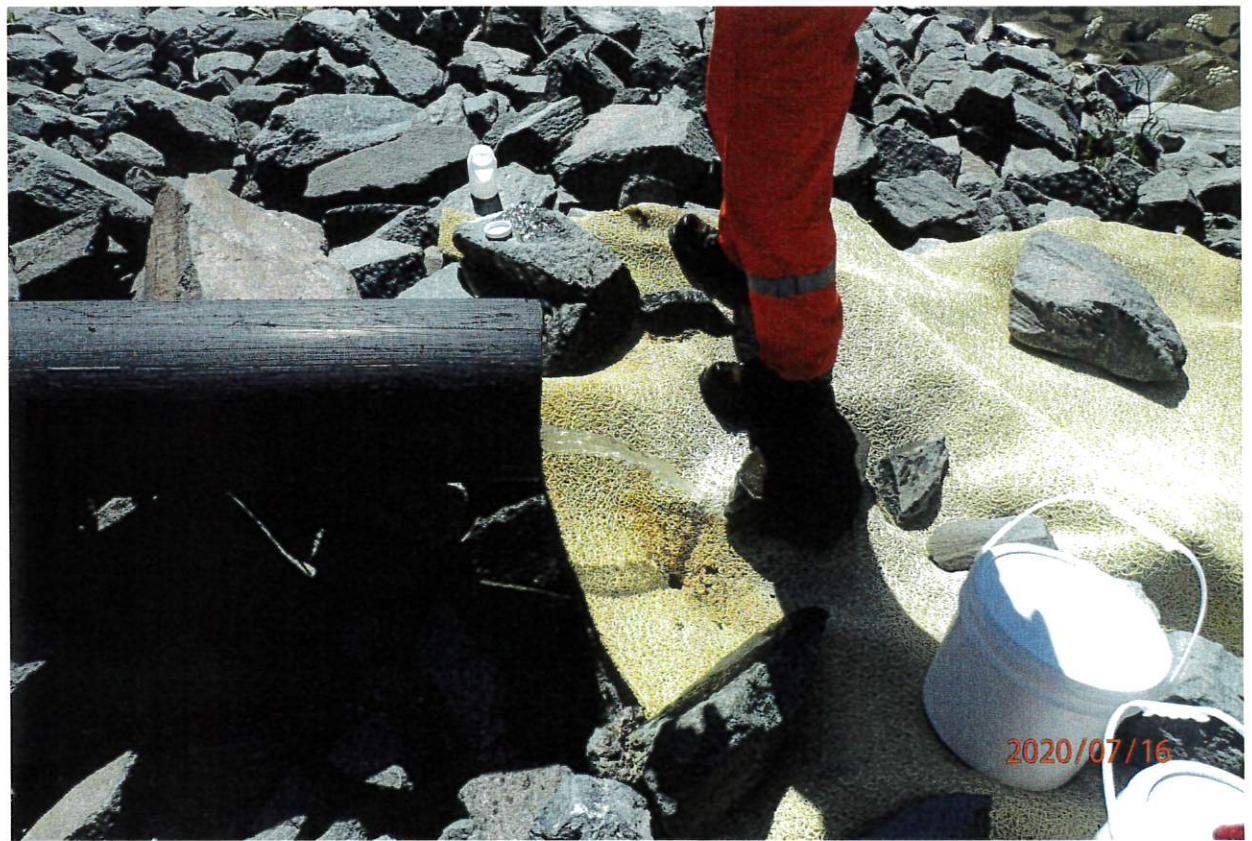
An estimated 162  $m^3$  of mine effluent is assumed to be spilled with this event. The discharge line was not in service at the time of the incident and no pumping associated with this infrastructure was occurring. The amount of spilled effluent was estimated by performing a "bucket test" on the leaking discharge pipe (filling a vessel with a known

Photo 2: Leak draining out of discharge pipeline.

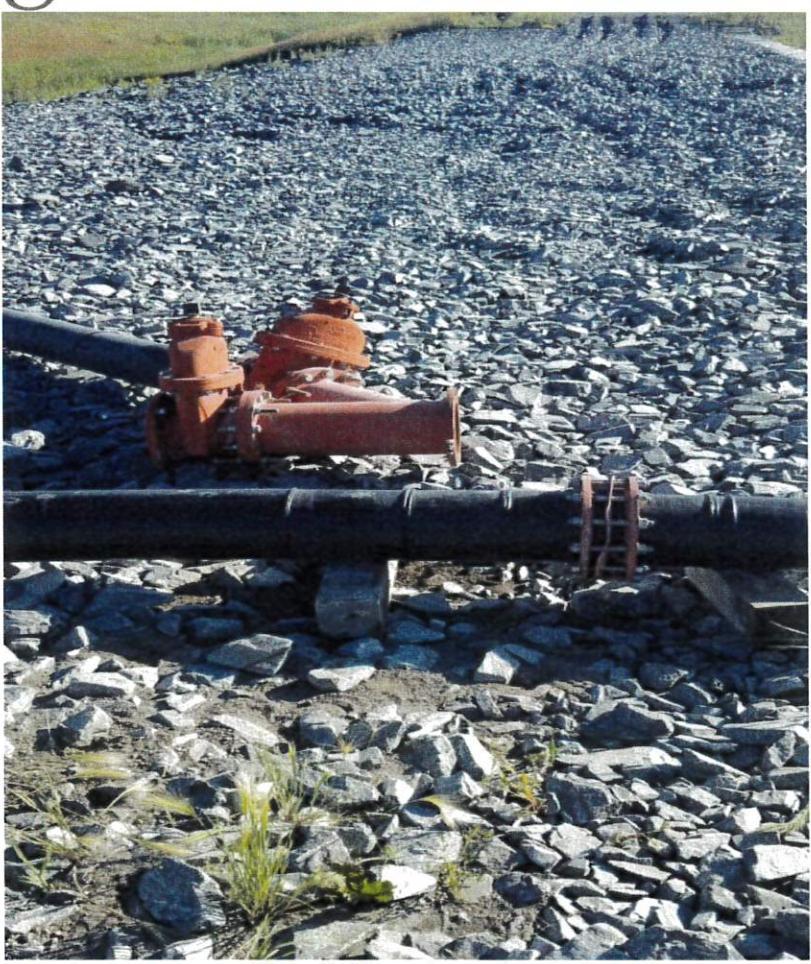
Photo 3: Wye valve replaced.

The wye valve was removed and replaced with a solid line by 2100 hours the same day. This type of wye valve will no longer be used on site and a different style of wye will be reinstalled should there be a need to discharge Sediment Pond 1 in the future.

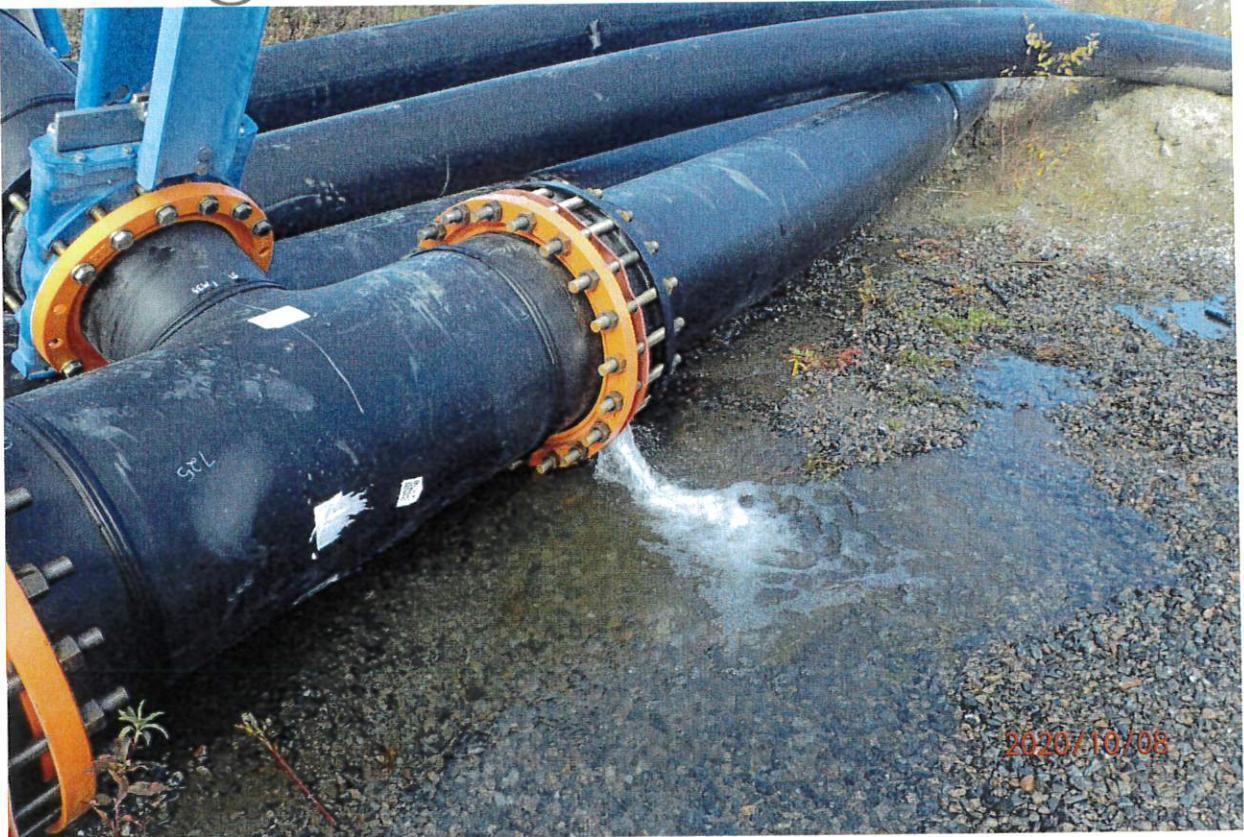
Photo 2: Leaking gasket at time (1500) of sampling.

Upon investigation into this event some deficiencies were noted. The main issue being, when the valve was replaced last, an incorrect style of gasket was used which was not intended for this application. Another deficiency identified was a lack of pressure monitoring instrumentation on this line. This has been addressed with a pressure feedback loop that will allow for monitoring 24/7 by Mill operations.

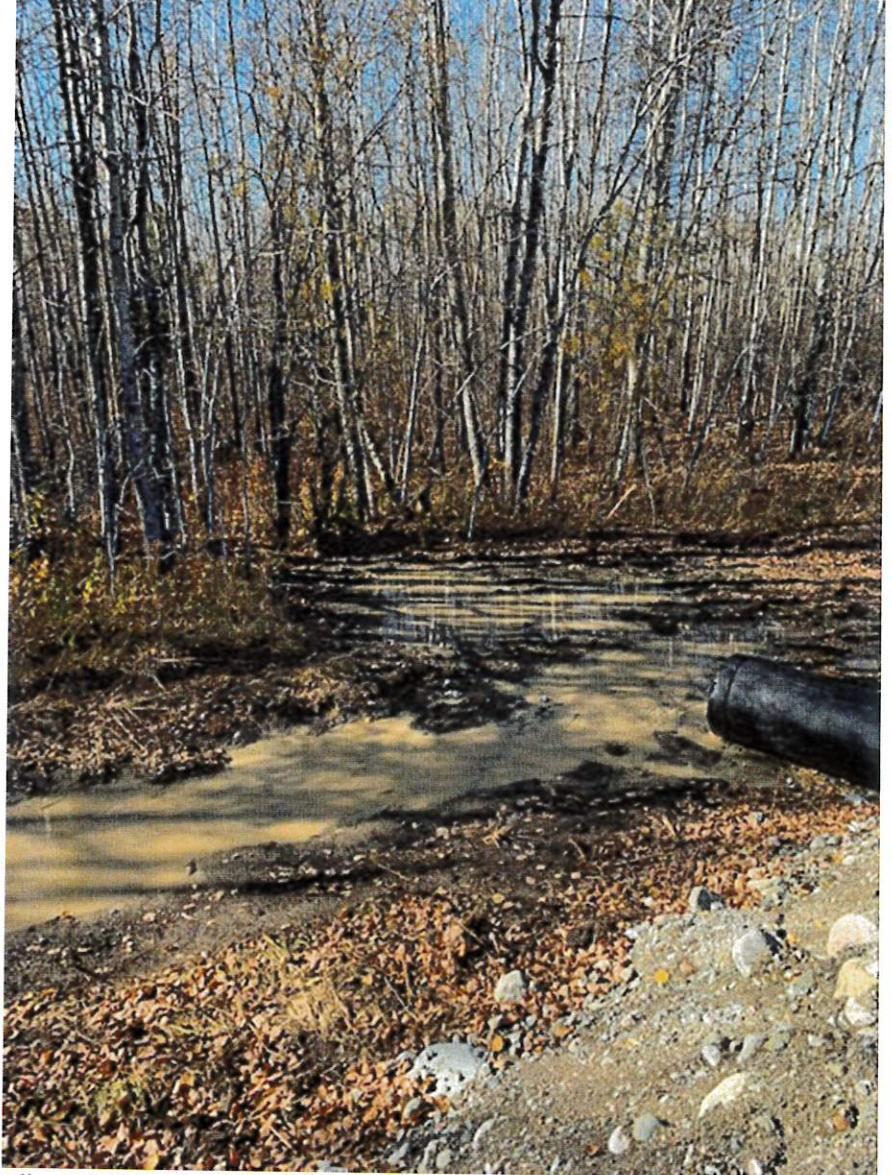
Fig 3: Sediment Release as originally found, with a black pipe being used as a culvert

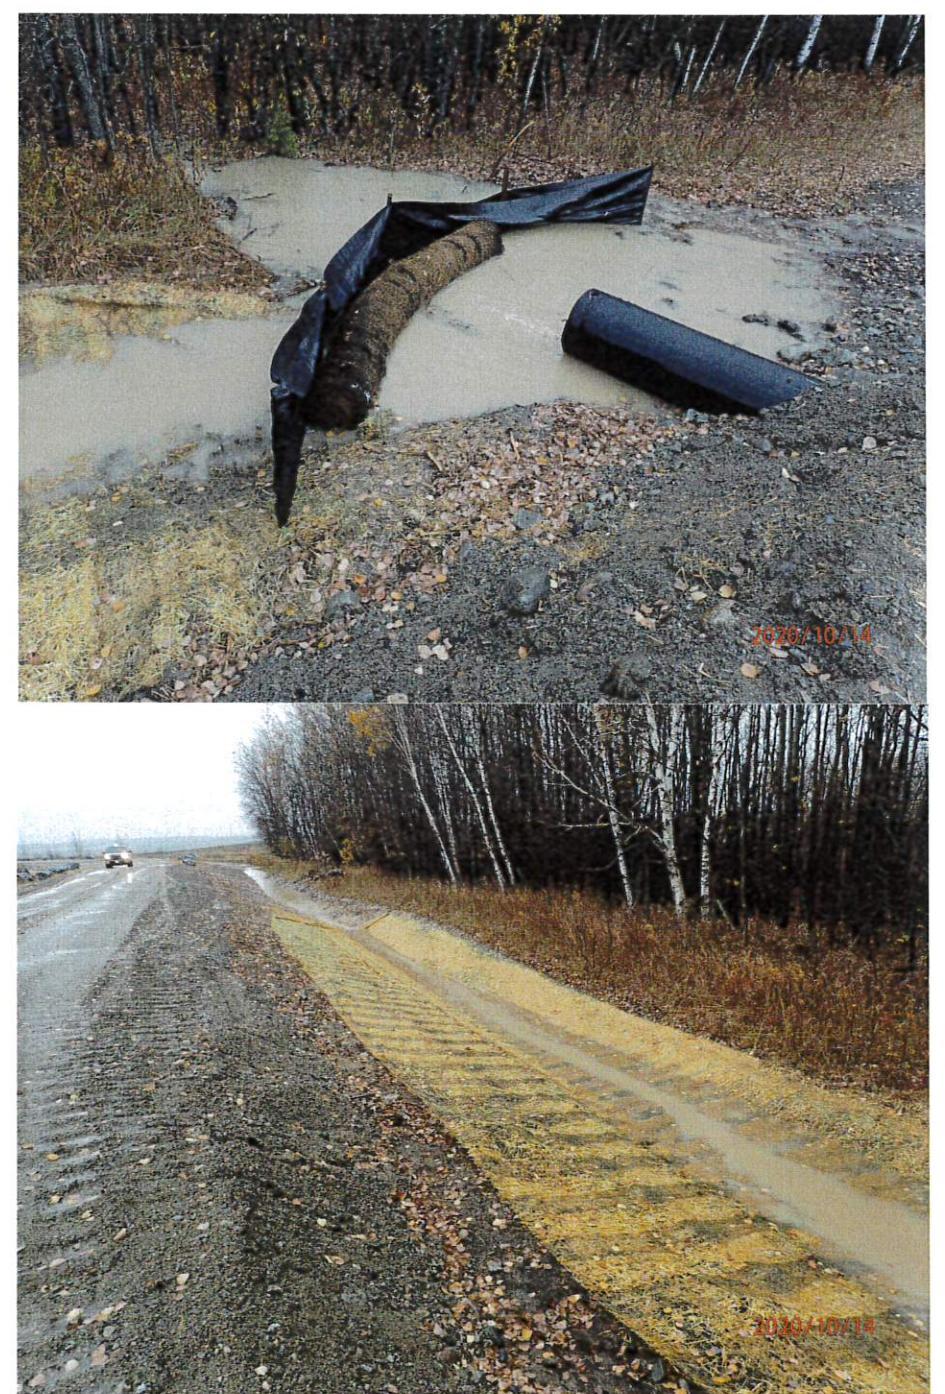
Continuous monitoring of the WCD was completed during the week which identified more erosion control measures were required. As shown in Figure 5, total suspended laden water was continuing to leave the batch plant reclamation area during rain events.

Fig. 5: Previously installed erosion controls deemed to have minimal effect on the turbid water leaving the batch plant reclamation area.

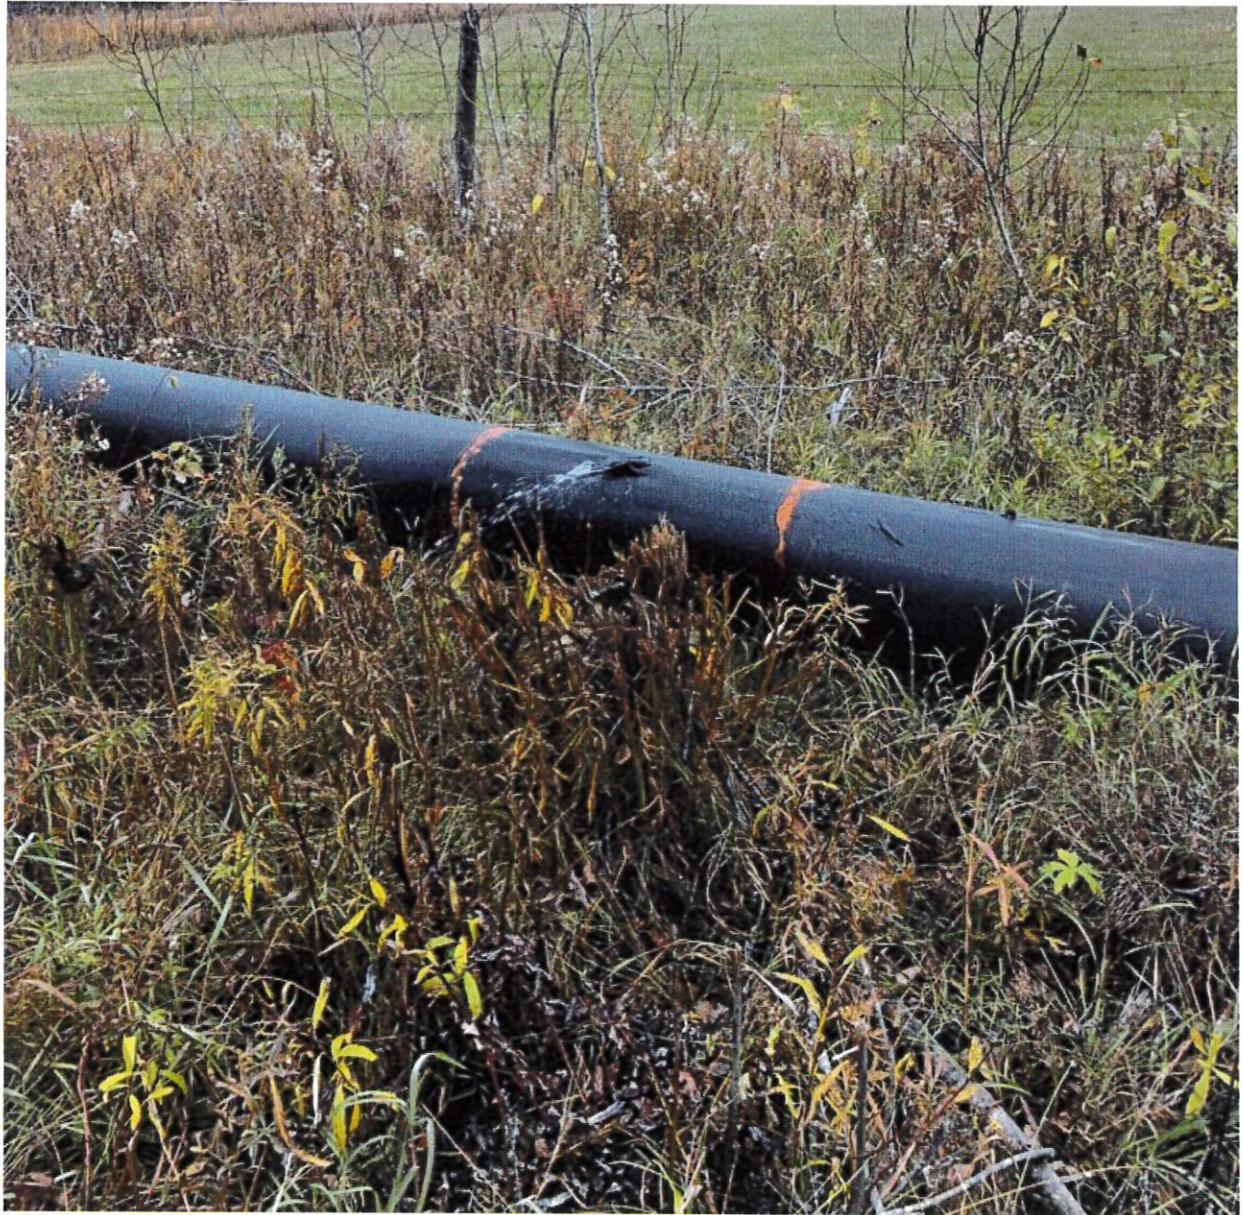
Photo 2: Leaking EDL2 pipe when discovered.

An estimated 500 L of treated mine effluent is assumed to be spilled with this event. This number is an estimate as it is unknown how long the event occurred. It hadn't started when the Environmental Department and Project Coordinator passed the location of the leak to get to EDL2 during discharge. Therefore, pooled water in the road ditch beside the pipe was used to calculate the spilled volume. This event occurred over 600 meters away from fish bearing water but was the same treated effluent being discharged from EDL2 into the Pinewood River.

Upon investigation into this event some deficiencies were noted. There was not an Inspection and Test Plan (ITP) included in the construction package for this pipeline. This has been corrected so that all pipeline contracts include an ITP before commissioning.

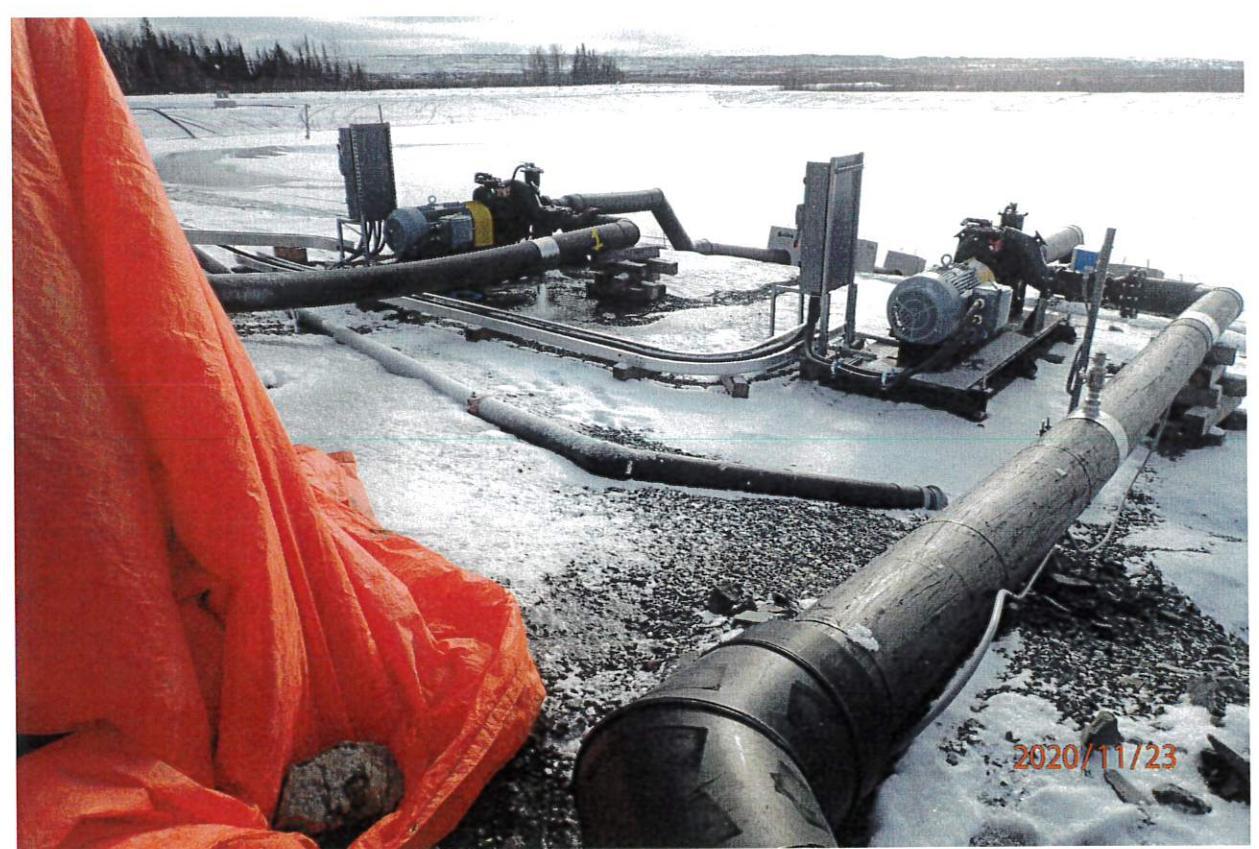
At 0945 on November 23rd, the New Gold Environment Department was contacted to attend a possible reportable incident concerning a failed vent on the Outflow Basin (OB) pipeline to Water Management Pond. Upon initial assessment it appeared any effluent lost would report to the OB and repair of the vent was started by depressurizing the pipeline and thawing the vent.

Photo 1: OB pipeline drain point and OB pictured (vent being heated under orange trap).

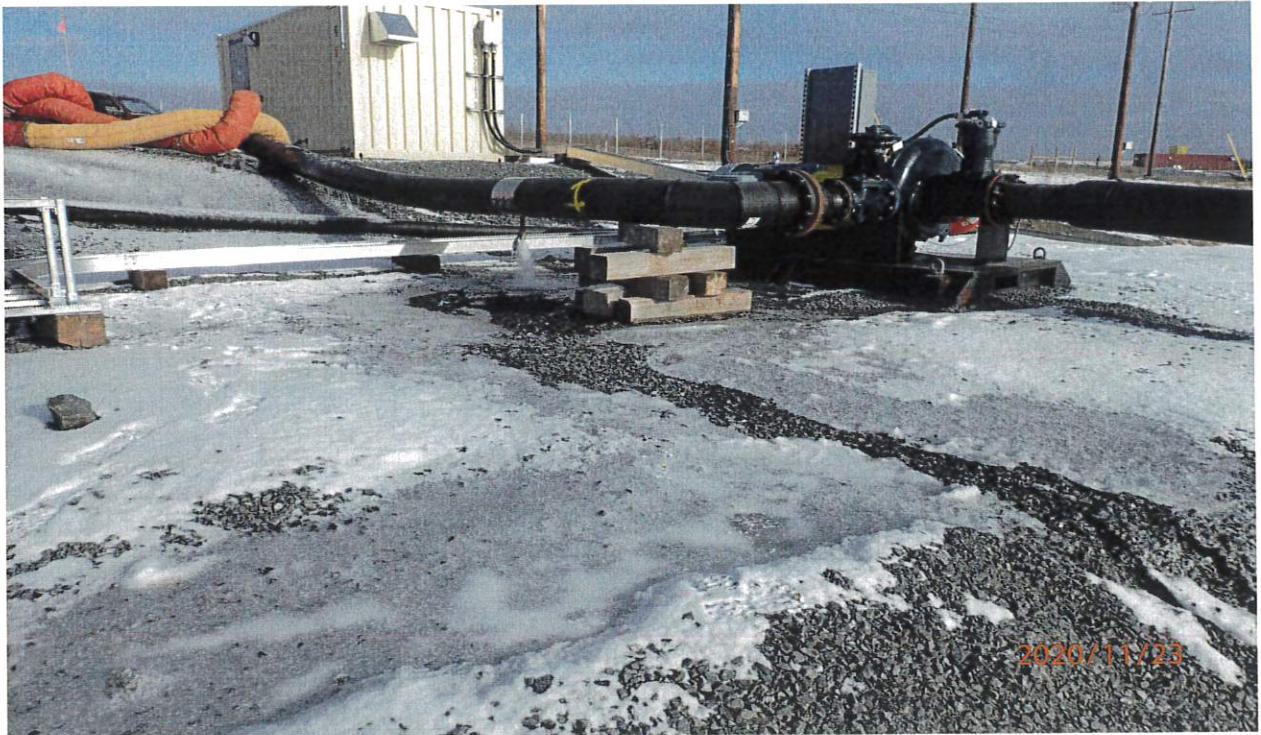
The assumption at the time was that any effluent leaving either the failed vent or the pipeline drain point would report to the OB. However, after some time had passed it became evident that as the ground thawed the effluent no longer reported to the OB but penetrated the ground.

Photo 2: Ice/snow thawed and eroded from drain point into OB

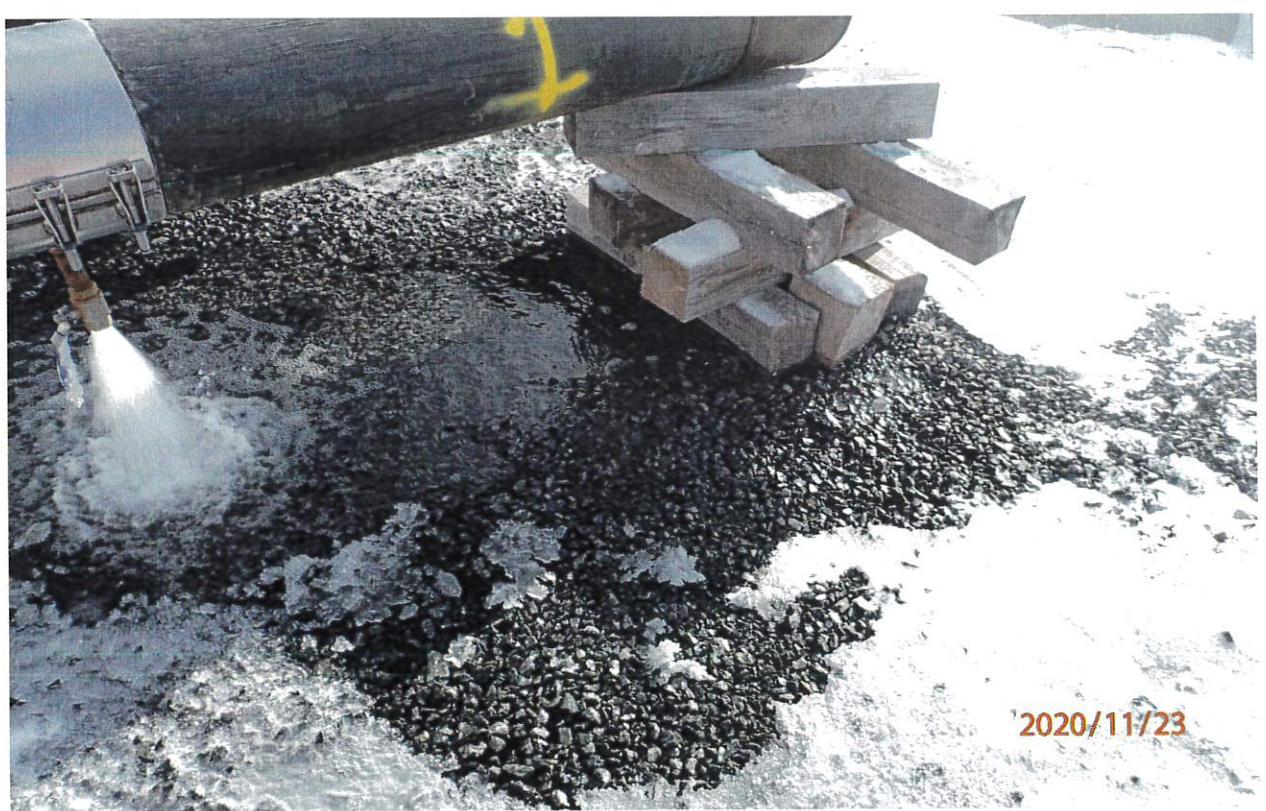
Photo 3: effluent seeping into impact site not reporting to OB
