### NEW GOLD RAINY RIVER MINE APPENDIX K EXCEEDANCE LETTERS SUBMITTED TO MECP AND REGULATORY REPORTING TABLE

### NEW GOLD RAINY RIVER MINE APPENDIX K.1 EXCEEDANCE LETTERS SUBMITTED TO MECP

#### SUBJECT: NORTH STATION AMBIENT AIR QUALITY EXCEEDANCES OF 24-HOUR TOTAL SUSPENDED PARTICULATE-MONITORING LIMITS - SAC REFERENCE #8876-BPJS8Z

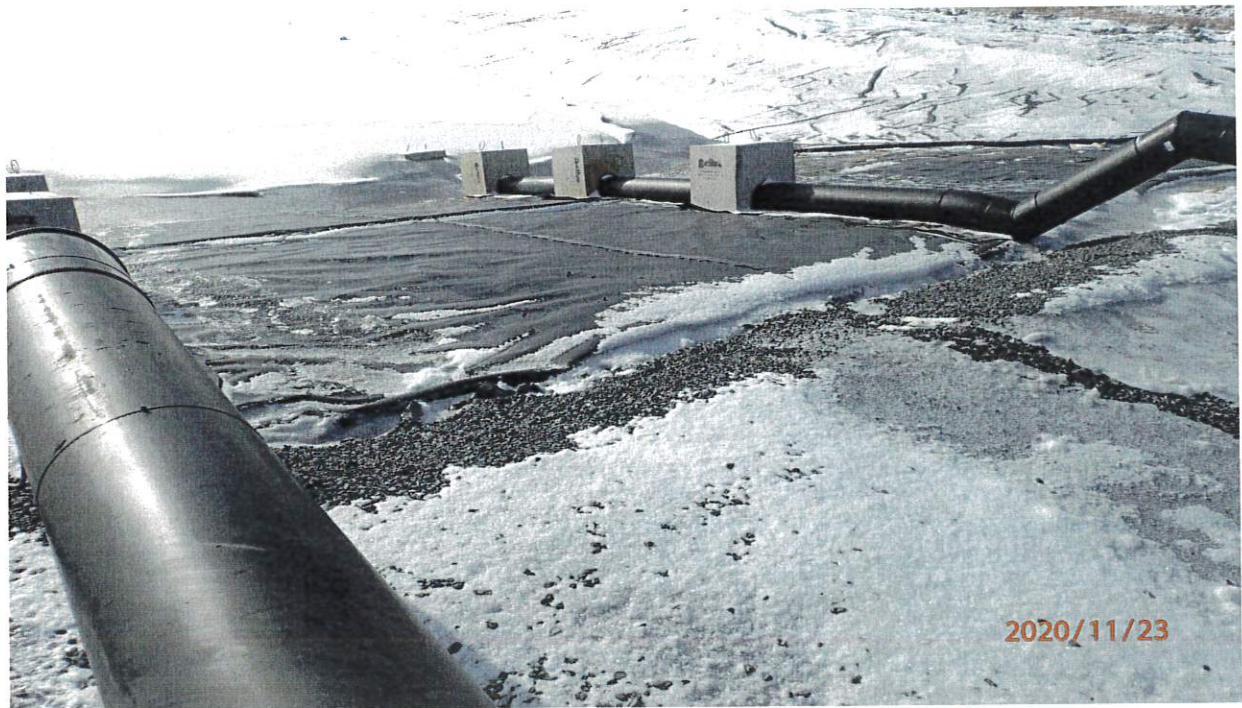
Photo 4: Evidence of effluent forming ice over liner but no flowing effluent.
