**NEW GOLD RAINY RIVER MINE
APPENDIX G
VEGETATION PLOT WORK SUMMARY
MEMO**

Our ref: 1003-024-006

Date: December 6, 2021

Re: **Rainy River Mine - 2021 Vegetation Trial Monitoring Summary Rev0**

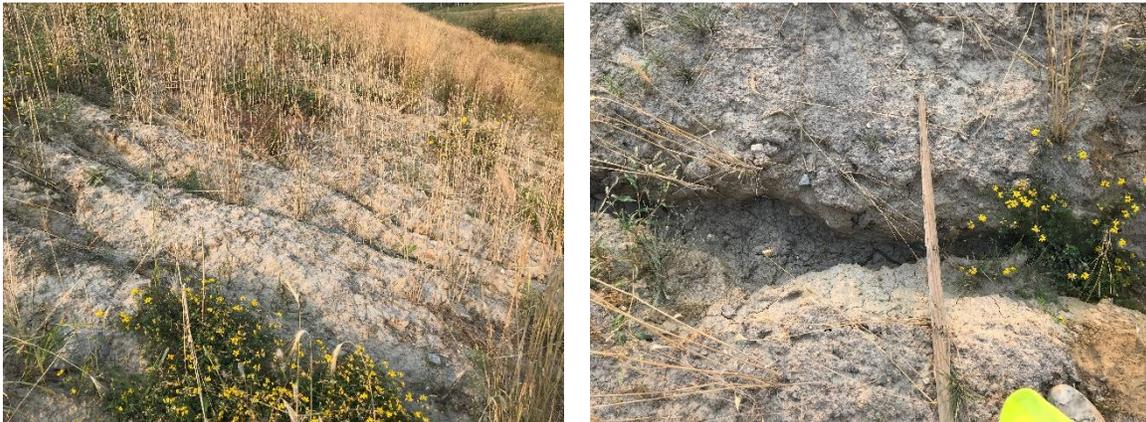
South	G Entire slope length (East side) Depth = 37 cm Width = 50-60 cm	G Entire slope length Depth = 40 cm Max width = ~1.2 m		
	Entire slope length (West side) Depth = 30 cm Width = 55-65 cm			
West	S, R Shallow and narrow rill erosion at crest and toe of slope (Depth < 10 cm)	S, R Shallow rill erosion over slope (Depth < 5 cm)	n/a	S, R Shallow rill erosion over slope (Depth < 5 cm)
		G Lower slope Depth = 32 cm Max width = 76 cm		G Lower slope Depth = 33 cm Max width = 66 cm

Figure 4: South Slope Rill (left) and Gully (right) erosion

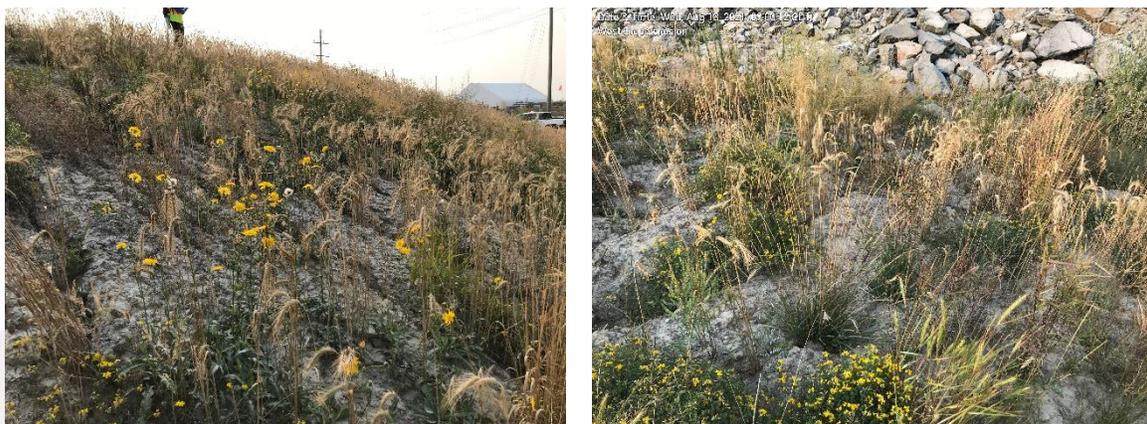
Figure 6: West Slope Rill (left) and Gully (right)

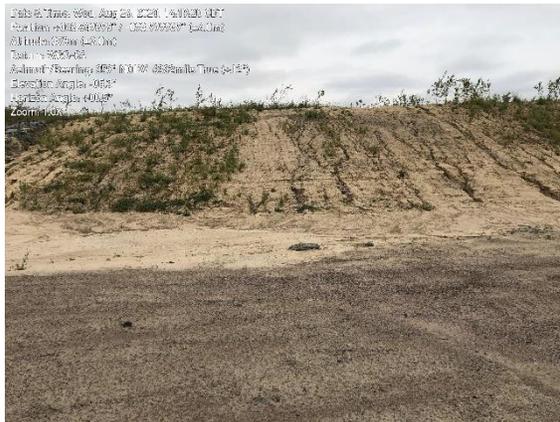
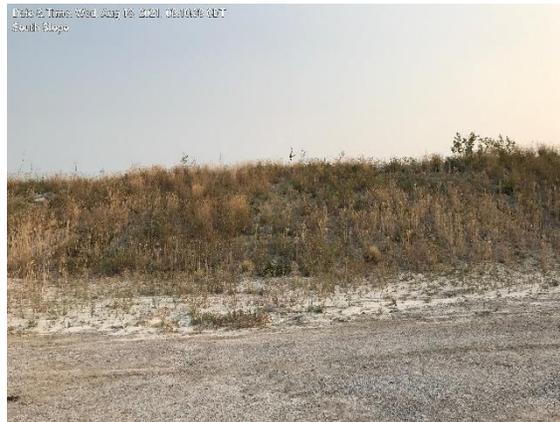
Vegetation ground coverage generally increased, ranging from 25% to 75% over the slopes (Table 2). Of note, all slopes were treated with ProGanics Biotic Soil Media in September 2020 to minimize further erosion. Ground coverage increased from 2020 in which most slope treatment areas had on average 25% coverage to almost 50% coverage in 2021.

Figure 7: South Slope Hydroseed – August 26, 2020 (left) and August 18, 2021 (right)

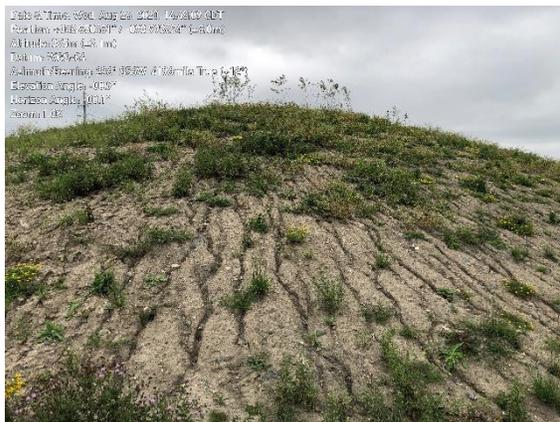
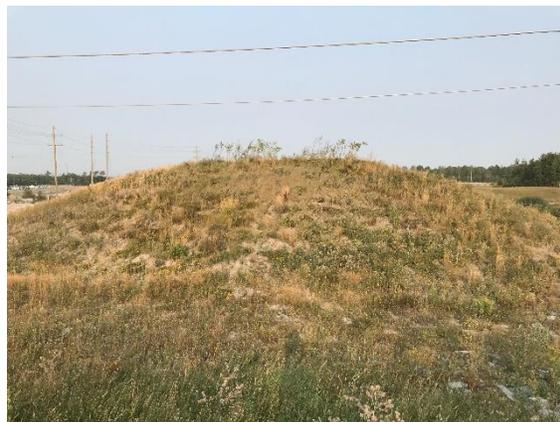
Figure 8: East Slope - August 26, 2020 (left) and August 18, 2021 (right)

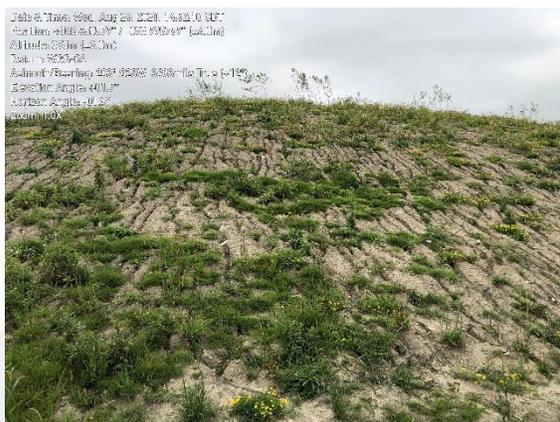
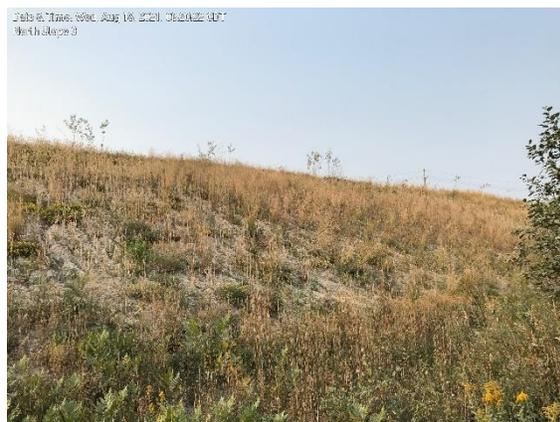
Figure 9: North Slope Control - August 26, 2020 (left) and August 18, 2021 (right)

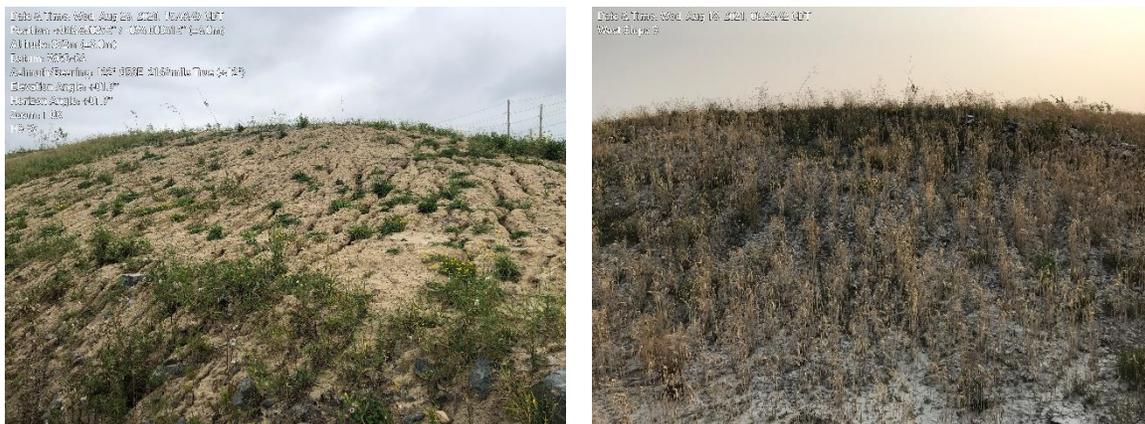
Figure 10: West Slope Broadcast - August 26, 2020 (left) and August 18, 2021 (right)

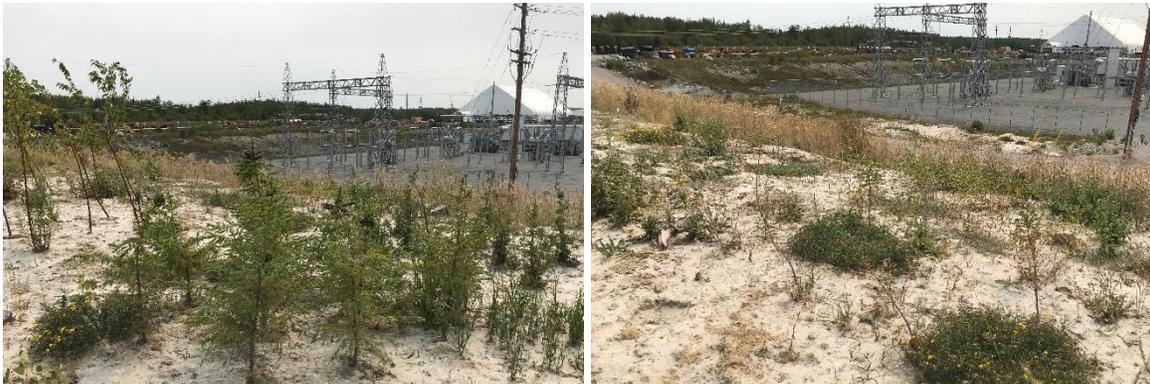
- Black Spruce – generally appeared to be doing better for the fertilized overburden and control soil treatments;
- White Spruce – appeared to be struggling for all four soil treatments; and
- Eastern White Cedar – overall appeared to be doing better for the fertilized overburden and control soil treatments.

Figure 11: Block 2 – Fertilized Overburden - Black Spruce (left) and White Spruce (right)

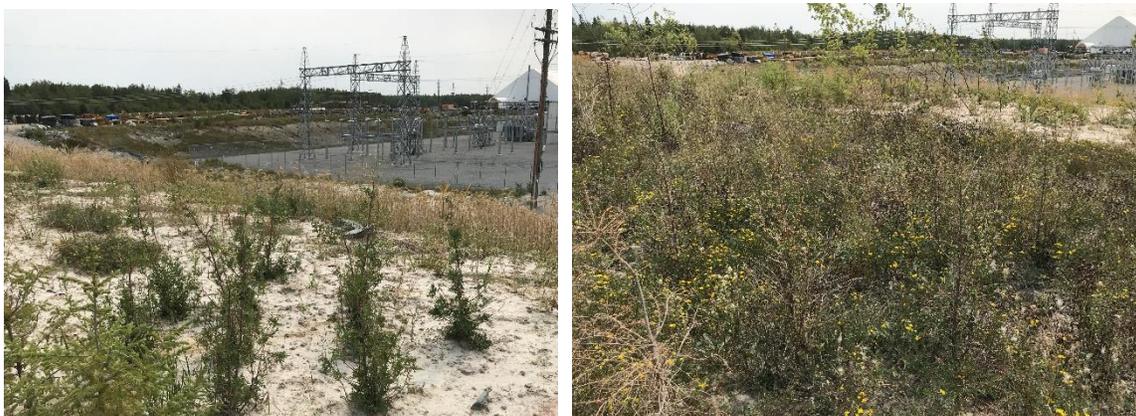
Figure 12: Block 2 - Fertilized Overburden – Cedar (left) and Tilled Topsoil – Cedar (right)

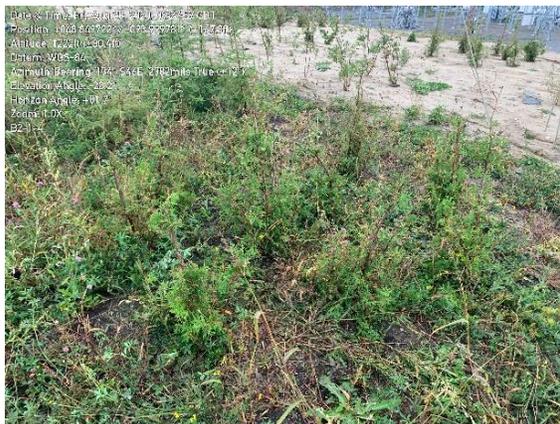
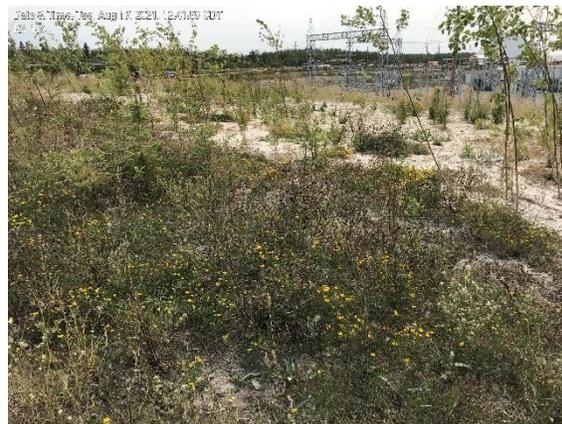
Figure 13: Block 2 – Thin Topsoil – Eastern white cedar plot as observed on August 28, 2020, (left), and August 17, 2021 (right)

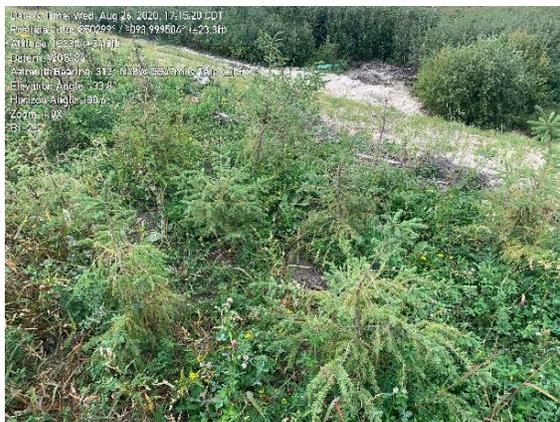
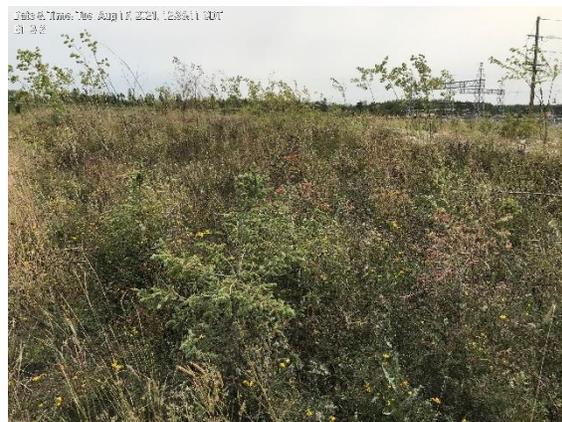
Figure 14: Block 1 – Tilled Topsoil – Black Spruce plot as observed on August 28, 2020, (left) and August 17, 2021 (right)

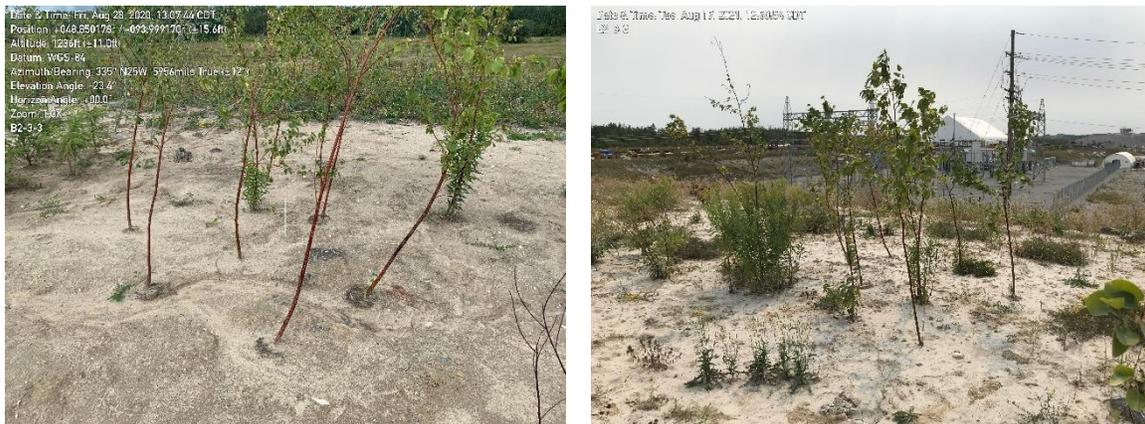
Figure 15: Block 2 – Fertilized Overburden – Black ash plot as observed on August 28, 2020, (left) and August 17, 2021 (right)

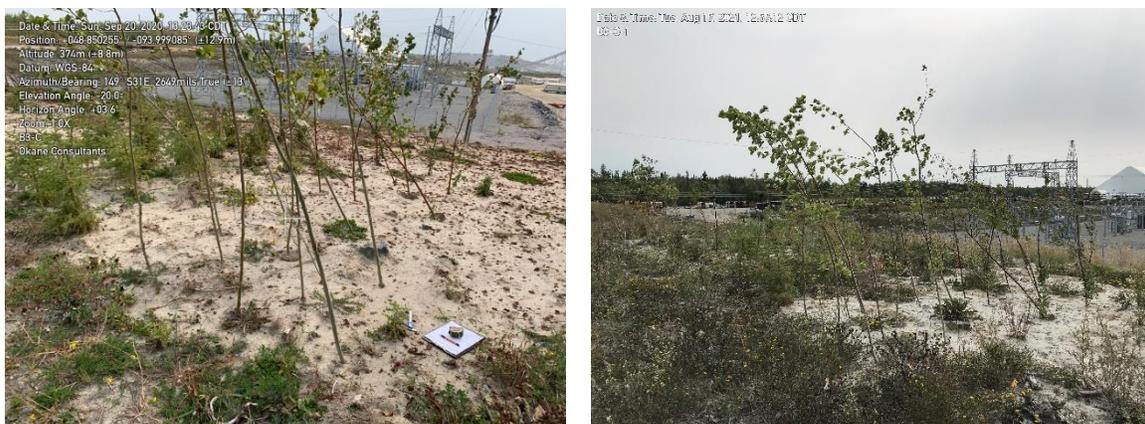
Figure 16: Block 3 – Control – Aspen plot as observed on August 28, 2020, (left) and August 17, 2021 (right)

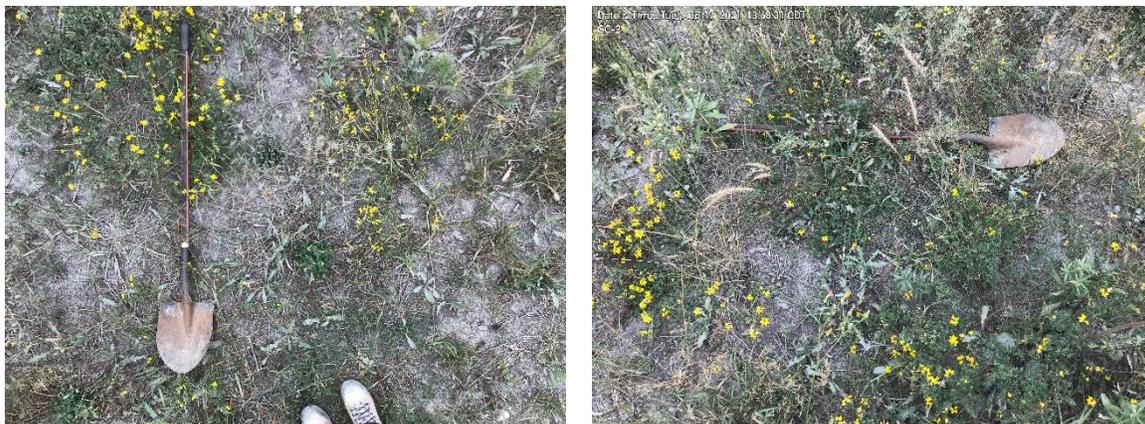
Minimal erosion was observed in the destructive plot, except for some down-slope erosion on the north edge of the plot. Vegetation was generally noted to have established well. Estimated percent ground cover during the annual survey in autumn was approximately 75% for 2020 and 2021. Only general observations of poor health were noted during the autumn visit; Table 6 includes a summary of general health, extrapolating the number of healthy trees from the totals recorded.

Figure 17: Destructive plot ground coverage
