NEW GOLD RAINY RIVER MINE APPENDIX O SCHEDULE 2 MDMER FISH HABITAT COMPENSATION PLAN

2018 Annual Monitoring Report – Schedule 2 MDMER Fish Habitat Compensation Plan Emo, Ontario TC111504

Re: 2018 Annual Monitoring Report Schedule 2 MDMER Fish Habitat Compensation Plan, Rainy River Mine Emo, Ontario

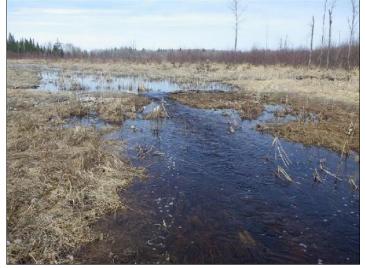
Plate A.2-1: Clark Creek Diversion Channel (CSS-1) – High Flow Monitoring

CSS-1 facing upstream during high flow conditions (April 25, 2018)

CSS-1 riffle during high flow conditions (April 25, 2018)

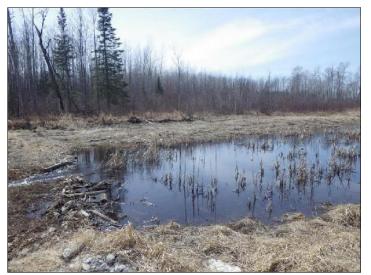
CSS-1 facing west from P3 stake (April 25, 2018)

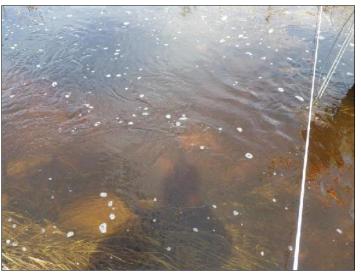
CSS-1 pool during high flow conditions (April 25, 2018)

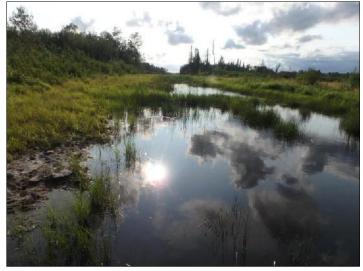
CSS-1 facing upstream during low flow conditions (July 24, 2018)

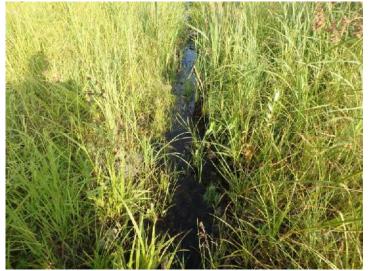
CSS-1 run with heavy vegetation cover (July 24, 2018)

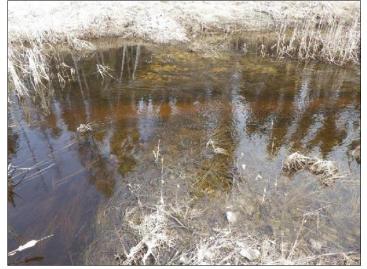
CSS-2 submerged riffle during high flow conditions (April 25, 2018)

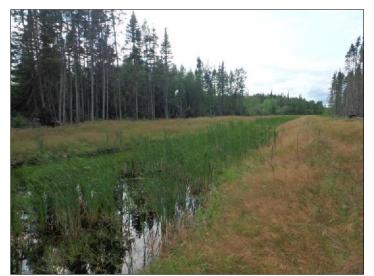
CSS-2 facing downstream (July 24, 2018)

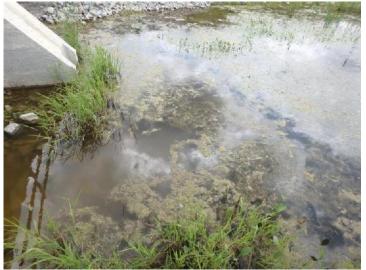
CSS-6 pool downstream of crossing (July 24, 2018)

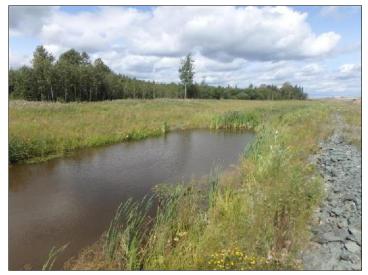
CSS-1 facing upstream during low flow conditions (July 24, 2018)

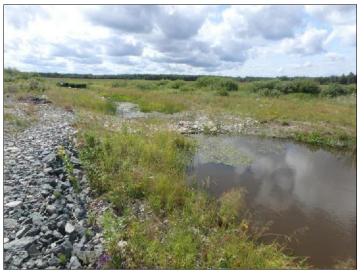
CSS-1 facing downstream towards Loslo Cr. confluence (July 24, 2018)

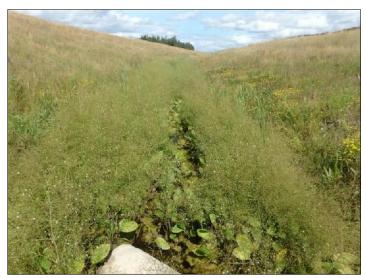
Plate A.4-3: West Creek Diversion Channel (CSS-2) – High and Low Flow Monitoring

CSS-2 facing northeast during low flow conditions (July 24, 2018)

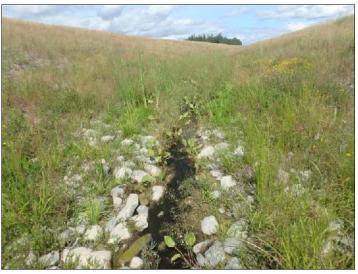
CSS-2 facing southwest during low flow conditions (July 24, 2018)

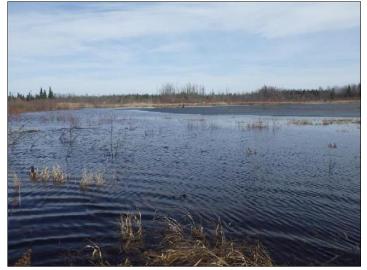
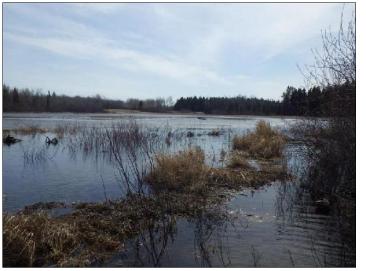
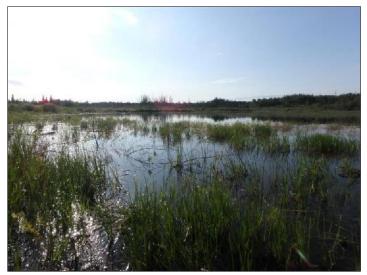
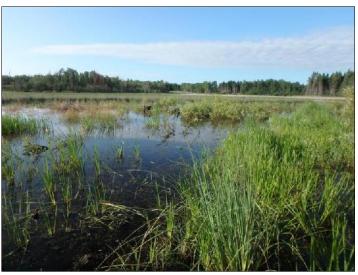
Plate B.1-2: Clark Creek Pond Stability of Structures Photo Station P2

Station P2 southeast; high flow conditions (April 25, 2018)

Station P2 facing southwest to dam (April 25, 2018)

Station P2 facing southeast; low flow conditions (July 27, 2018)

Station P2 facing southwest to dam (July 27, 2018)

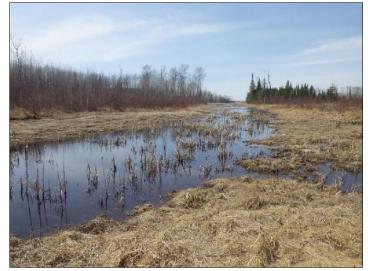
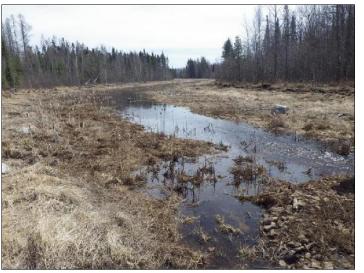
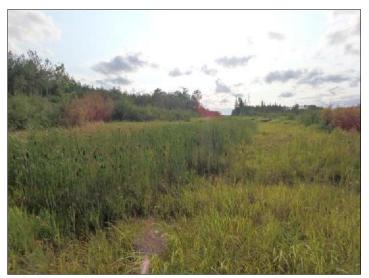
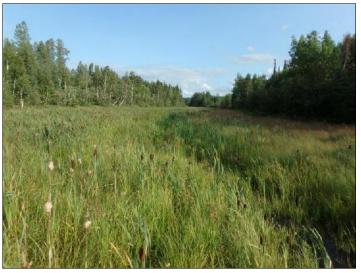
Plate B.1-3: Clark Creek Diversion Channel Stability of Structures Photo Station P3

Station P3 facing northwest; high flow conditions (April 25, 2018)

Station P3 facing southeast; downstream (April 25, 2018)

Station P3 facing northwest; low flow conditions (July 24, 2018)

Station P3 facing southeast; downstream (July 24, 2018)

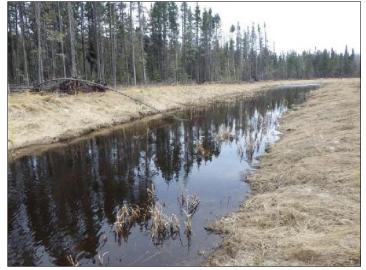
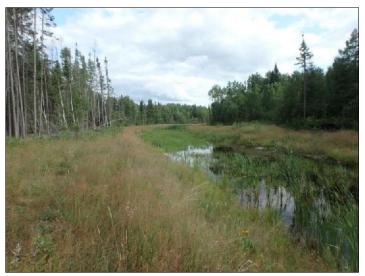
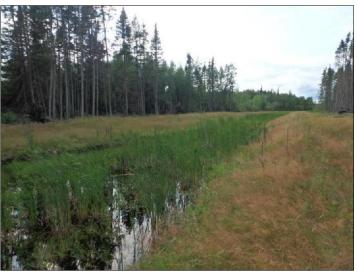
Plate B.1-4: Clark Creek Diversion Channel Stability of Structures Photo Station P4

Station P4 facing south; low flow condition (April 25, 2018)

Station P4 facing south; low flow condition (July 24, 2018)

Station P4 facing north; upstream (July 24, 2018)

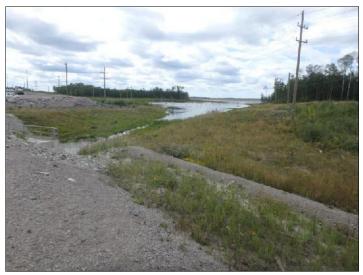
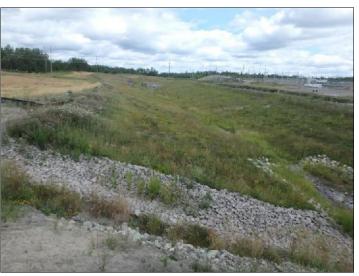
Plate B.2-1: Stockpile Diversion Channel Stability of Structures Photo Station P11

Station P11 facing southwest; low flow conditions (July 24, 2018)

Station P11 facing northeast (July 24, 2018)

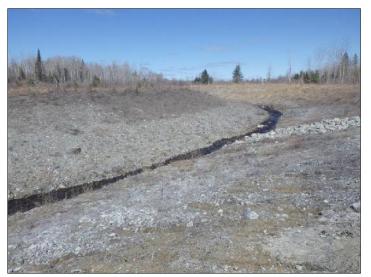
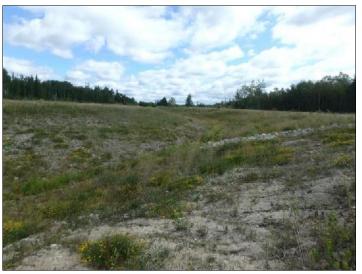
Plate B.2-2: Stockpile Diversion Channel Stability of Structures Photo Station P12

Station P12 facing northeast; high flow conditions (April 24, 2018)

Station P12 facing northeast; low flow conditions (July 24, 2018)

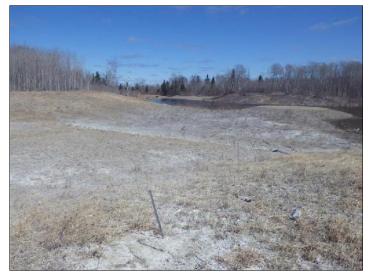
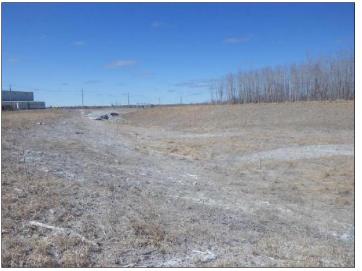
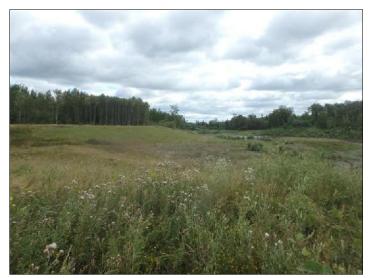
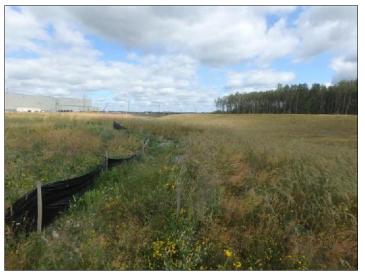
Plate B.2-4: Stockpile Diversion Channel Stability of Structures Photo Station P13

Station P13 facing northeast; high flow conditions (April 24, 2018)

Station P13 facing northwest; downstream (April 24, 2018)

Station P13 facing northeast; low flow conditions (July 24, 2018)

Station P13 facing northwest; downstream (July 24, 2018)

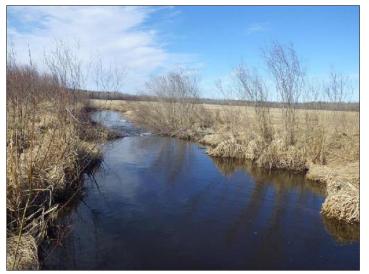
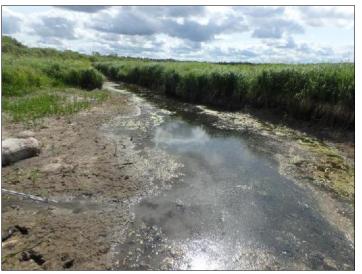
Plate B.3-2: West Creek Diversion Channel Stability of Structures Photo Stations P1 and P2

Station P2 facing southeast; high flow conditions (April 24, 2018)

Station P2 facing southeast; low flow conditions (July 24, 2018)

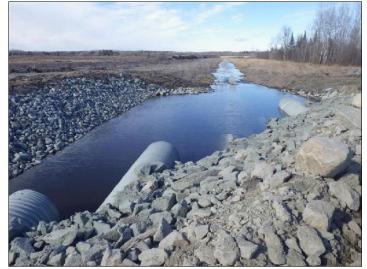
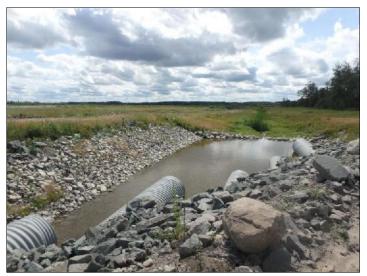
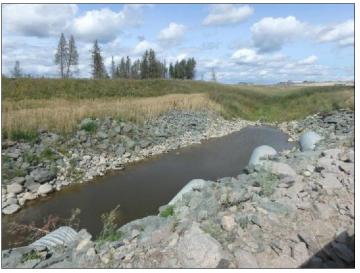
Plate B.3-3: West Creek Diversion Channel Stability of Structures Photo Station P3

Station P3 facing southwest; high flow conditions (April 24, 2018)

Station P3 facing southwest; low flow conditions (July 24, 2018)

Station P3, facing northeast; upstream (July 24, 2018)

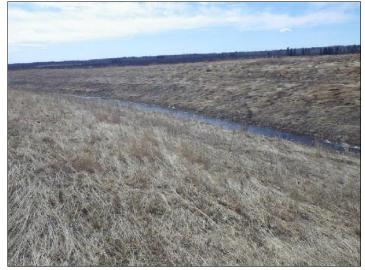
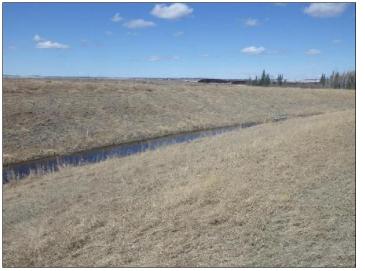
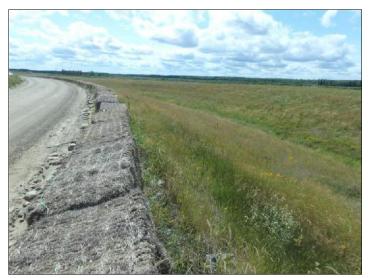
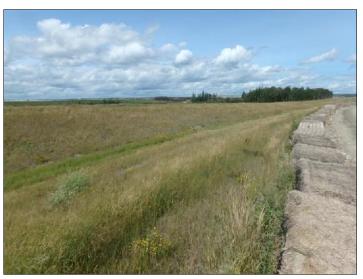
Plate B.3-4: West Creek Diversion Channel Stability of Structures Photo Station P4

Station P4 facing southwest; high flow conditions (April 26, 2018)

Station P4 facing northeast; upstream (April 26, 2018)

Station P4 facing southwest; low flow conditions (July 24, 2018)

Station P4 facing northeast; upstream (July 24, 2018)

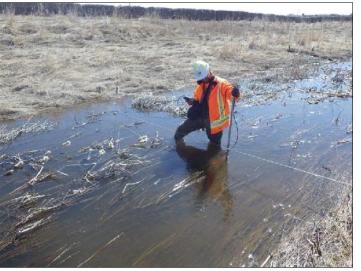
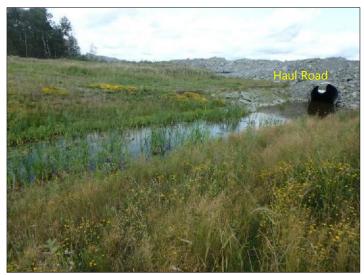
Plate B.3-5: West Creek Diversion Channel Stability of Structures Photo Station P5

Station P5 facing south; high flow conditions (April 26, 2018)

Station P5 facing northeast (July 24, 2018)

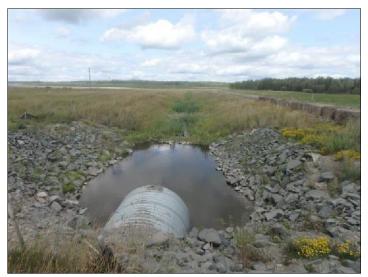
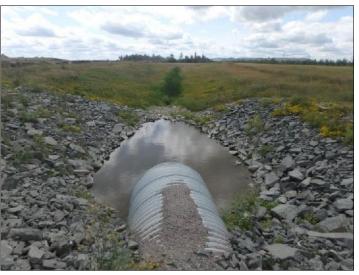
Plate B.3-6: West Creek Diversion Channel Stability of Structures Photo Station P6

Station P6 facing northeast; low flow conditions (July 24, 2018)

Station P6 facing southwest; downstream (July 24, 2018)

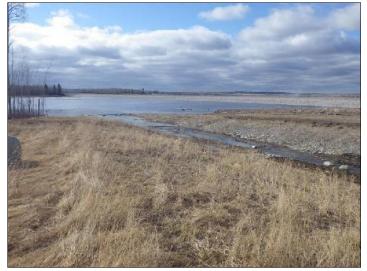
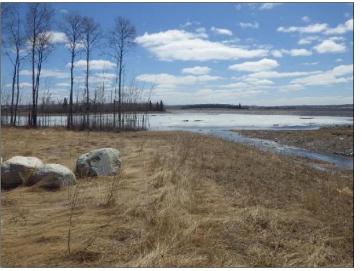
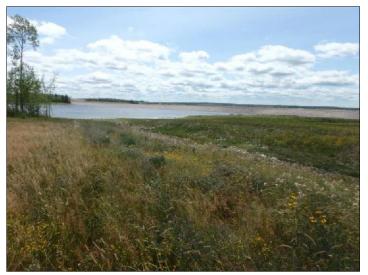
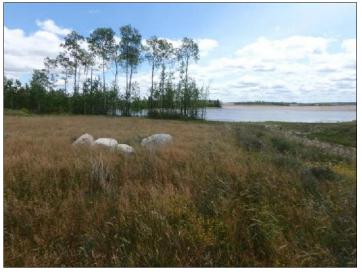
Plate B.3-9: West Creek Diversion Channel Stability of Structures Photo Station P8

Station P8 facing southeast; high flow conditions (April 24, 2018)

Station P8 facing southeast; low flow conditions (July 24, 2018)

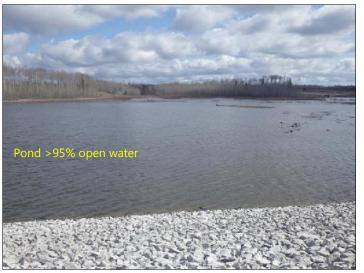
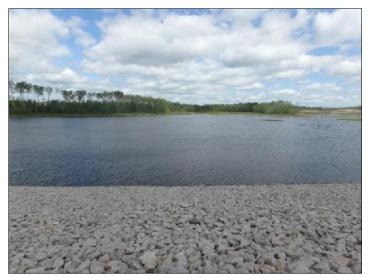
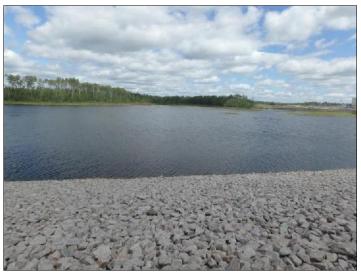
Plate B.3-10: West Creek Pond Stability of Structures Photo Station P9

Station P9 facing northeast; high flow condition (April 26, 2018)

Station P9 facing northeast; low flow conditions (July 24, 2018)

Station P9 facing northeast (July 24, 2018)

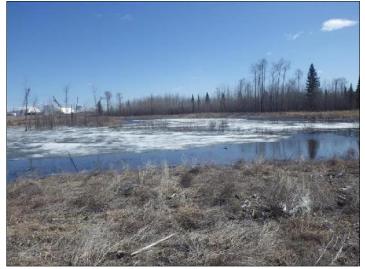
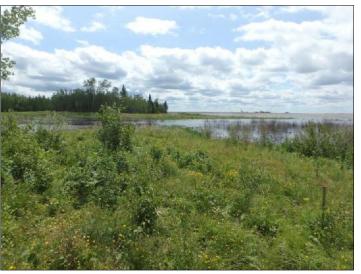
Plate B.3-12: West Creek Pond Stability of Structures Photo Station P10

Station P10 facing southeast; high flow conditions (April 24, 2018)

Station P10 facing southeast (July 24, 2018)
