## **ANNUAL MONITORING OF OFFSET MEASURES- 2021**

**YEAR 5 OF 5**

NEW GOLD INC.  
Rainy River Mine  
P.O. Box 5  
Emo, Ontario  
P0W 1E0

Ref. 20-2713  
20 December 2021

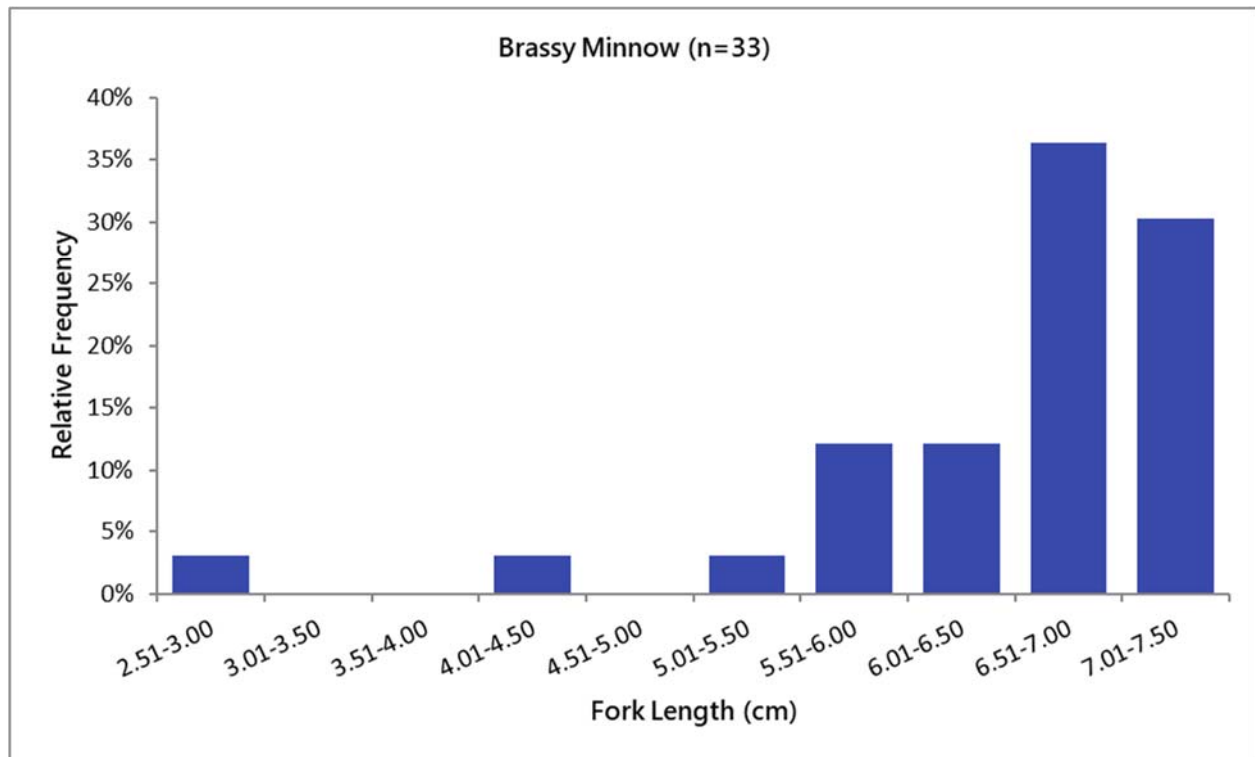
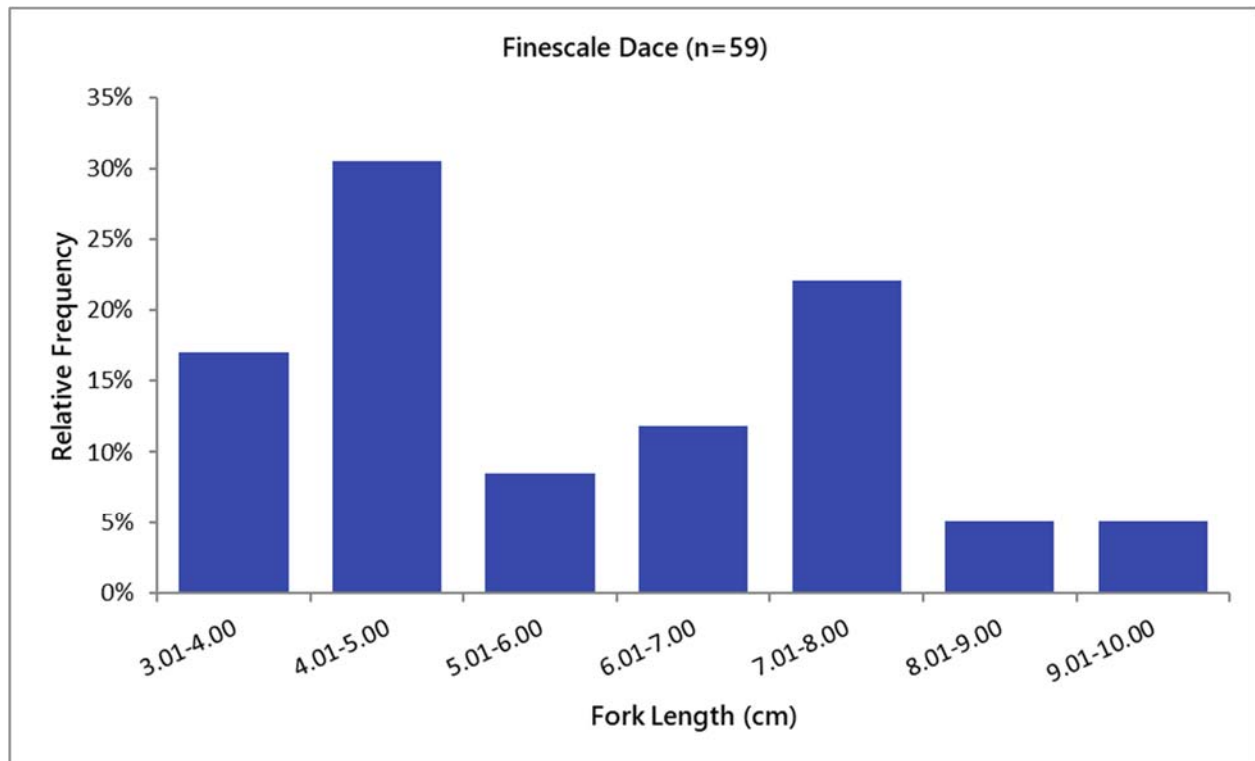
In Teeple Pond the fish community included (listed in order of abundance) Finescale Dace, Brook Stickleback, Northern Redbelly Dace, Central Mudminnow, Fathead Minnow, Brassy Minnow, Pearl Dace, and Johnny Darter (Tables 3-2 and 3-3). There was an abundant fish community in the Pond with a total of 6,911 fish captured. This included CPUEs of 31 fish per 1,000 seconds for electrofishing effort, 575 fish per 15 m seine net haul, and 0.49 fish captured per minnow trap hour (Table 3-3; Appendix Table A.3 to A.5). Histograms indicate that multiple age classes of a variety of species were captured in the Pond (Appendix Figure A-1).

Note: Johnny Darter (n=1) and Pearl Dace (n=3) not plotted due to low capture

**Figure A-1: Length frequency Distributions for Fish Collected at Teeple Pond, Rainy River Mine 2021**

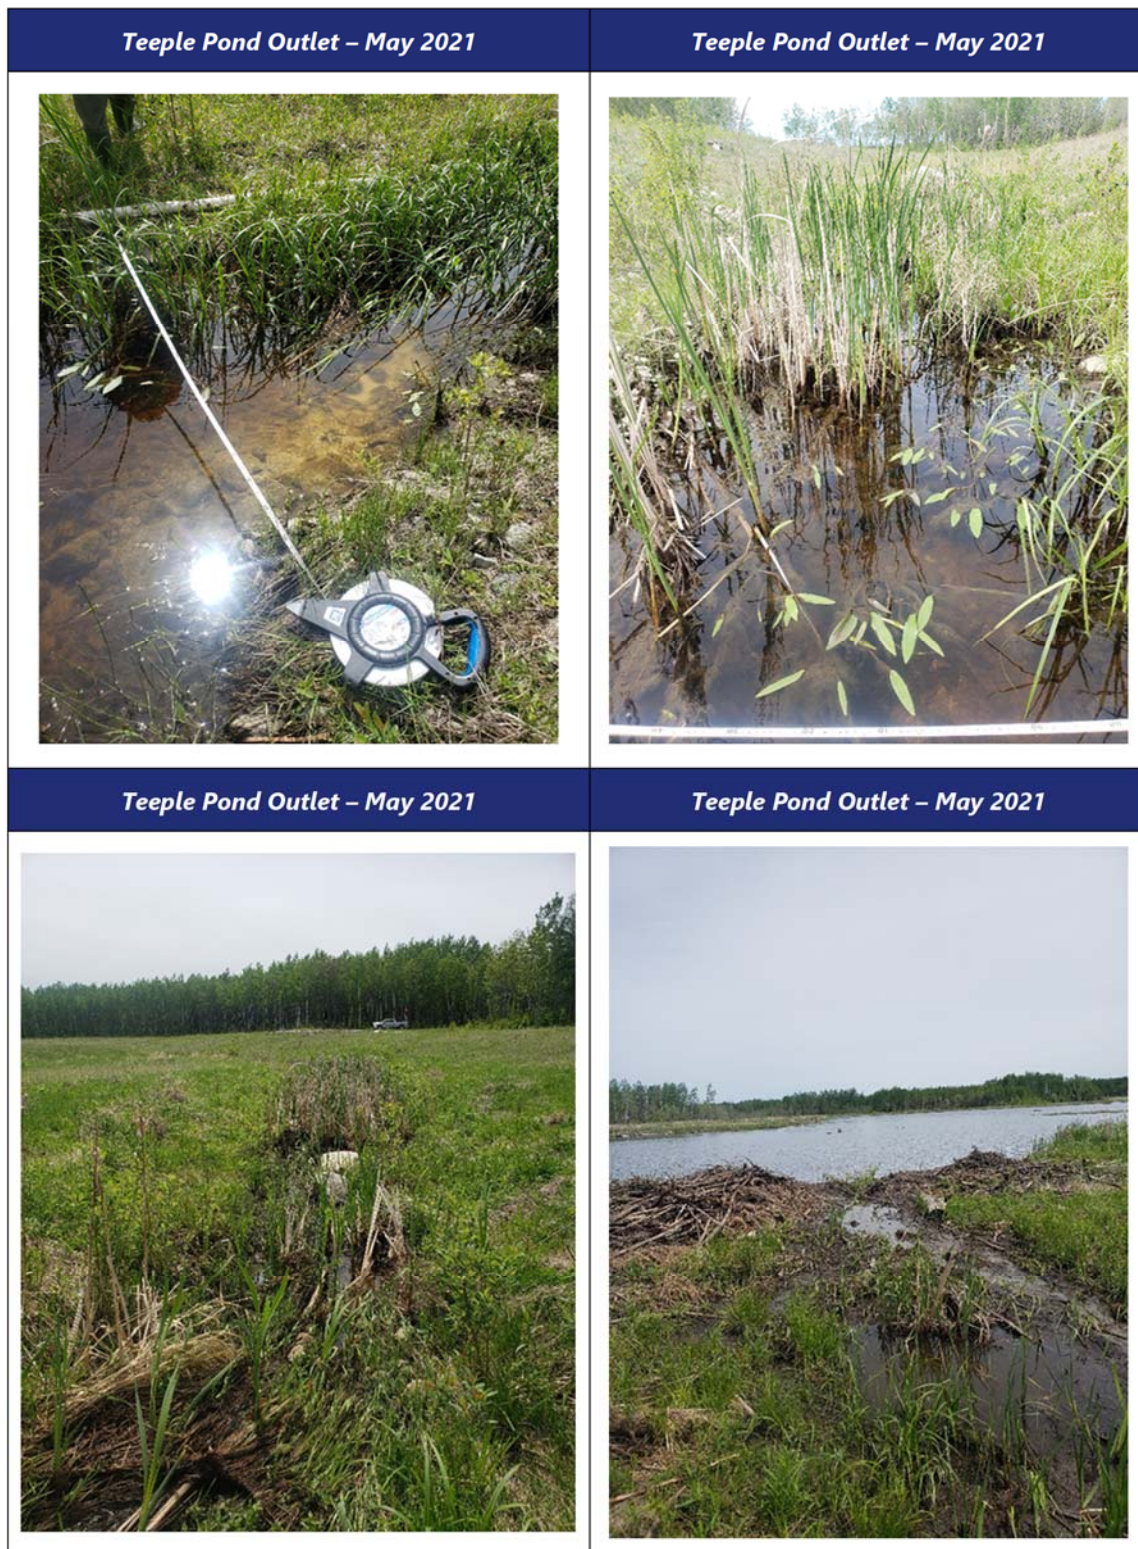
Riparian vegetation along Teeple Pond Outlet is extensive with little exposed soil. Cattail, grasses and sedges (*Carex* spp.) comprised the majority of the vegetation (Appendix Photo B-1 and B-2). Other species included, red clover (*Trifolium pratense*) small willow (*Salix* sp.) and alder (*Alnus* sp.). Submergent macrophytes were primarily coontail whereas burreed, pond weed and sedges along the shoreline were the dominant instream emergent vegetation. Throughout the constructed channel instream cover for fish is comprised of numerous boulder clusters and pool habitat. However, monitoring over the last five years indicates that the Outlet only provides seasonal habitat and is not meeting the intent of the Offset Plan (Appendix Photo B-2) due to insufficient connectivity to Teeple Pond as a result of beaver activity and in 2021 likely the result of extremely low amounts of precipitation (Section 3.1.2). It should be noted that during the May Outlet survey a beaver dam was present at the upstream end of Outlet and beaver activity continued until early summer.

**Photo B-1: Teeple Pond Outlet Habitat, May 2021**

- 1) To address low water levels in Teeple Pond Outlet investigate solutions or mitigation to address water levels that are not consistent with those specific in the plan ensure stabilization of connectivity between the Outlet and Teeple Pond.
- 2) Species diversity within the Pond and Outlet remain below the target of nine species. It is recommended that New Gold review opportunities to relocate fish at the RRM under appropriate permits and approvals to increase the overall community diversity; and,

- 3) RRM staff should continue to manage beaver activity in the Teeple system to maintain the flows downstream.

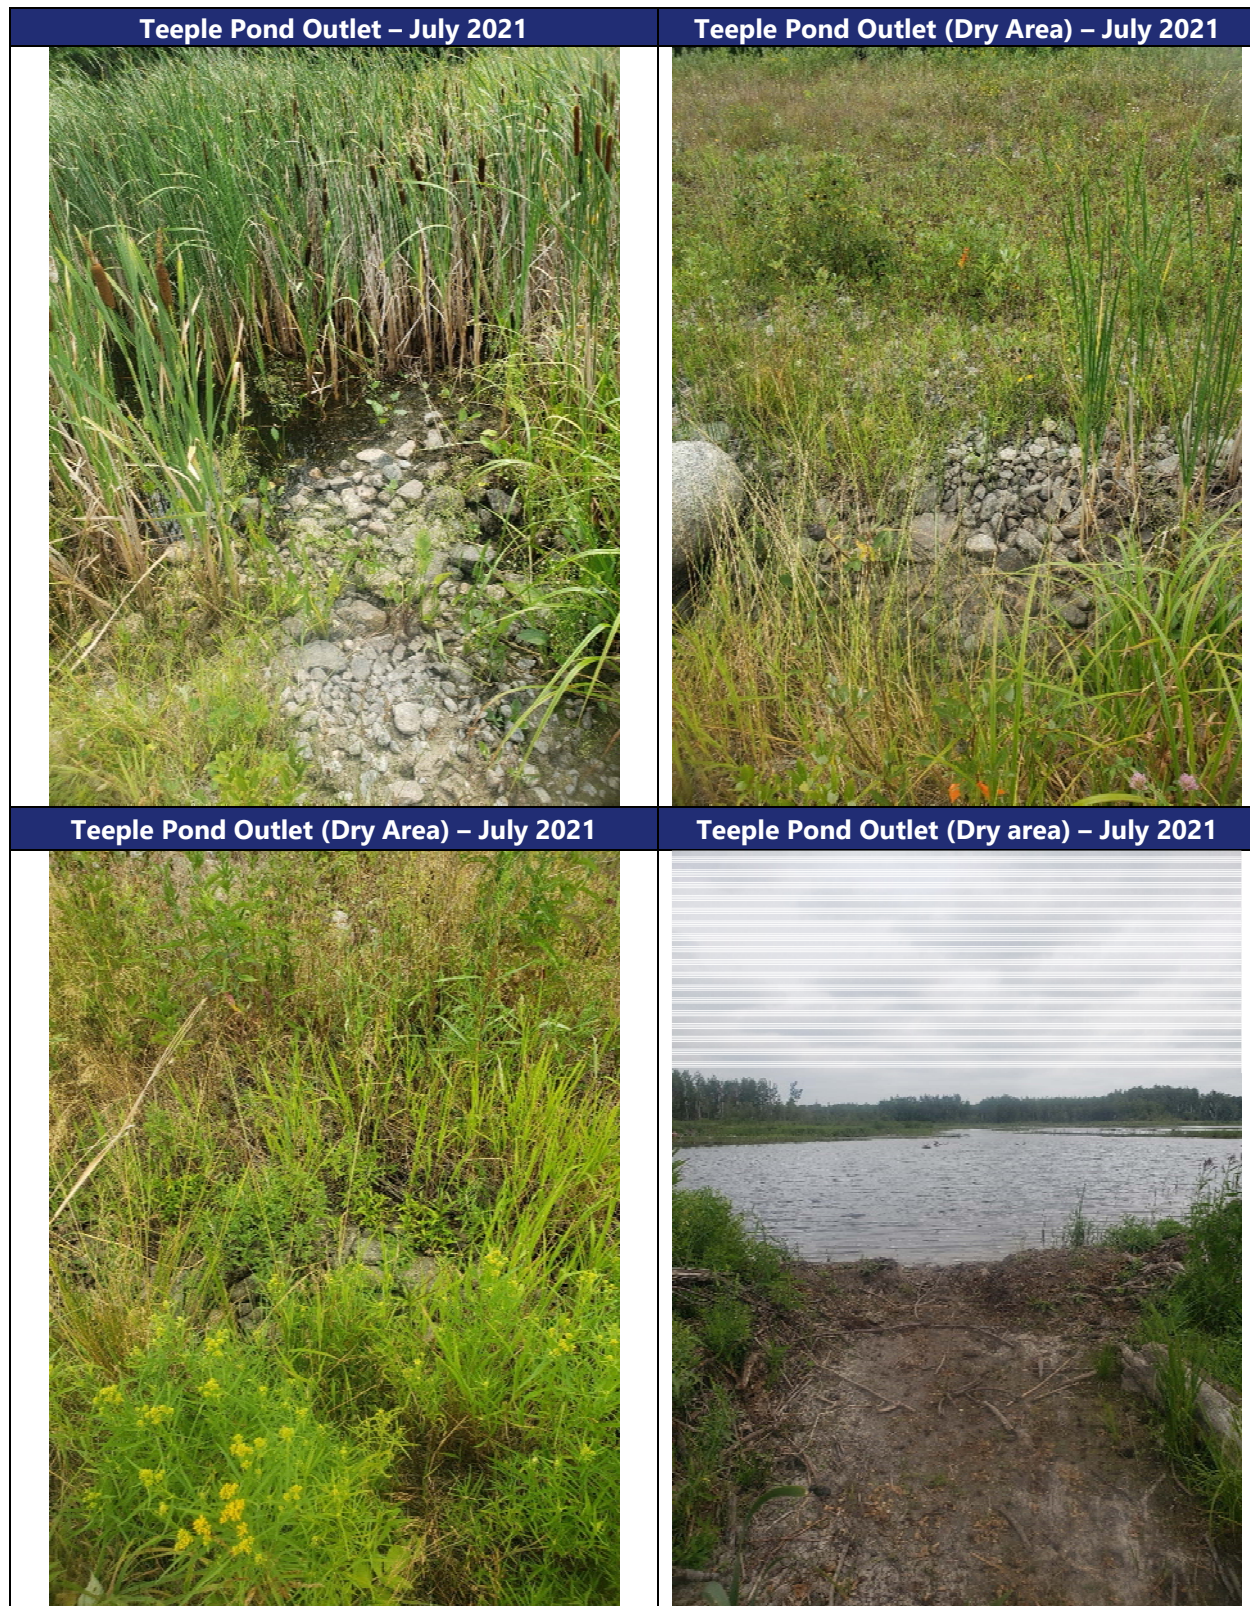
**Photo B-2: Teeple Pond Outlet Habitat – July 2021**

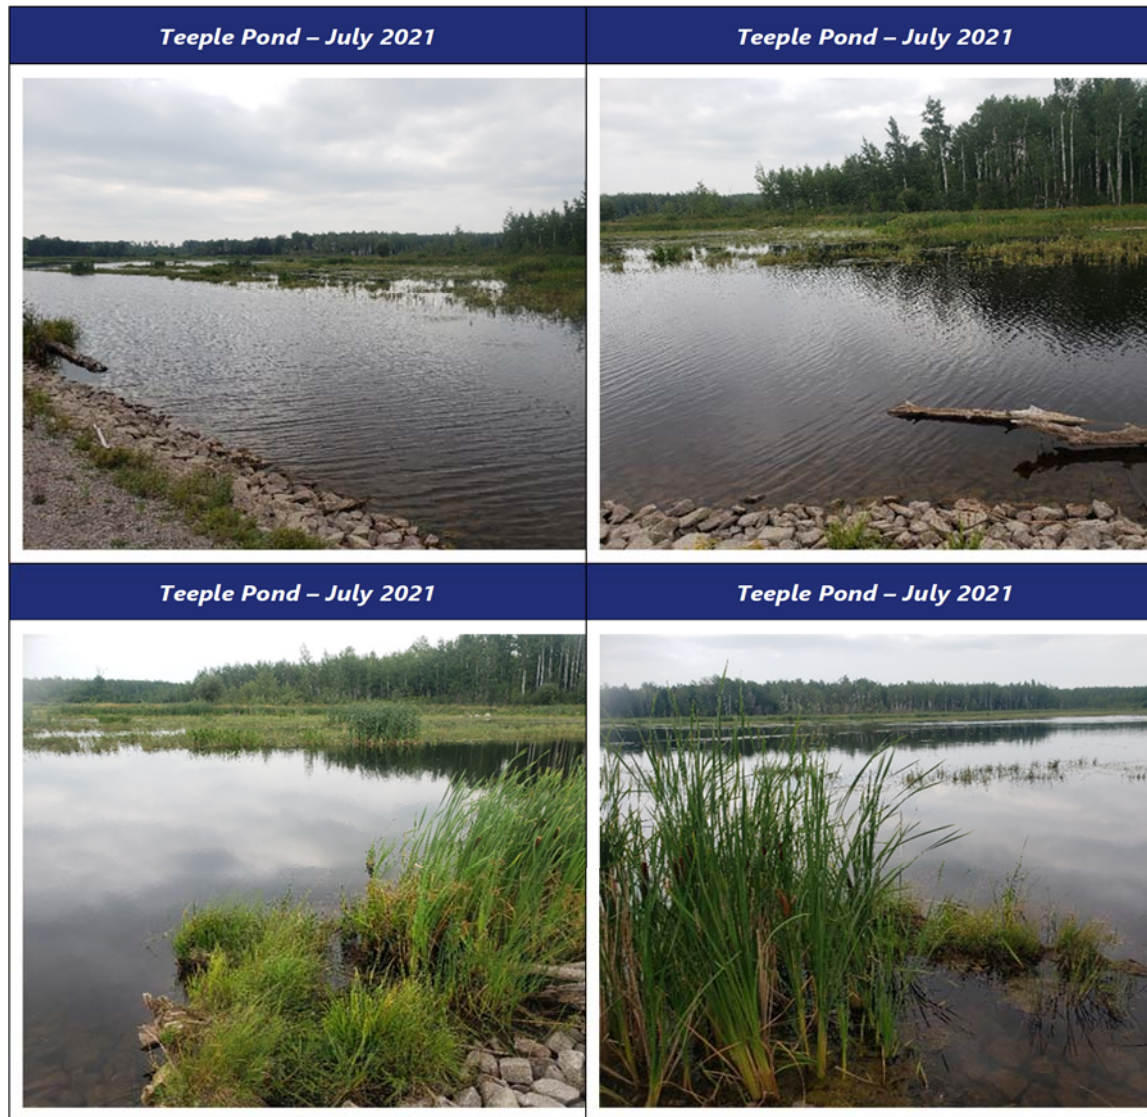
The shoreline of Teeple Pond is well vegetated with the primary species identified including cattails, sedges and grasses. Aside from the wetted dam face, greater than 90% of the perimeter of the Pond has a robust and self-sustaining riparian vegetation community (Appendix Photo B-3). Within the Pond there were many submergent macrophytes including burreed, pond lily, pond weed and coontail. In-water structures remain stable from original construction and include boulders and wood debris piles that continue to provide cover for fish. The beaver dam observed in May was likely affecting the Pond level and the water level within the Pond / Outlet complex.

**Photo B-3: Teeple Pond Habitat – Jul 2021**
