**NEW GOLD RAINY RIVER MINE  
APPENDIX L  
WILDLIFE MORTALITY LOG**

**NEW GOLD RAINY RIVER MINE  
APPENDIX M  
EXCEEDANCE LETTER SUBMITTED  
TO MECP**

**RE:1000L Ferrous Sulfate Spill – SAC Reference #2157-B4ZRSU**

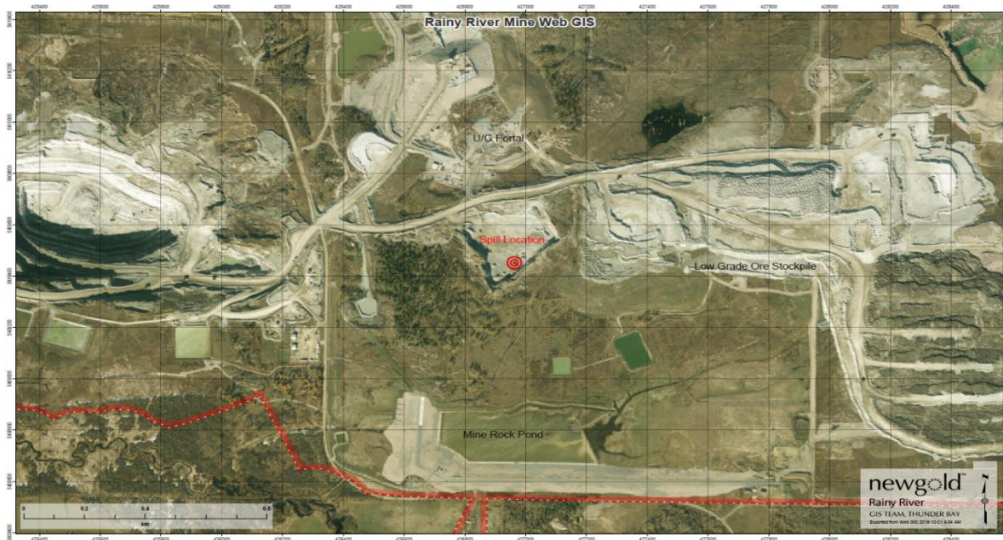
Photo 1: Map of site denoting spill location.

At 0300 hours the operator of drill 903 noticed an unexpected drop in fuel level well drilling blast holes in the East Outcrop. (See photo 1 below)

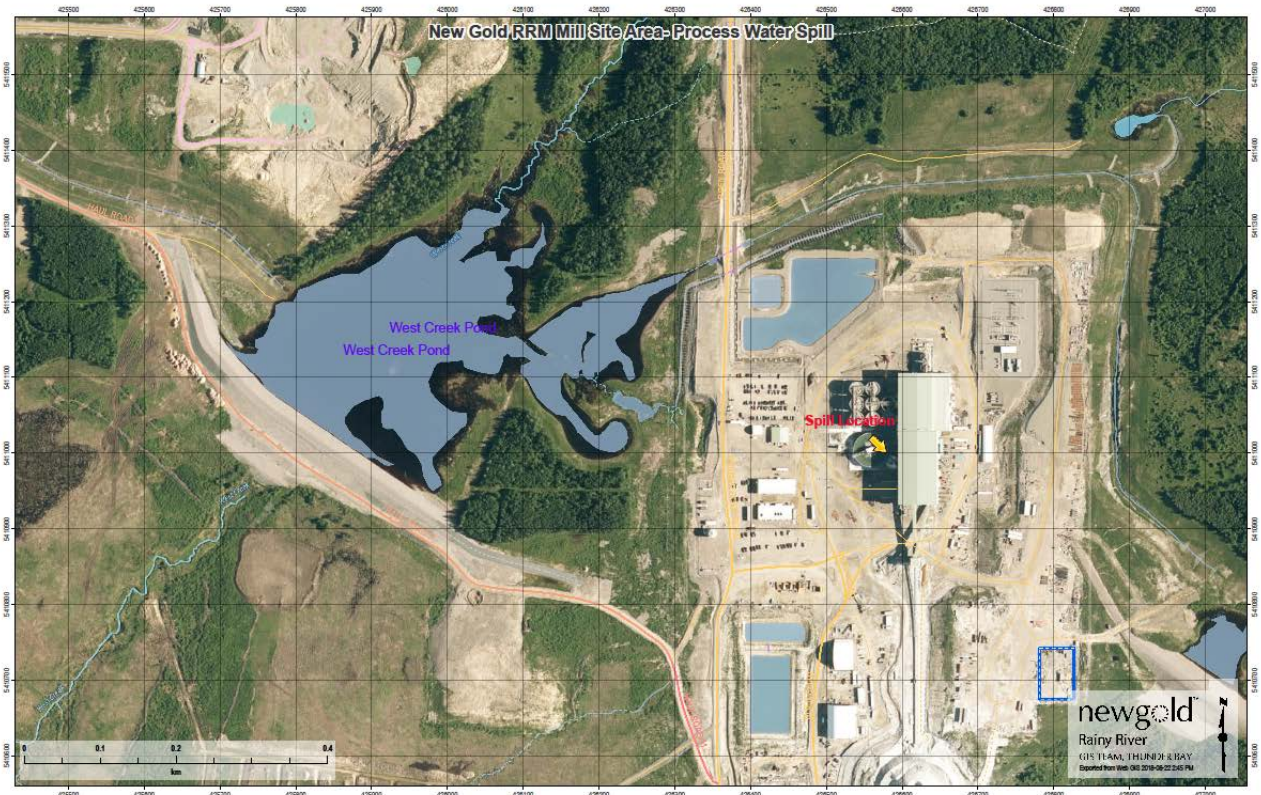
Photo 2. New Gold Rainy River Mine Process Plant site. Spill location denoted in red.

The pump was immediately shut off. Approximately 57L of process water ponded within 25 meters of the door, where it was 100% contained. Mill Door 18W is located 300 to 400 m west of the West Creek Pond and Diversion waterway (Photo 2). Natural topography and man-made features prevented the spill from reaching any further than the alleyway.

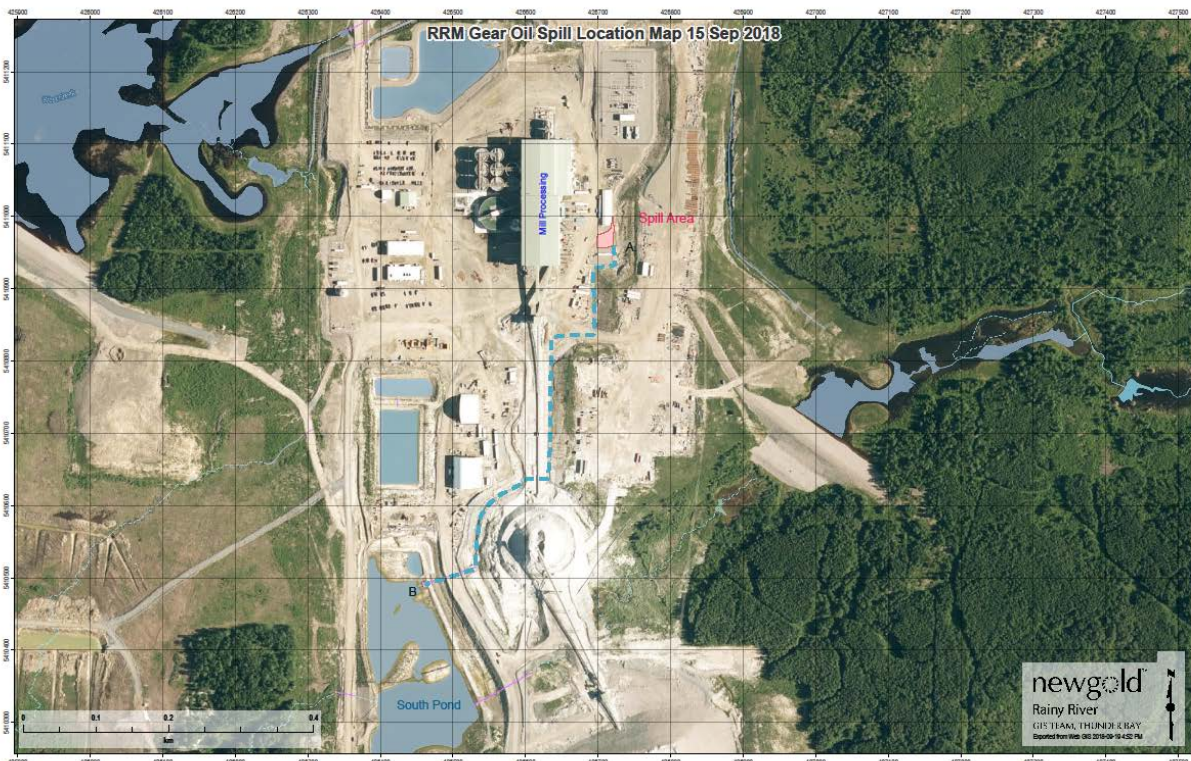
The spill occurred approximately 100 m east of mill process building in a laydown area which borders the plant site east drainage ditch system. Runoff water collects in the ditch and is channeled south through the site into the South Pond (Photo 3). All runoff water from the spill area was contained by this internal drainage system the South Pond. Water from the South Pond is used by the mill for processing ore. Any overflow is routed to the Mine Rock Pond via a 20-inch pipeline. New Gold will monitor the South Pond for evidence of hydrocarbon sheen.

Photo 3. GIS image of spill area (pink) and location of contact water drainage ditch (blue hatch).

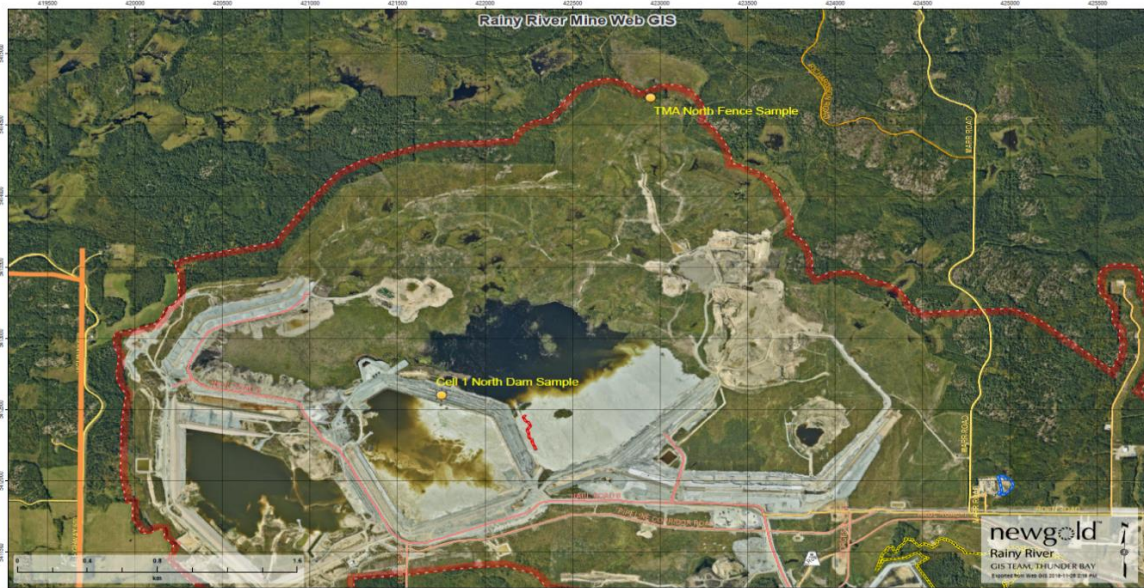
Photo 2: Map showing ESA Boundary

Winds were gusting up to 35 km/h out of the south and it was evident at the time that the plume was travelling outside of the Environmentally Sensitive Area (ESA) boundary. Samples of snow were taken from Cell 1 north dam and from the northern most tip of the ESA boundary to assess the level of impact. (See Photo 2).

The samples taken were analyzed by ALS Environmental Laboratories in Thunder Bay, indicate there was little to no impact at that time. Tests show the three most prevalent elements on Cell 1 dam to be calcium, iron and sulfur at 38,200 mg/L, 10,600 mg/L and 17,300 mg/L, respectively. Tests results from the TMA North Fences samples showed levels of these elements to be lower by a factor of one thousand times or more (See appendix A).

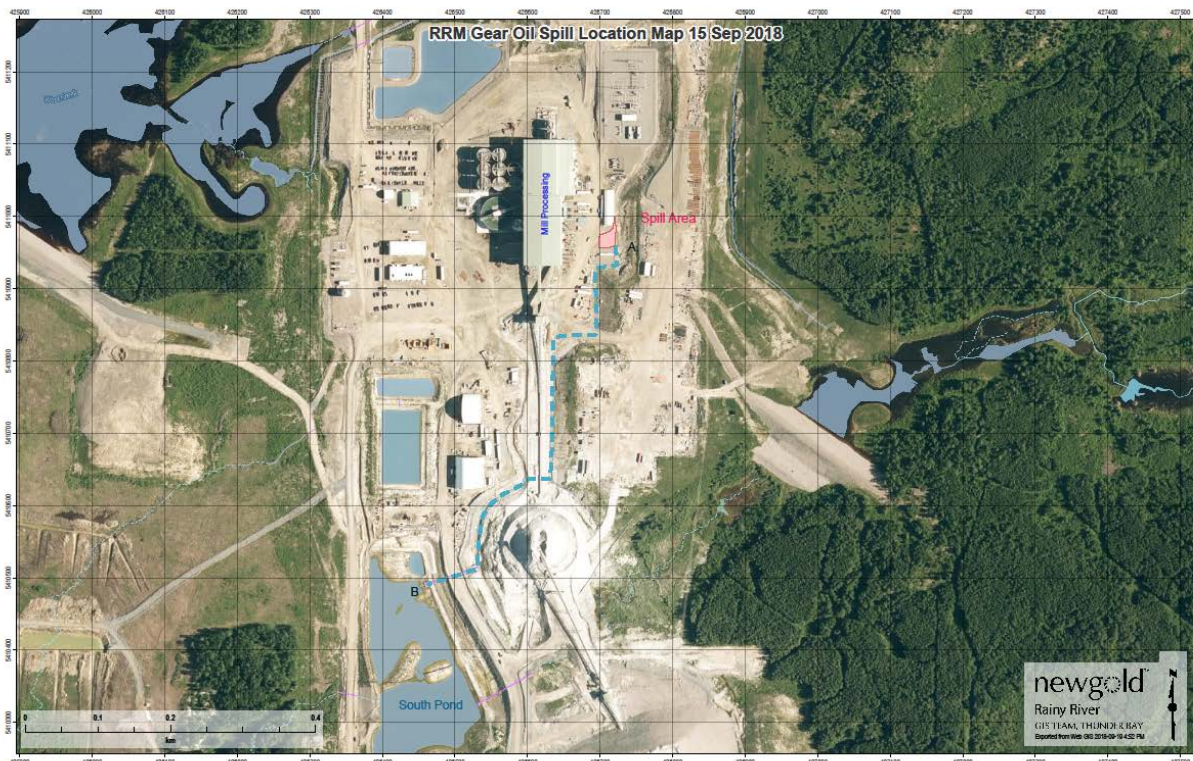
The spill occurred approximately 100 m east of mill process building in a laydown area which borders the plant site east drainage ditch system. Runoff water collects in the ditch and is channeled south through the site into the South Pond (Photo 3). All runoff water from the spill area was contained by this internal drainage system the South Pond. Water from the South Pond is used by the mill for processing ore. Any overflow is routed to the Mine Rock Pond via a 20-inch pipeline. New Gold will monitor the South Pond for evidence of hydrocarbon sheen.

Photo 3. GIS image of spill area (pink) and location of contact water drainage ditch (blue hatch).
