**NEW GOLD RAINY RIVER MINE  
APPENDIX L  
EXCEEDANCE LETTERS SUBMITTED  
TO MECP, CEAA**

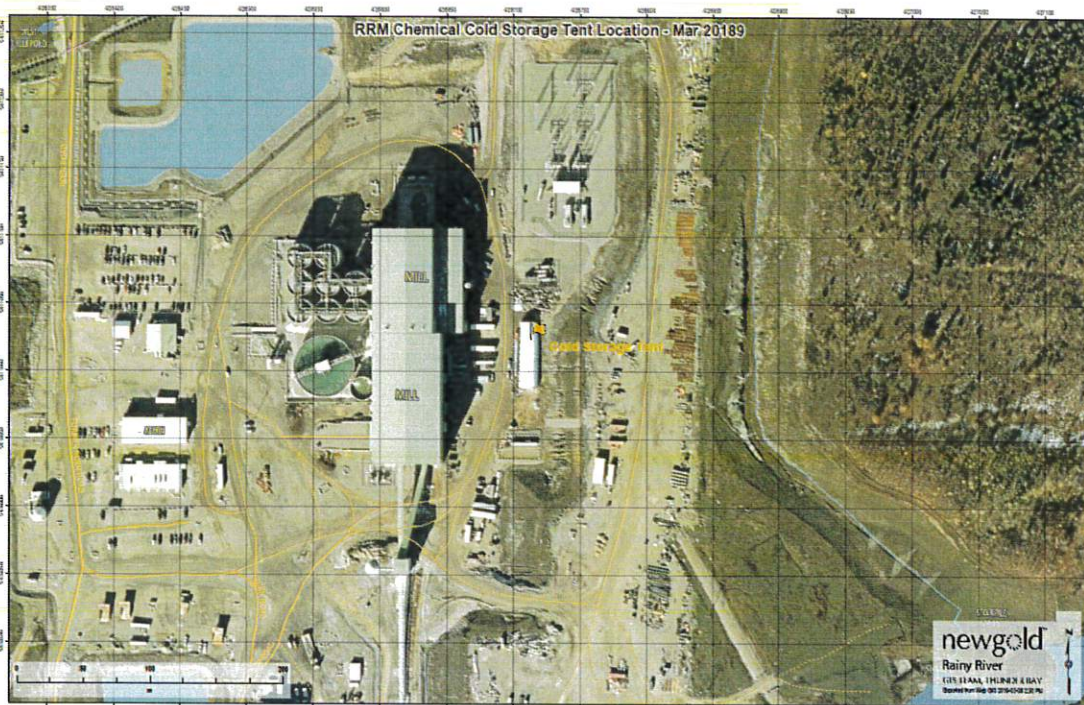
Further to the notification to the Spills Action Center (SAC) Reference #2828-B9SKZ5; on February 27, 2019 at 08:50 hours, a copper sulphate spill was noted on the gravel/clay floor of the covered chemical cold storage tent east of the Mill (Figure 1). The original volume was estimated at 200 kg, but it has since been corrected to approximately 30 kg.

Figure 1. Plan view of plant site showing location of Mill and covered chemical cold storage tent.

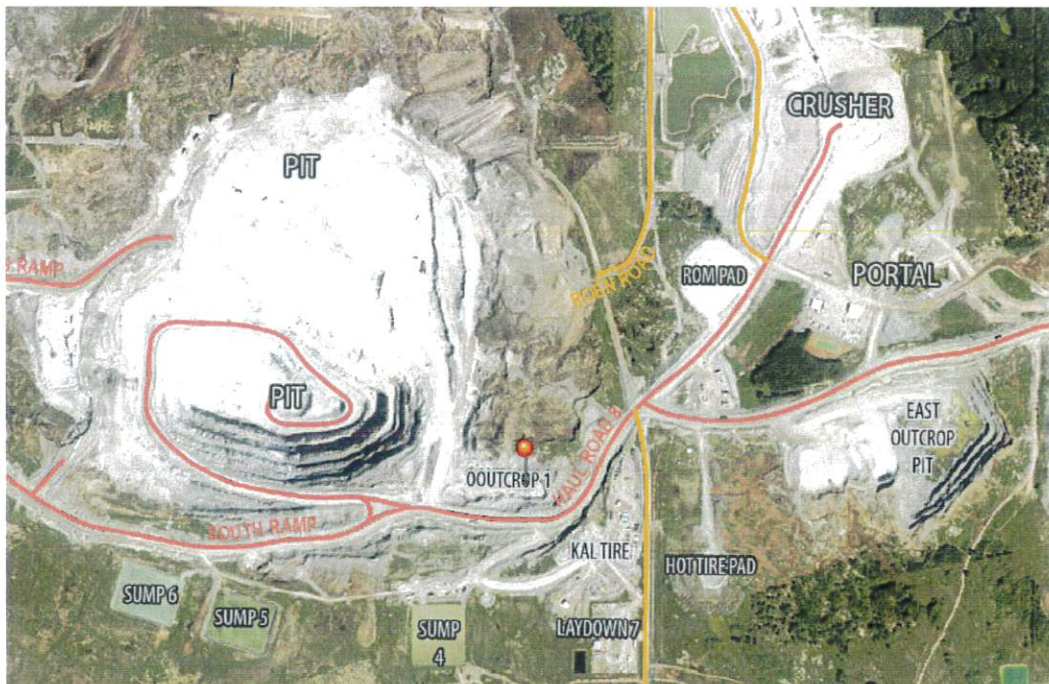
Further to the notification to the Spills Action Center (SAC) Reference #7470-BEK4MD: On July 29, 2019 at 00:30 hours, diesel fuel was sighted flowing out of a ruptured fuel line of an 830 Haul Truck at Outcrop 1 within the open pit. Mitigation measures were put in place and the spill was halted within 5 minutes. The cause of the spill was due to a rock hitting the fuel line of the haul truck. The haul truck has since been repaired.

Figure 1. Location of where spill occurred (Outcrop 1).

A 604 Shovel Operator noticed the diesel fuel spilling out of the fuel line of the haul truck as they were loading. Work stopped, and spill pads were laid down until spill containers could be put into place. Vacuum trucks were called to the scene to remove the fuel until the tank was empty. Approximately 120L of diesel fuel was spilled onto gravel. There are no nearby watercourses.

Approximately 5 yards of contaminated gravel was collected and placed in a contaminated soil bin for removal offsite by a certified hazardous waste hauler. See below photos of the spill area cleaned up. The area was returned to the original grade.
