### NEW GOLD RAINY RIVER MINE APPENDIX K EXCEEDANCE LETTERS SUBMITTED TO MECP AND REGULATORY REPORTING TABLE

### NEW GOLD RAINY RIVER MINE APPENDIX K.1 EXCEEDANCE LETTERS SUBMITTED TO MECP

#### SUBJECT: NORTH STATION AMBIENT AIR QUALITY EXCEEDANCES OF 24-HOUR TOTAL SUSPENDED PARTICULATE-MONITORING LIMITS - SAC REFERENCE #8876-BPJS8Z

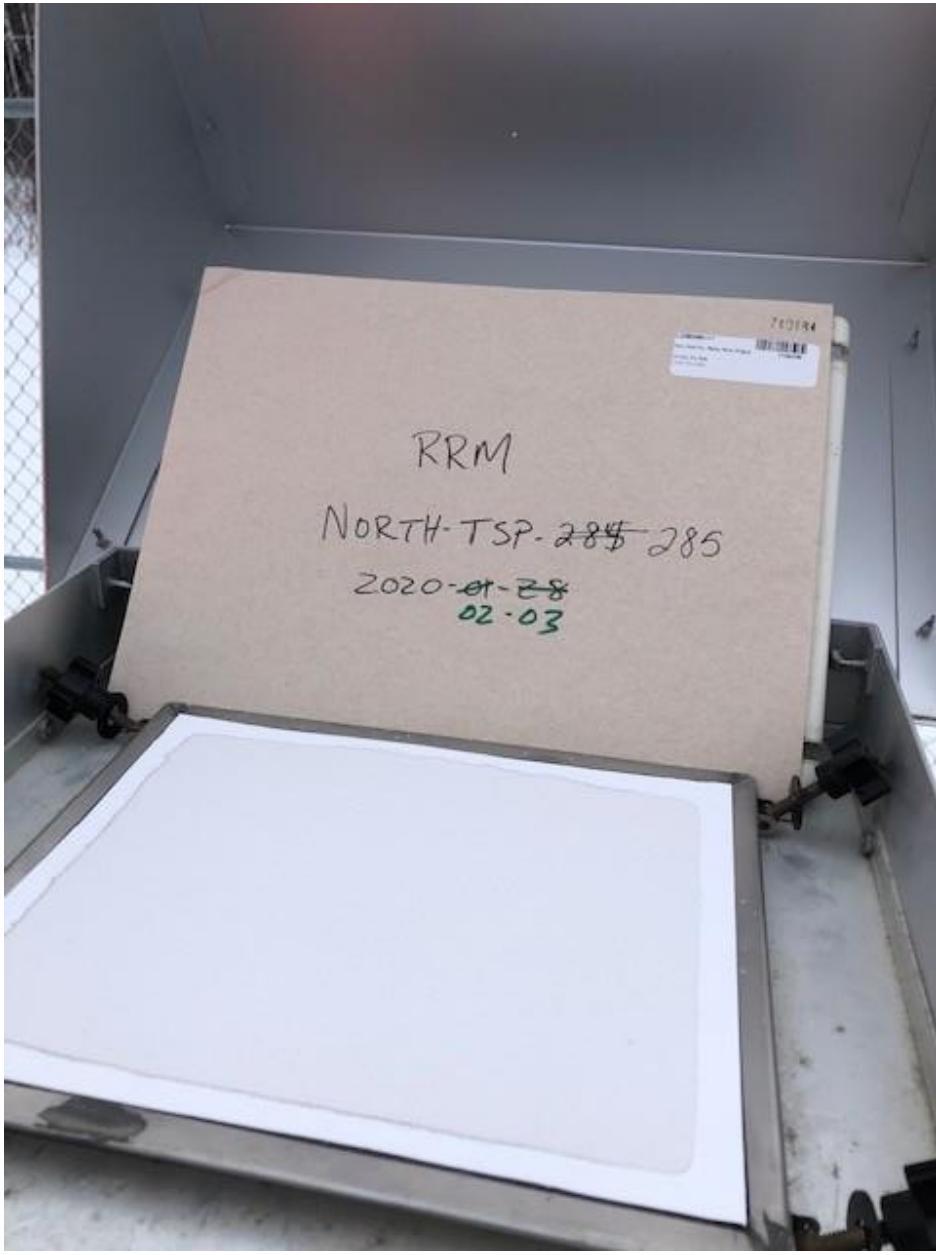
Figure 3: Photo of the North Station TSP Filter sampled on February 3, 2020

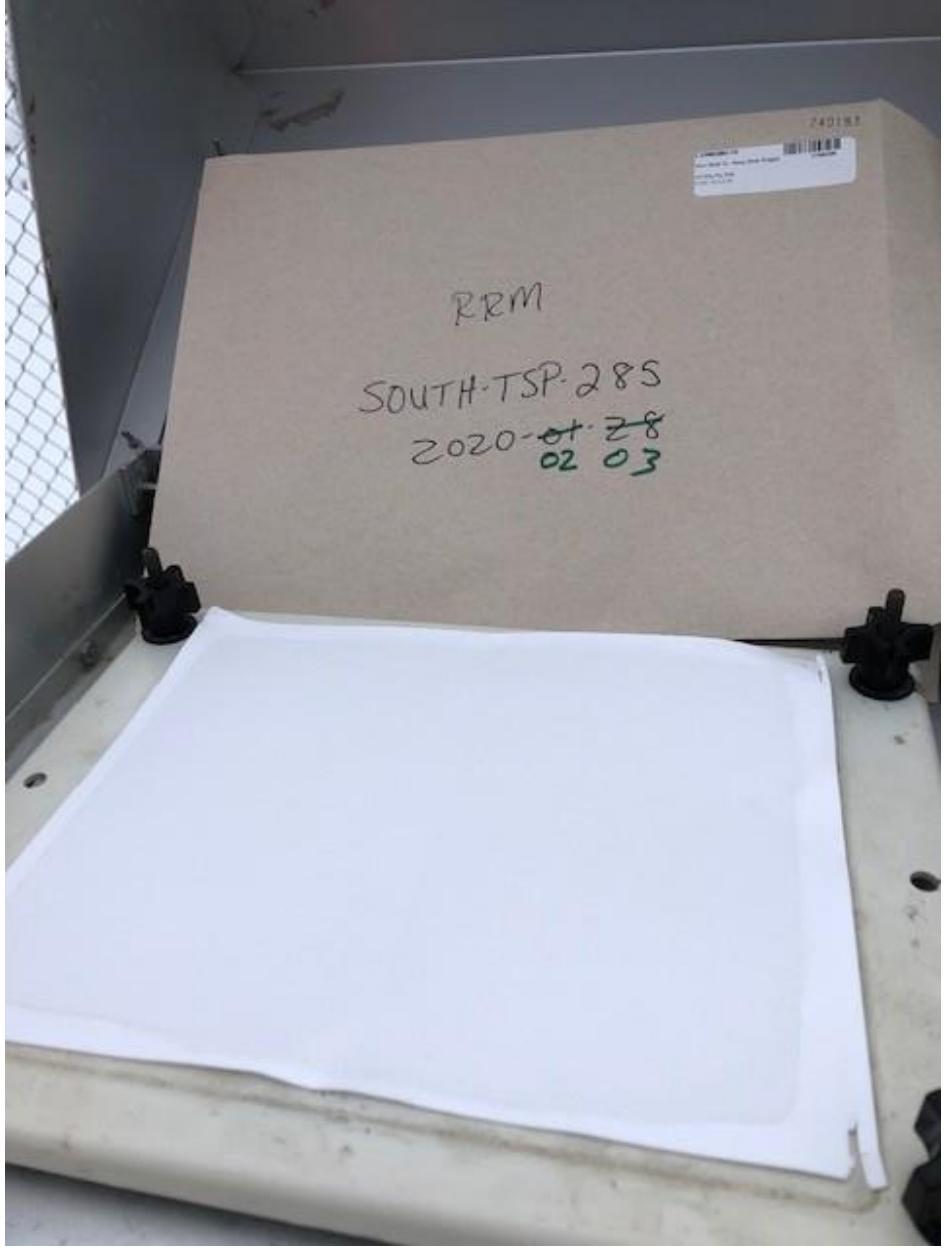
Figure 4: Photo of the South Station TSP Filter sampled on February 3, 2020

New Gold will continue to apply the mitigation measures as described in the previous letter sent on May 13, 2020, and is actively working on improving our sampling and maintenance procedures of ambient air quality monitoring equipment to allow for faster reaction time on errors. In addition, New Gold will be providing more training for New Gold employees on equipment maintenance and calibration.

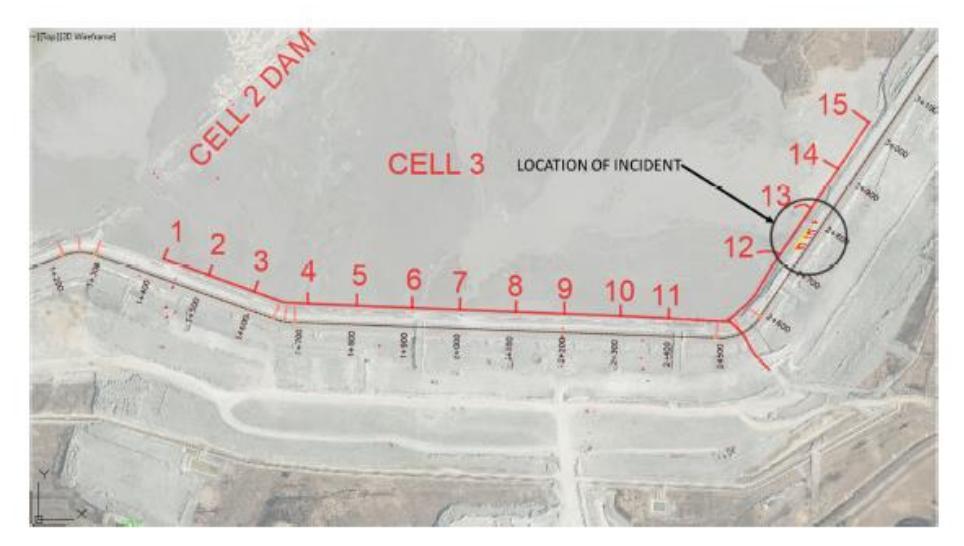
On June 3<sub>rd</sub>, the tailings line was inspected around 6:30 am by the Mill Manager and the Mill Superintendent. At that time, the extent of the tailings was below 369 masl. Later that morning the Tailings Engineer performed his daily inspection and noticed the exceedance as shown in Figures 1, 2 and 3. This was communicated to the Environmental Manager around 12:30 pm who required that tailings deposition be halted immediately. Appropriate regulatory agencies were then notified. The average tailings slurry exceedance was 0.08 masl with a maximum of 0.12masl at one location.

Figure 1 - Aerial View of Incident

A plan was then put in place to re-route the tailings, using the redundant tailings line, to another location as shown in yellow on Figure 4. At that location, the normal tailings slurry operating level is 371.1masl with a current slurry level of approximately 366.6masl. The line extending from the primary tailings' deposition, currently positioned on the TMA dams will be extended to this location within 10 days and the redundant tailings line will be shut down. A minimum of two (2) daily inspections will continue to be performed along all tailings pipelines. Any problems will be immediately rectified, and appropriate Agencies notified.

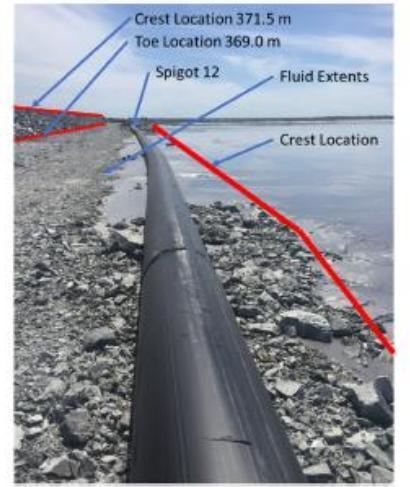
FIGURE 2 – Pipeline Looking South-West

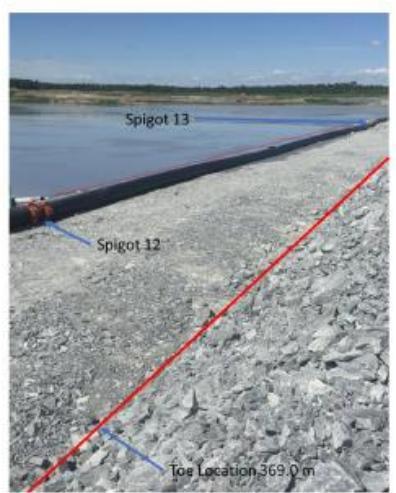
FIGURE 3 - Standing on 371.5 Looking North

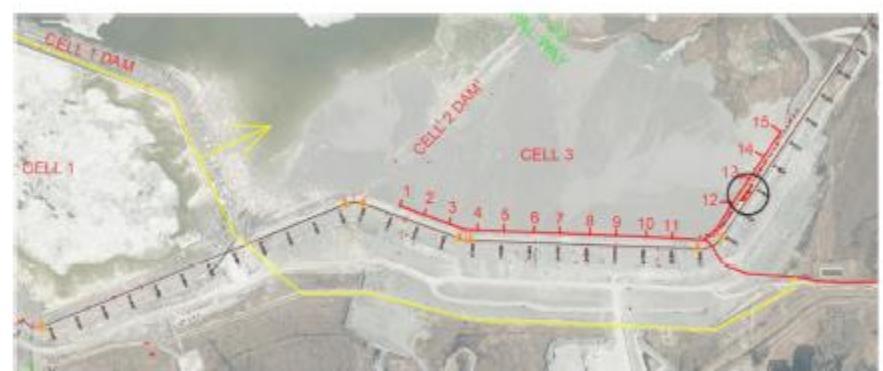
Figure 4 - Alternate Discharge Location

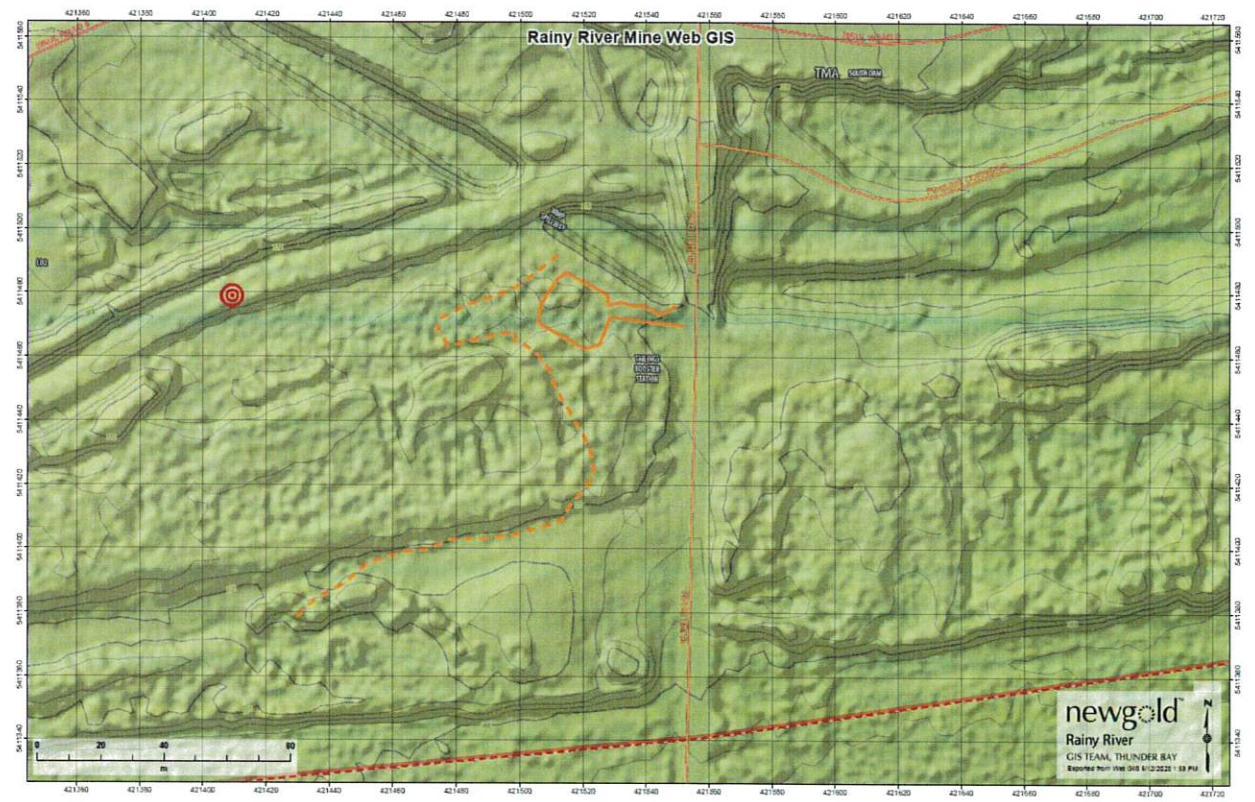
In Photo 2 the same location with the same drawings are shown with the topographic background selected. This image is not updated so the entire compacted gravel pad is not shown, nor the booster station sump. The purpose of the image below is to illustrate that the water likely stayed within the mine footprint and either reported to the spillway or the booster station sump.

Photo 2: Incident location with Topography.

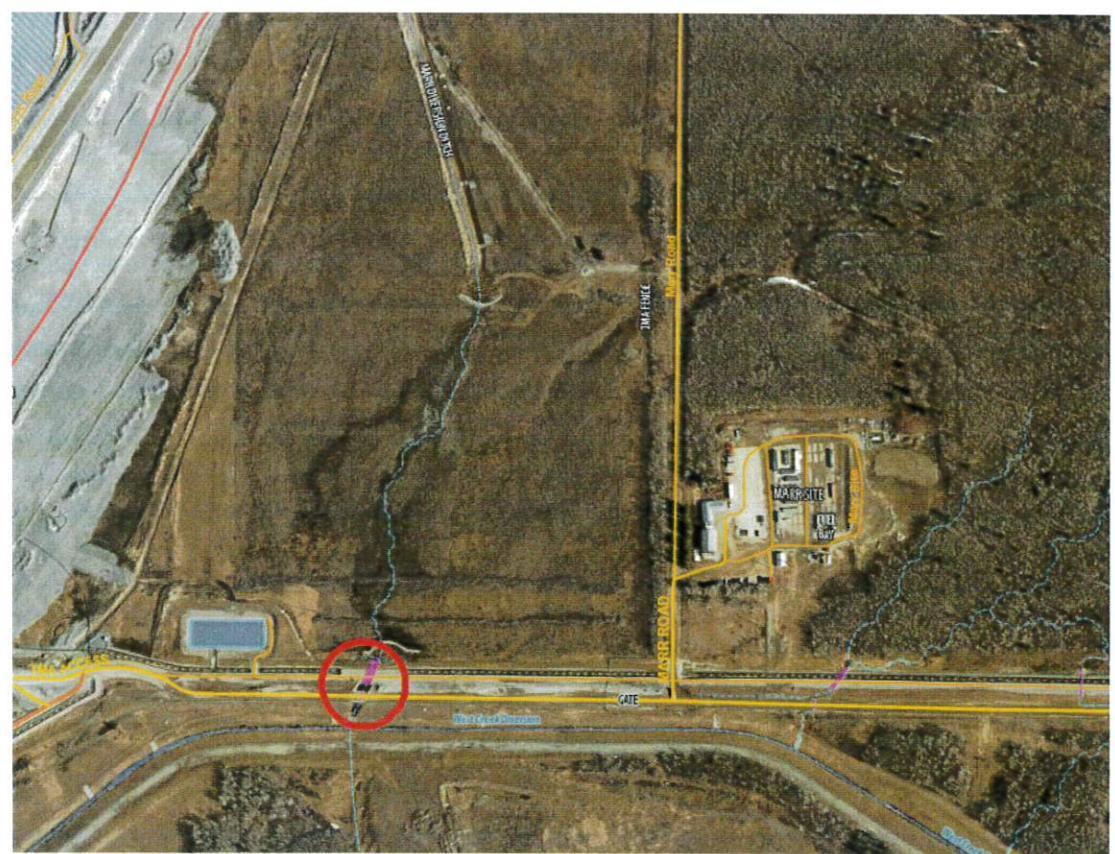
Figure 1. Plan view of Marr Site, Marr Diversion and West Creek Diversion showing location of where the turbid water was spotted flowing under Roen Road.

The water flowing through the culvert appeared to be sediment-laden water originating from Marr Diversion upstream the culvert. Upon discovery of the turbid water, a total suspended solids sampled was collected and Site

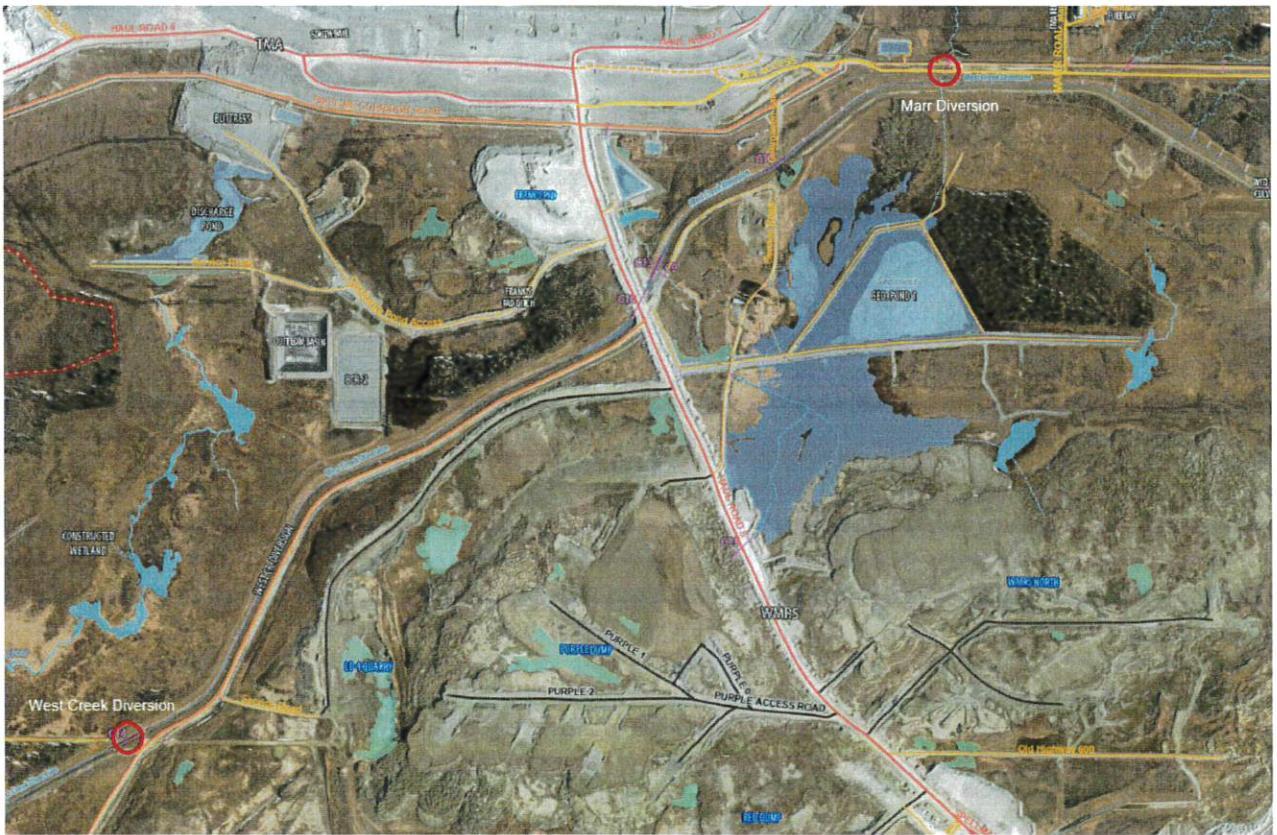
Figure 3. The two different area's where turbidity and total suspended solids samples were collected while the incident was occurring.

Once the emergency pump was activated at the end of Marr Diversion, there was an immediate decrease in turbidity and total suspended solids as shown with the June 9, 2020 sample taken at 09:40.

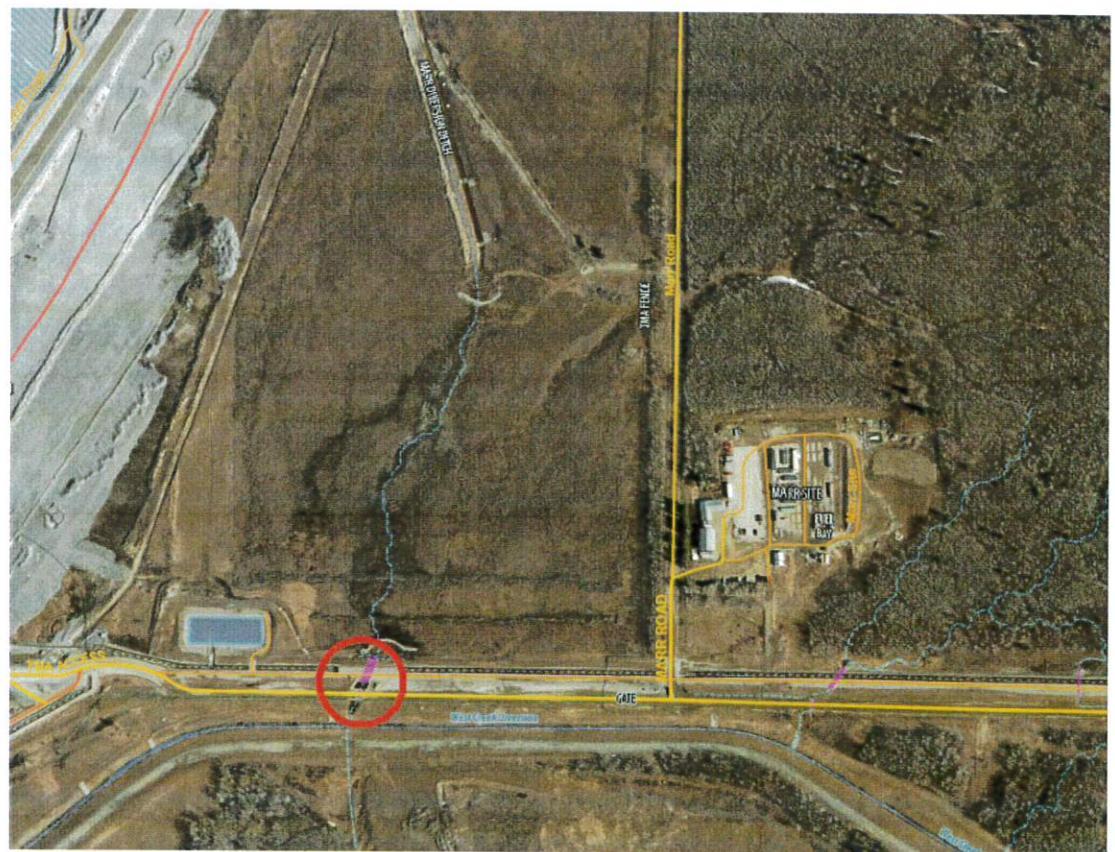
Figure 1. Plan view of Marr Site, Marr Diversion and West Creek Diversion showing location of where the turbid water was spotted flowing under Roen Road.

The water flowing through the culvert appeared to be sediment-laden water originating from Marr Diversion upstream the culvert. Upon discovery of the turbid water, a total suspended solids (TSS) sample was collected, and Site Services was contacted to begin pumping a sump that manages the Marr Diversion water in case of an emergency. Further environmental staff arrived at the incident site at 08:30 and collected a TSS sample and a turbidity sample. The turbidity sample was analyzed with an infield turbidity reader and was 855.1 NTU.

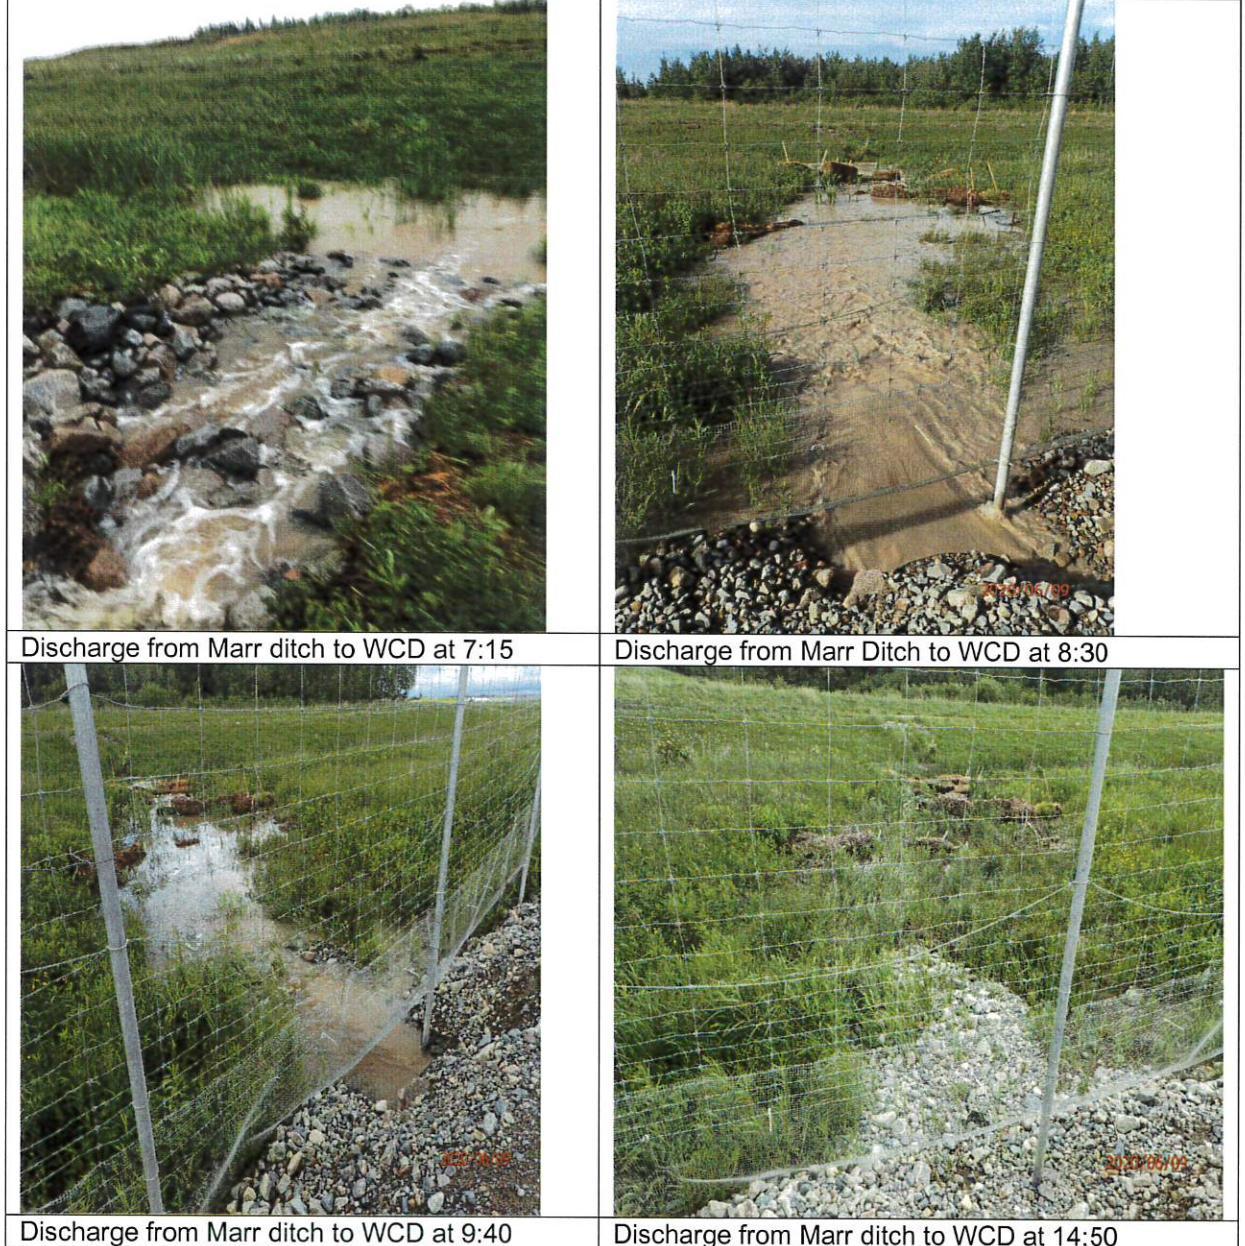
Figure 2 Time progression of the TSS exceedance into from Marr Diversion into West Creek Diversion.

RRM's site services was able to activate the pump within the Marr Diversion sump and started to redirect water to the South Dam seepage collection system at 08:45. This seepage collection system is pumped back into the Tailings Management Area.

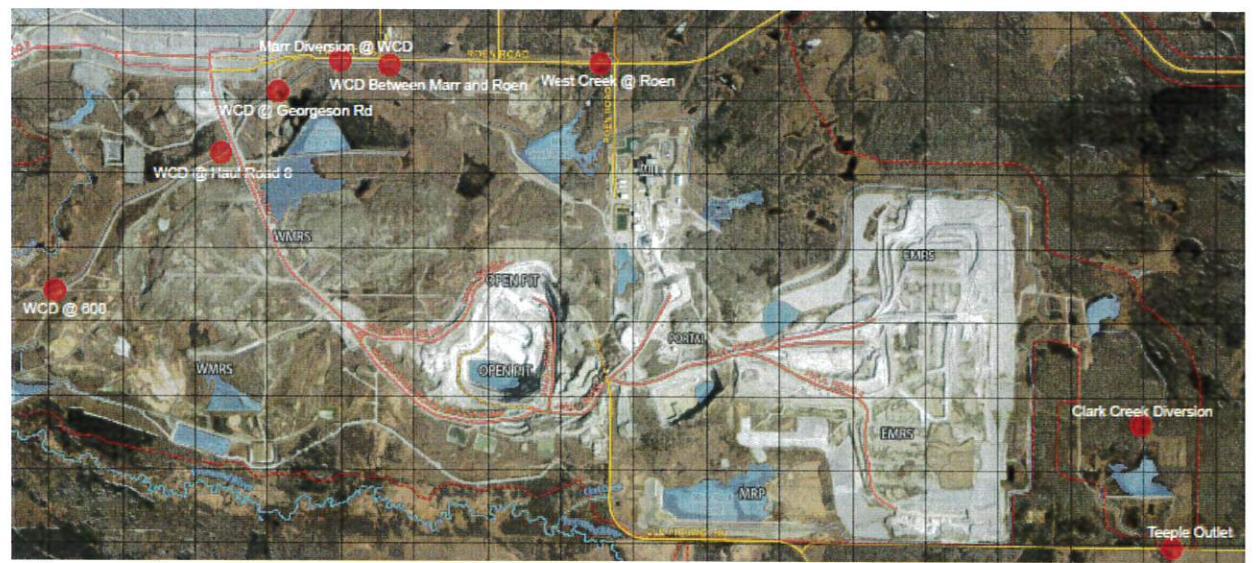
Figure 3. All areas where turbidity and total suspended solids samples were collected while the incident was occurring.

Once the emergency pump was activated at the end of Marr Diversion, there was an immediate decrease in turbidity and total suspended solids as shown with the June 9, 2020 sample taken at 09:40.

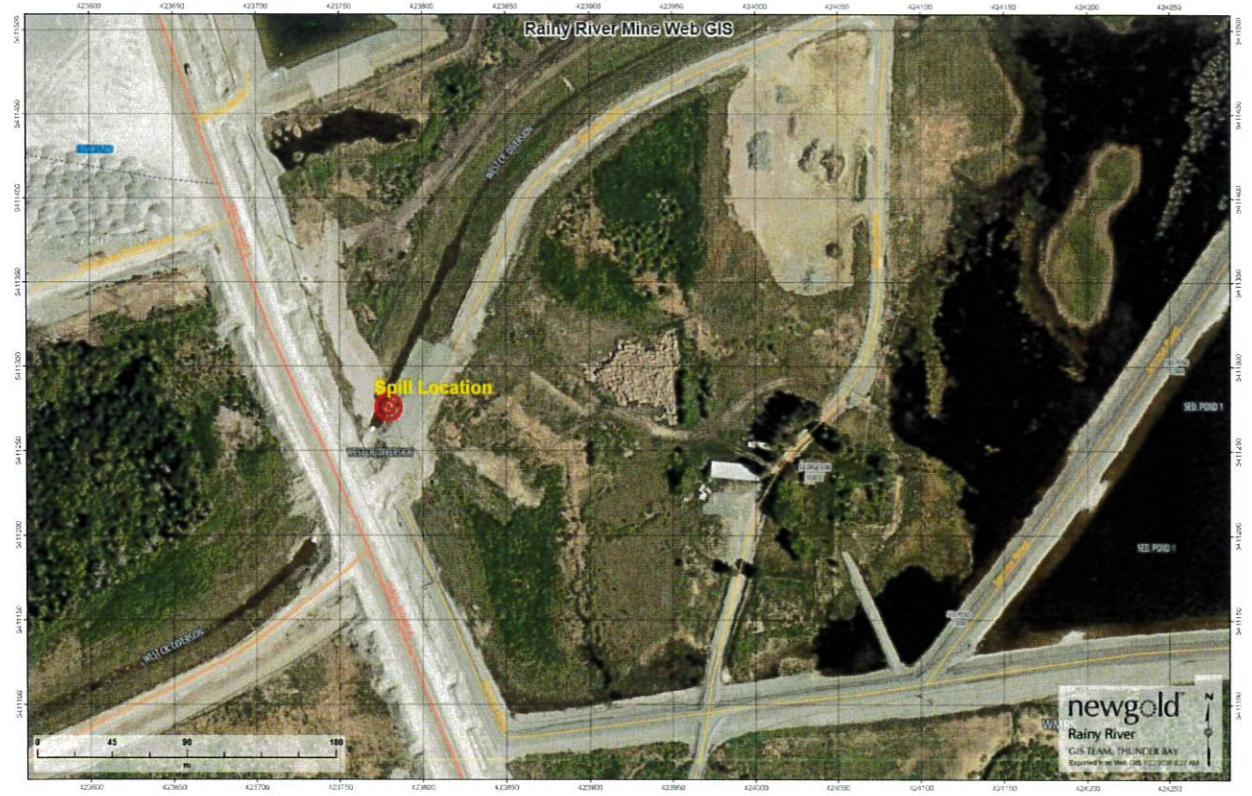
At 1515 on July 16<sup>th</sup>, 2020, the Sediment Pond 1 discharge line was found to be leaking. A call was made to Site Services Department and the leaking valve was removed and replaced with a hardline connection. A sample was collected that included all discharge parameters including acute toxicity. At the time of sampling, fish were observed in the West Creek Diversion and showed no signs of stress.

Photo 1: Map depicting spill location (red dot).

The wye valve was removed and replaced with a solid line by 2100 hours the same day. This type of wye valve will no longer be used on site and a different style of wye will be reinstalled should there be a need to discharge Sediment Pond 1 in the future.

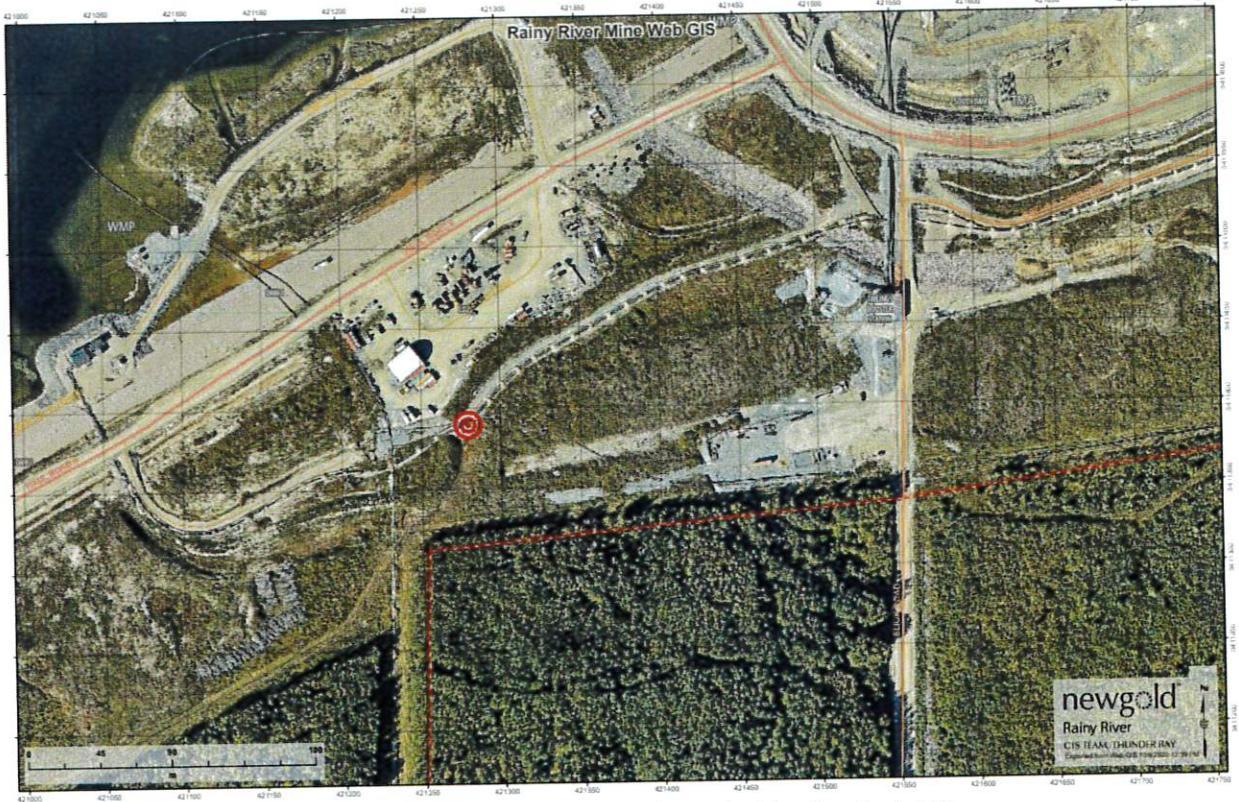
Photo 1: Map depicting failed valve gasket location (red dot).

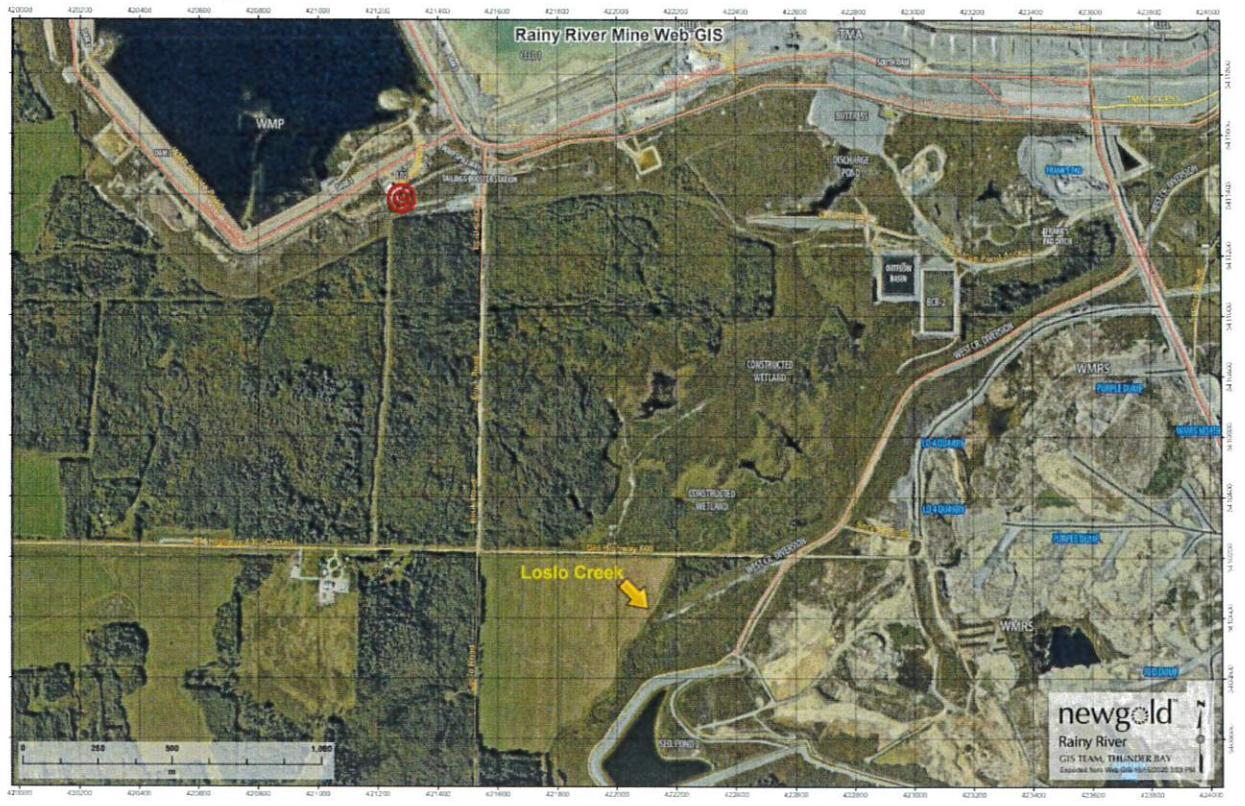
Photo 3 Spill location in relation to fish habitat (Loslo Creek)

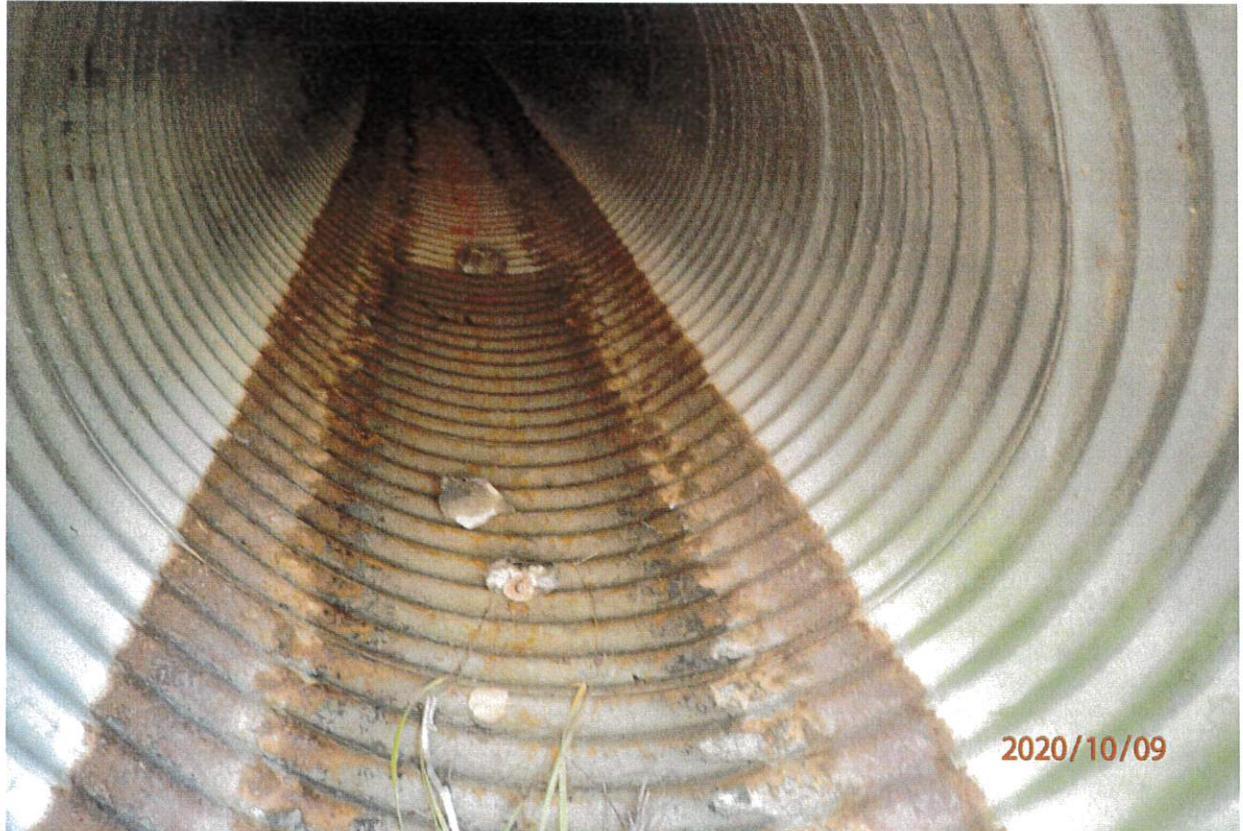
Photo 4: Culvert Under Old Highway 600.

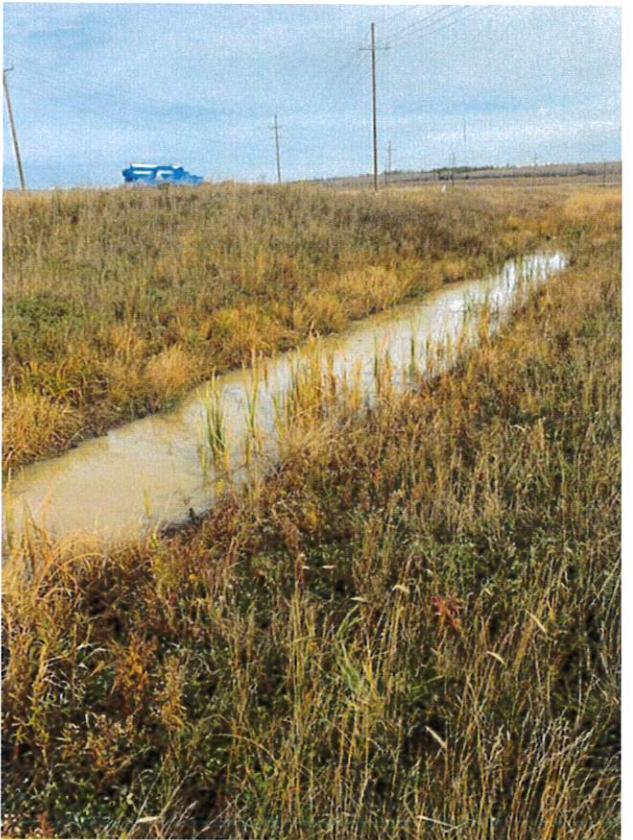
After a large rain event on the morning of October 12<sup>th</sup>, turbidity readings were completed along the West Creek Diversion (WCD). At 10:55 October 12<sup>th</sup>, the NTU reading at our SW25 Station was 283 NTU (Figure 1).

Fig. 1: SW25 sampling station at 10:55am

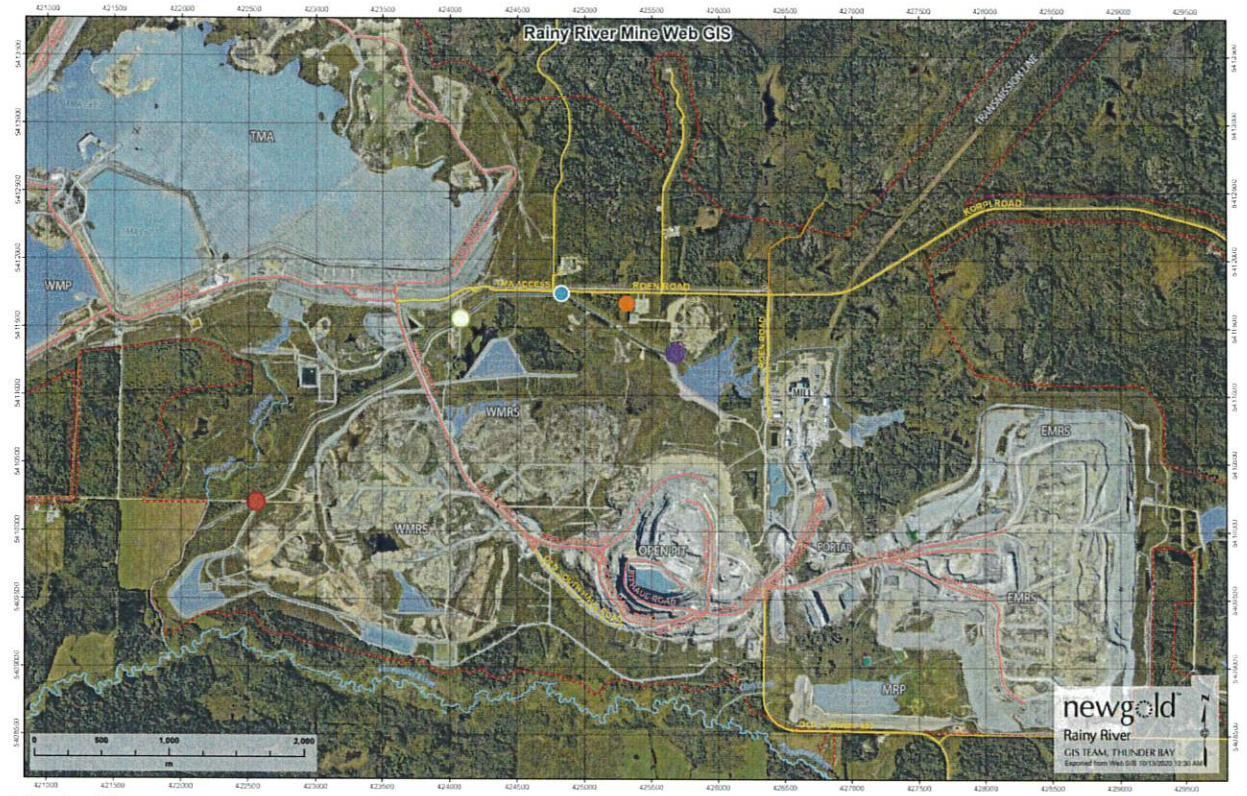
Further investigation was completed to find the source of the plume. Around 14:00 the sediment release was identified at the concrete plant laydown south of Roen Rd seen in Fig. 2 below. This laydown is currently being reclaimed which involves excavating the soil, and has been identified as the source of the sediment release. Figure 3 shows a black pipe being used as a

Fig 2: The sediment release was observed from the orange circle, the four samples taken are show by the red, green, blue and purple circles which are SW26, SW25, Upstream of Marr Diversion, and West Creek Diversion Inlet, respectively.

At 14:30 New Gold personnel were notified, and on site to remediate. At 16:30, silt fence, erosion blanket and a coir log were installed as seen in Figure 4. The concrete laydown is planned to be reclaimed within the next two weeks. At roughly 15:00 the TSS exceedance was reported to SAC, and an update was given at 17:40 to notify them that mitigation measures had been installed.

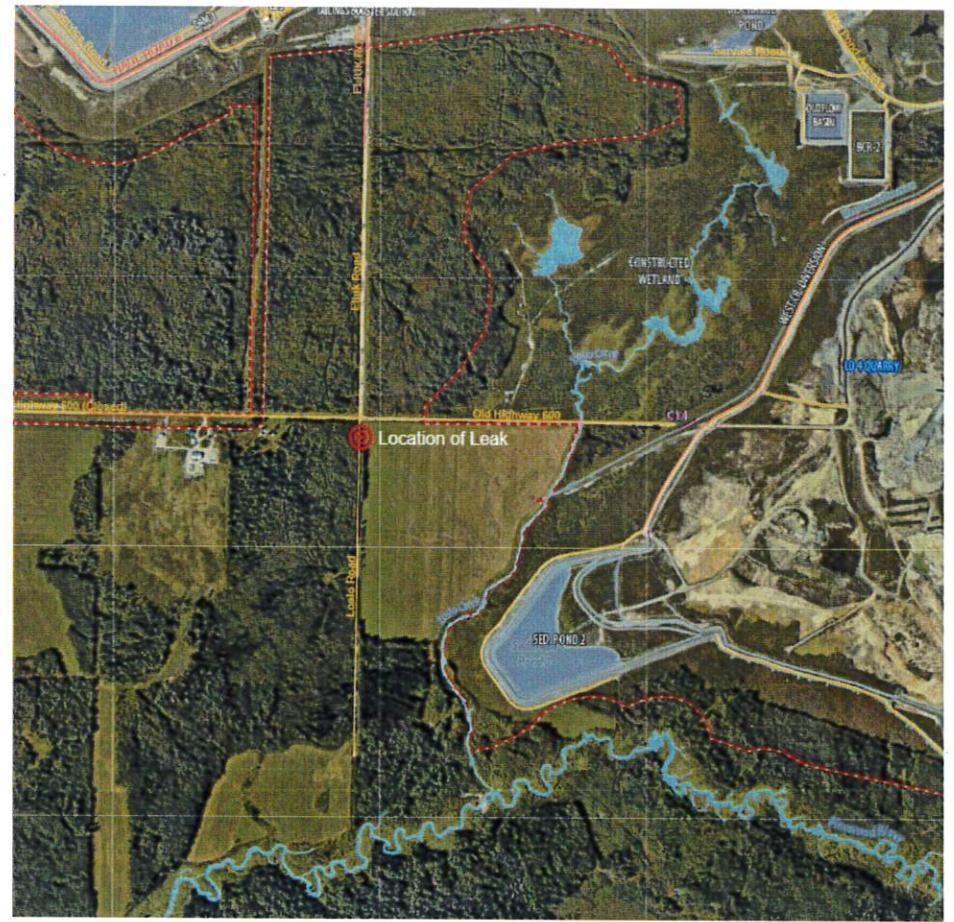
Photo 1: Map depicting pipe leak location (red dot).

Upon investigation into this event some deficiencies were noted. There was not an Inspection and Test Plan (ITP) included in the construction package for this pipeline. This has been corrected so that all pipeline contracts include an ITP before commissioning.

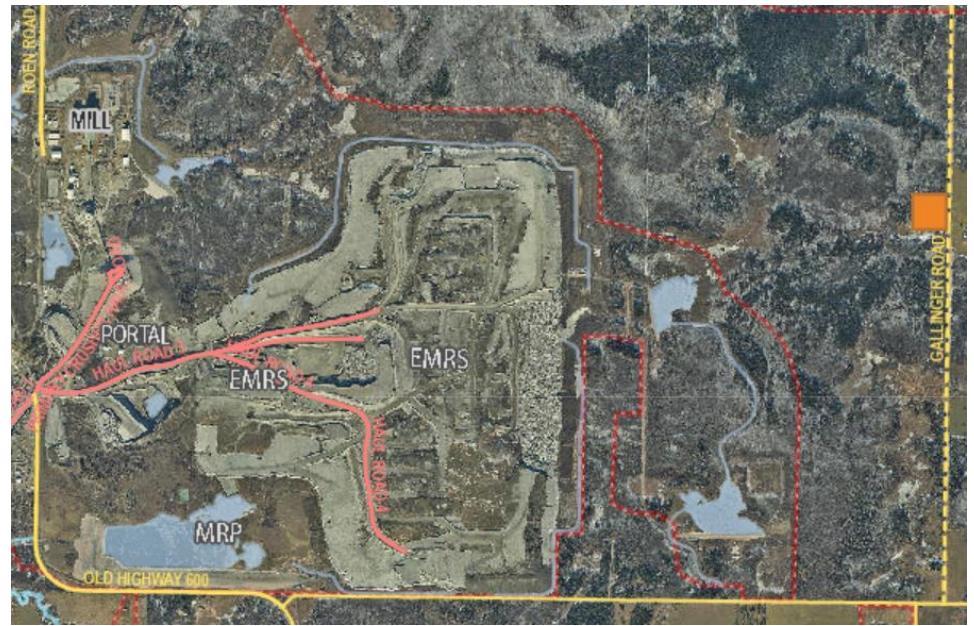
During the review of November air quality lab results, it was noted that on November 11<sup>th</sup>, 2020, the total suspended particulates (TSP) concentration at Gallinger Ambient Air Quality Monitoring Station had exceeded Ministry approved limits of 120 ug/m<sup>3</sup>. On November 11, 2020, the TSP concentration at Gallinger Ambient Air Quality Monitoring Station was 158.3 ug/m<sup>3</sup>.

Figure 1: Map of EMRS, the Gallinger Station is marked with an orange square.

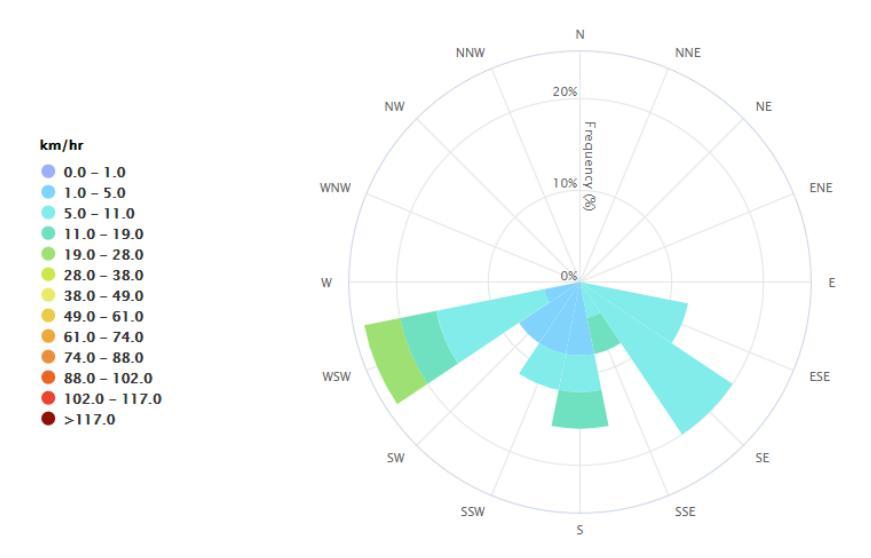
TSP samples were collected during a 24-hr period on November 11, 2020 as per Rainy River Project Ambient Air Quality Monitoring Plan, accepted by MECP on November 9th, 2016. During this 24-hour period, predominant wind direction was from the west southwest and some wind from the southeast. (see Figure 2) With these wind directions, it is likely that the source of the dust would be from the East Mine Rock Stockpile, which is situated to the southwest of the air monitoring station and suggests that the source was related to the haul road dust.

Figure 2: Windrose for November 11, 2020 at Barron Weather Station

New Gold will continue to maintain the haul roads, applying water or calcium chloride under non-freezing conditions. New Gold is exploring other potential mitigation measure to reduce the dust on the haul roads.

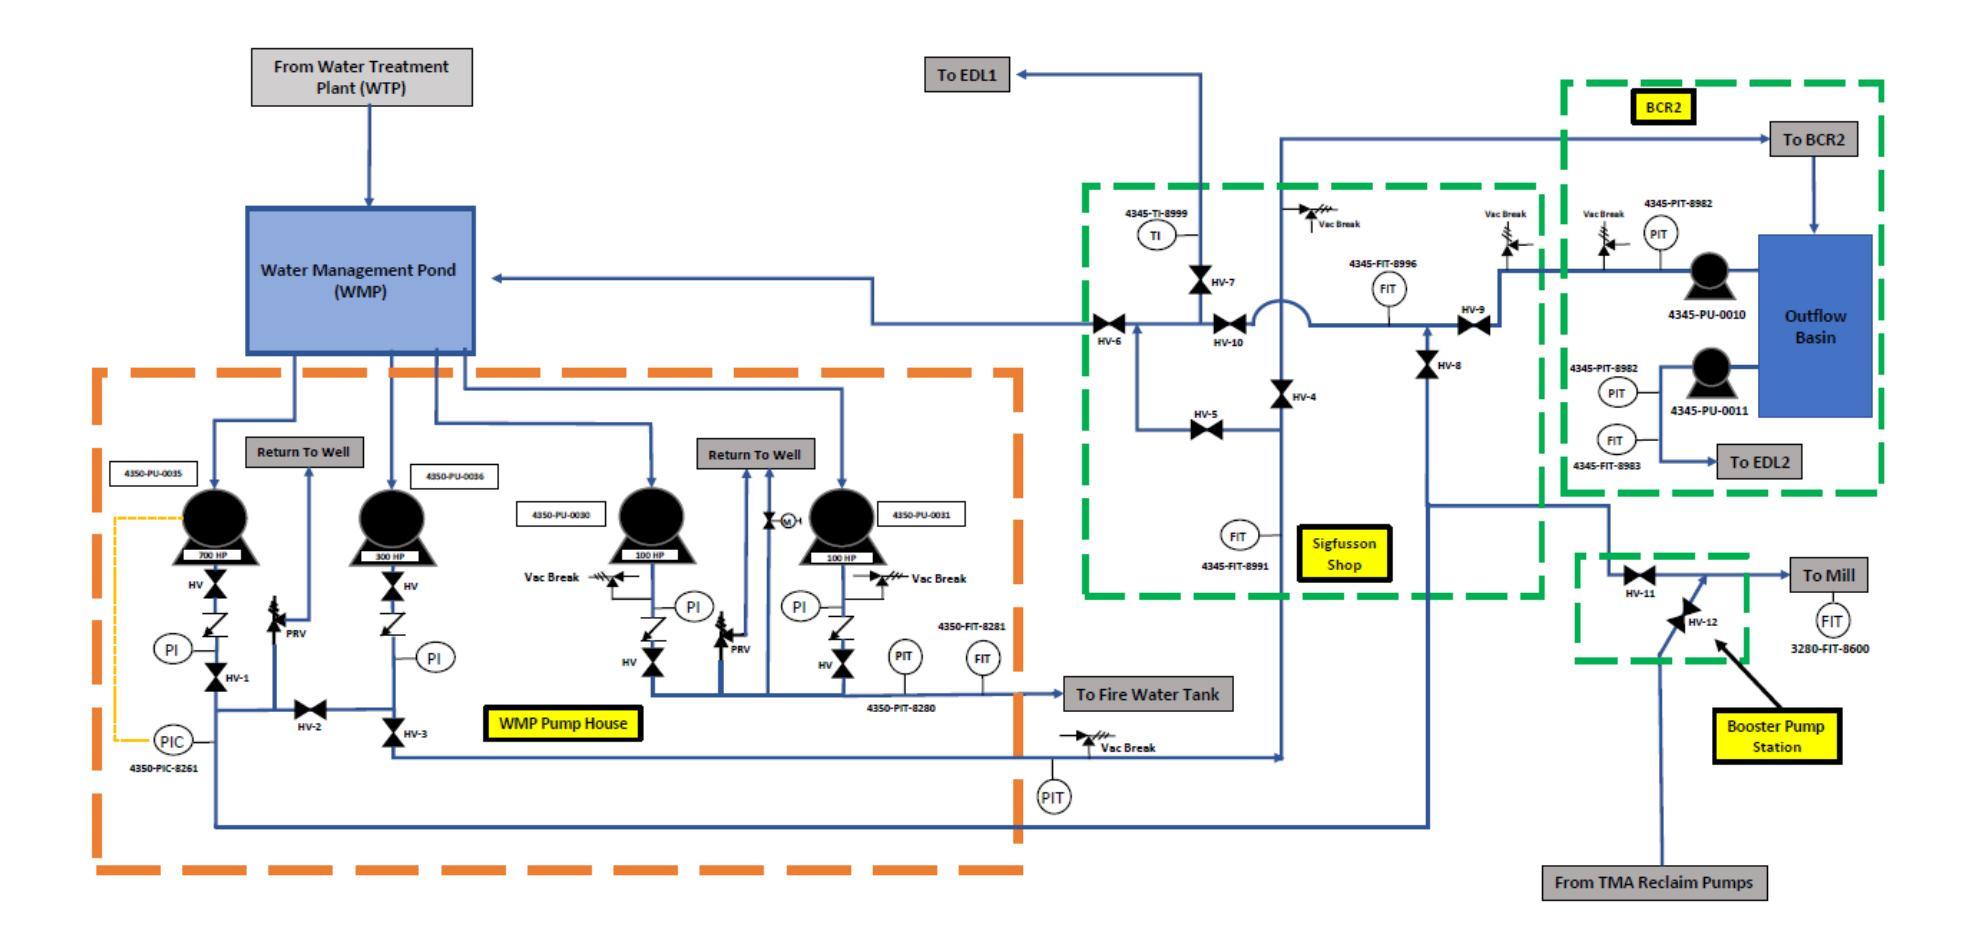
Figure 1: Rainy River Mine EDL1 and EDL2 Discharge Configuration and Water Distribution Schematic

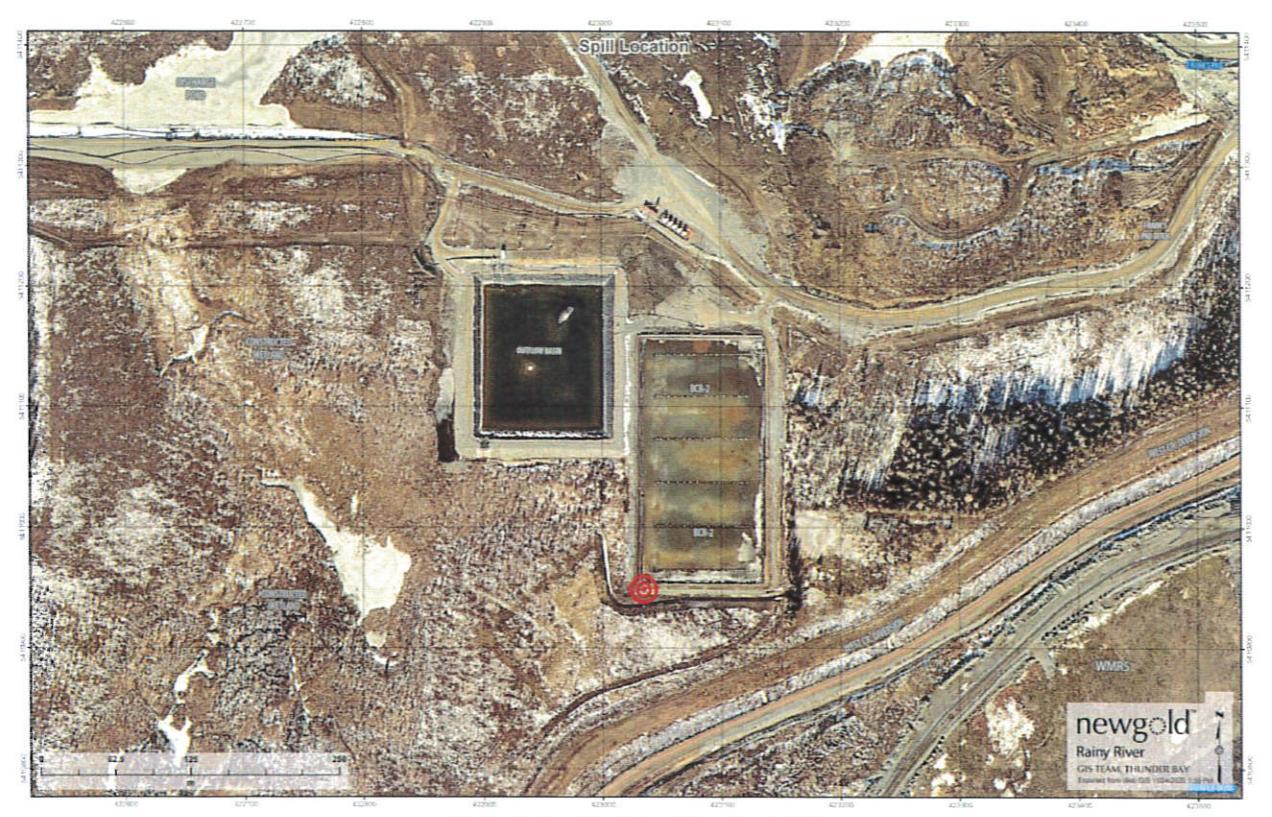
At 1600 on November 20th, 2020, it was noticed that BCR2 was overtopping as the transfer pump to the Outflow Basin had stopped even if it was shown as active on the Mill digital control system. It was found that the pump communication box had lost power. Power was restored, the transfer pump was restarted and the water level in BCR2 was shortly returned to the normal operating level. Due to a procedural error, New Gold Environment was unaware of this incident until 0718 on November 23<sup>rd</sup>, 2020, at which time an investigation was initiated.

Photo 1: Incident location (red dot).
