**NEW GOLD RAINY RIVER MINE
APPENDIX K
EXCEEDANCE LETTERS
SUBMITTED TO MECP**

SUBJECT: NORTHWEST STATION AMBIENT AIR QUALITY EXCEEDANCE OF 24-HOUR TOTAL SUSPENDED PARTICULATE MONITORING LIMITS

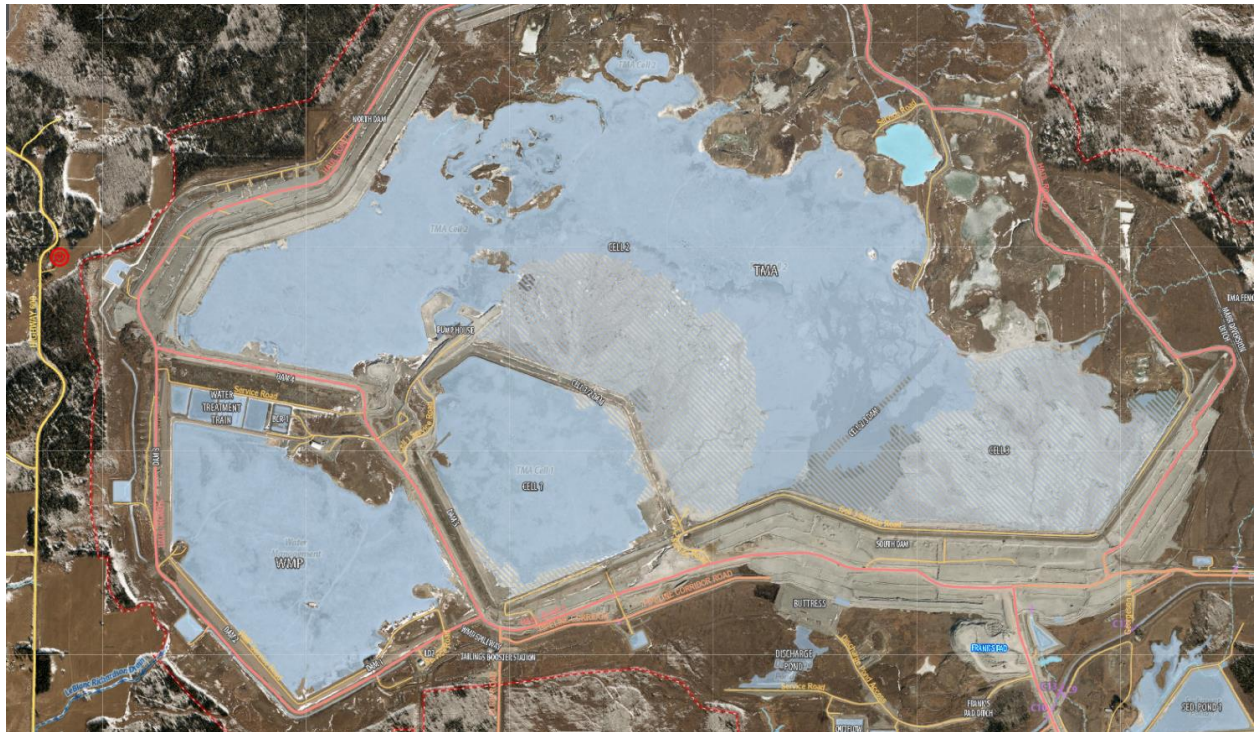
The Northwest Ambient Air Quality Monitoring Station is located approximately 400 m due west of the Tailings Management Area (TMA) on the Rainy River Mine Site (Figure 1). Highway 600 itself passes by the Ambient Air Quality Monitoring Station in a north-south direction at approximately 70 meters to the west.

Figure 1: Map of TMA, the Northwest Station is marked with a red target.

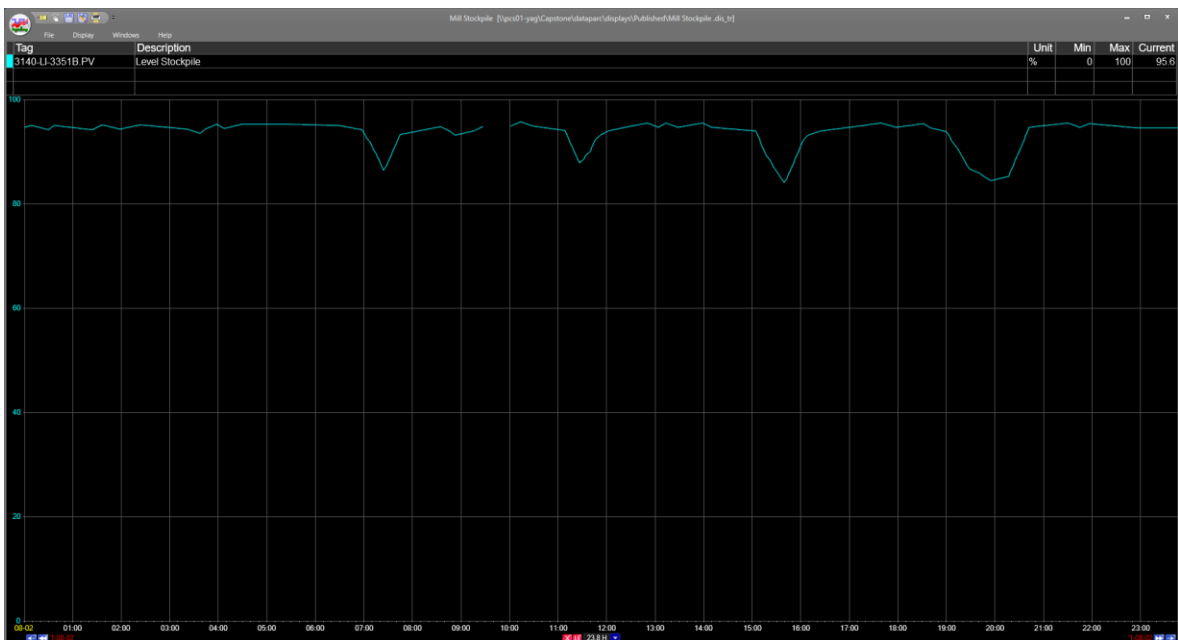
Figure 3 Coarse Ore Stockpile height from August 2, 2021 ($\mu\text{g}/\text{m}^3$)

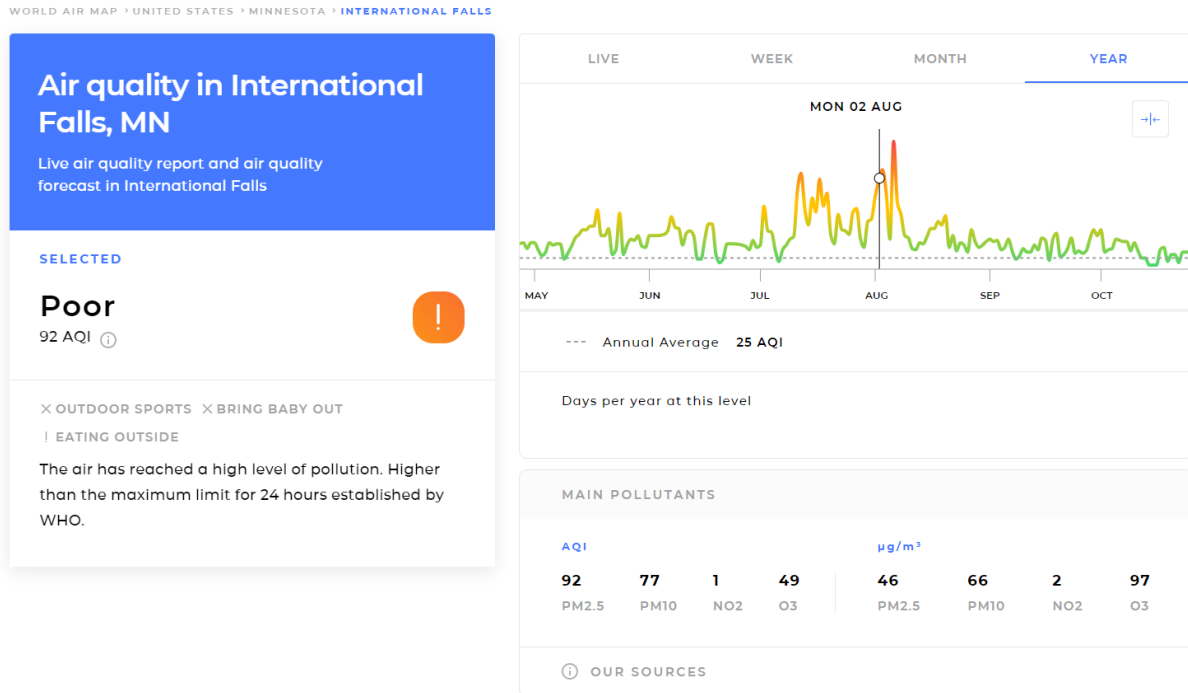
The cause of the exceedance is due to the increased smoke in the area from local wildfires. The third air quality station, Tait Road Monitoring Station, also reported a high sample reading of 53.38 $\mu\text{g}/\text{m}^3$ but was deemed to be an invalid sample due to exceeding the total volume limit. Below I have also attached the E-Sampler readings for the day which show consistently elevated total suspended particulate readings over the 24 hours as well as an Air Quality Advisory for International Falls for August 2, 2021. I have also included the Coarse Ore Stockpile height during those 24 hours.

Figure 4 Air Quality advisory for International Falls, MN for August 2, 2021.
