**NEW GOLD RAINY RIVER MINE
APPENDIX K
EXCEEDANCE LETTERS
SUBMITTED TO MECP**

RE: Overpressure Exceedance

APRIL 11, 2022 TOTAL SUSPENDED SOLIDS EXCEEDANCE AT WEST CREEK AND MARR DIVERSION CONFLUENCE

**Re: Emergency Dump Pond #3 and North Dam Seepage Collection Pond #3
Unplanned Effluent Release – SAC Reference #1 - 1RWVOG**

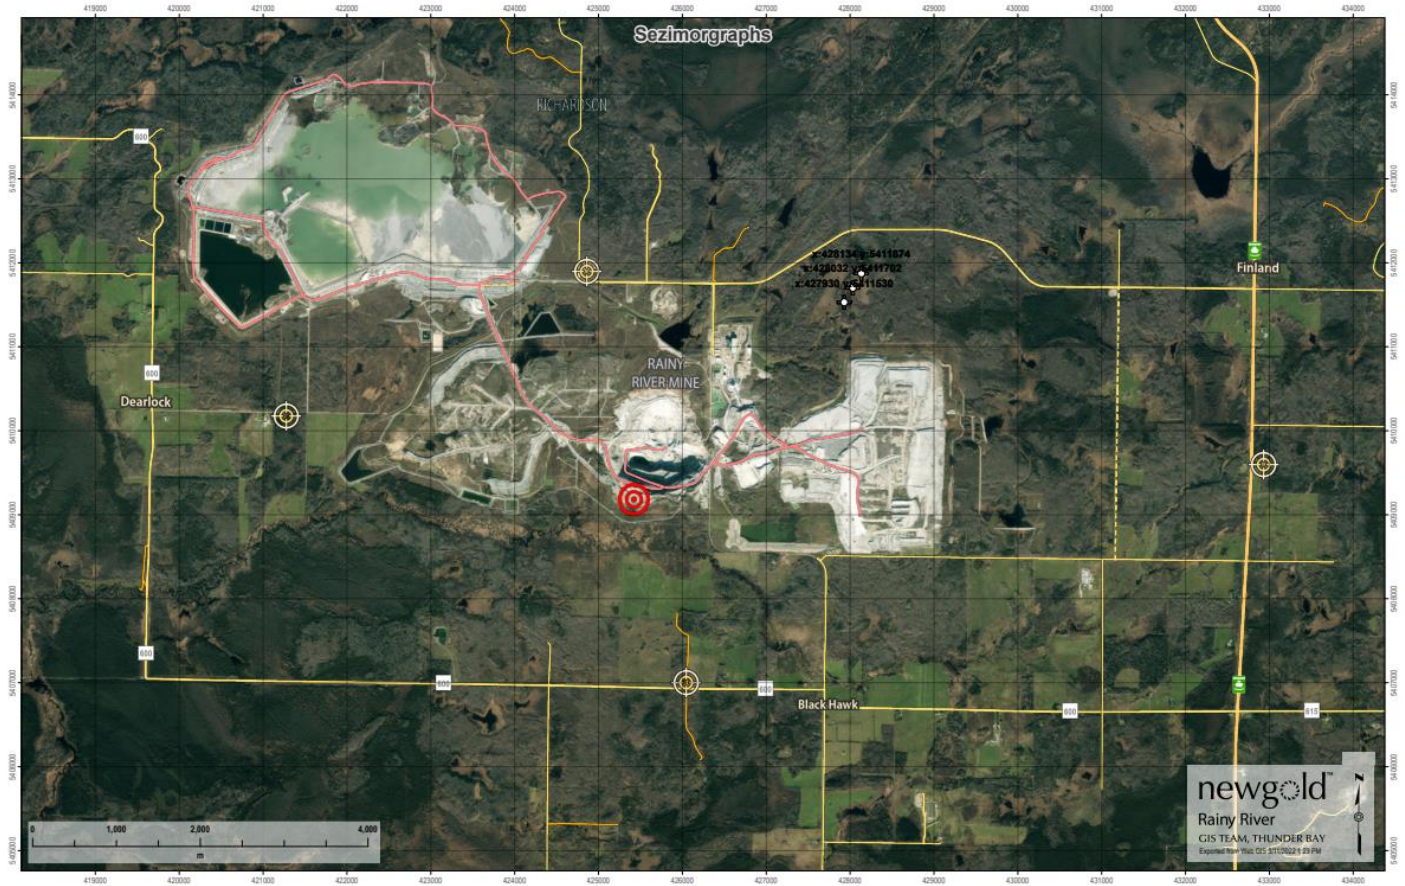
- 1- The blast was known as a frost shot, this term is used when frost has been driven into previously blasted material to the point that it cannot be handled and loaded. The holes for a frost shot are much shallower than a typical production shot.
- 2- The blast was at a higher elevation than any blast prior, except for the original ramp that dropped into the pit below the original Laydown 7 lookout.
- 3- The sky was overcast on Saturday March 5th, which amplified the effect of the sound of the blast.
- 4- The timing in a frost shot needs to be quite a bit faster than a production shot which also increase the vibration/sound of a blast.
- 5- There was a northerly wind the day of the blast which explains why the southern most instrument detected higher levels whereas the other 3 instruments did not read levels over the peak limit of 128.0 dB(L).

Figure 1. Plan view of RRM showing the location of Explotech sensors and blast location

Frost shots at this elevation are a very rare occurrence and are not likely to occur again in the near future. Should the need arise to do another frost shot, a smaller blast with a longer delay will be planned and communities will be notified. If possible, the blast will be delayed if there are overcast conditions at the time of the blast as well. No blasts since 2022-03-05 have triggered an exceedance.

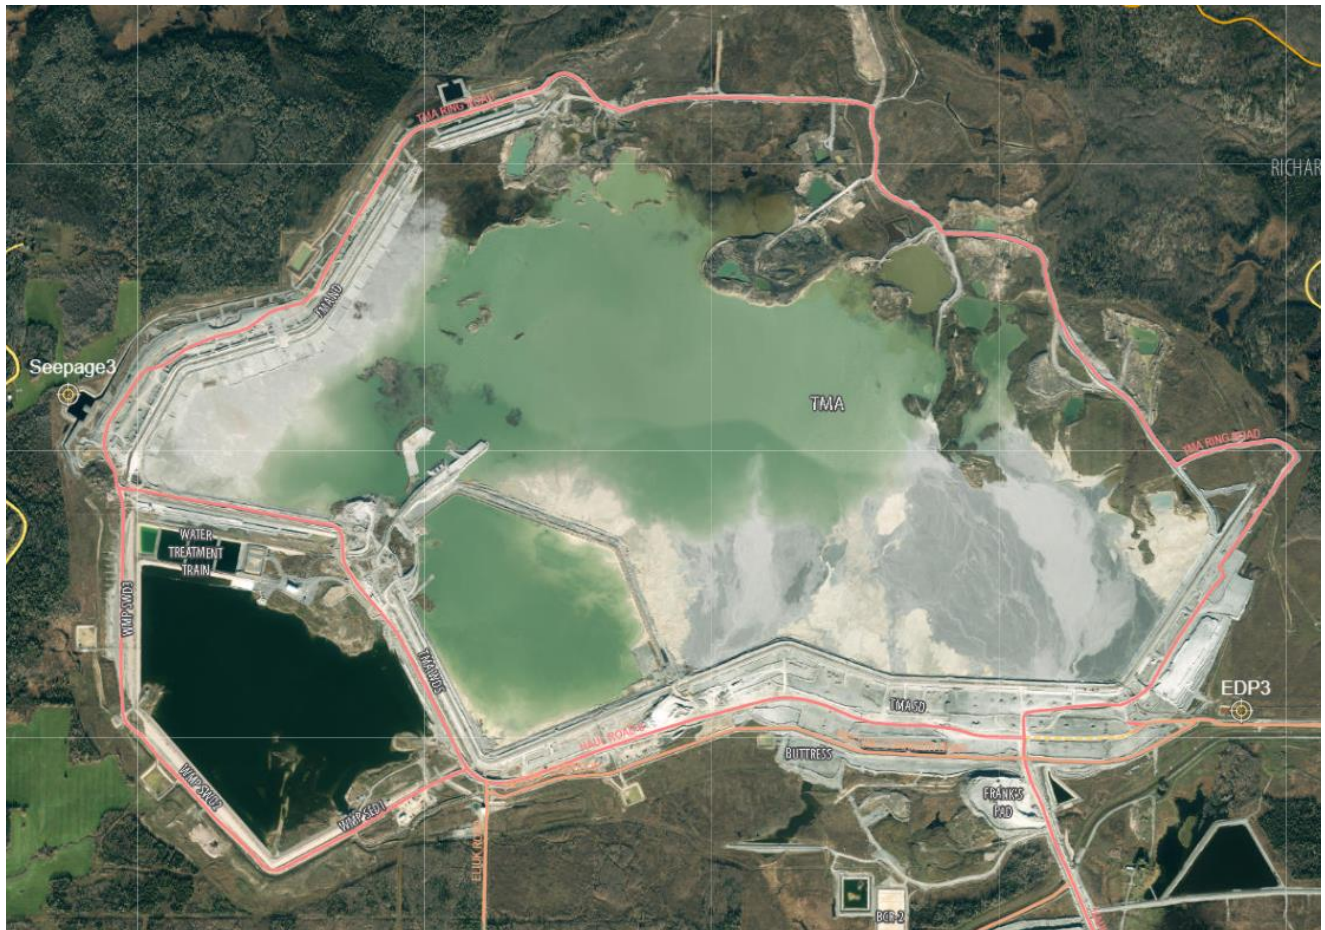
The quantities of the MDMER Section 3 prescribed deleterious substances, as calculated mass loadings utilizing the mass loading formula in MDMER Section 20(1), are provided in Table 2. The location of the deposit at EDP3 at zone 15U E424399.06, N5411825.73 and at Seepage3 at zone 15U E419979.45, N5412951.80.

Figure 2 Seepage3 and EDP3 locations around Tailings Management Area.

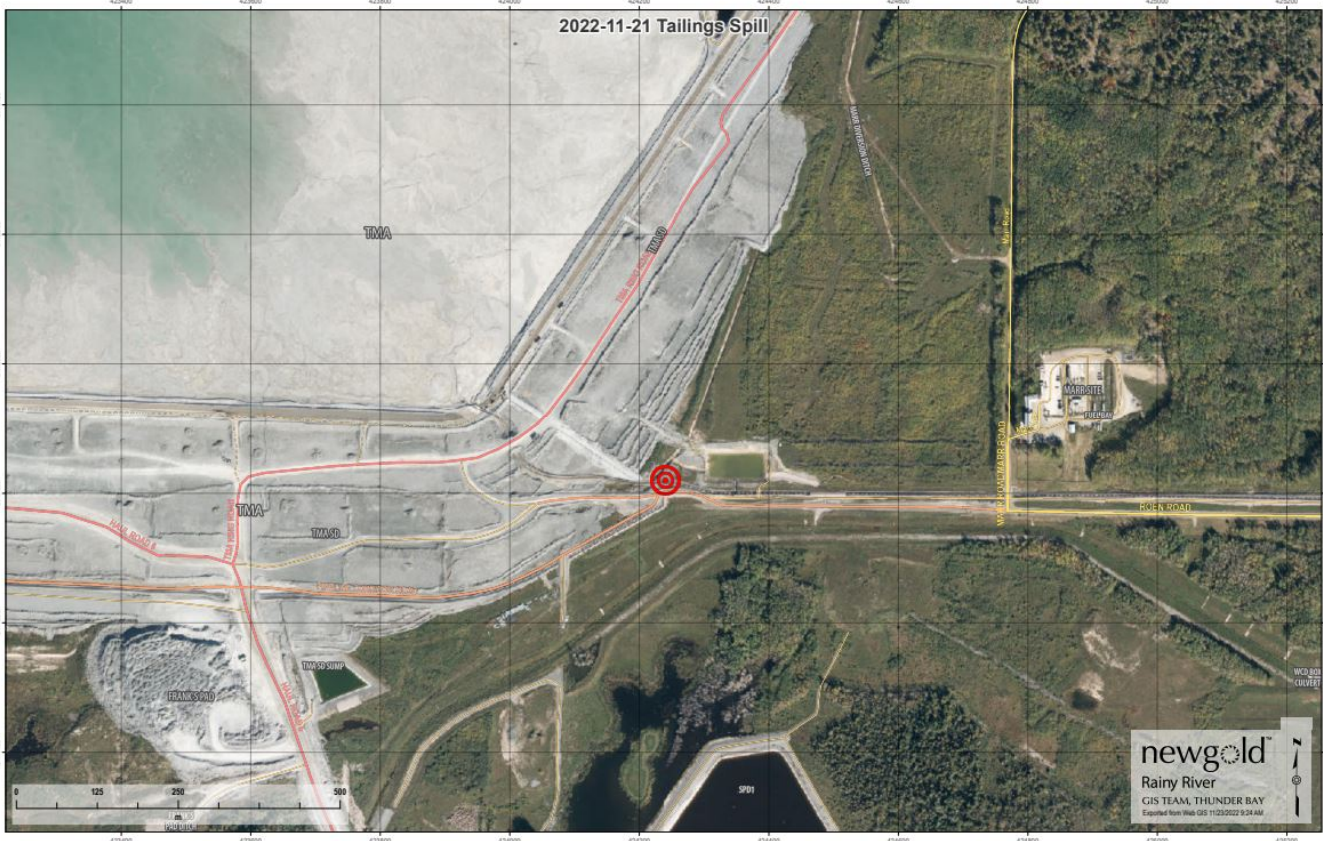
Figure 1: Location of Spill

No sampling was completed due to the consistency of the tailings outside of containment. All tailings that did not report to containment were collected with a HydroVac truck..

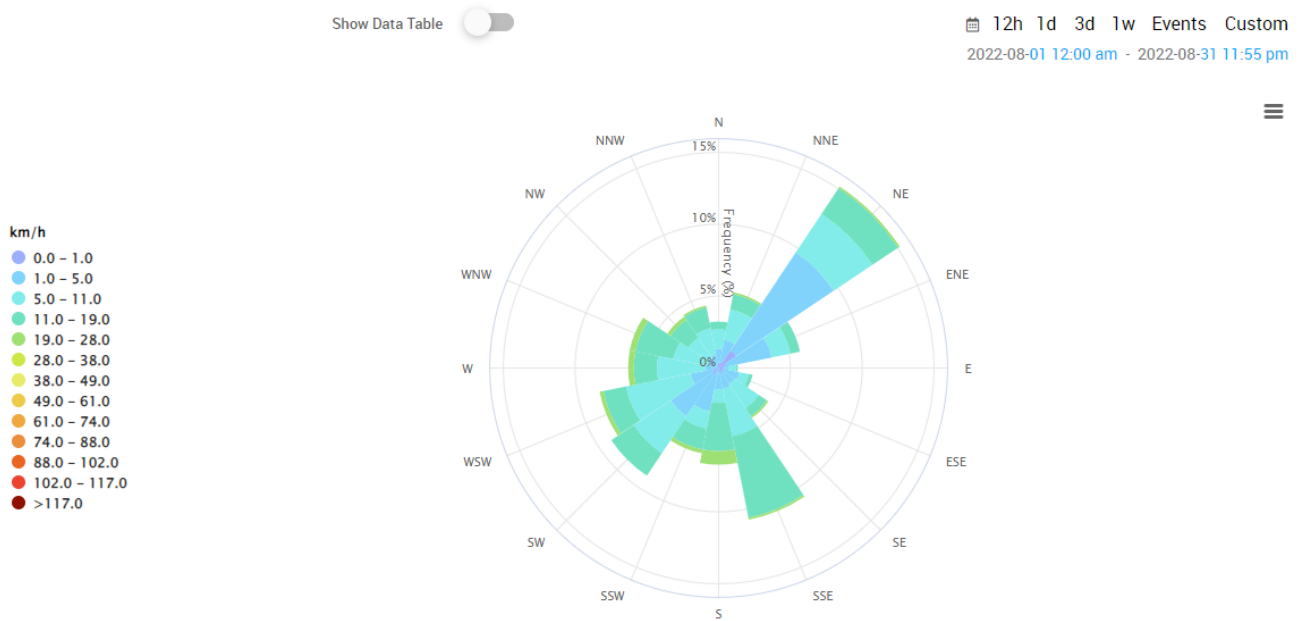
The sources of the August 2022 dustfall exceedance at South station are difficult to determine due to the mixed wind direction and velocity. Dust from the primary crusher to the North of the station could have been a factor, as well as dust created by the road material crusher or EMRS dumping to the Northeast. Public traffic also likely contributed. Dust suppression water trucks were available and in use on site during that time.

Figure 2: Barron Site weather station wind velocity and percentage for the month of August 2022.

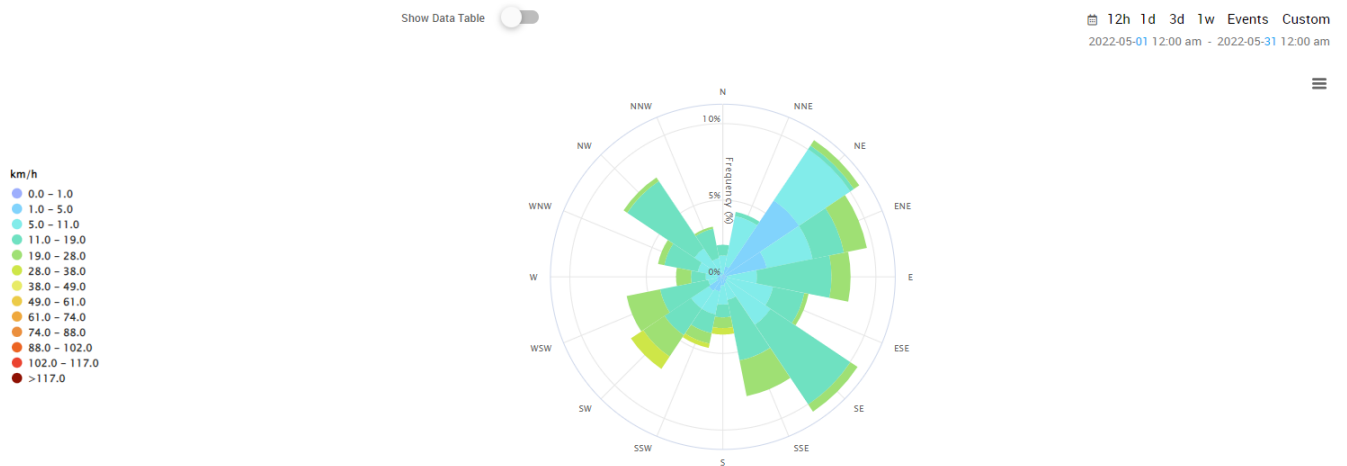
The sources of the May 2022 dustfall exceedance at Northwest station is difficult to determine due to the mixed wind speed velocity. The sources could be partially mine site related as well as public traffic related depending on size of plume and wind velocity. The elevated dust related activity happening with in the Tailings Management Area at Rainy River Mine during that time was contractor mobilization and commencement of the Stage 4 TMA Dam Raise. Dust suppression water trucks were available and in use onsite during that time period.

Figure 2 shows Barron Site weather station wind velocity and percentage for the month of May 2022.
