**NEW GOLD RAINY RIVER MINE
APPENDIX H
EXCEEDANCE LETTERS
SUBMITTED TO MECP**

RE: EDL1 Daily and Monthly Average Copper Limit and Daily Free Cyanide Limit Exceedances

RE: Southern Pit Ring Road Ditch Failure SAC Reference #1-7ON9RQ

RE: Unauthorized Deposit of Treated Mine Effluent SAC Reference #1-EYQHAV

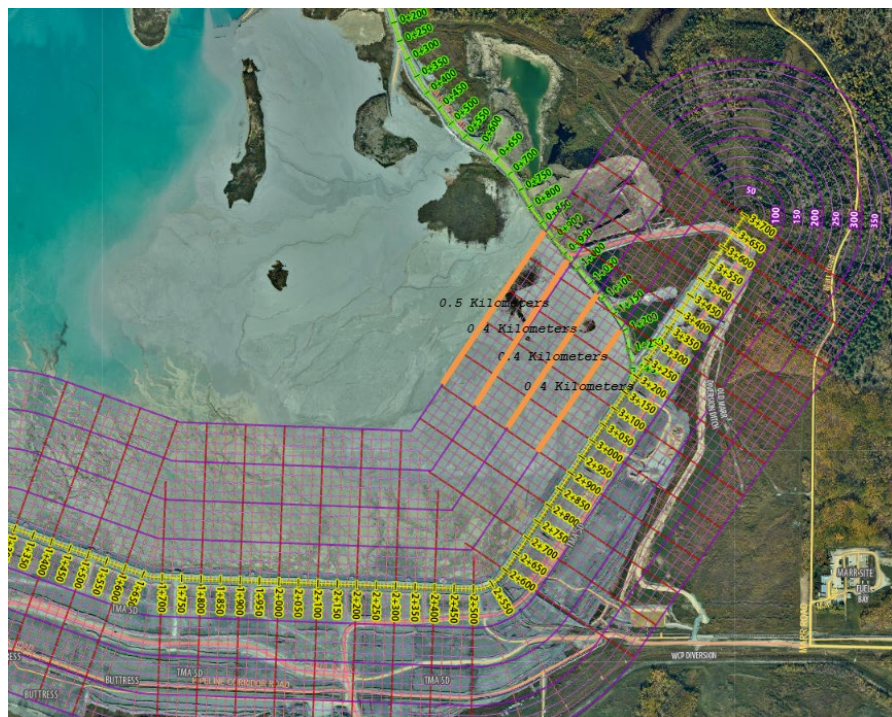
Figure 3: Snow fence trial location late 2024.

1. TMA Chemical Suppressant:
 - a. Two suppressants selected and under review by Metallurgy to ensure no impact to the extraction process in the Mill.
 - b. Once review is completed, successful suppressant(s) will be trialed (10 ha) on TMA Cell 1 by using the Fat Truck equipped with a spray bar.
 - i. It is estimated application will take approximately 2 weeks.
2. Snow fencing:
 - a. Opportunity to use snow fencing for dust prevention and snow entrapment.
 - b. Trial planned later this year in the Northeast corner of the TMA. Trial area yet to be determined.

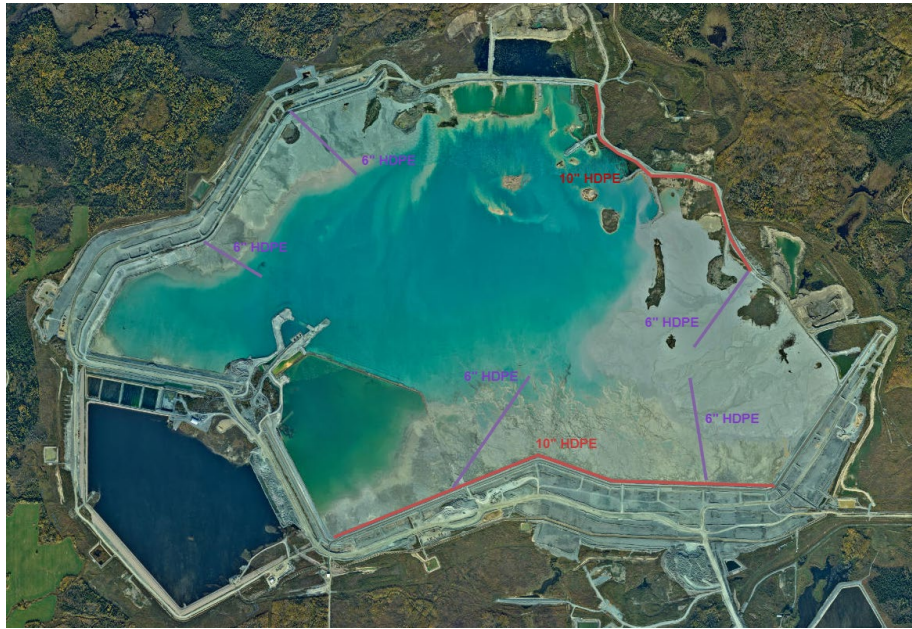
Figure 4: Theoretical layout of TMA perforated piping network planned to be operating by October 2024.

- a. Network build around the TMA for constant re-wetting of the tailings year-round with perforated pipe.
- b. Water provided by the TMA Reclaim Pumphouse pumps.
- c. All piping has arrived at site. 50% of it has been fused.
- d. Perforated lines will be pulled out into the TMA using the Fat Truck
- e. Planned to be in operation by October 2024.

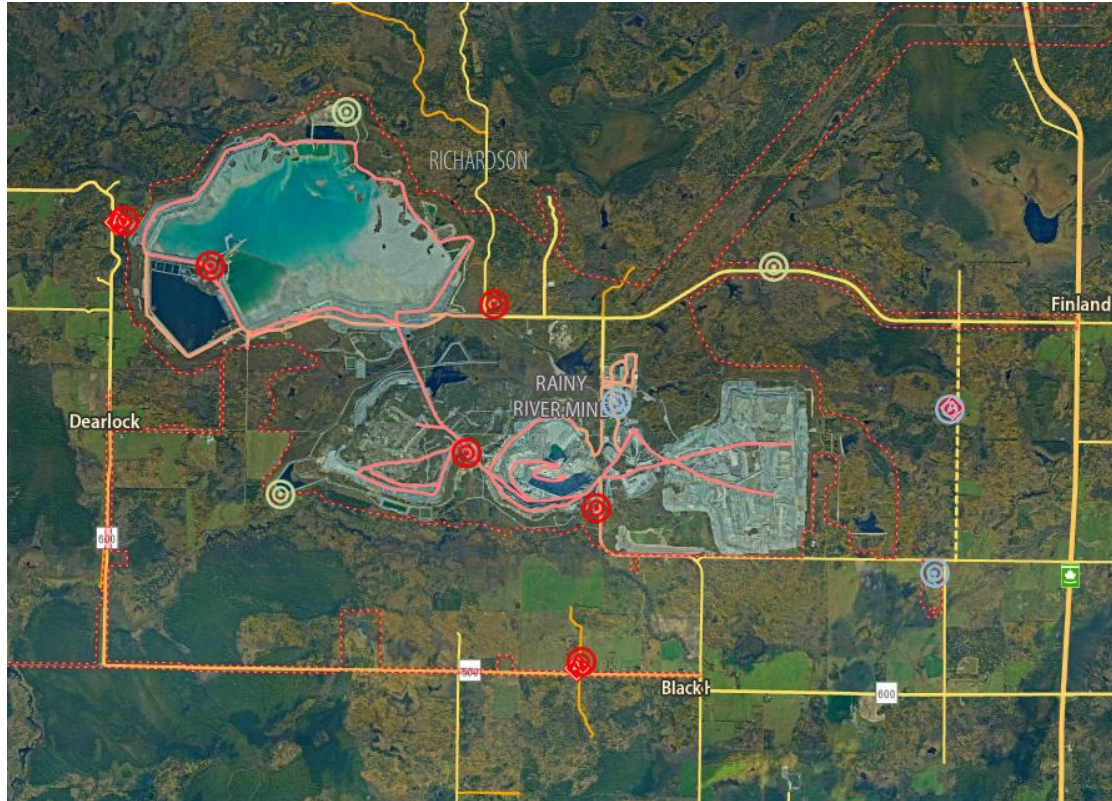
Figure 5: Proposed real-time dust monitoring locations. Blue targets: current existing units. Red targets: proposed locations for new units. Yellow targets: additional unit locations if required.

Rainy River will also be setting up a real-time dust monitoring network and dashboard to monitor fugitive dust on the project boundary throughout the site. This will allow notification if fugitive dust is being generated and precautions are required to be implemented to protect site workers or surrounding environment and neighbours.

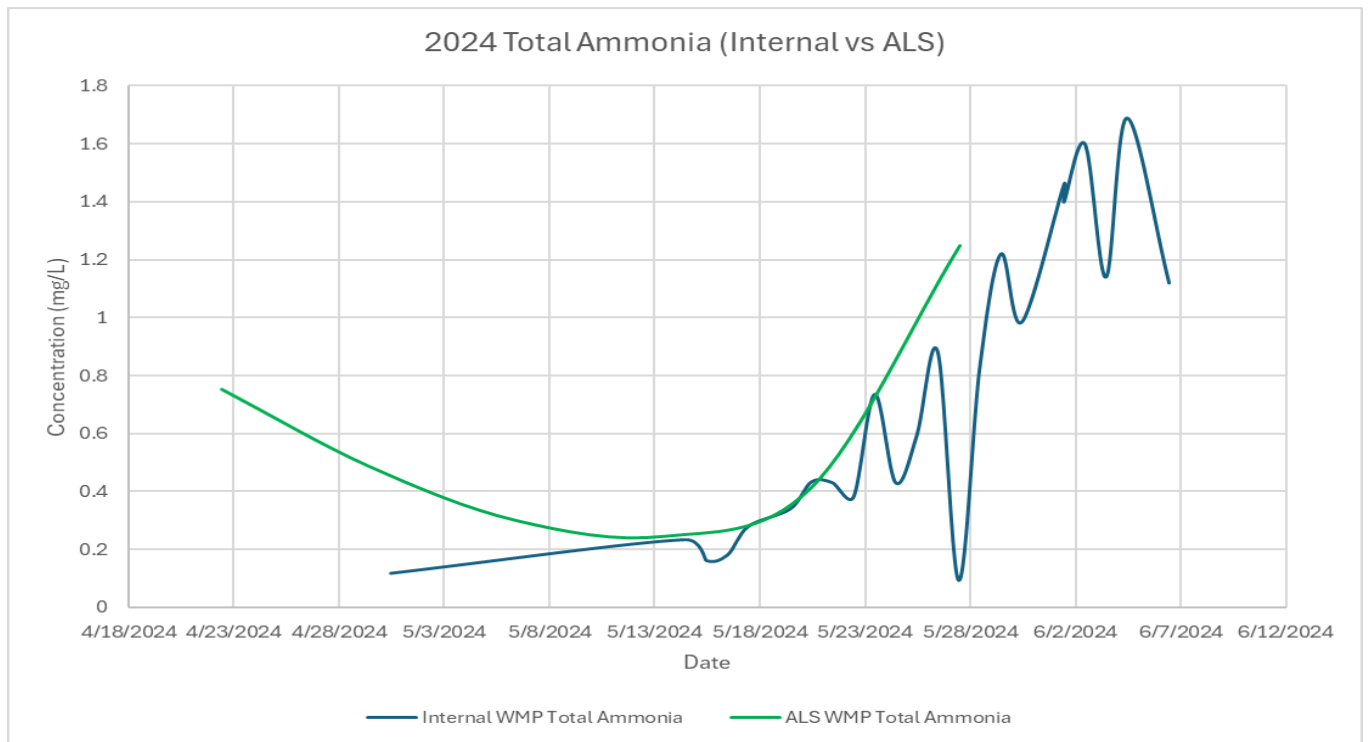
Figure 1

During the early afternoon of June 7th questions about WTP operations prompted a review of internal data and total ammonia was found to have increase roughly 4x in the span of a week. Internal samples were rechecked by both WTP operators and NG Environment. Unionized ammonia was calculated to be as high as 0.133mg/L. Discharge was shut down by 15:50 that day and remains shut down. On June 7th ALS Solutions was reviewed to confirm this increase and on 2024-05-27 unionized ammonia levels had risen to 0.0567mg/L, again roughly a 4x increase in a weeks' time.

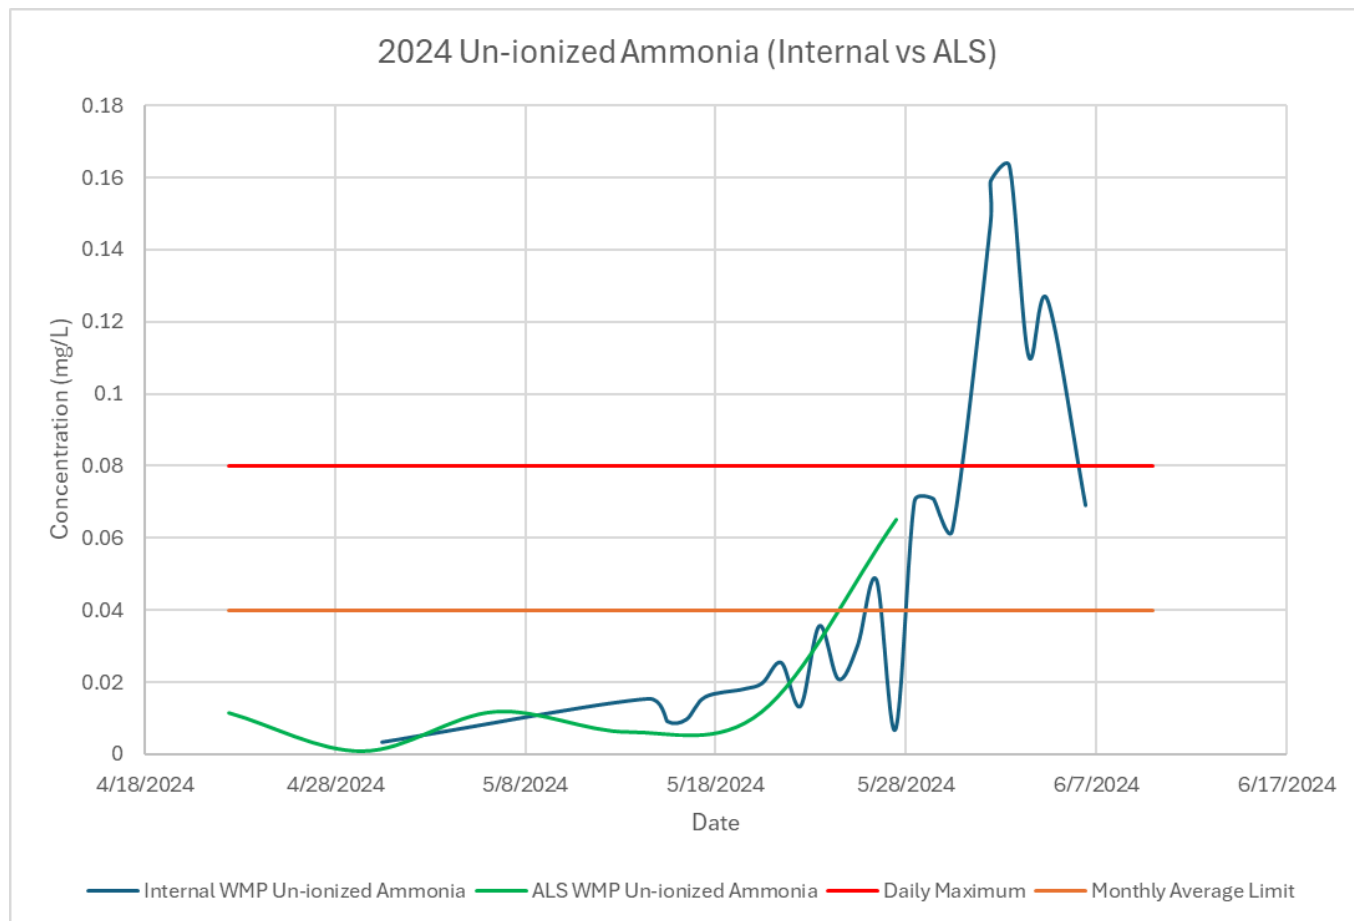
Figure 2

BCR2 and Water Treatment Plant were the only two inputs active on 2024-05-25 to the WMP (which only contained 1.7 Mm3 at the time).

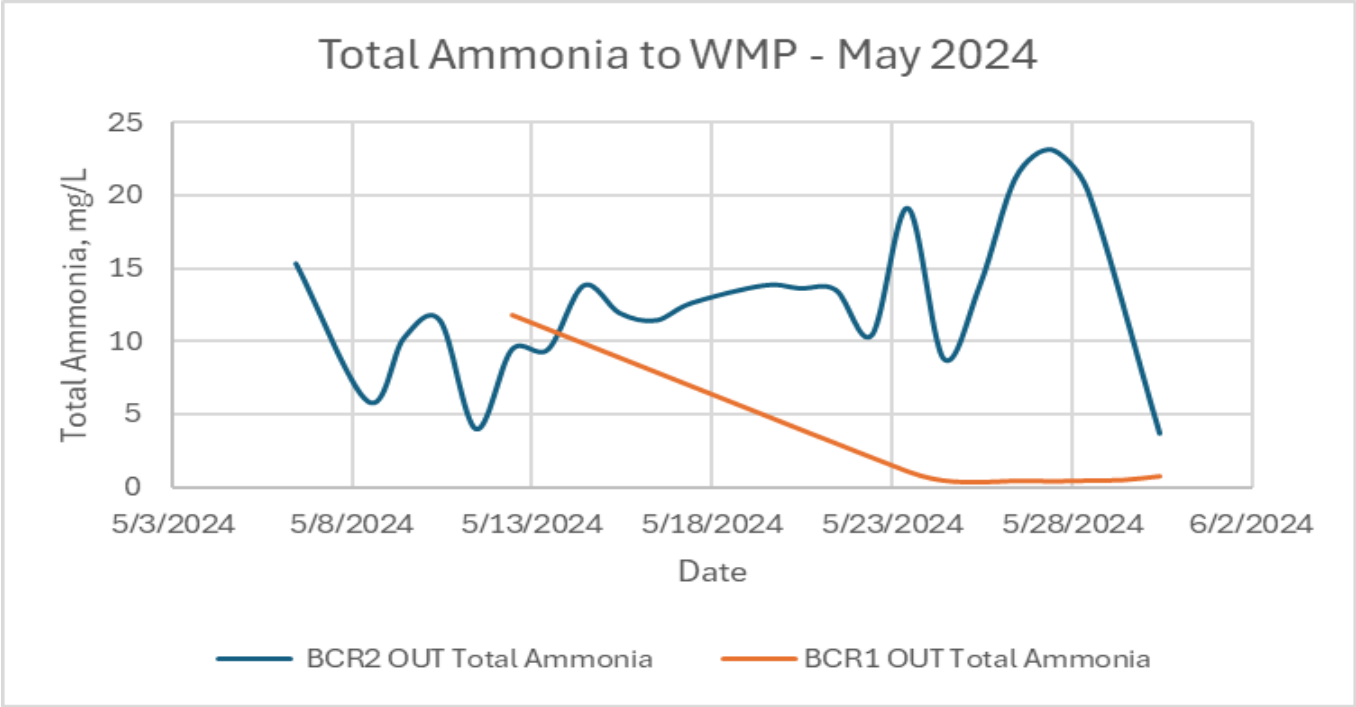
Figure 3

BCR2 was switched to treating WMP water on May 30, 2024, but due to running out of glycerol, the treatment rate was decreased on June 1, 2024 to 7,200 m³/day until it ran out of glycerol and was stopped at about 10:00 on June 3, 2024.

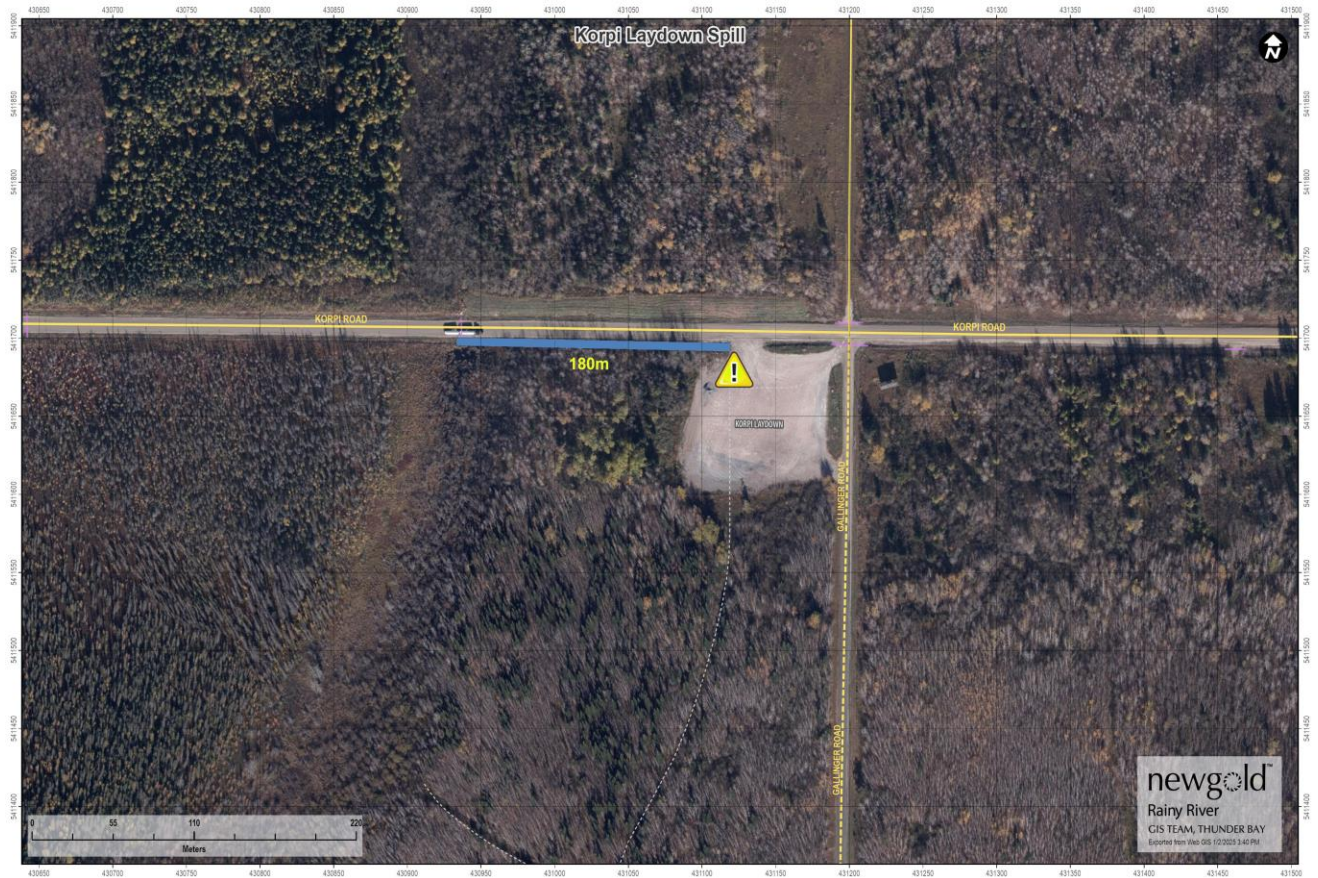
To mitigate this issue, the hydrovac truck operator was directed to clean up the spill immediately using the same truck. An estimated 70 percent of the spill was vacuumed into the truck as the spill was on icy ground leaving about 30 percent frozen. Furthermore, the location of the spill is about 180m away from the closest fish bearing waterway (as shown in figure 4). Therefore, there is little chance this remaining water will reach fish habitat.

Figure 4: Spill Location Overview.

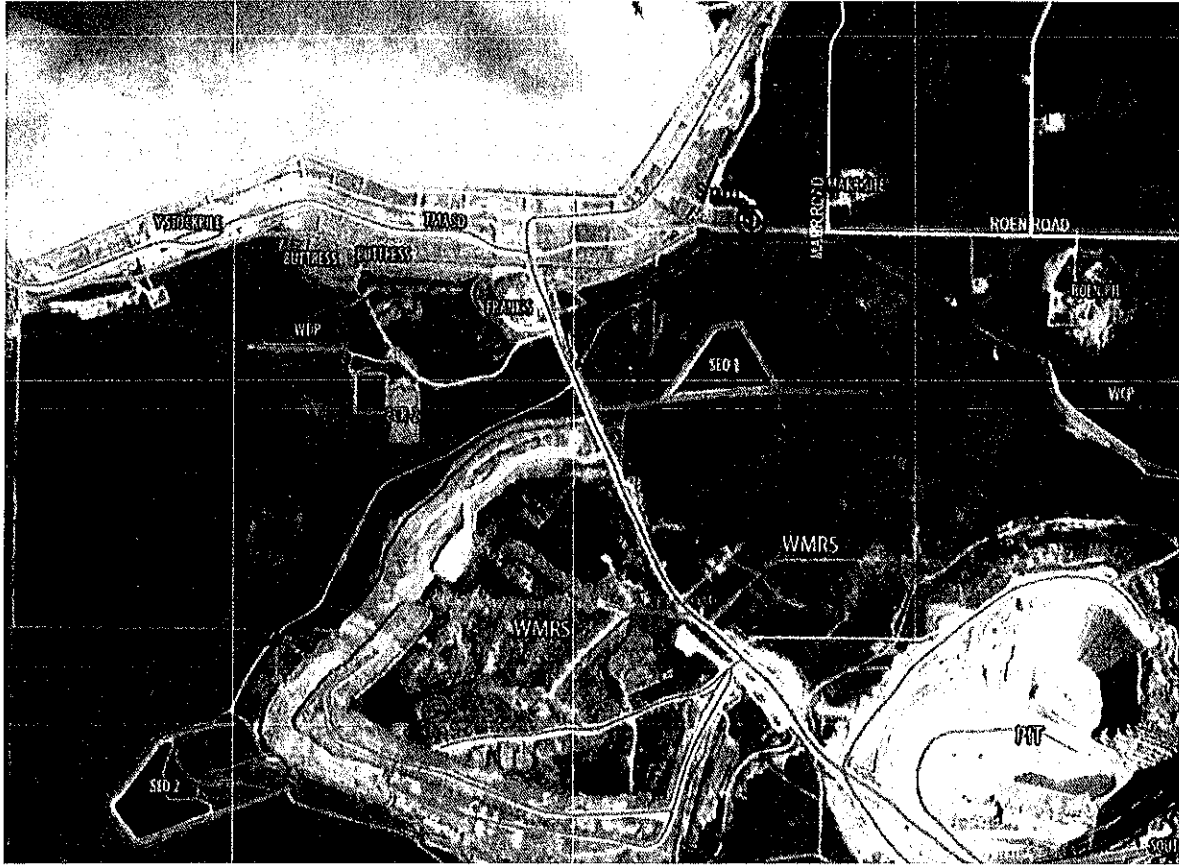
Water samples were collected and sent to ALS labs in Thunder Bay for analysis, including acute toxicity at the location of the spillway and rock ridge before there was dilution. Downstream surface water samples were collected at SW25 and SW26 along the West Creek Diversion. The preliminary Certificate of Analysis (COA) from ALS for the effluent sample indicated that there were no exceedances of the daily ECA Effluent Limits and the acute lethality test results for Rainbow Trout and *Daphnia magna* were both considered a pass. The Total Suspended Solid were elevated at 22.6 mg/L which was over the monthly ECA Effluent Limit of 15 mg/L as well as the *Escherichia coli* (E. coli) over the monthly limit of 100 organisms/100 mL with a value of 341 organisms/100 mL. The E. coli exceedance was deemed to be mobilized into the system from the rainfall travelling through animal feces upstream. No elevated E. coli has been noted in the Tailings Management Area year-to-date. See Figure 5 and 6.

Figure 6 Incident Location Overview; showing the initial spill location and the downstream locations that were sampled.
