**NEW GOLD RAINY RIVER MINE
APPENDIX K
EXCEEDANCE LETTERS
SUBMITTED TO MECP**

newgoldTM Rainy River

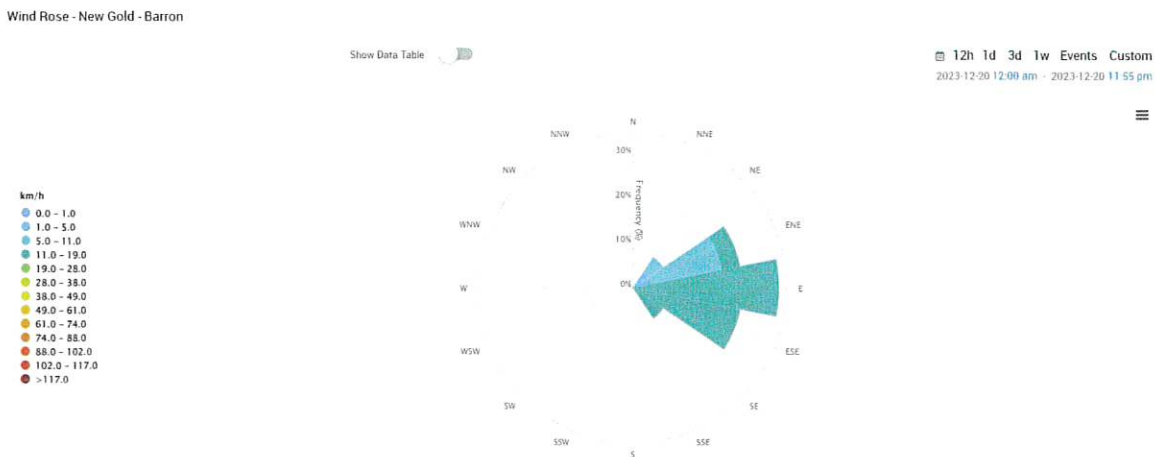
Figure 1: Wind Rose for December 20, 2023, at the Barron Weather Station

During the review of the December air quality results, it was noted that on December 20th, 2023, the concentrations of TSP and iron at the Northwest Station were 199.2 µg/ m³, and 4.96 µg/ m³, respectively. These exceeded the ministry approved limits of 120 µg/ m³ and 4.00 µg/ m³. The wind rose from the Barron Weather Station Wind indicates the primary wind direction was from the East, indicating that this was due to activities in the TMA. A dust inspection using a portable aerosol spectrometer from this day also indicate there was a high level of dust in the TMA and at the Northwest Station, and visible dust in the air over the TMA with was reported via phone call to yourself on December 21, 2023.

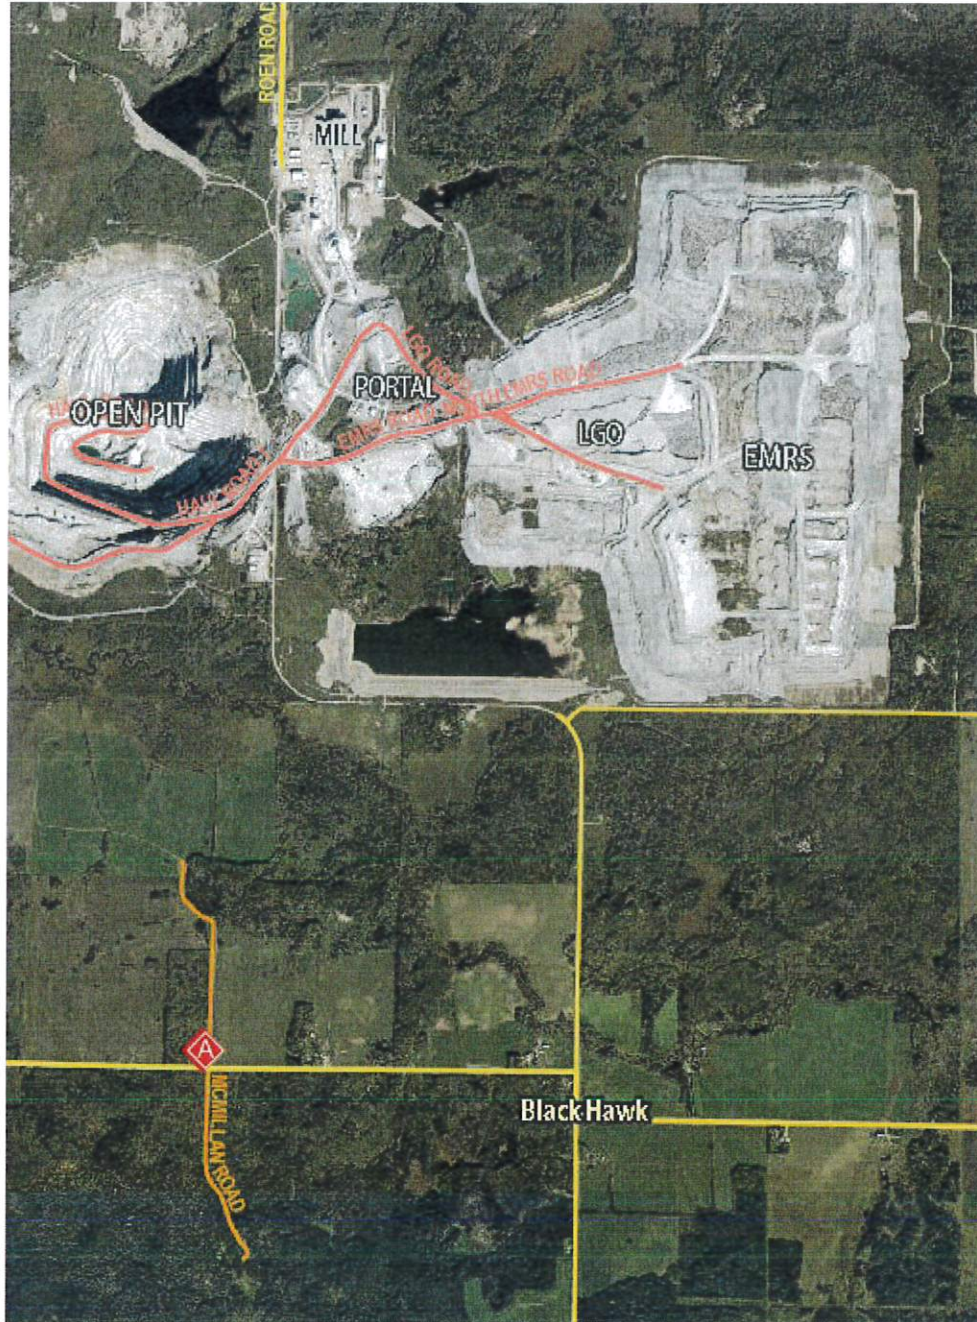
Figure 1: South Air Quality Station, located South of mine site

The South Ambient Air Quality Monitoring Station is located on McMillan Road, South of the Rainy River Mine Site (Figure 1). During this 24-hour period, predominant wind direction was from the Northeast (Figure 2). With this wind direction, the source of dust was likely from the RRM site activities.

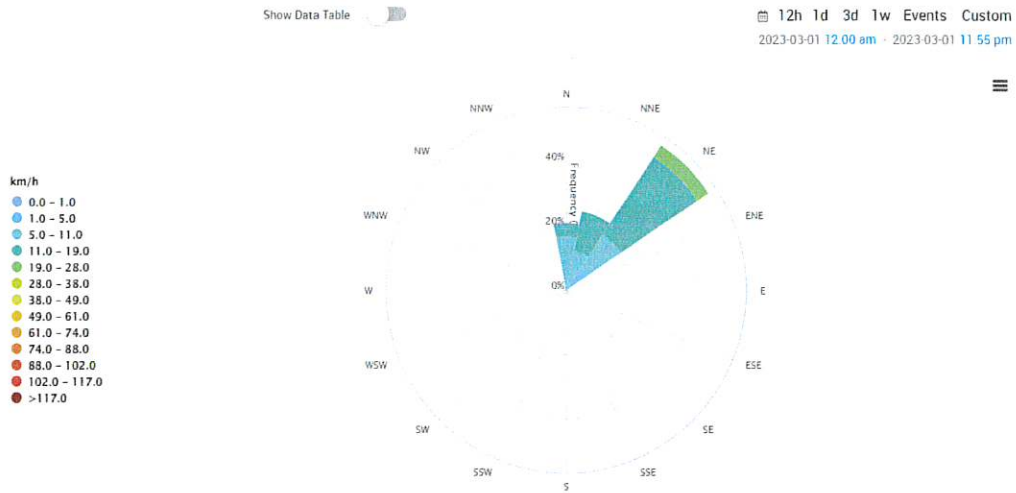
Figure 2: Windrose from March 01, 2023 at Barron Weather Station

During the review of the first quarter air quality report, it was noted that on March 01 and March 07, 2023, the TSP concentration at the Northwest Ambient Air Quality Monitoring Station had exceeded Ministry approved limits of 120 $\mu\text{g}/\text{m}^3$ during a 24-hour period. The TSP concentrations were 162.99 $\mu\text{g}/\text{m}^3$, and 152.10 $\mu\text{g}/\text{m}^3$, respectively.

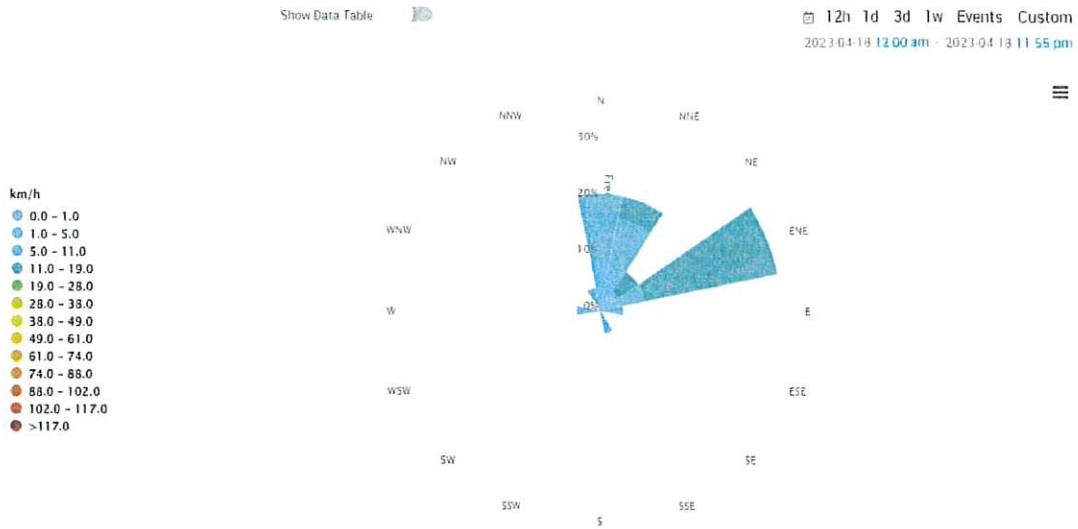
Figure 1: Wind Rose from April 18, 2023 at the Barron Site

During the review of the second quarterly air quality report, three instances of TSP concentrations exceeding the Ministry approved limit of 120 $\mu\text{g}/\text{m}^3$ during a 24-hour period were noted. On April 18, 2023, and May 06, 2023, the TSP concentration at the Northwest Ambient Air Quality Monitoring Station were 158.89 $\mu\text{g}/\text{m}^3$ and 121.51 $\mu\text{g}/\text{m}^3$ respectively. On April 30, 2023, the TSP concentration at the South Ambient Air Quality Monitoring Station (McMillan Road) was 123.83 $\mu\text{g}/\text{m}^3$. With the TSP exceedances on April 30, 2023 at South Station, and May 06, 2023 at Northwest Station, there were exceedances of the Ministry limit of 4 $\mu\text{g}/\text{m}^3$ for Iron, with concentrations of 4.07 $\mu\text{g}/\text{m}^3$ and 5.10 $\mu\text{g}/\text{m}^3$, respectively. Primary wind direction for exceedances at the Northwest Station were from the Northeast and East, indicating the high TSP concentrations were due to activities in the TMA. The primary wind direction on April 30th, 2023, was from the North, indicating that the TSP exceedance at South Station was caused by activities in the pit.

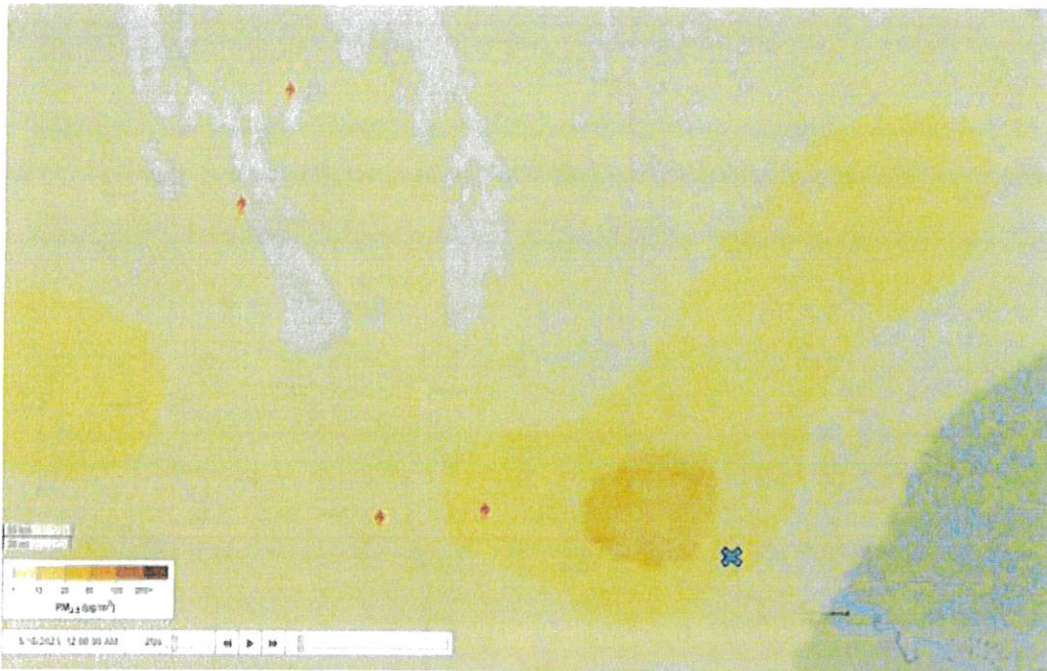
On May 18, 2023, the PM2.5 concentration at North, South, and Northwest Station exceeded the Ministry approved limit of 27 µg/m³. The concentrations were 36.47 µg/m³, 38.17 µg/m³, and 35.02 µg/m³, respectively. As shown in Figure 4, PM2.5 concentrations were elevated on May 18, as a smoke plume from forest fires with PM2.5 concentrations between 28 µg/m³ and 120 µg/m³ passed through the area. Figure 5 shows a photo of the North Air Quality Station, with visible haziness caused by the smoke plume.

Figure 4: Air Quality Map showing expected elevated PM2.5 concentrations due to forest fires in the area surrounding the Rainy River Mine on May 18, 2023.

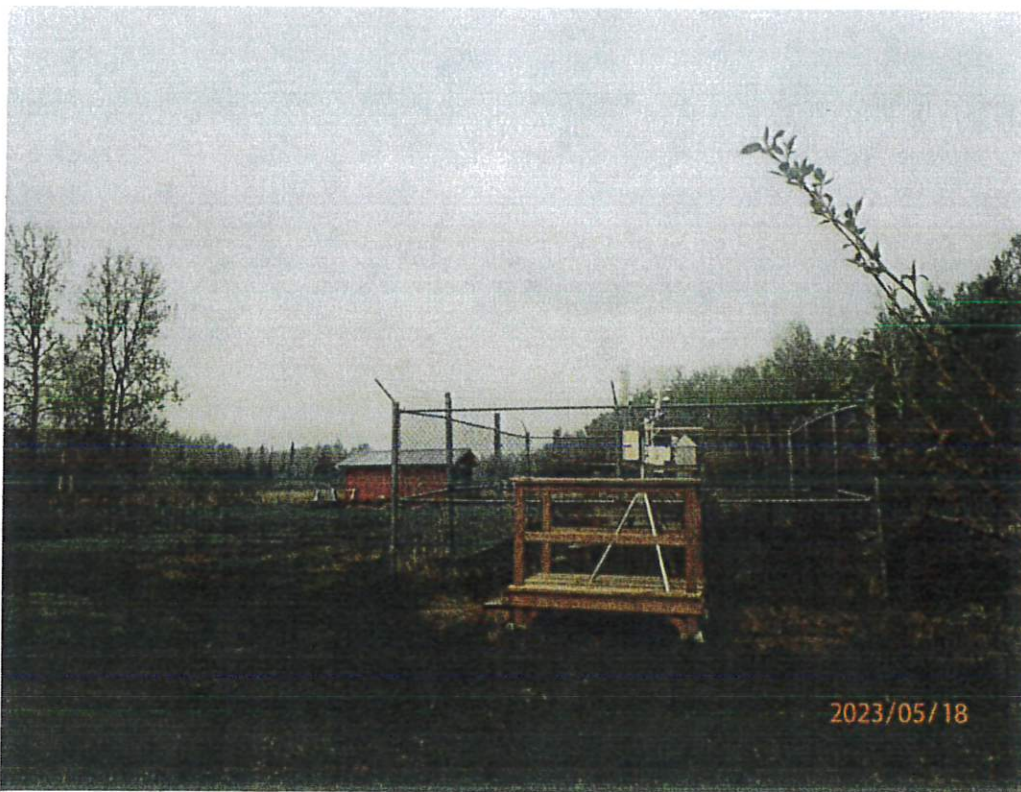
Figure 5: North Air Quality Station on May 18, 2023, with forest fire smoke in the background.

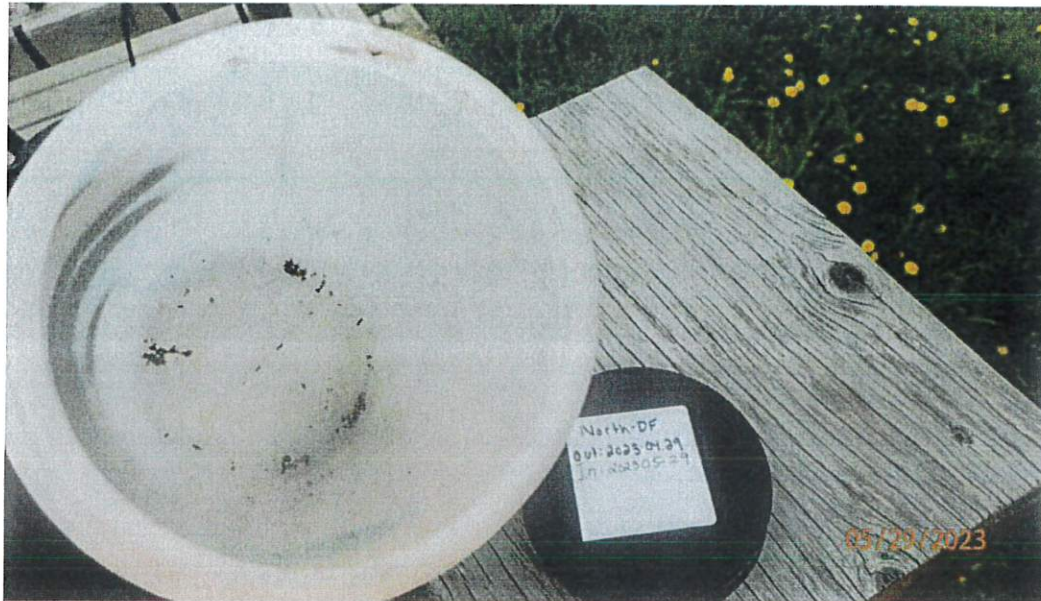
Over the month of June, the Dustfall total concentration at North Station exceeded the Ministry approved limit of $7 \mu\text{g}/\text{m}^3$. This concentration was due to contamination from organic material in the sample. The concentration including organics was $13.83 \mu\text{g}/\text{m}^3$, but once organic material was removed, the fixed dustfall concentration was below the Ministry limit, at $3.66 \mu\text{g}/\text{m}^3$.

Figure 5: North Station Dustfall jar after sampling during the month of June, 2023, before shipping to certified laboratory.

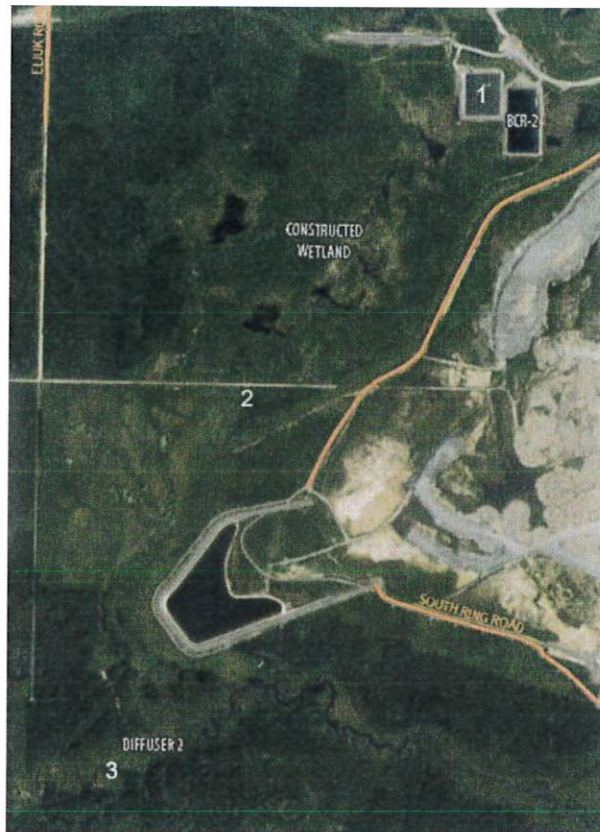
1. Outflow Basin – Sampled with Discharge Kit
2. Remnant Loslo Creek and Old Hwy 600 crossing – Sampled with Discharge Kit and Acute Toxicity
3. SW22A – Sampled with Discharge Kit

Figure 2 August 21st incident response sampling locations completed by Environmental Department.
