RAINY RIVER MINE

OPERATION, MAINTENANCE AND SURVEILLANCE MANUAL

PART II - TAILINGS MANAGEMENT AREA

Version 2022-1

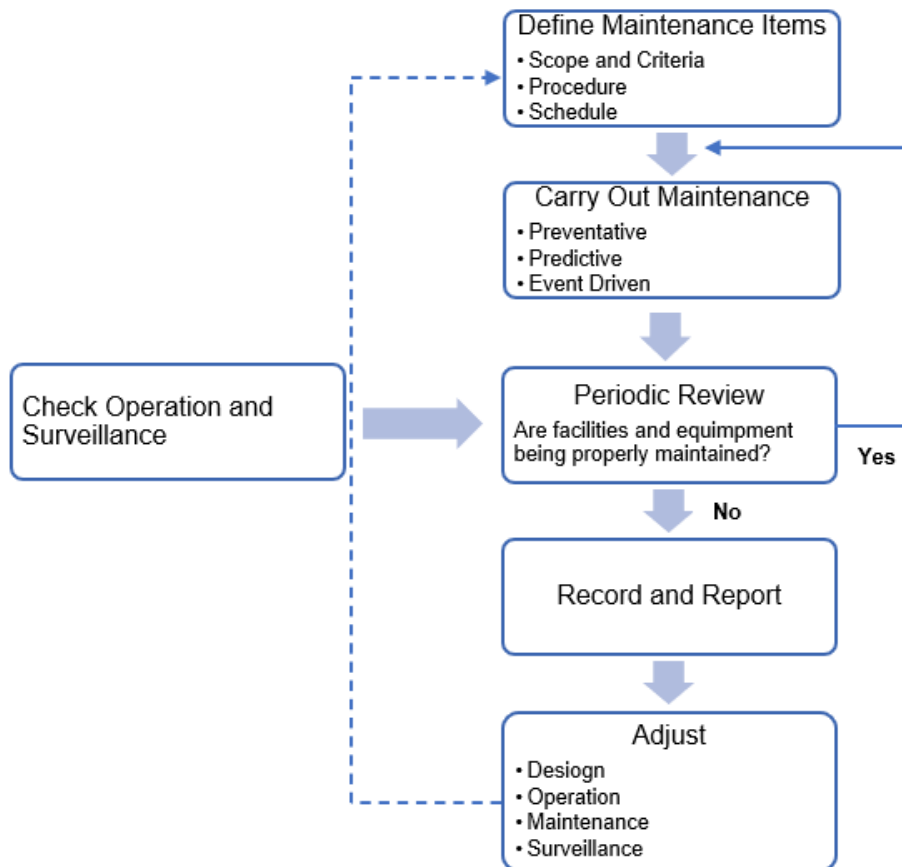
Figure 4- 1: Maintenance Flow Chart

Maintenance records are retained by NGI teams who perform the work in accordance with the procedures described in this document. The teams are Site Service, Mill, Environment and Capital Projects. The maintenance flowchart is illustrated in Figure 4- 1.

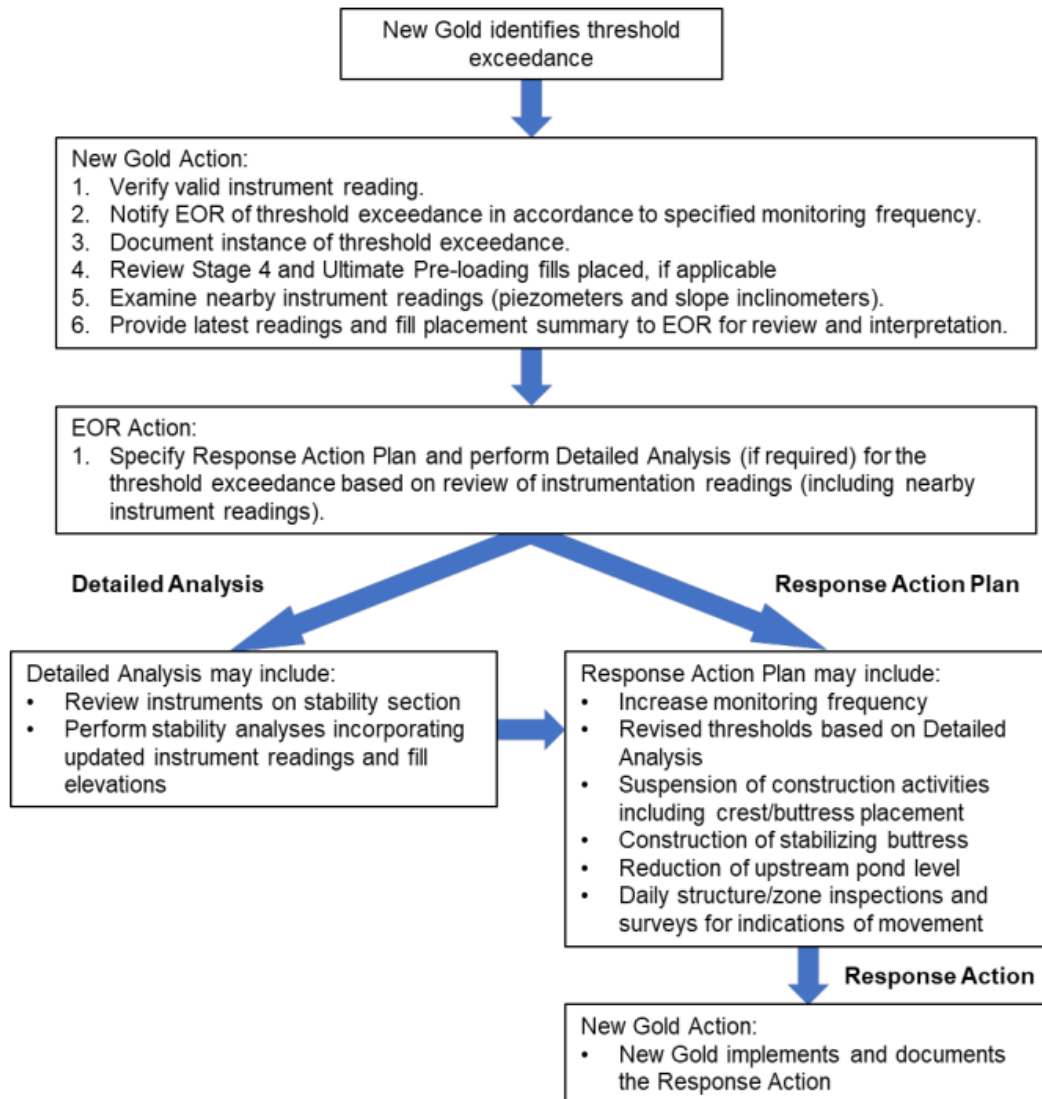
Figure 5- 2: Threshold Exceedance Responsibilities Workflow

The action plan to address exceedance of the thresholds is shown in Figure 5- 2.

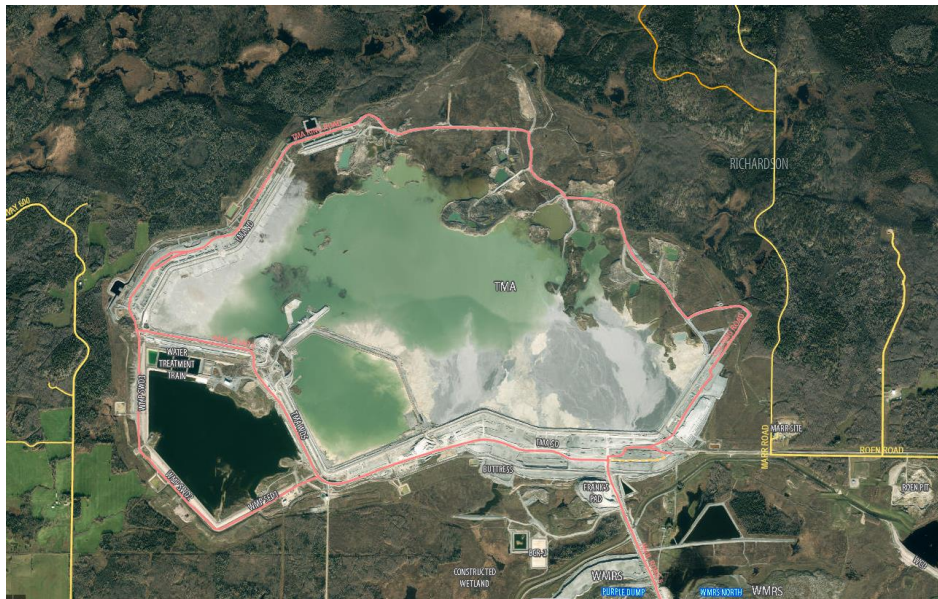
Fig 1. Plan View of TMA

Inspect the condition of the Spillway:

6. Is there damage to the Sill? YES NO
7. Is there damaged to the toe? YES NO
8. Is there damaged to the side walls? YES NO

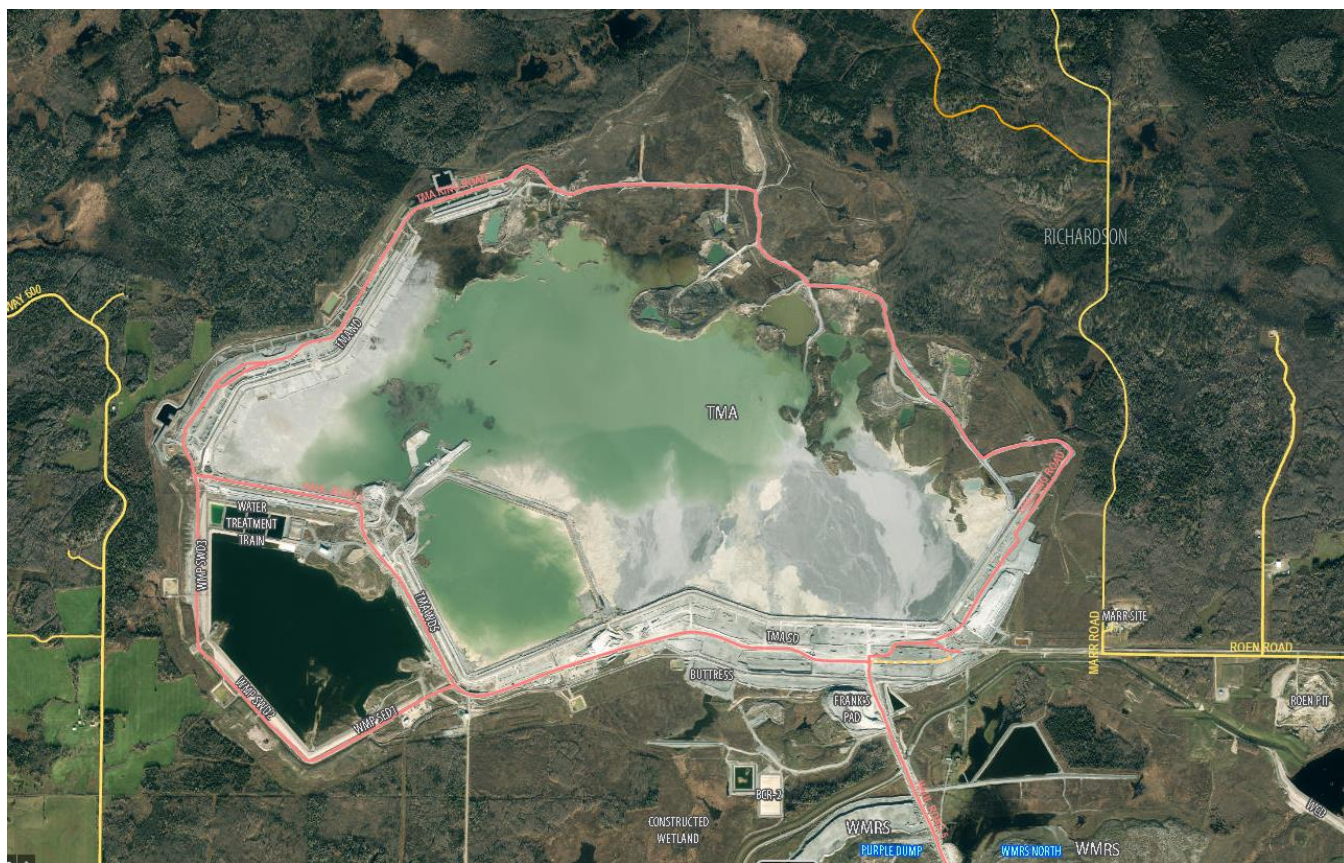
Fig 1. Plan View of TMA

Record of Seepage

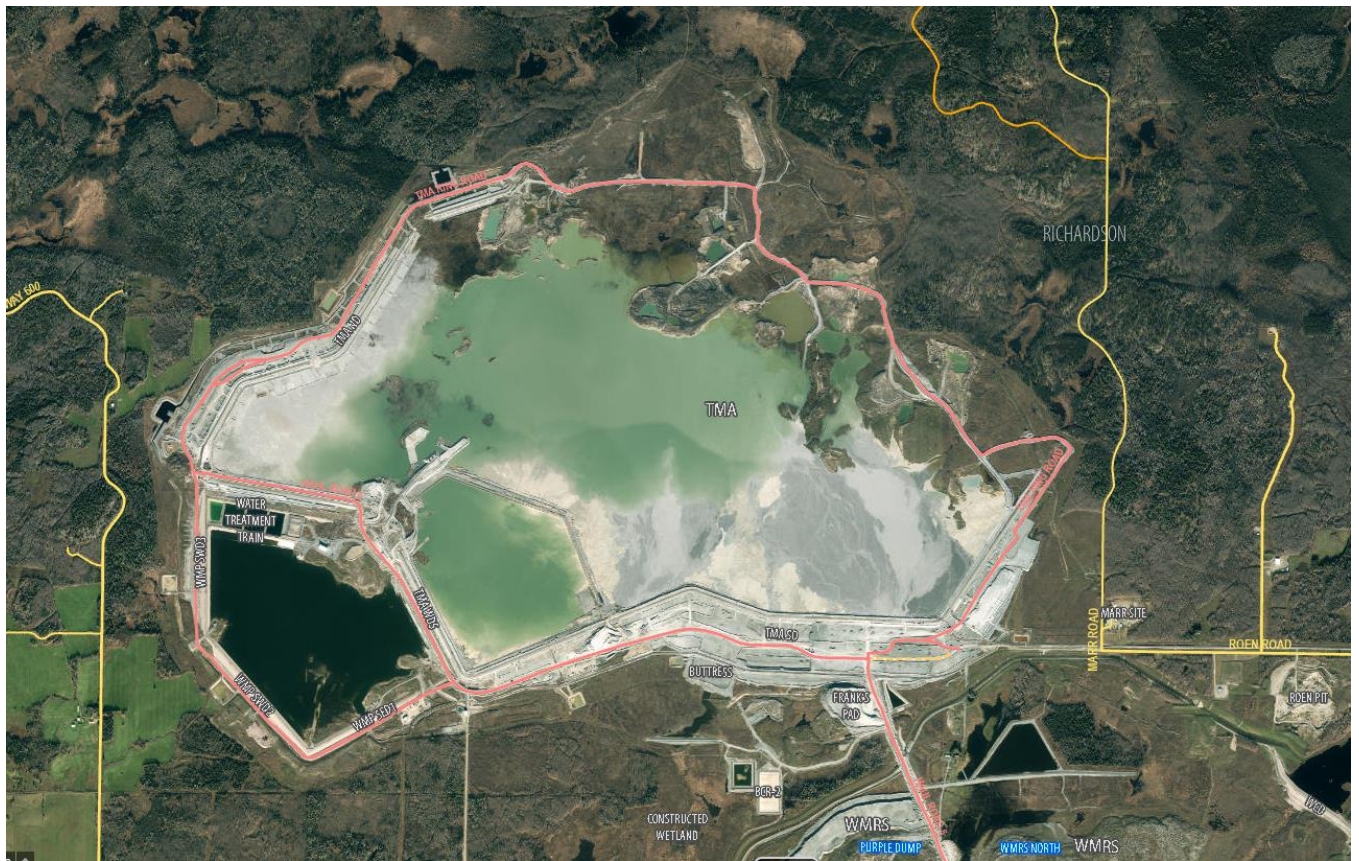
Fig. 1. Plan View of TMA

9. Inspect the rest of the dam using the Routine Weekly Inspection Checklist. Look for signs of deformation such as:
 - New or increased seepage (If observed go to the Increased Seepage SRP)
 - Other areas of deformation
10. If anything looks unusual report back to Capital Project Manager immediately.
11. Continue to measure and record the Length, Width etc. every hour and check that there are no changes. Report any changes in the measurements to the Capital Project Manager immediately.
12. Continue to inspect the entire dam every two hours following the Routine Weekly Inspection Checklist.
13. Do not leave site until manager instructs you to do so.
