**RAINY RIVER MINE**

**OPERATION, MAINTENANCE AND SURVEILLANCE  
MANUAL**

**PART II - TAILINGS MANAGEMENT AREA**

**January 2024  
Version 2024-1**

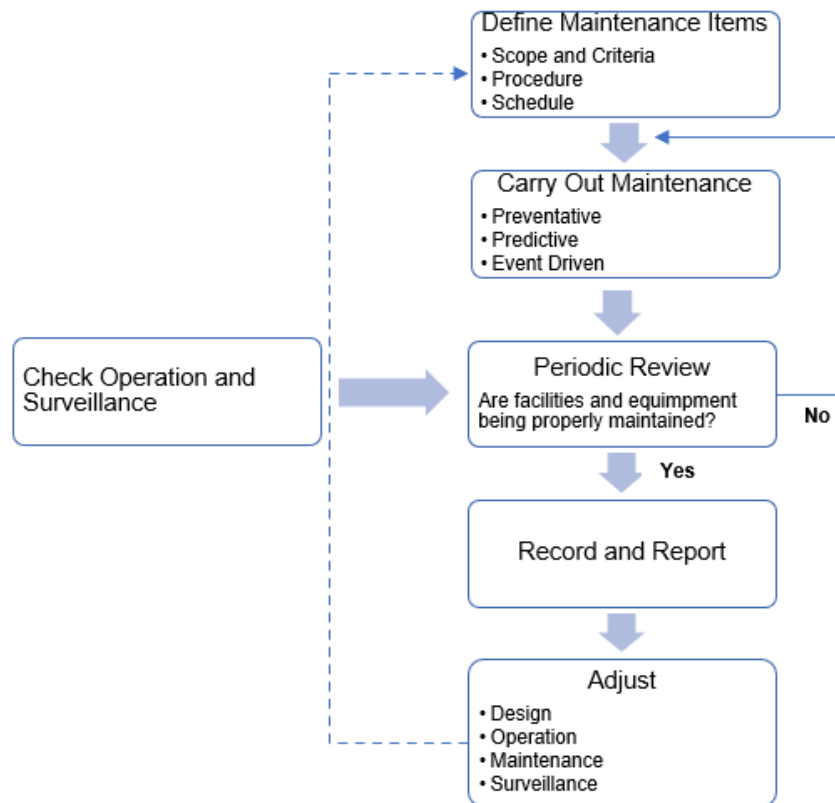
**Figure 5- 2: Maintenance Flow Chart**

Maintenance records are retained by NGI teams who perform the work in accordance with the procedures described in this document. The teams are Site Service, Mill, Environment and Capital Projects. The maintenance flowchart is illustrated in Figure 5-2.

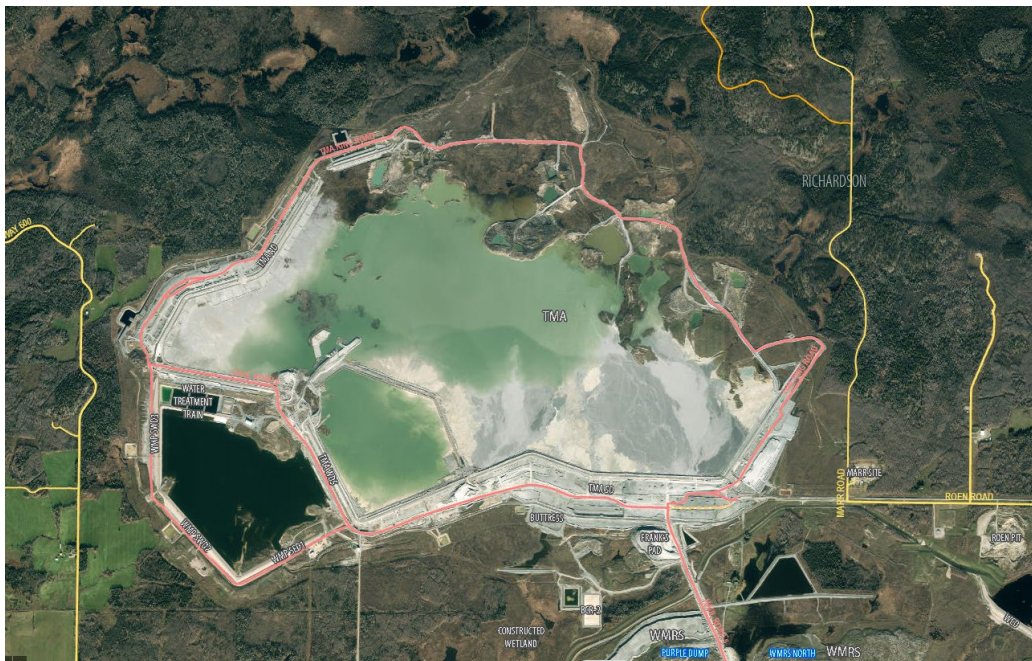
Fig 1. Plan View of TMA

1. From a safe vantage point check that it is safe to approach the dam. Call the Capital Project Manager if the dam is not considered safe to approach.
2. Record weather conditions: \_\_\_\_\_
3. Record Pond level \_\_\_\_\_
4. Is there any sign of new deformation such as: cracking, slumping, change of alignment and depressions?                      YES      NO
  - a. If yes use deformation checklist to record details of the observations.
5. Is there any sign of new or increased seepage?                      YES      NO
  - a. If yes use seepage checklist to record the details of the observations.
6. Is there damage to the spillway?                      YES      NO
  - a. If yes use seepage checklist to record the details of the observations
7. Estimate the length of tailings beach. SD: \_\_m, WD: \_\_m, ND: \_\_m

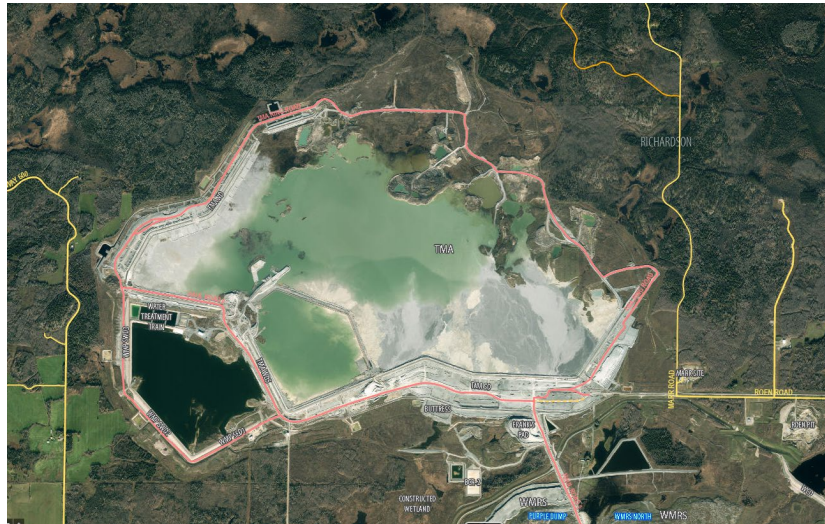
Fig 1. Plan View of TMA

6. Is there damage to the Sill? YES NO
7. Is there damage to the toe? YES NO
8. Is there damage to the side walls? YES NO

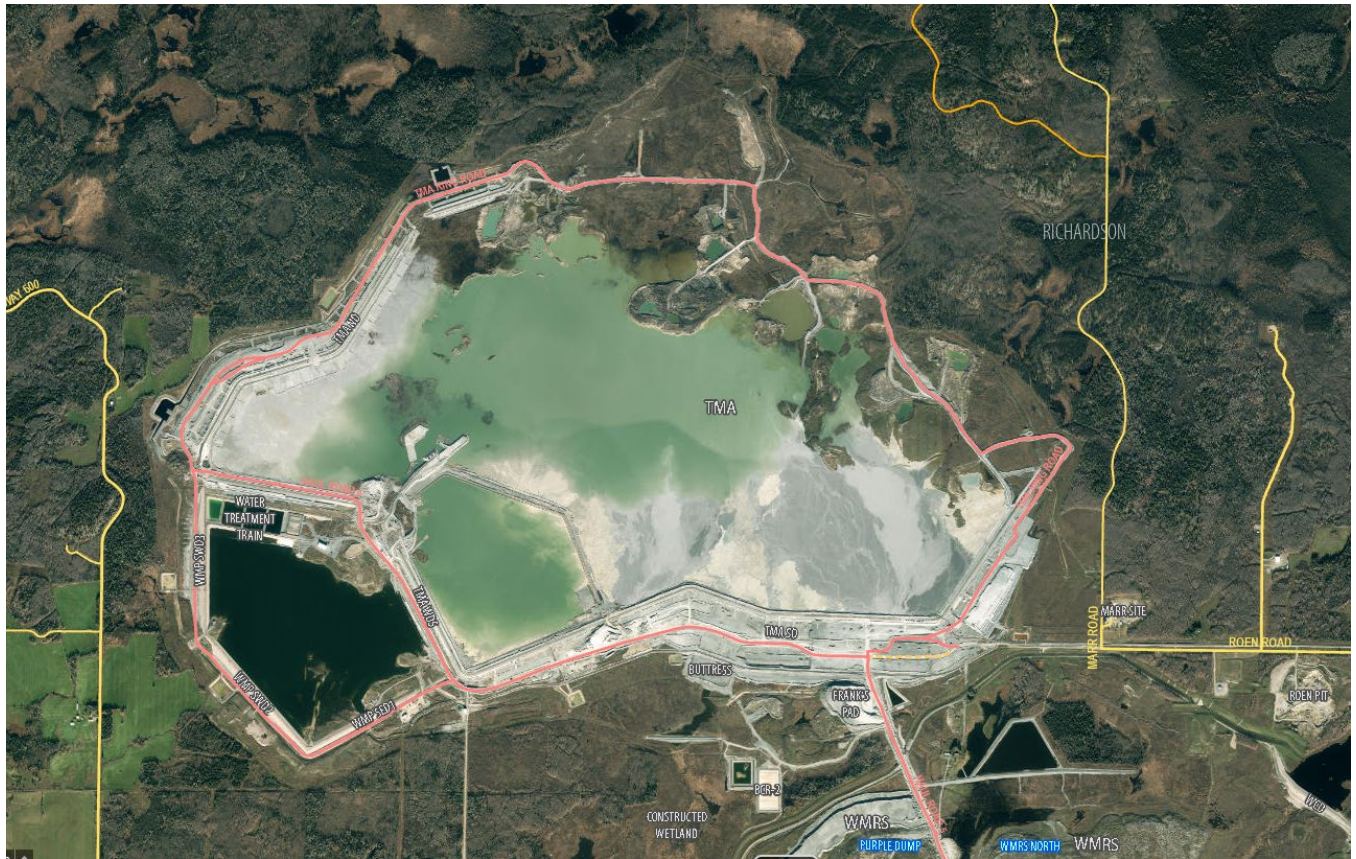
Fig. 1. Plan View of TMA

9. Inspect the rest of the dam using the Routine Weekly Inspection Checklist. Look for signs of deformation such as:
  - New or increased seepage (If observed go to the Increased Seepage SRP)
  - Other areas of deformation
10. If anything looks unusual report back to Capital Project Manager immediately.
11. Continue to measure and record the Length, Width etc. every hour and check that there are no changes. Report any changes in the measurements to the Capital Project Manager immediately.
12. Continue to inspect the entire dam every two hours following the Routine Weekly Inspection Checklist.
13. Do not leave site until manager instructs you to do so.
