APPENDIX C

CONDITION 3 SUPPORTING DOCUMENTATION

Re:	Monthly Surface Water Quality Results Summary – May 2015
Date:	June 24 <sup>th</sup> , 2015
From:	Nigel Fisher, Manager, Environment
То:	Ray Boivin, Senior Environmental Officer, Kenora Area, MOECC

# newg and Rainy River Project

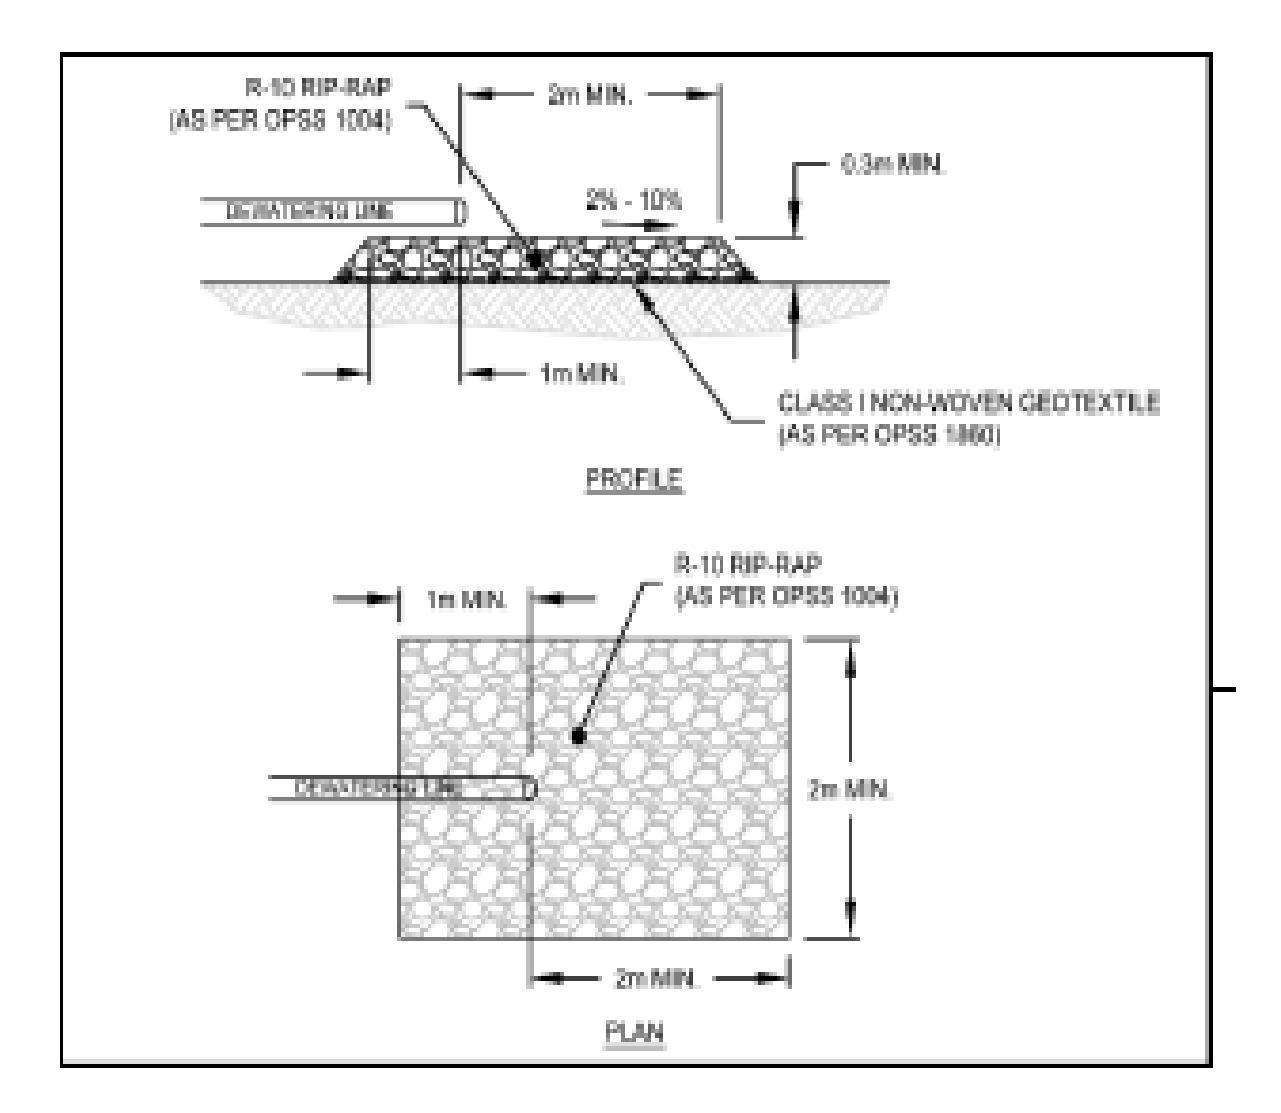
Figure 1; Typical Splash Pad drawing to be followed for all construction de-watering splash pads

- New Gold Spill Reporting Procedure
- New Gold Water Taking Procedure
- OPSS 518 : Construction specification for control of water from dewatering operations
- OPSS 517 : Construction specifications for dewatering of pipeline utility and associated structure excavation
- Typical Splash Pad Drawing Figure 1 attached
