**NEW GOLD RAINY RIVER MINE
APPENDIX N
2018 ANNUAL MONITORING REPORT-
OFFSET PLAN FOR FISHERIES ACT**

2018 Annual Monitoring Report – Offset Plan for Fisheries Act
Section 35(2)(b) Authorization
Emo, Ontario
TC111504

**Re: 2018 Annual Monitoring Report
Offset Plan for Fisheries Act Section 35(2)(b) Authorization, Rainy River Mine
Emo, Ontario**

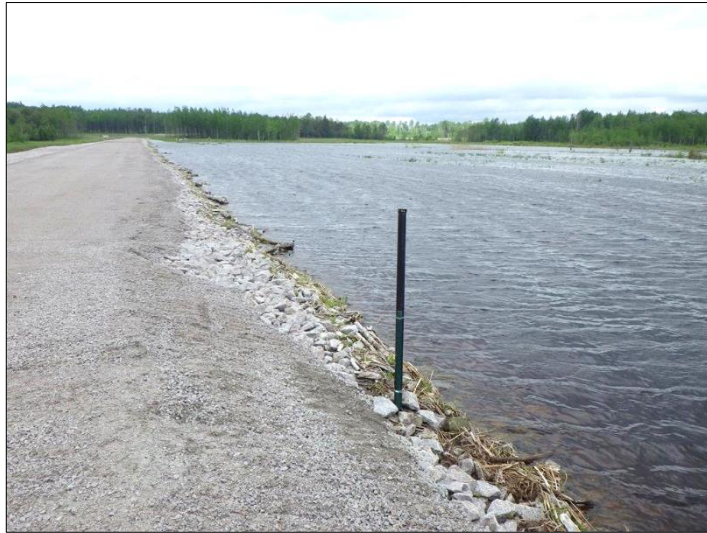
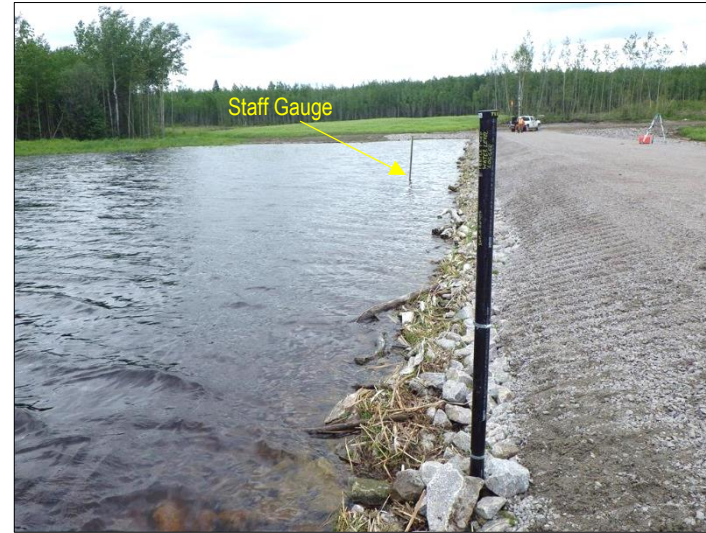
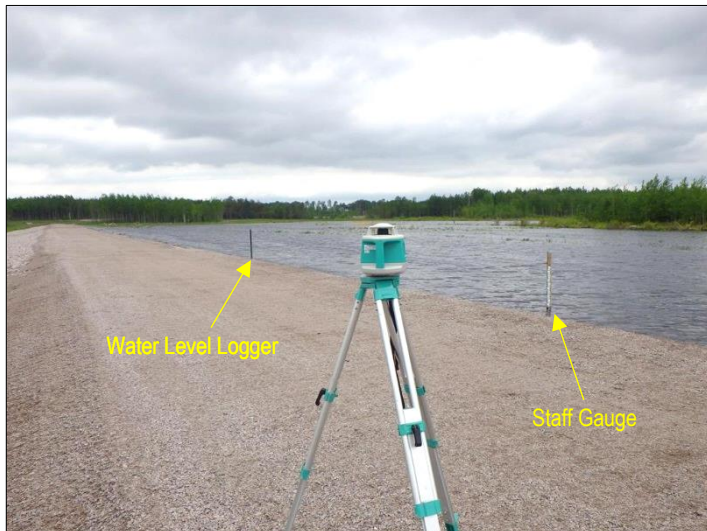
Plate A.1-1: Teeple Pond Water Level Logger Installation

Water level logger facing west on dam (June 10, 2017)

Water level logger facing east on dam (June 10, 2017)

Water level logger facing northwest (June 10, 2017)

Barometric pressure logger mounted on tree (June 10, 2017)

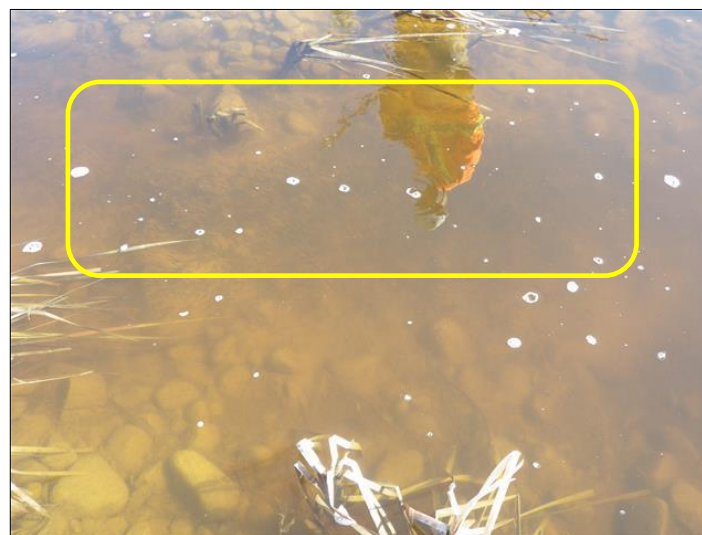
Large school of juvenile cyprinids in CSS-2 pool (April 25, 2018)

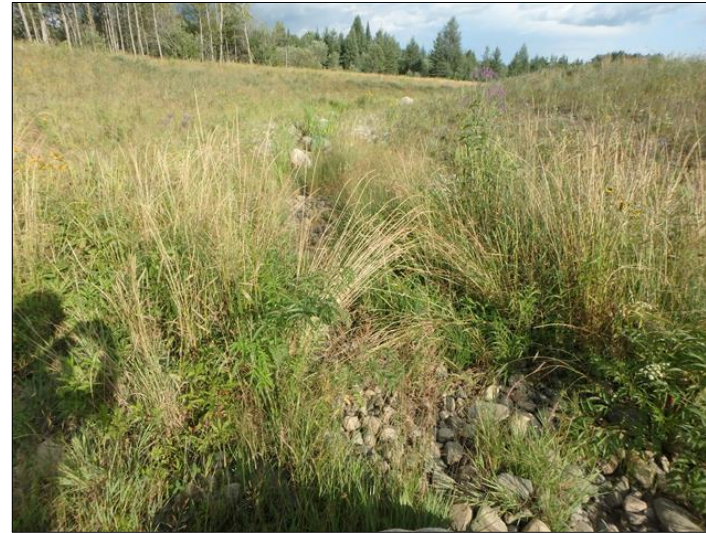
CSS-1, facing downstream (July 27, 2018)

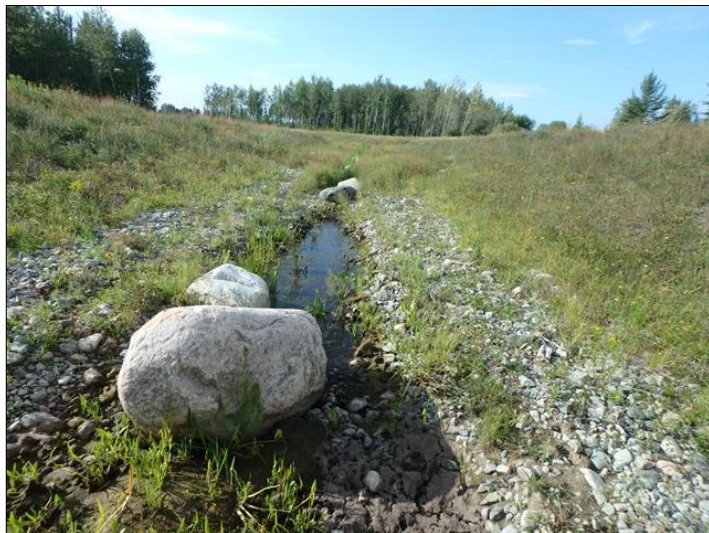
CSS-2, facing upstream (July 27, 2018)

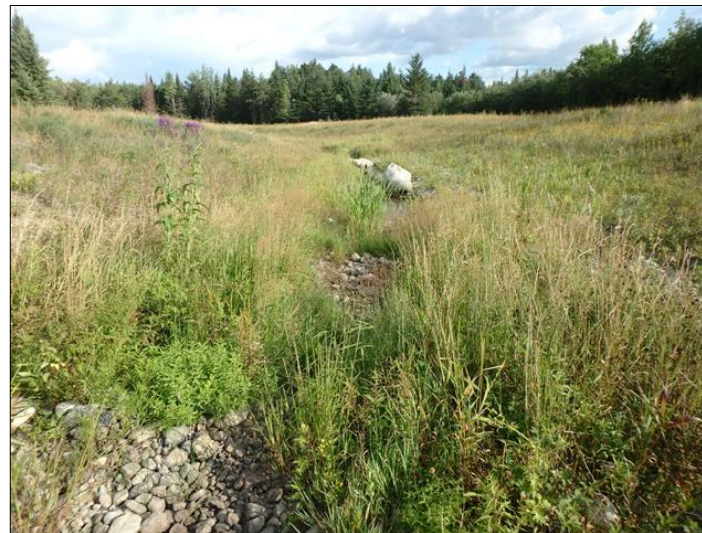
CSS-2 facing downstream (July 27, 2018)

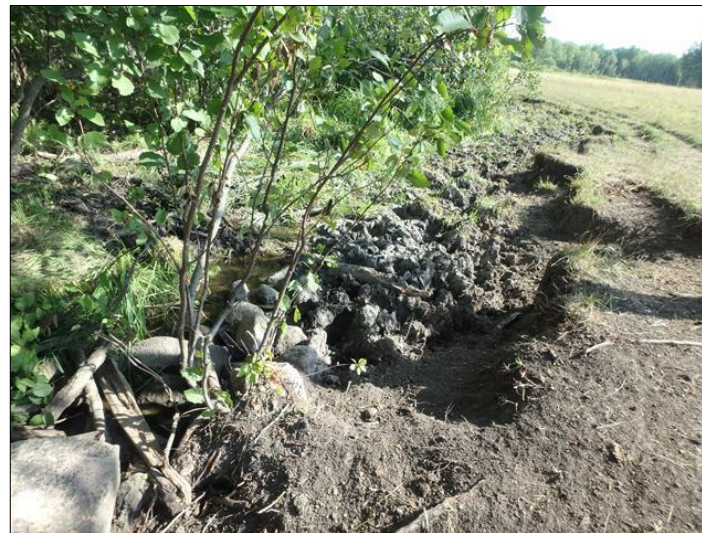
Erosion from cattle destabilization and exposed soil; CSS-3 (July 27, 2018)

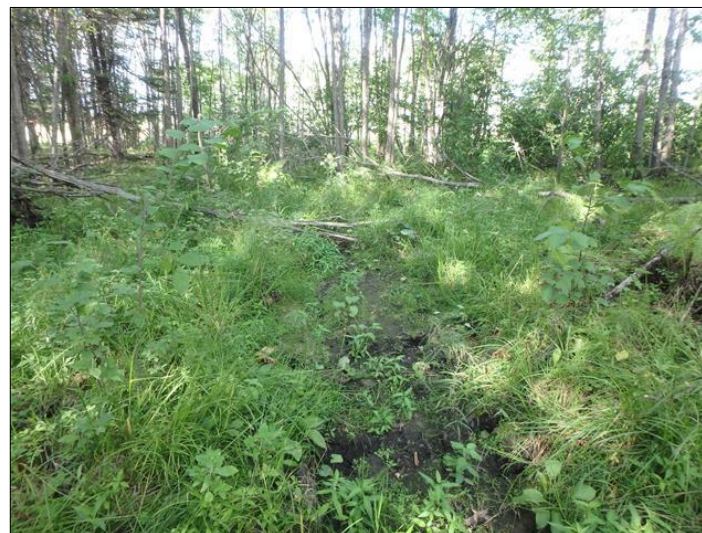
Dry channel at CSS-11 (July 27, 2018)

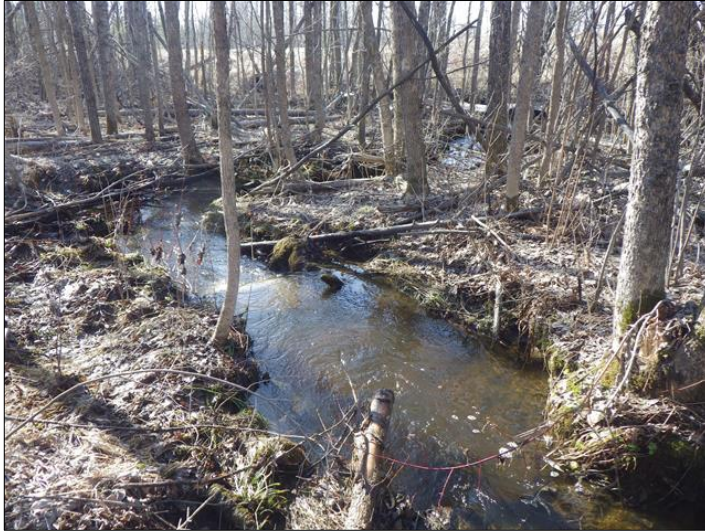
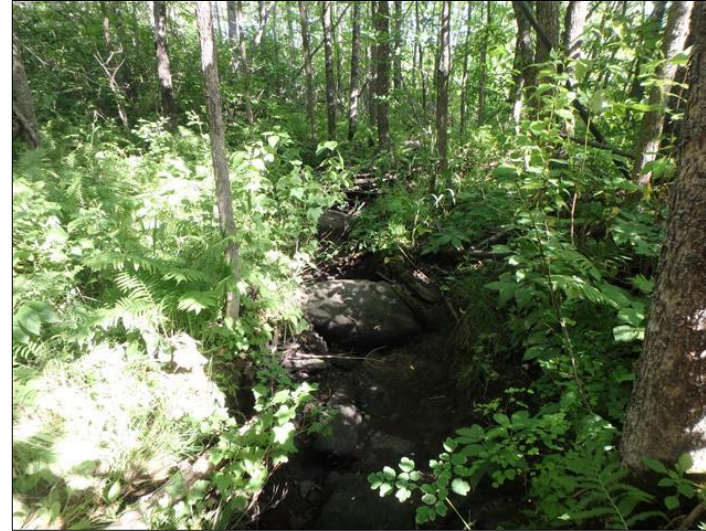
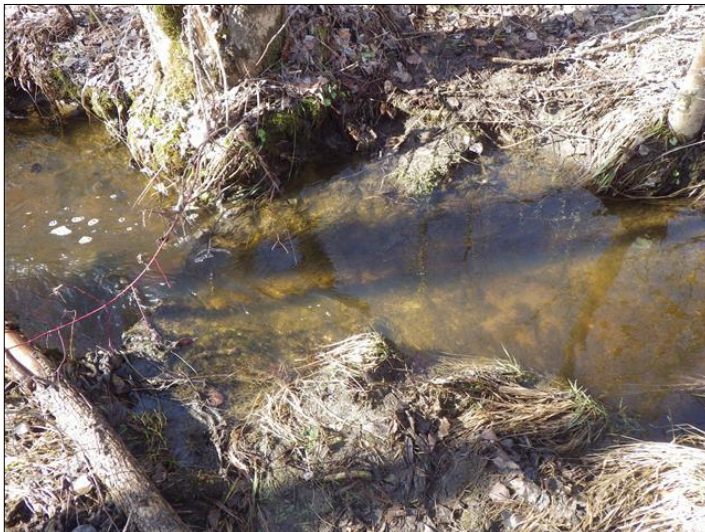
As noted in section 5.2, the shallow conditions under very low flow are considered typical during periods of intermittency, and 2018 represented drier than average conditions (Figure 2). Photo station P8 was positioned immediately upstream of the Teeple Road culvert crossing and includes two bedrock controls within the natural channel alignment. These features had no flow over the rocks at the time of assessment, thereby posing a barrier to fish passage. Again, isolated pools are expected during intermittent flows such as those observed during the summer of 2018. No evidence of erosion was observed between the constructed outlet channel confluence with the original Teeple Drain and photo station P8.

Station P8 facing south; downstream (April 25, 2018)

Station P8 facing south; downstream (July 29, 2018)

Station P8, natural channel, during high flow (April 25, 2018)

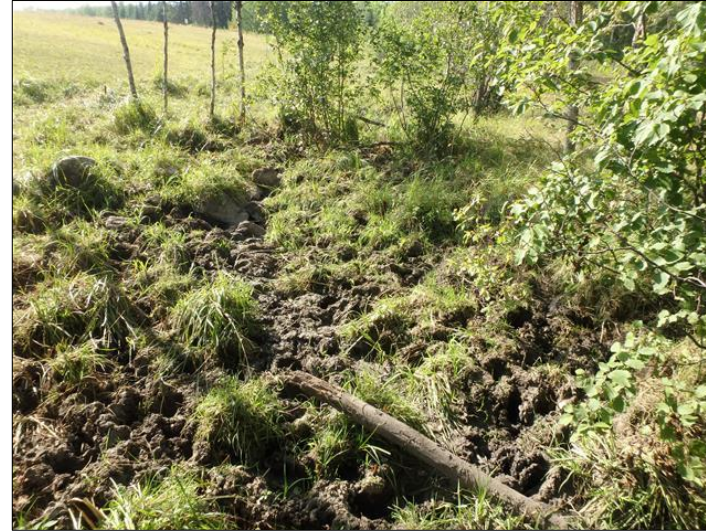
Station P9 facing northwest; upstream – no flow (July 29, 2018)

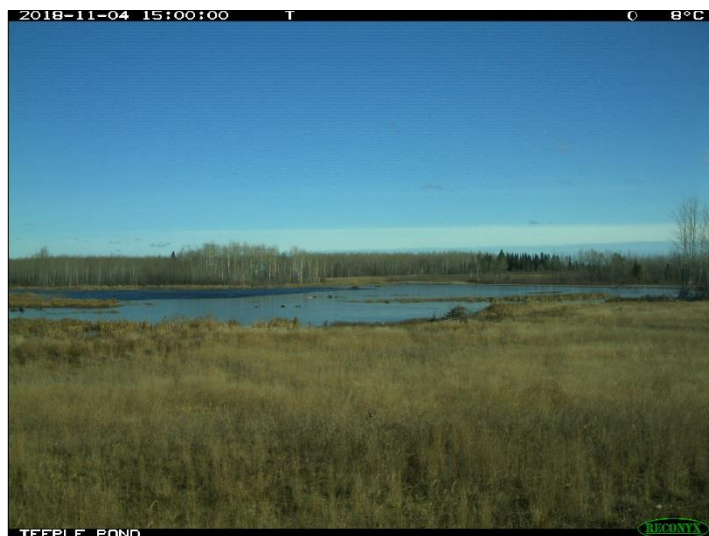
Ice forming on pond since Nov. 2 (November 4, 2018)

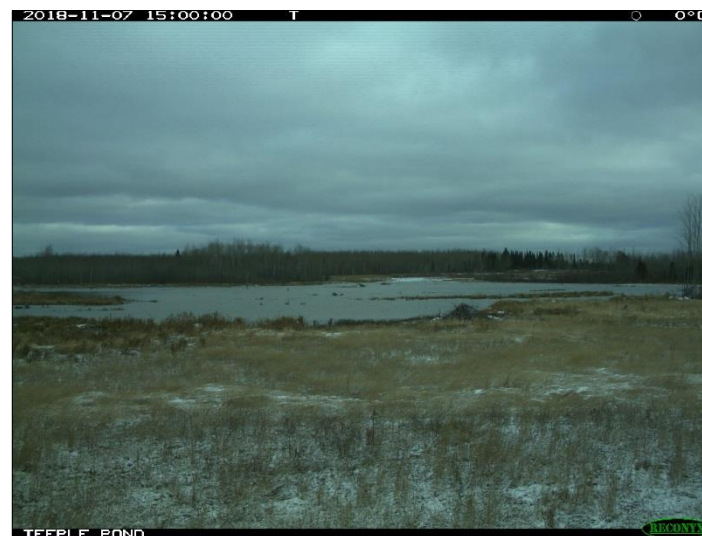
Ice cover absent from pond since November 5 (November 7, 2018)

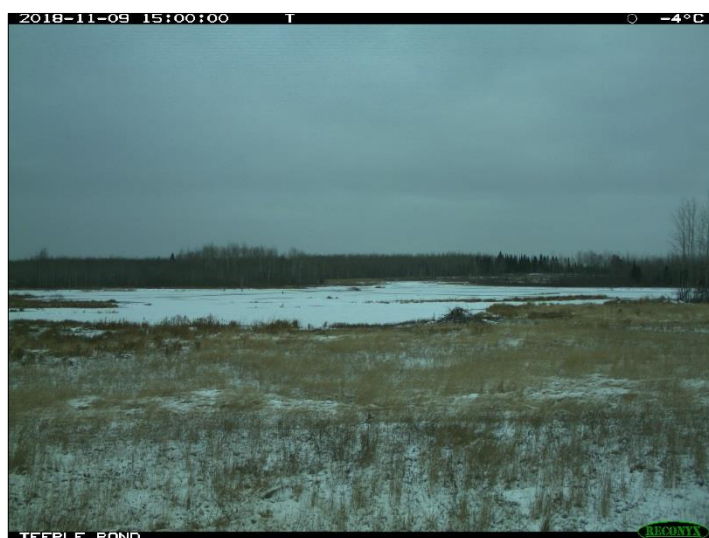
Continuous ice cover documented (November 9, 2018)

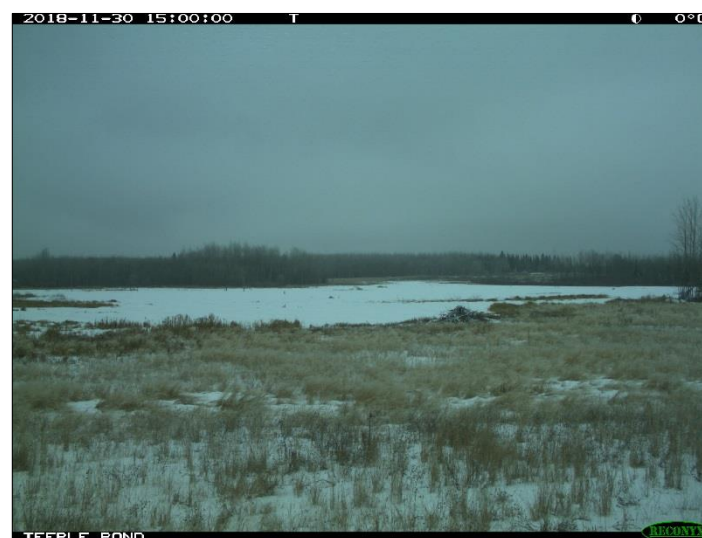
Ice coverage remained unchanged since Nov. 9 (November 30, 2018)

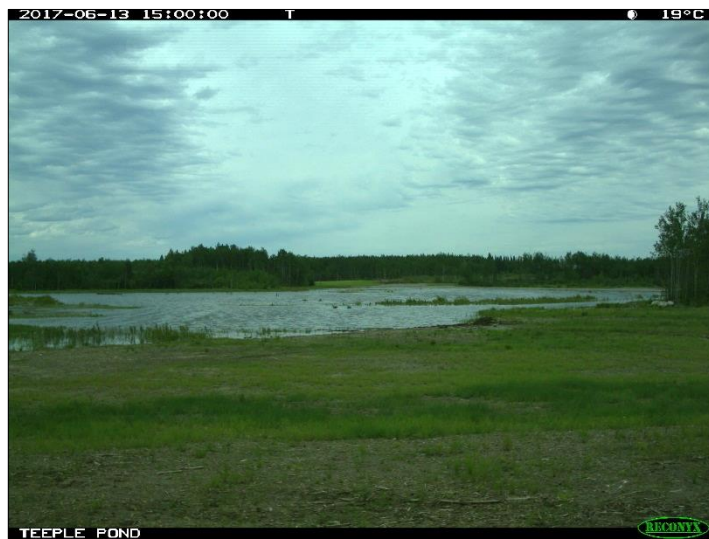
Water level before 22 mm rain; June 13, 2017

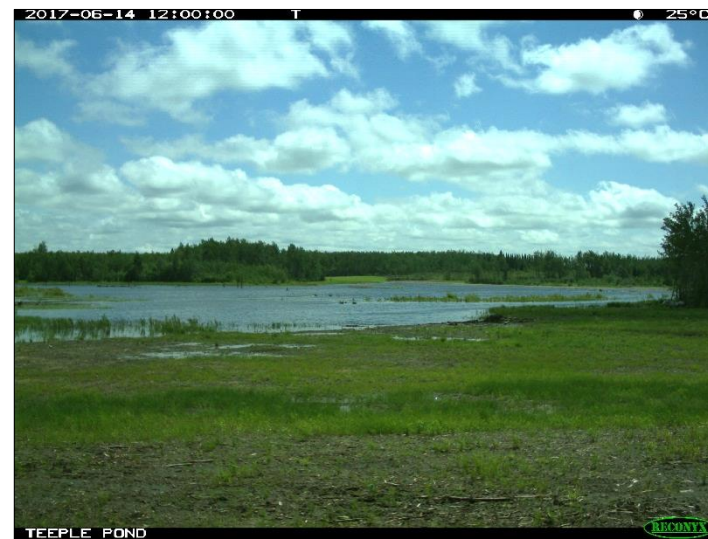
Water level after 22 mm rain; June 14, 2017

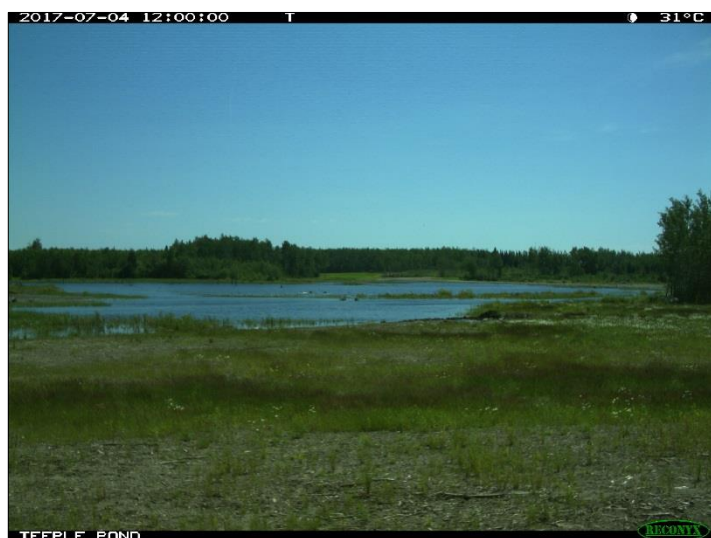
Water level before 33 mm rain; July 4, 2017

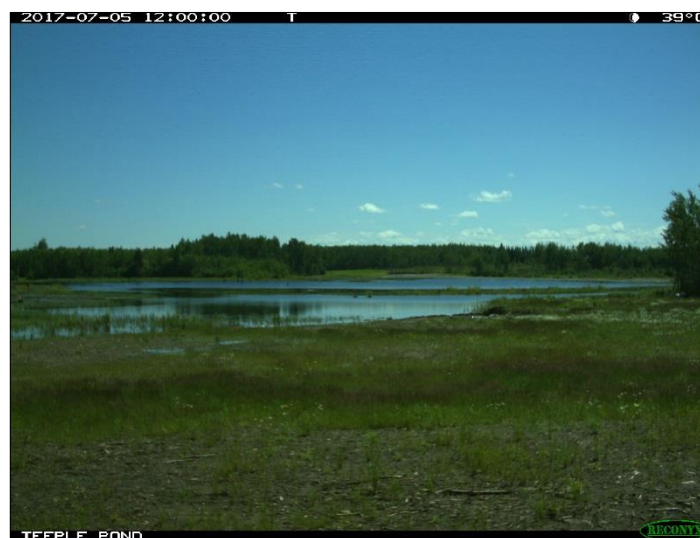
Water level after 33 mm rain; July 5, 2017

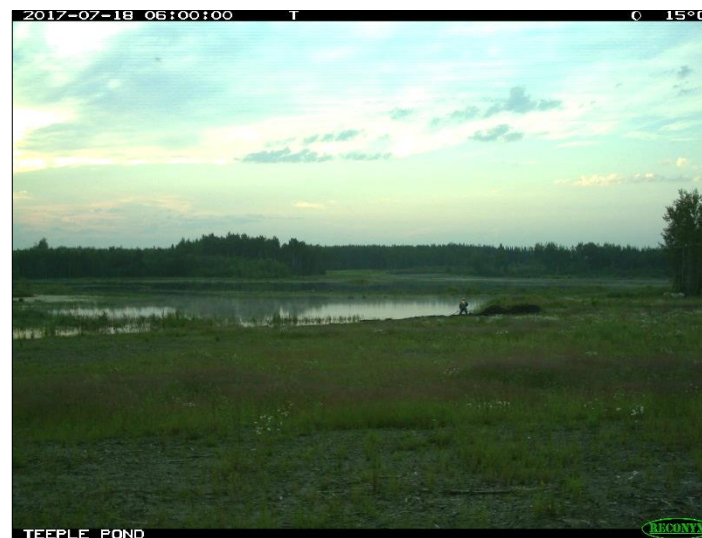
Trapper working near outlet; July 18, 2017

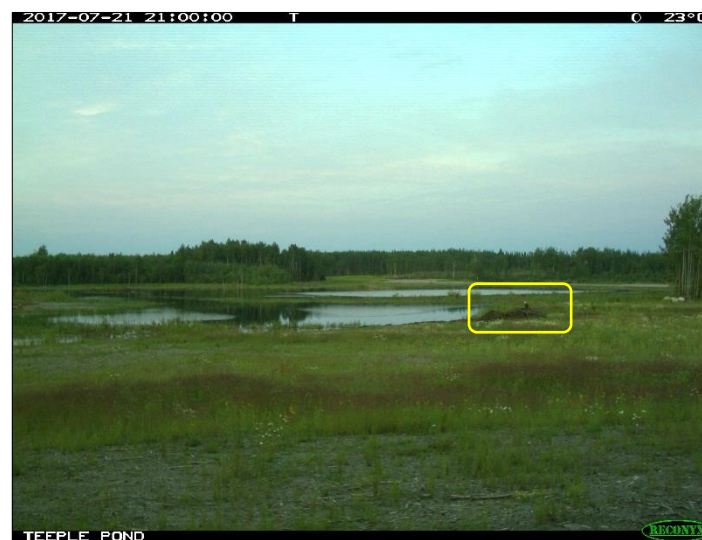
Bald Eagle on outlet debris mound; July 21, 2017
