**NEW GOLD RAINY RIVER MINE
APPENDIX B
EMRS RECORD OF CONSTRUCTION**

2022 EMRS Progressive Reclamation Record of Construction

1003-223-001

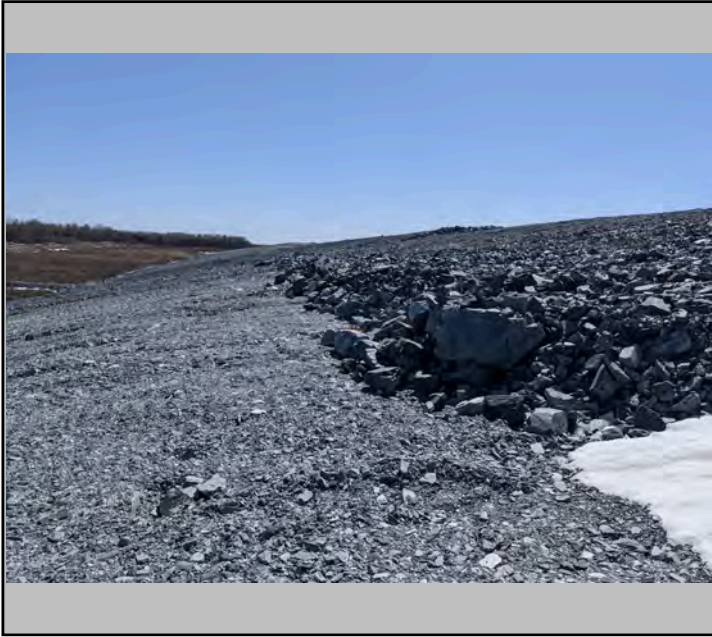
Photo #: 1

EMRS East Slope

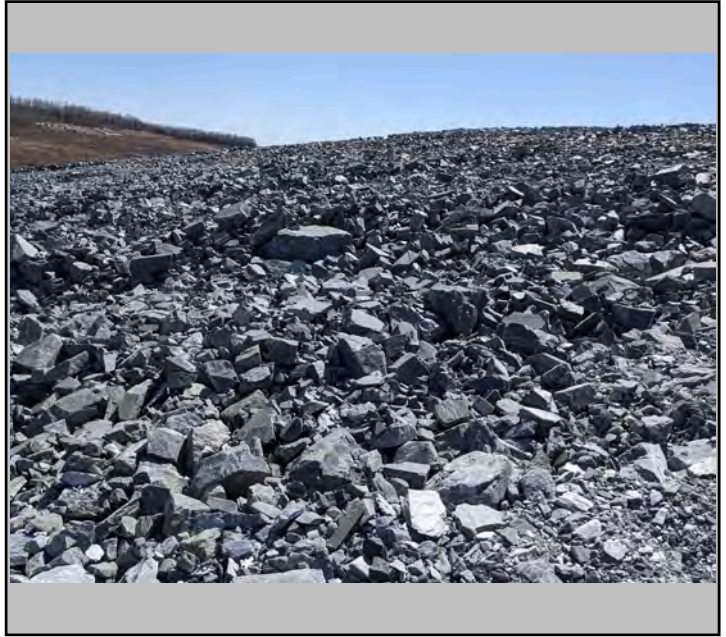
Photo #: 2

EMRS East Slope

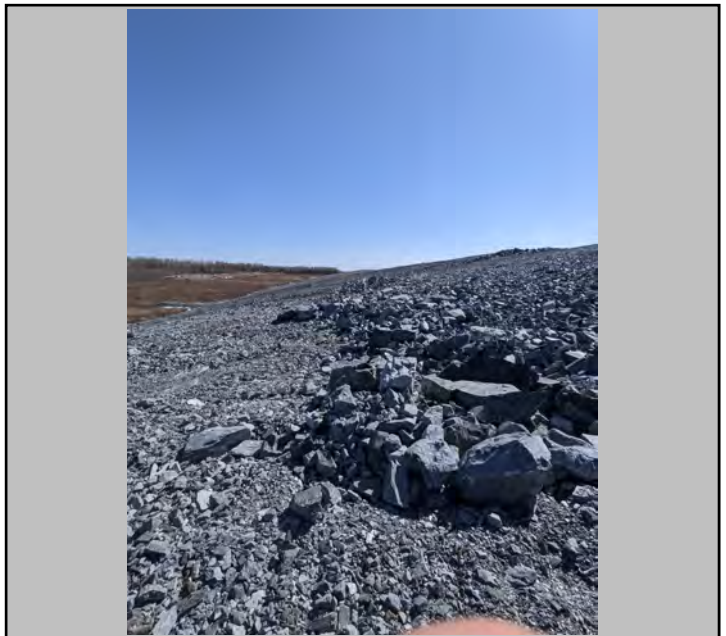
Photo #: 4

EMRS East Slope

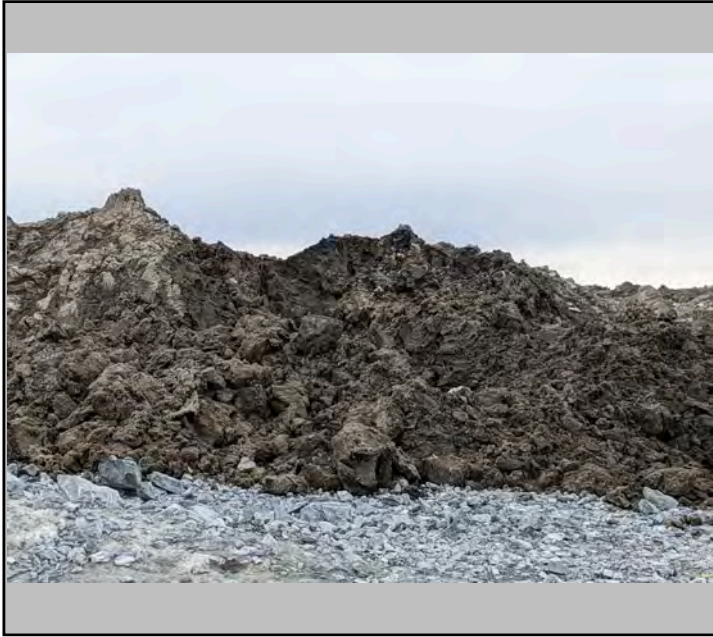
Photo #: 1

Stockpile sampling.

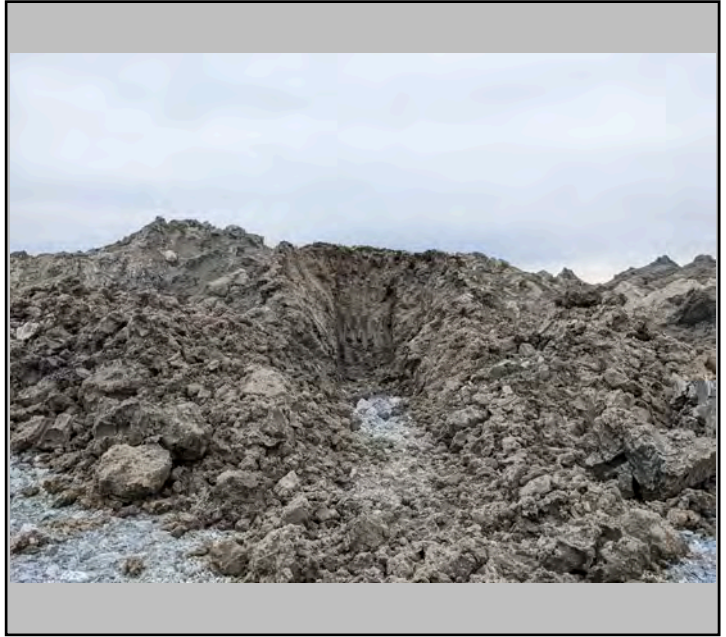
Photo #: 2

Stockpile sampling.

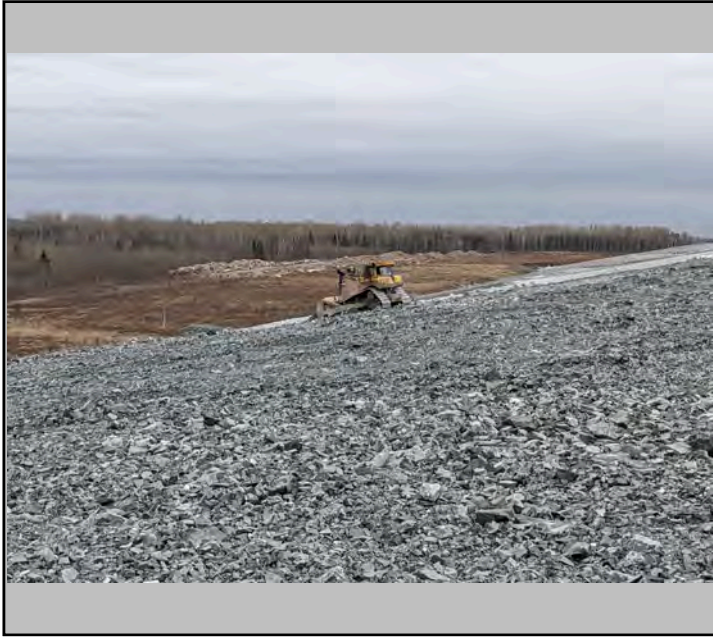
Photo #: 1

D8-2 preparing slope for reclamation.

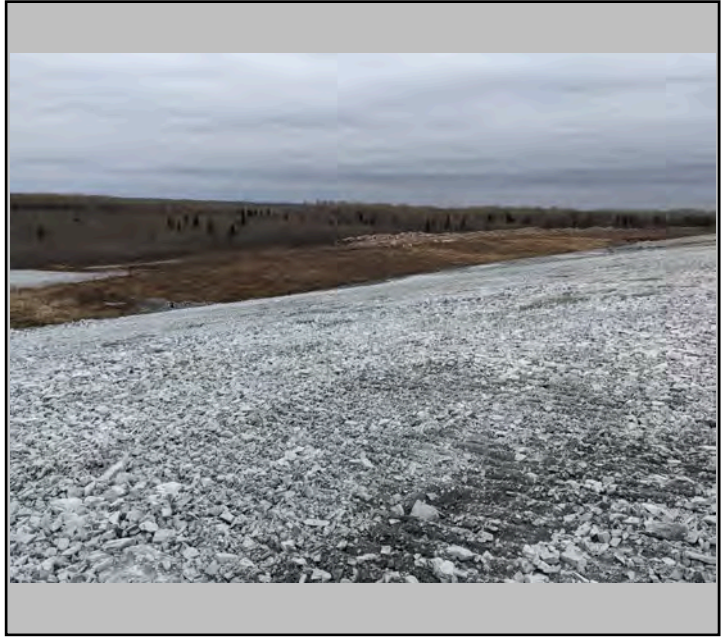
Photo #: 2

D8-2 preparing slope for reclamation.

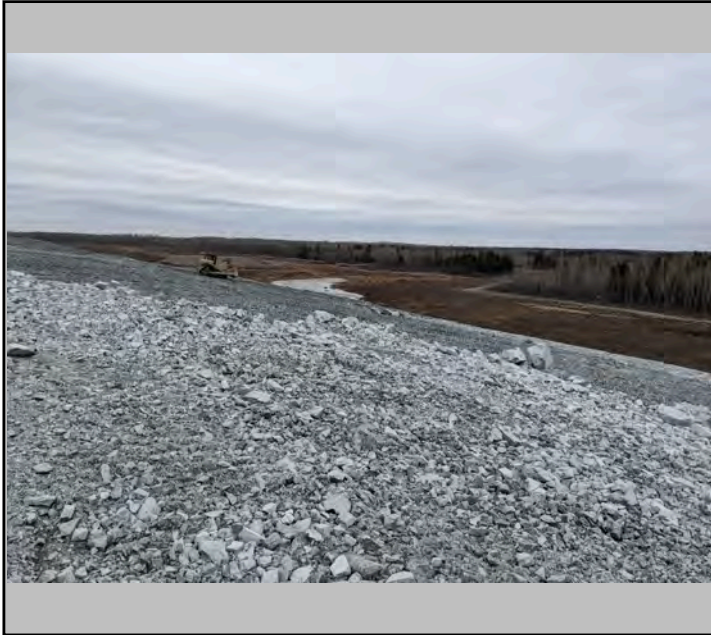
Photo #: 1

D8-2 preparing slope for reclamation work.

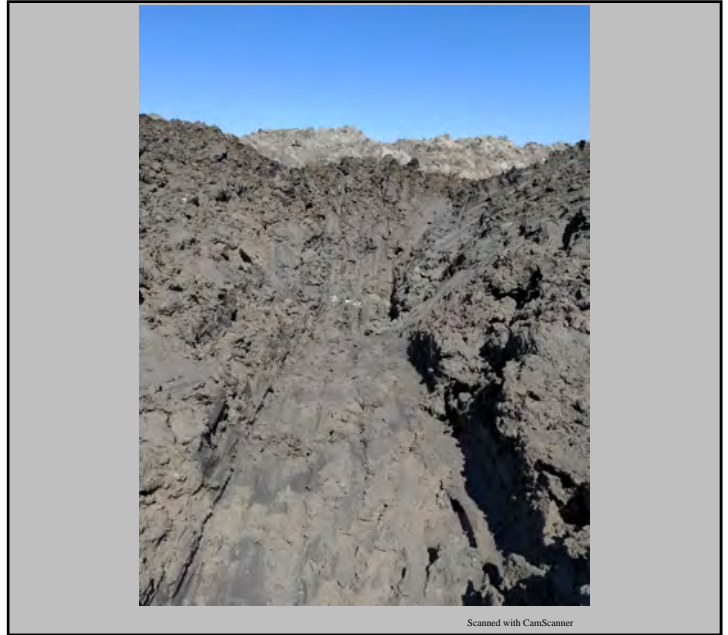
Photo #: 2

Obtained EMRS22_SP_S009_220503.

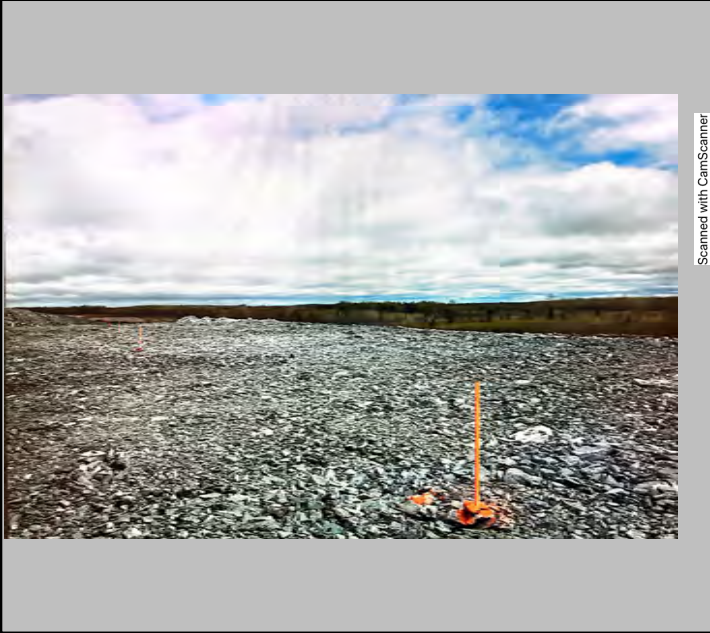
Photo #: 1

Staked line 20m Back from crest.

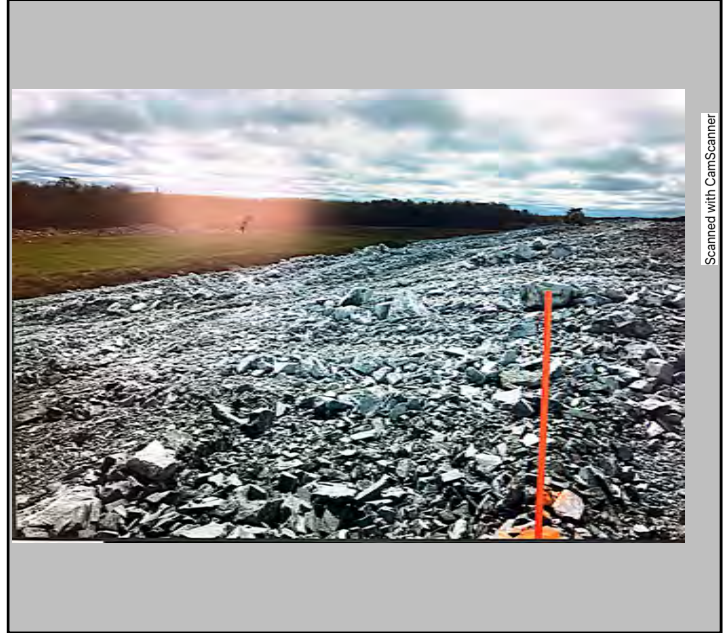
Photo #: 2

418 Dozer preparing slope prior to base survey
from 0+690 - 0+783

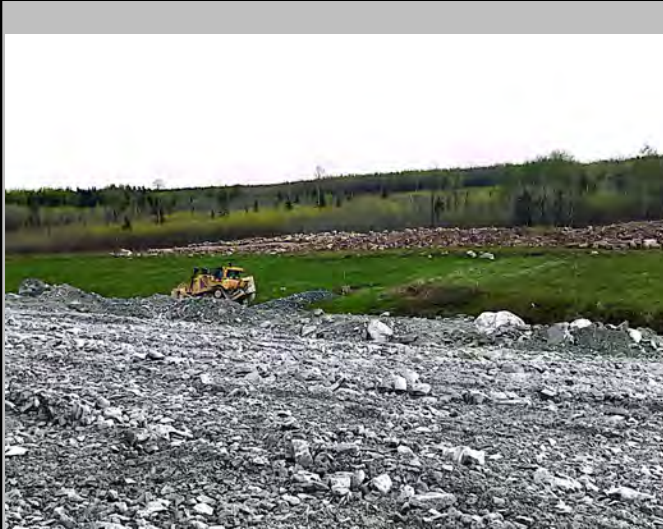
Photo #: 1

418 Dozer preparing slope prior to base survey from 0+690 - 0+783.

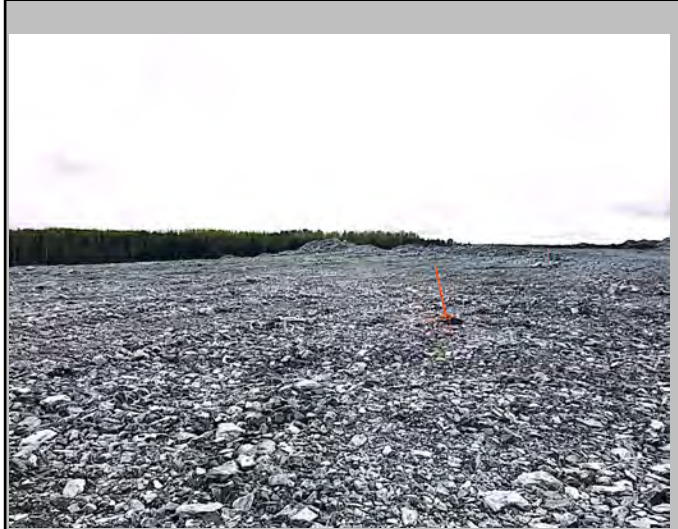
Photo #: 2

Prepared slope ready for base survey.

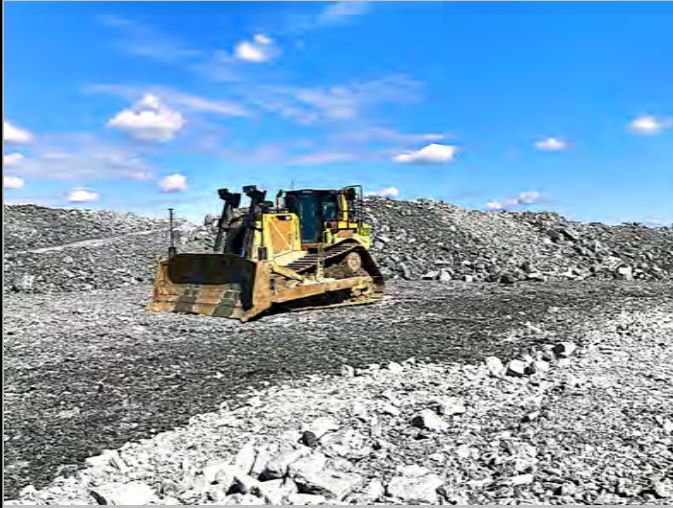
Photo #: 1

420 Dozer arrived at the location

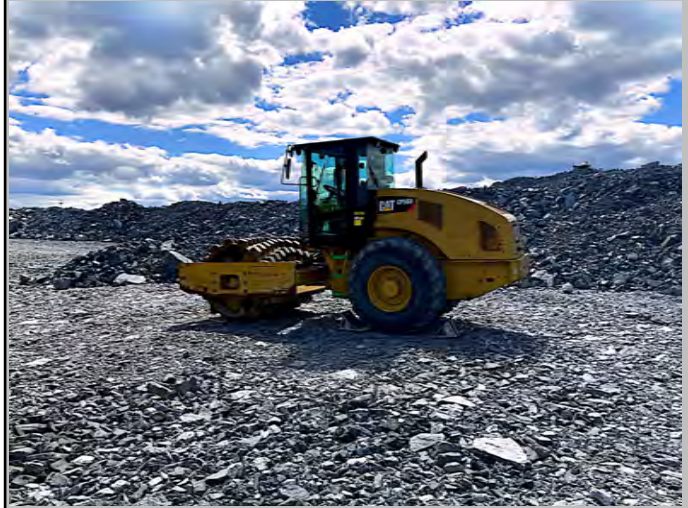
Photo #: 2

Sheep foot roller arrived at location.

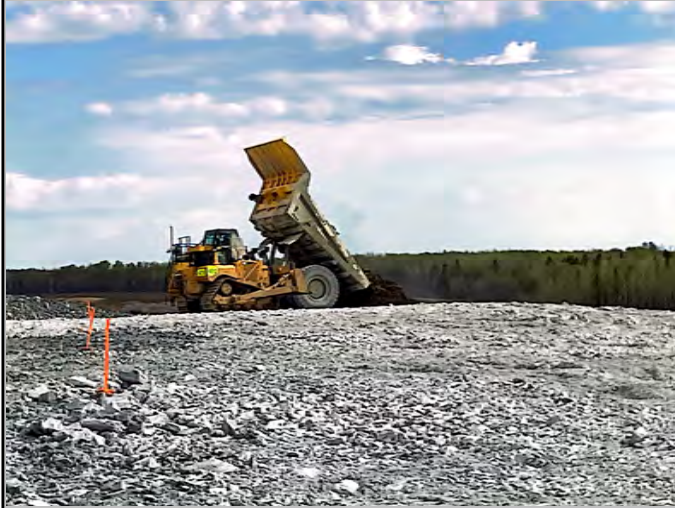
Photo #: 1

Truck 233 dumping CCL panel 30 lift 1. +/-0+700.

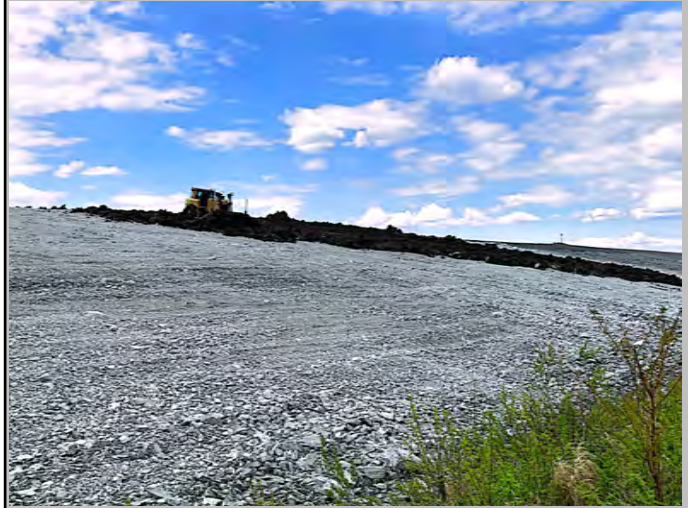
Photo #: 2

Dozer 420 Placing CCL panel 30 lift 1. +/-0+700.

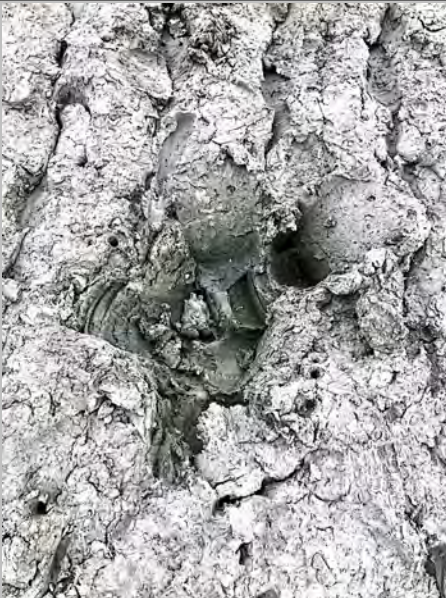
Photo #: 3

Sample:
EMRS22_PR_MC_HY_AT_P30_L1_S509_2200523

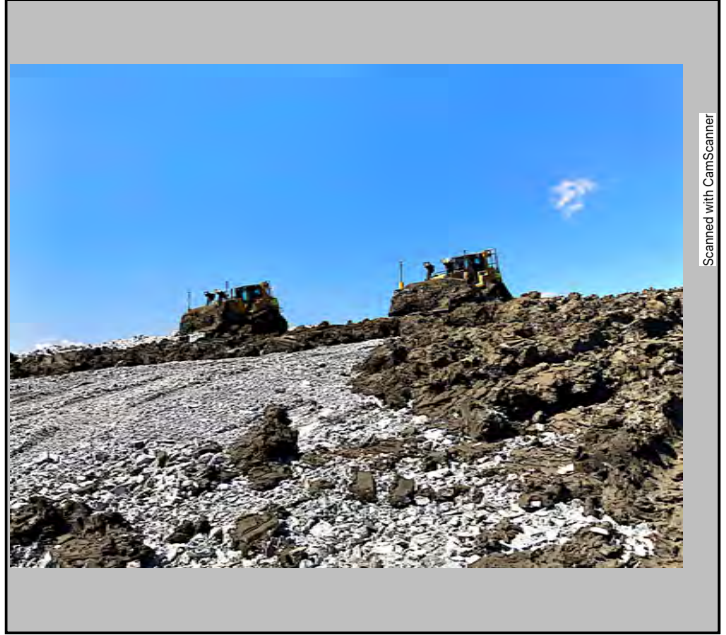
Photo #: 2

Dozer 420 and 421 Placing CCL lift 1 in panel 30

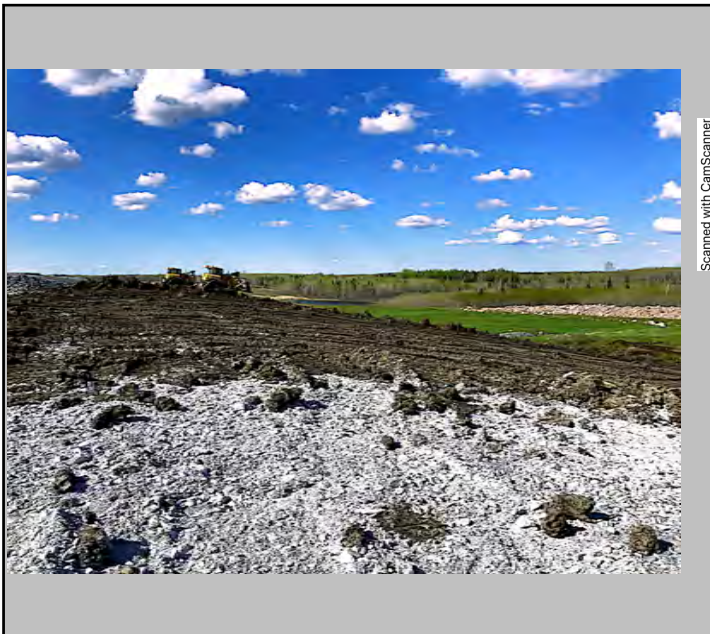
Photo #: 3

Panel 30 Lift 1 mostly placed.

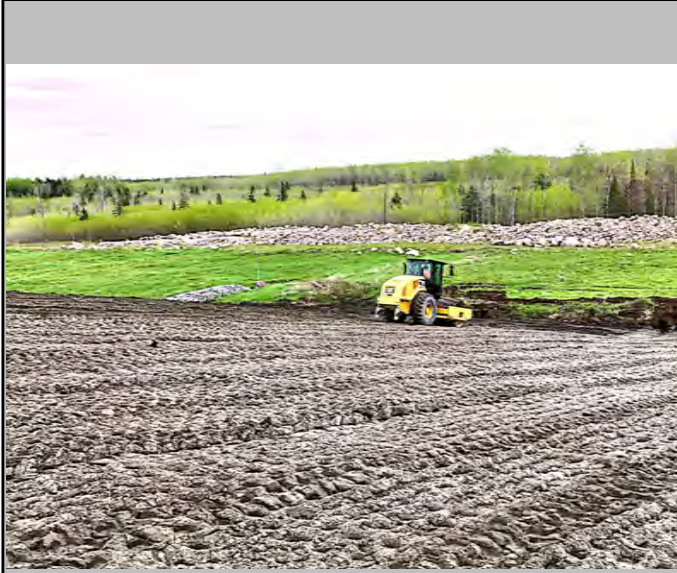
Photo #: 1

Cat CP56B compacting panel 30 Lift 1.

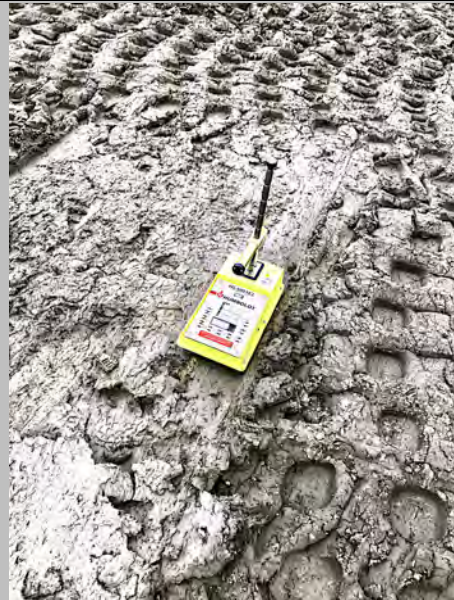
Photo #: 2

Compaction testing.

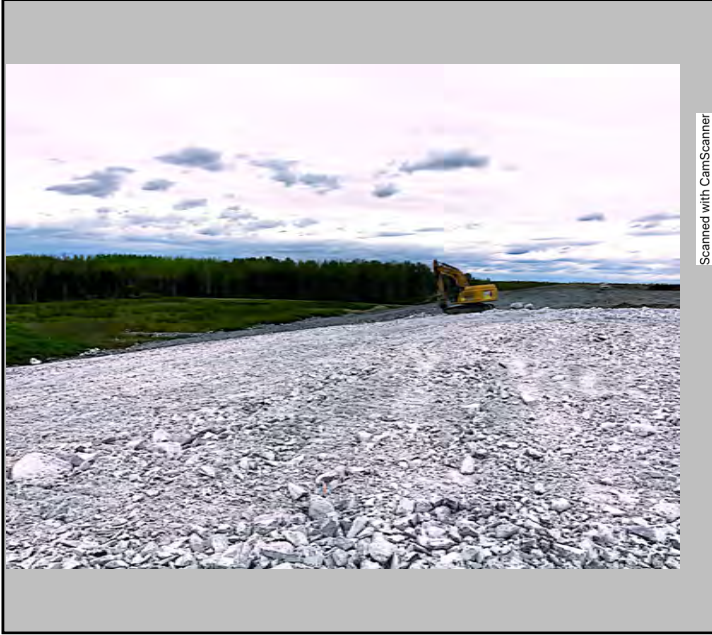
Photo #: 5

Panel 31 slope complete for reclamation.

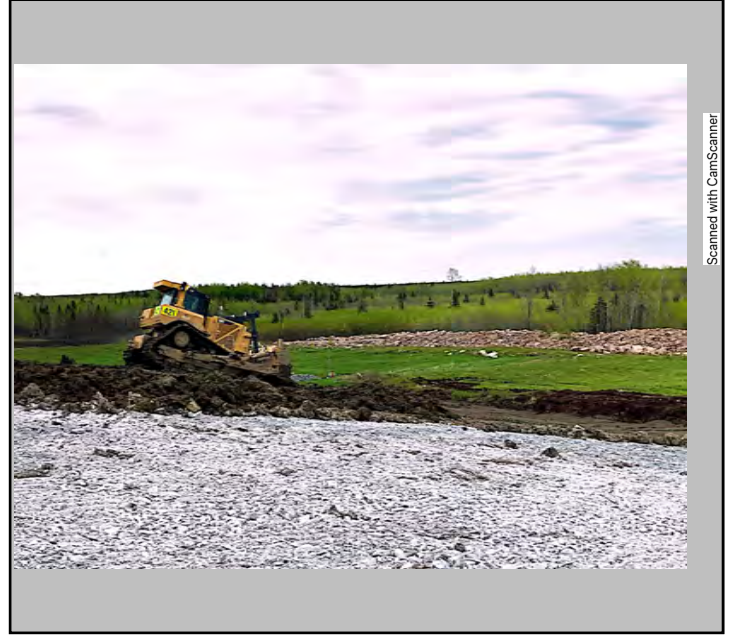
Photo #: 6

Dozer 421 starting CCL lift 2 on panel 30. At the south west corner.

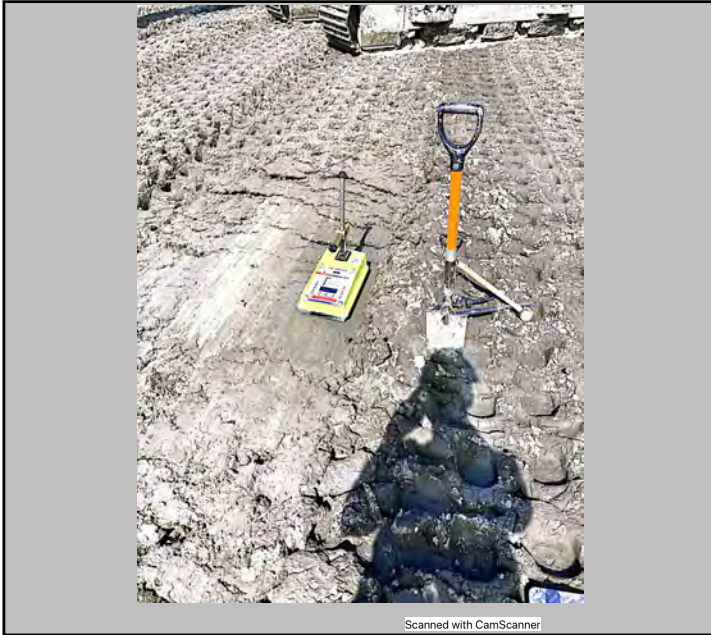
Photo #: 1

Nuclear Gauge compaction test D467.

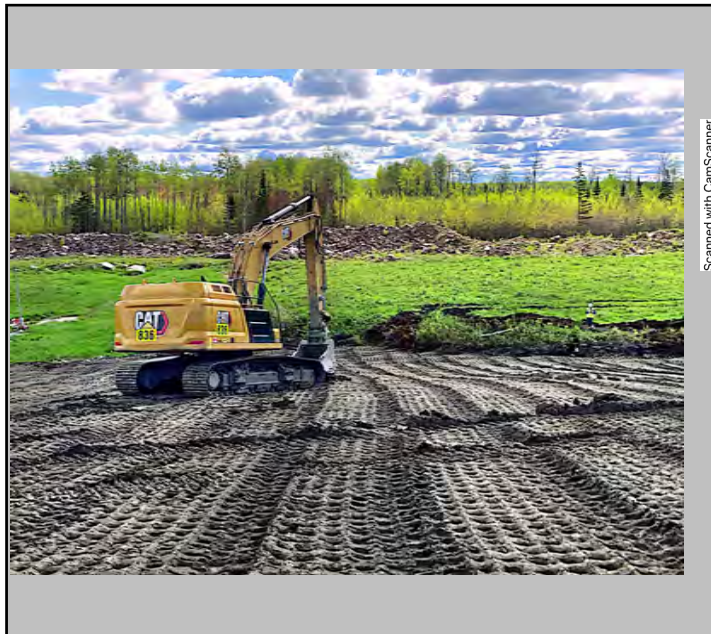
Photo #: 3

Excavator 836 Removing oversize rock.

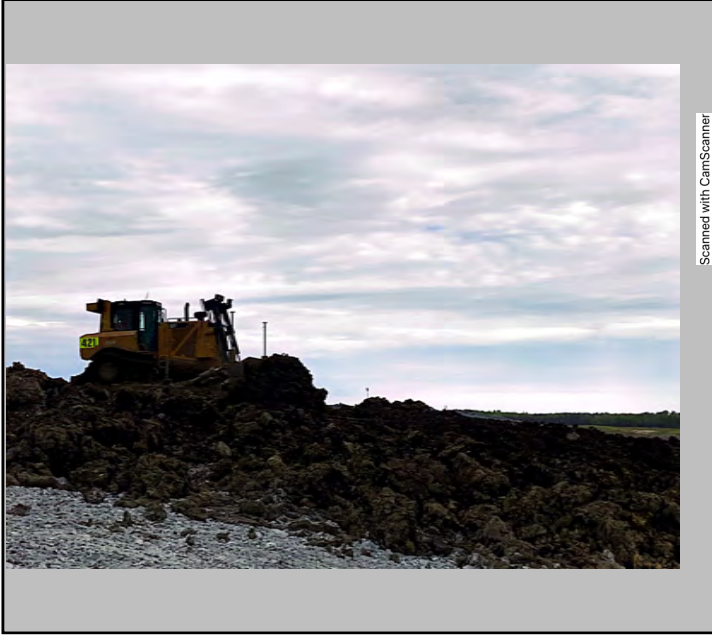
Photo #: 1

421 Dozer placing NCL Panel 30 Lift 3.

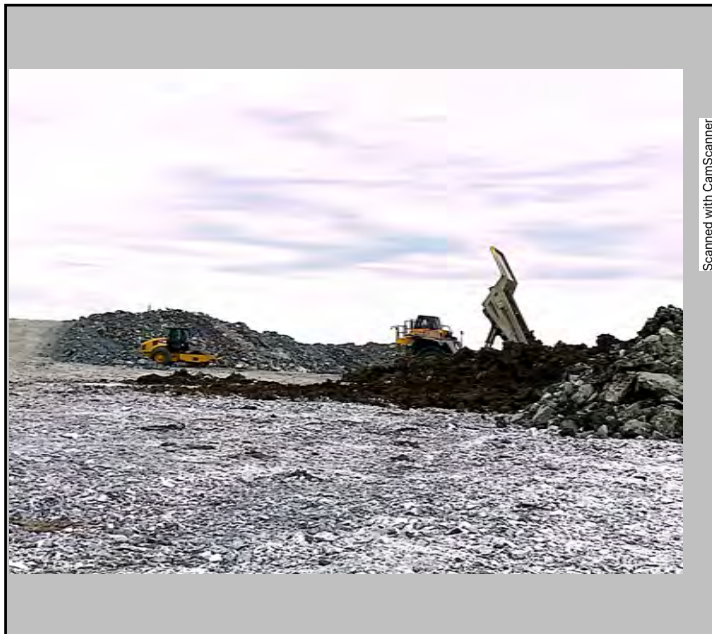
Photo #: 3

235 Truck dumping NCL material at Panel 30 for Lift 3.

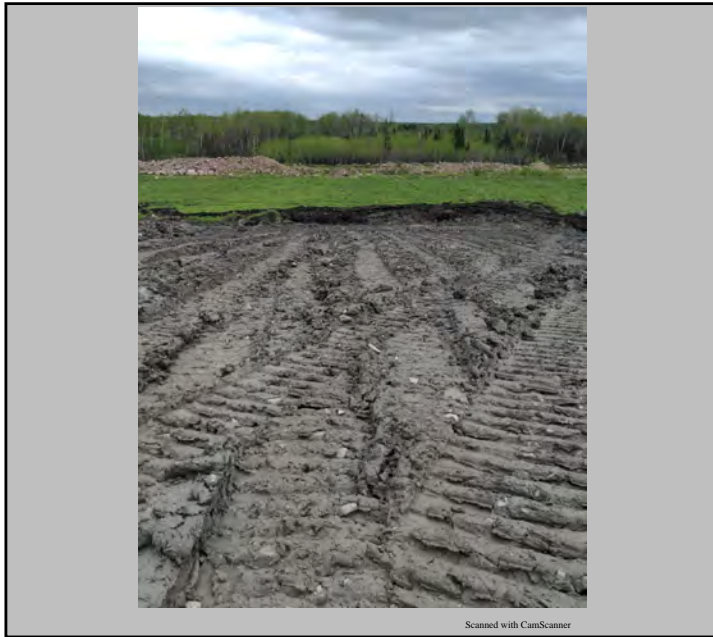
Photo #: 1

Panel 30 NCL Lift 3 placement.

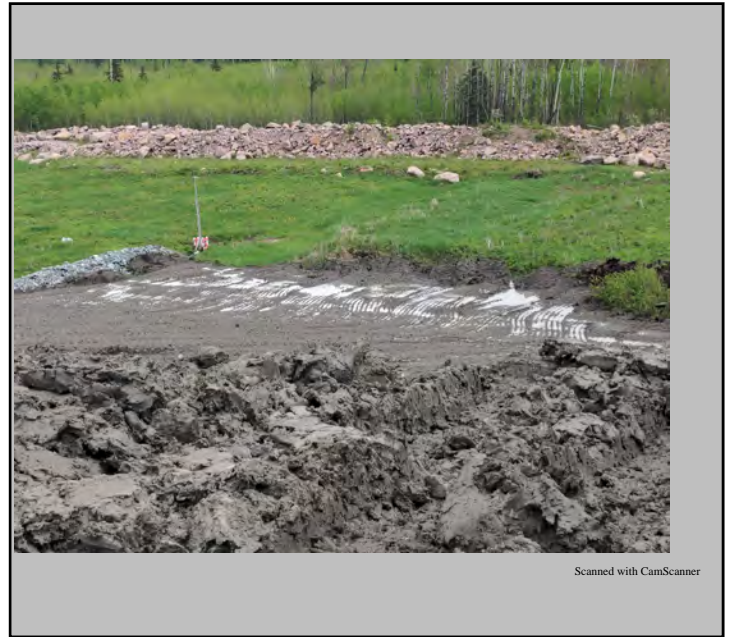
Photo #: 2

Water pooling after rain storm on Panel 30 CCL Lift 2.

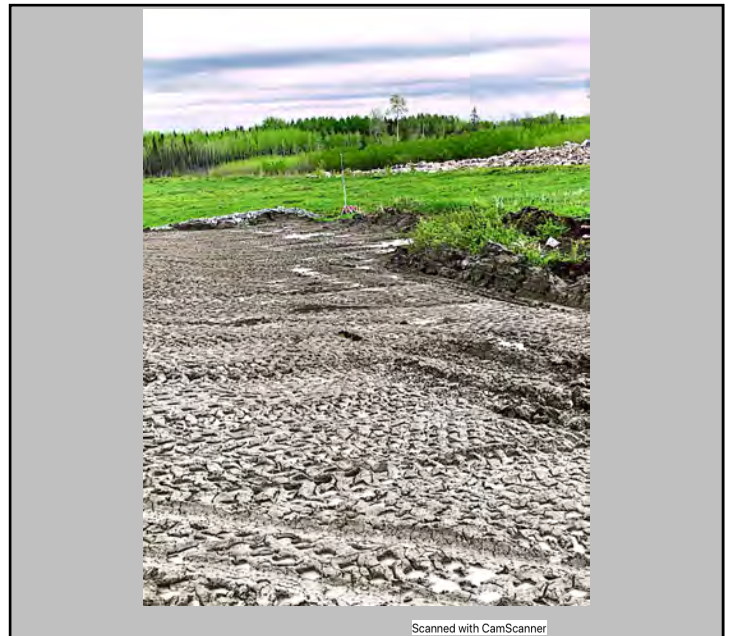
Photo #: 4

Water pooling after rain storm on Panel 30 CCL Lift 2.

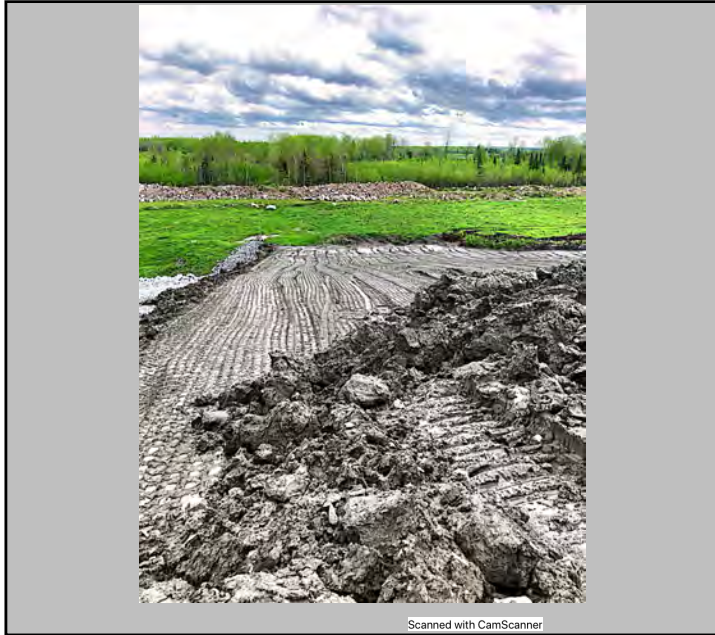
Photo #: 1

Panel 30 CCL Lift 2.

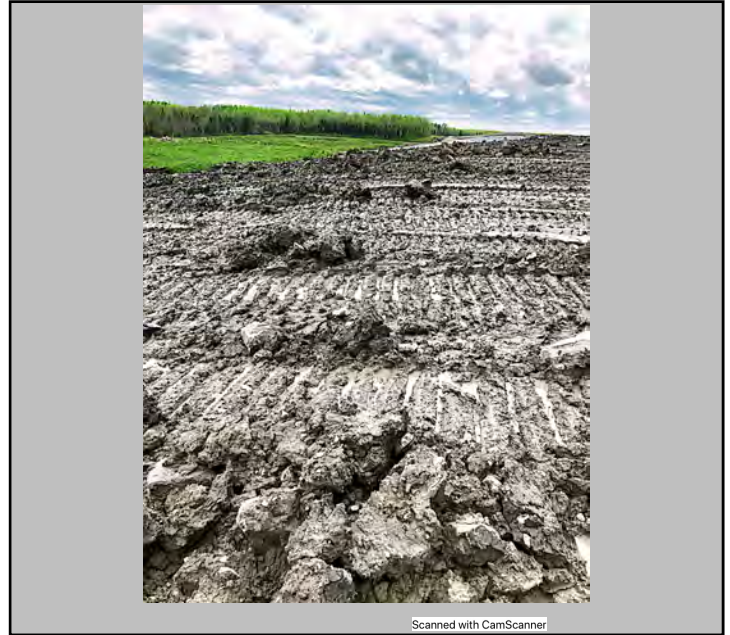
Photo #: 2

Panel 30 NCL Lift 3.

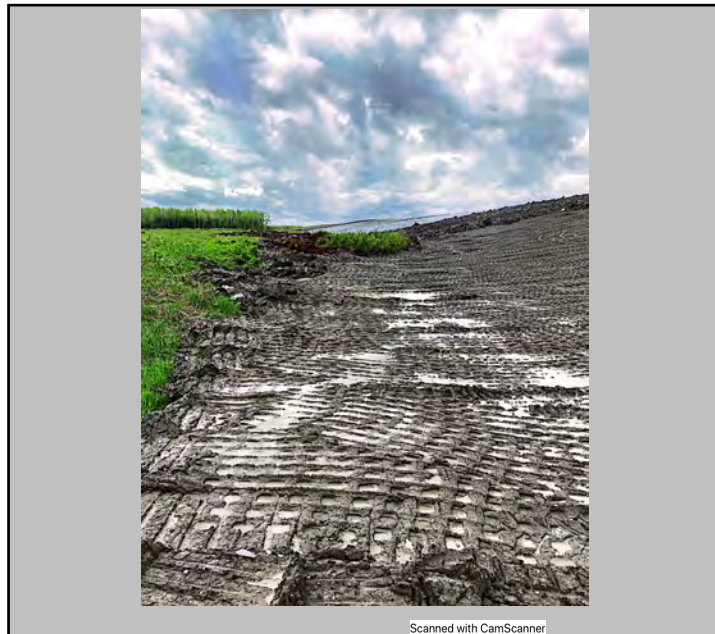
Photo #: 3

Water pooling on the Panel 30 CCL Lift 2.

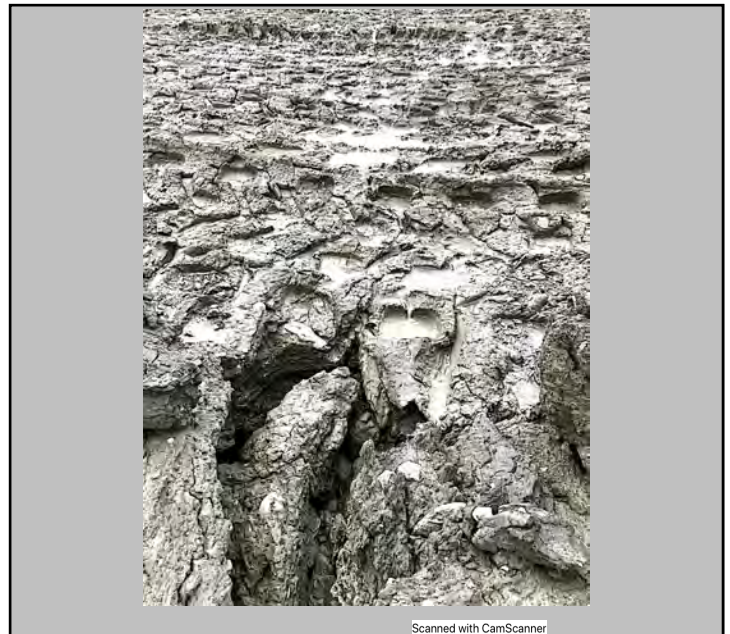
Photo #: 4

Heavy saturated clay after rain.

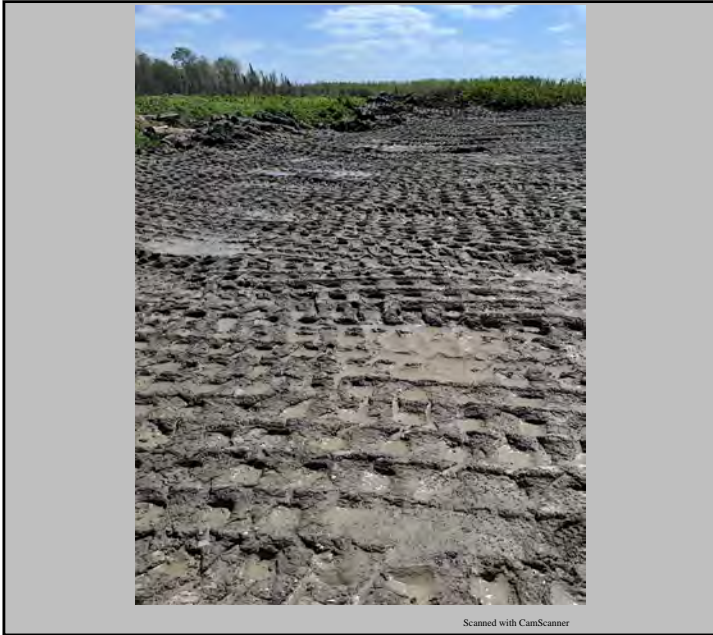
Photo #: 1

Panel 30 CCL Lift 2.

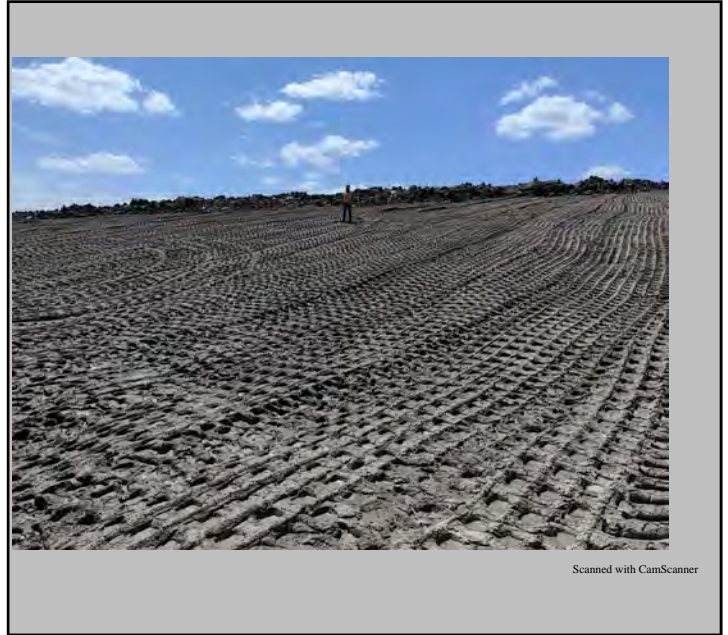
Photo #: 2

Panel 30 CCL Lift 2.

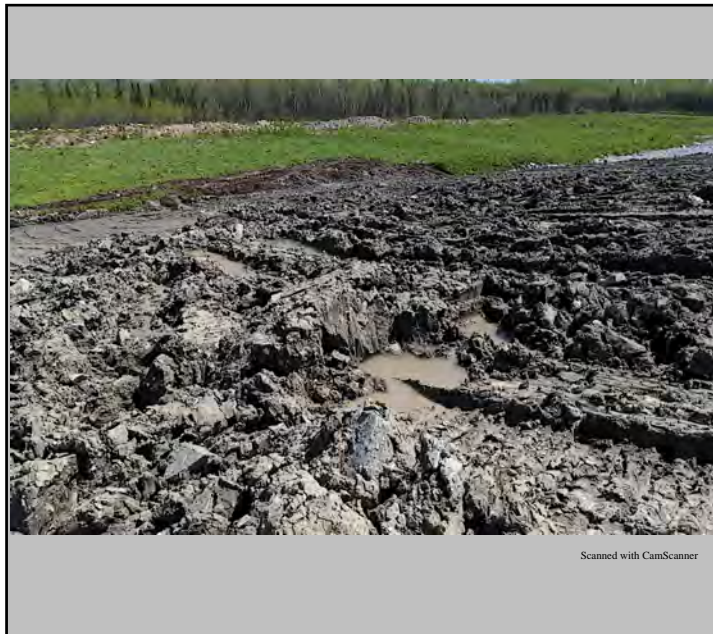
Photo #: 3

Panel 30 NCL Lift 3.

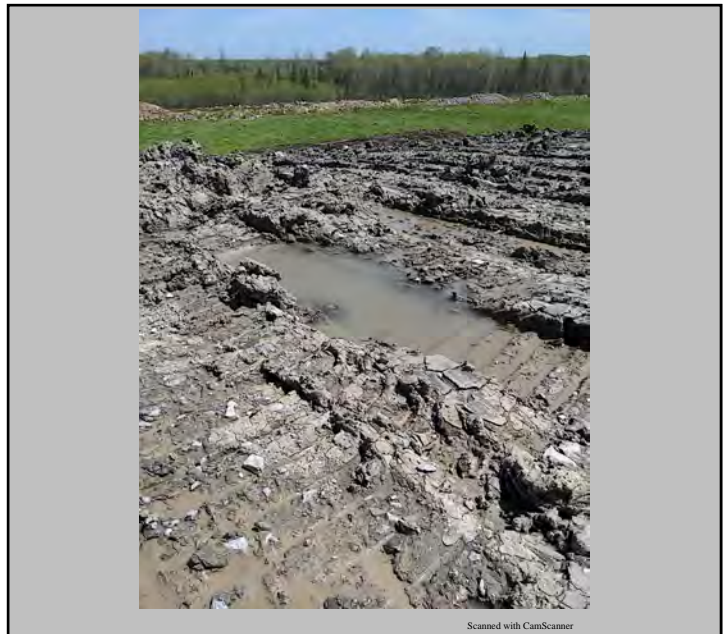
Photo #: 4

Panel 30 NCL Lift 3.

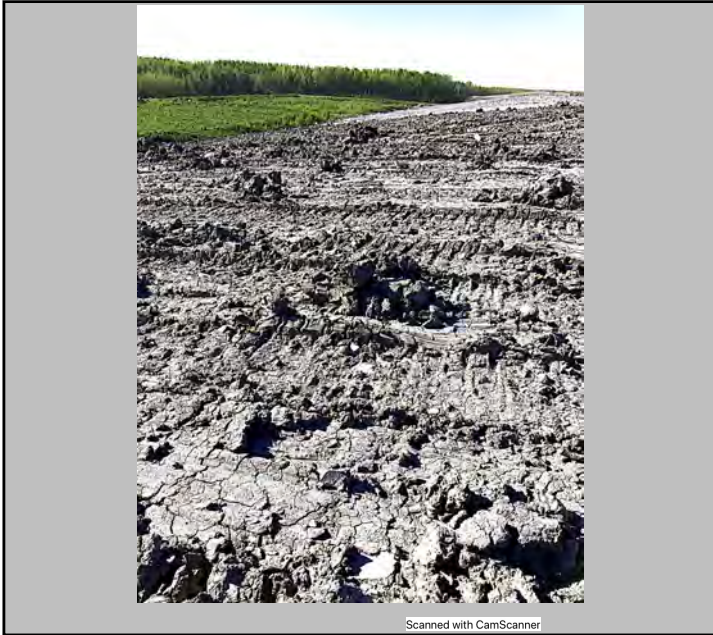
Photo #: 1

Panel 30 NCL Lift 3

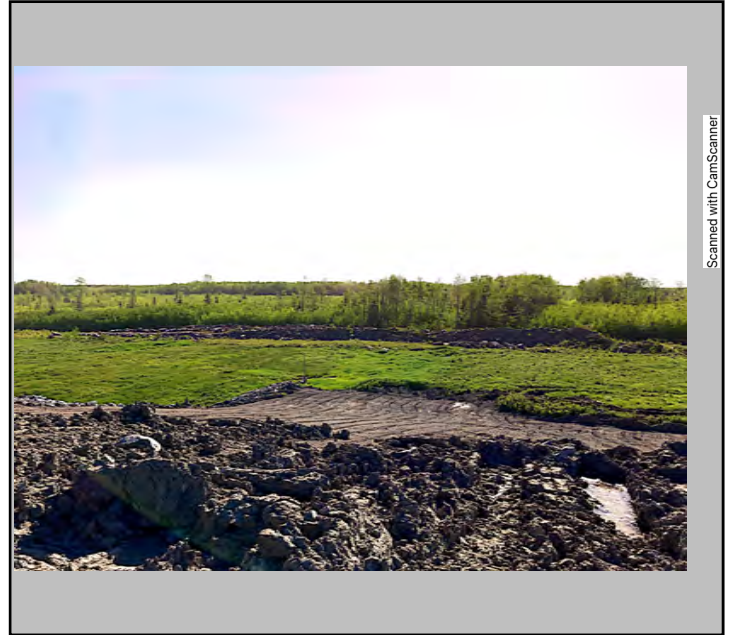
Photo #: 2

Panel 30 NCL Lift 3 and CCL Lift 2

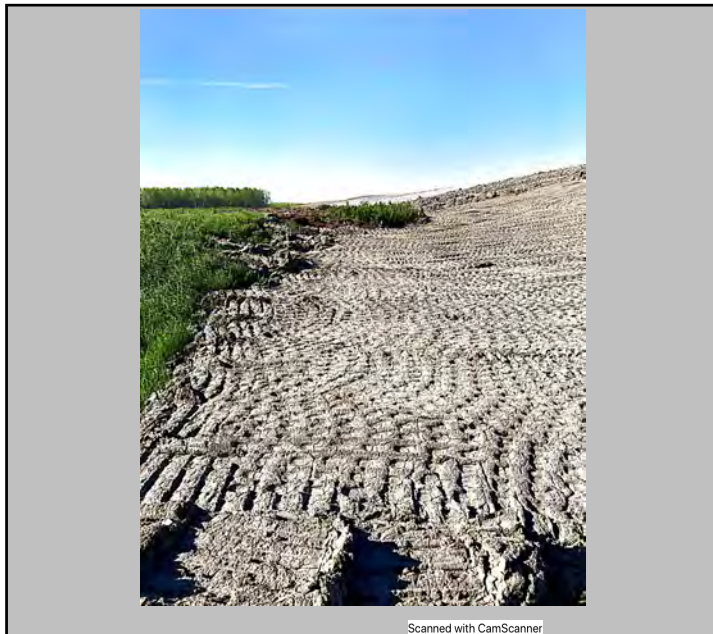
Photo #: 3

Panel 30 CCL Lift 2

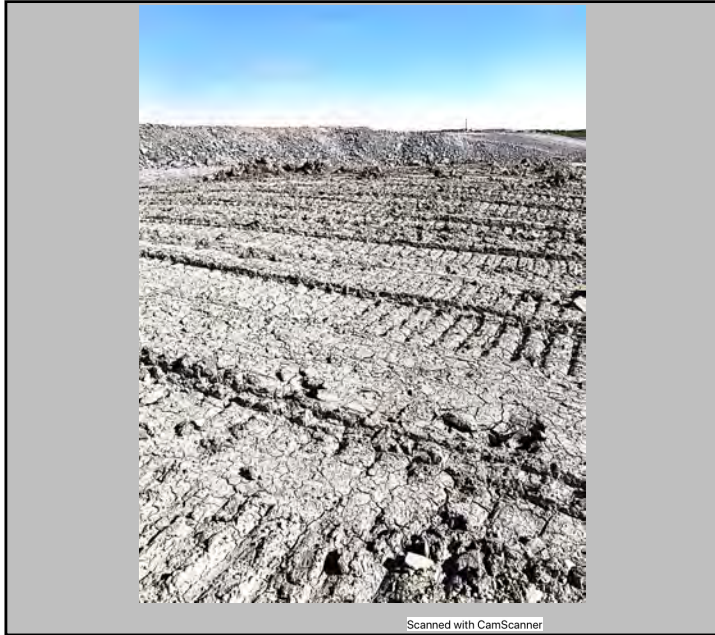
Photo #: 1

Panel 30 NCL lift 3.

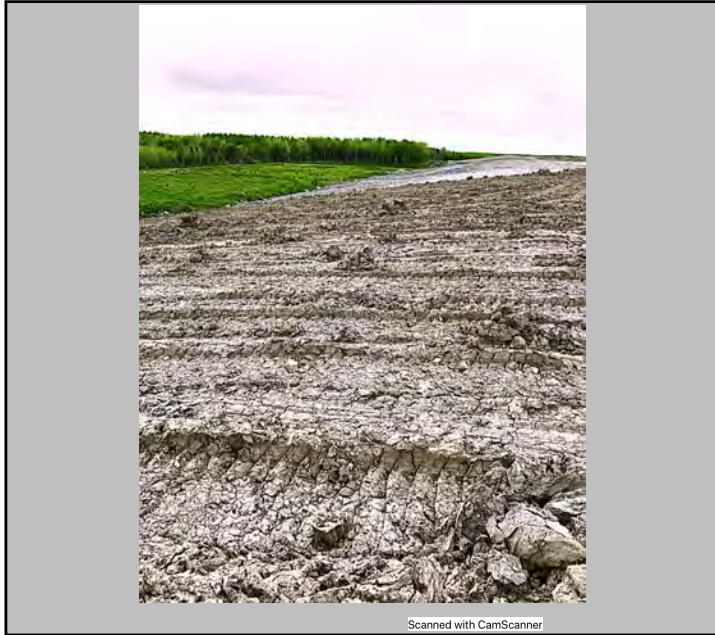
Photo #: 1

Panel 30 NCL Lift 3

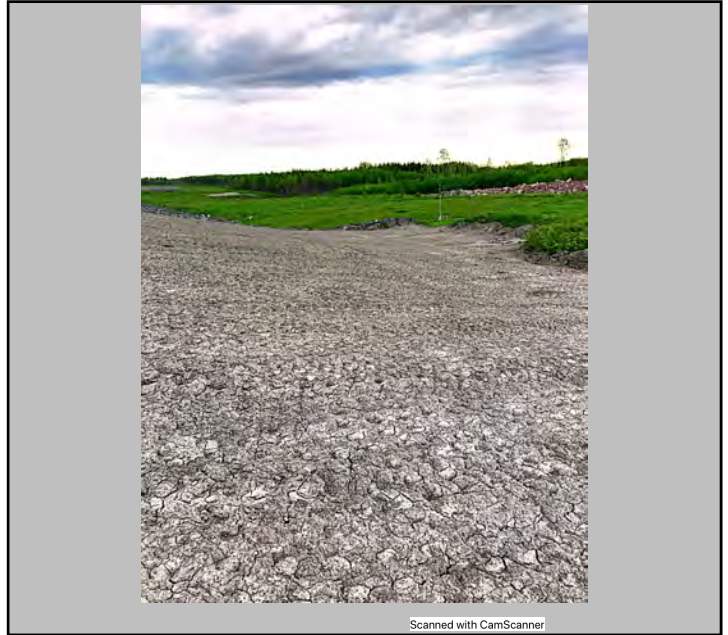
Photo #: 2

Panel 30 CCL Lift 2

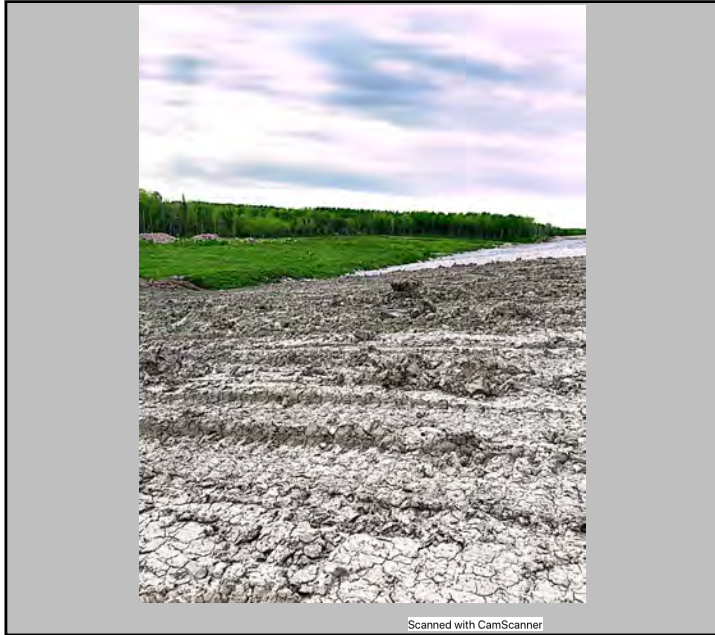
Photo #: 1

Panel 30 NCL Lift 3

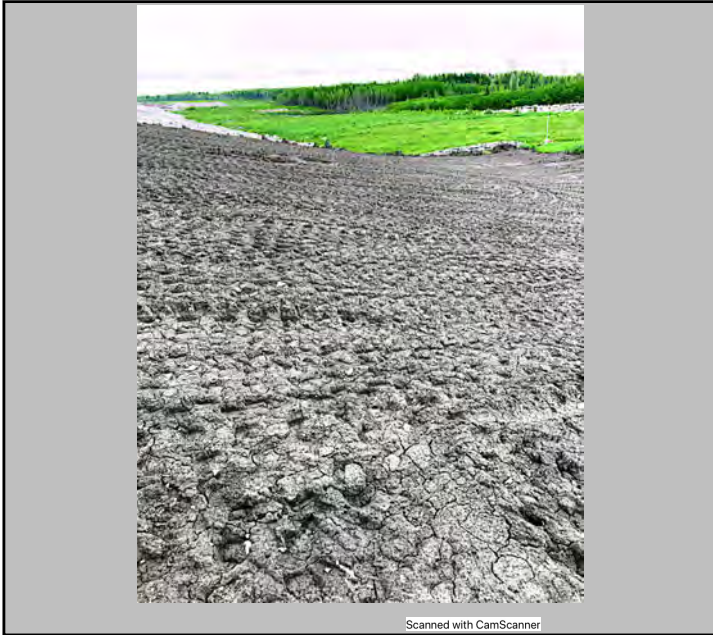
Photo #: 1

Panel 30 CCL Lift 2 has desiccation on the exposed portion. Rain visually added moisture to the surface.

Panel 30 CCL Lift 2

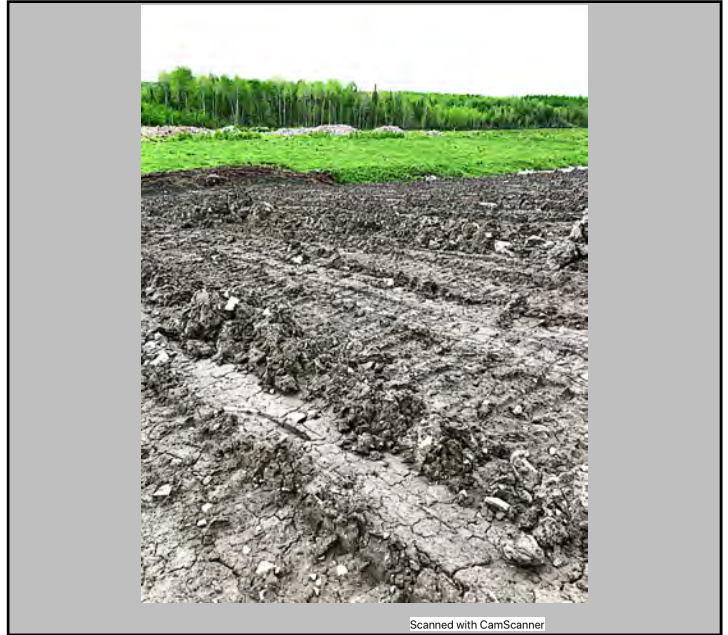
Photo #: 2

Panel 30 NCL Lift 3, Material has dried on the surface and has some sections retaining standing water. Rain visually added moisture to the surface.

Panel 30 NCL Lift 3

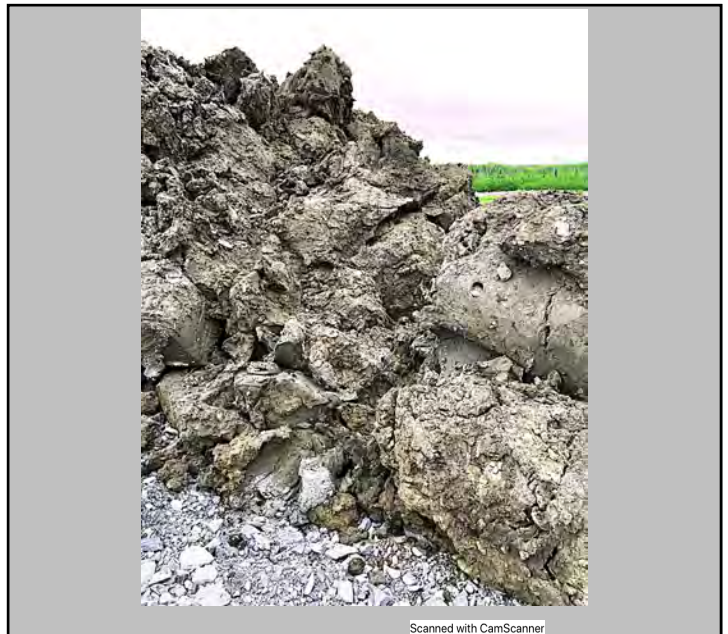
Photo #: 4

Clay material stockpiled on crest of Panel 31 and 32.

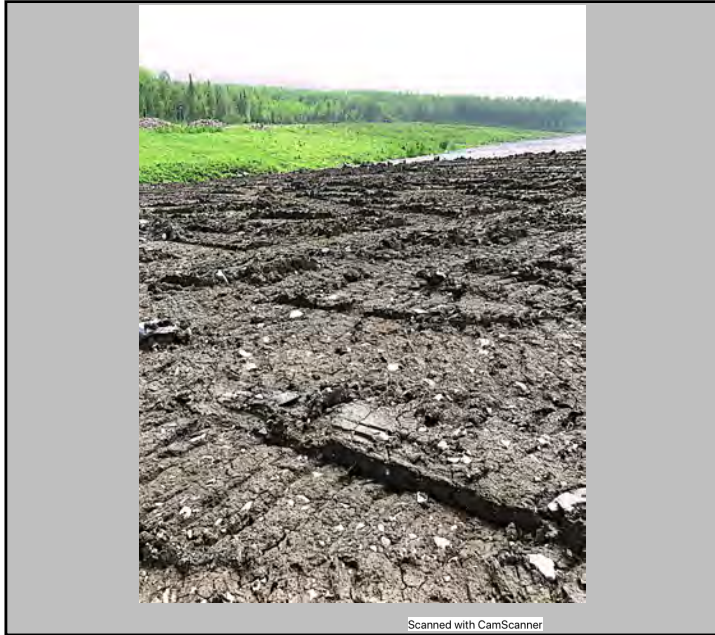
Photo #: 1

Panel 30 NCL Lift 3, Material had dried on the surface and has some sections retaining standing water. Rain visually added moisture to the surface.

Panel 30 NCL Lift 3

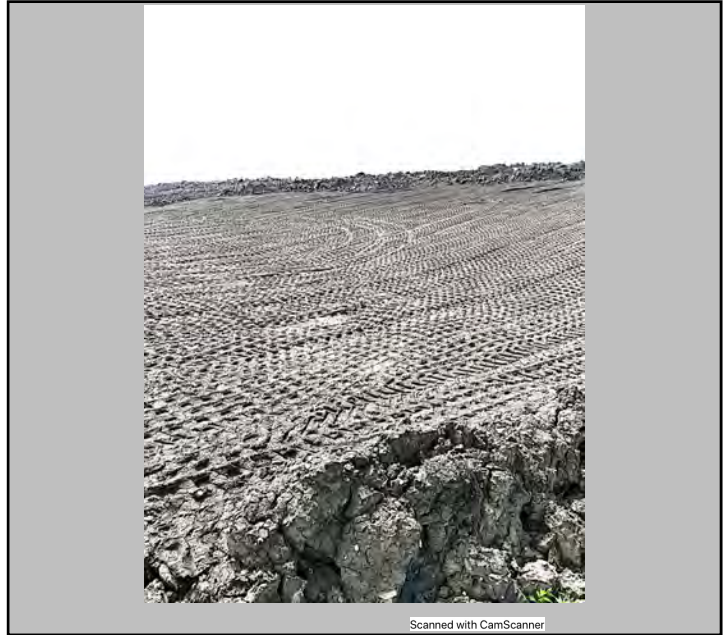
Photo #: 2

Panel 30 CCL Lift 2 has desiccation on the exposed portion. Rain visually added moisture to the surface.

Panel 30 CCL Lift 2
