**NEW GOLD RAINY RIVER MINE
APPENDIX B
EMRS RECORD OF CONSTRUCTION**

2022 EMRS Progressive Reclamation Record of Construction

1003-223-001

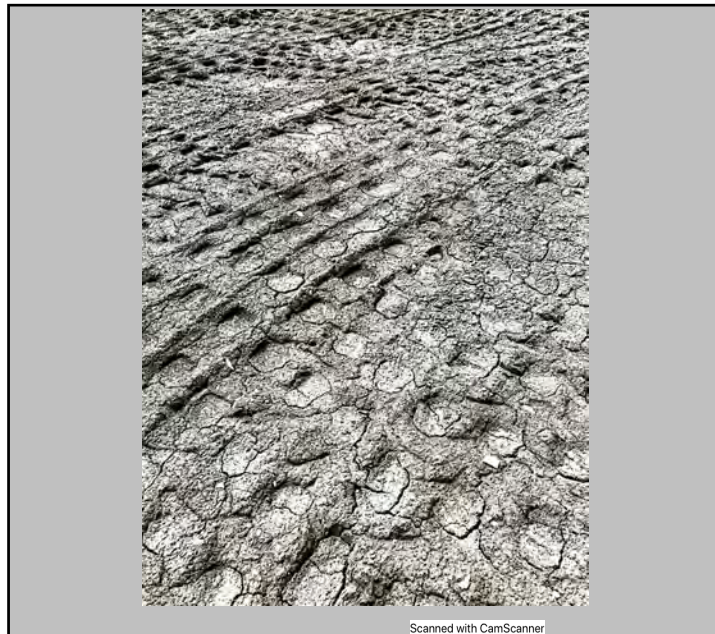
Photo #: 3

Panel 30 CCL Lift 2 has desiccation on the exposed portion. Rain visually added moisture to the surface.

Panel 30 CCL Lift 2

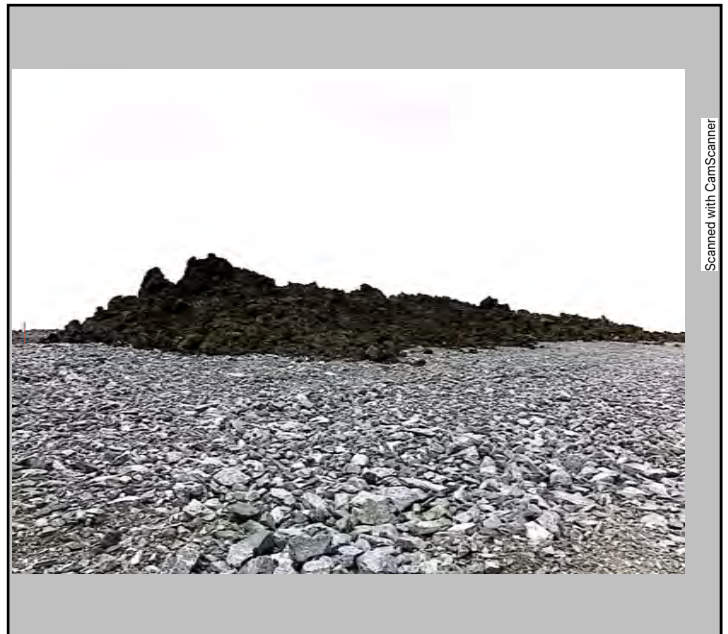
Photo #: 4

Clay material stock piled on crest from STA 0 +693 to 0+600

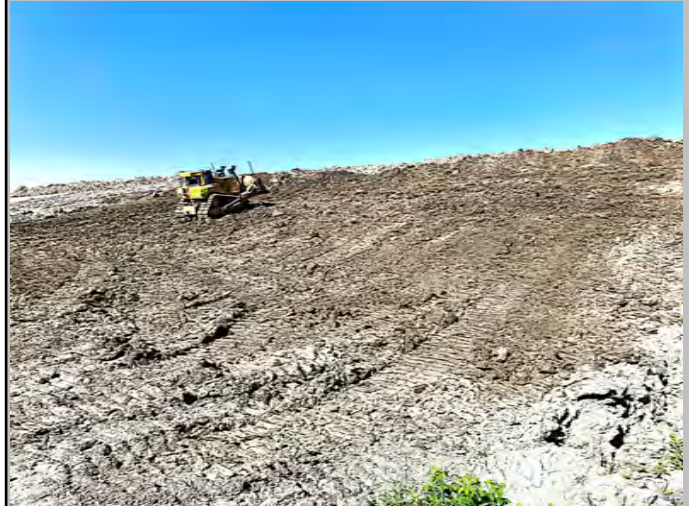
Photo #: 2

Dozer 421 re-working exposed CCL L2 in P30.

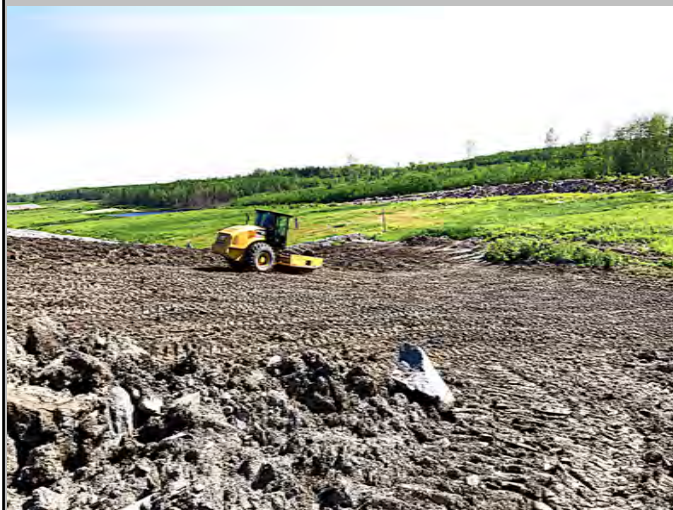
Photo #: 3

Packer on exposed section of CCL L2 in P30.

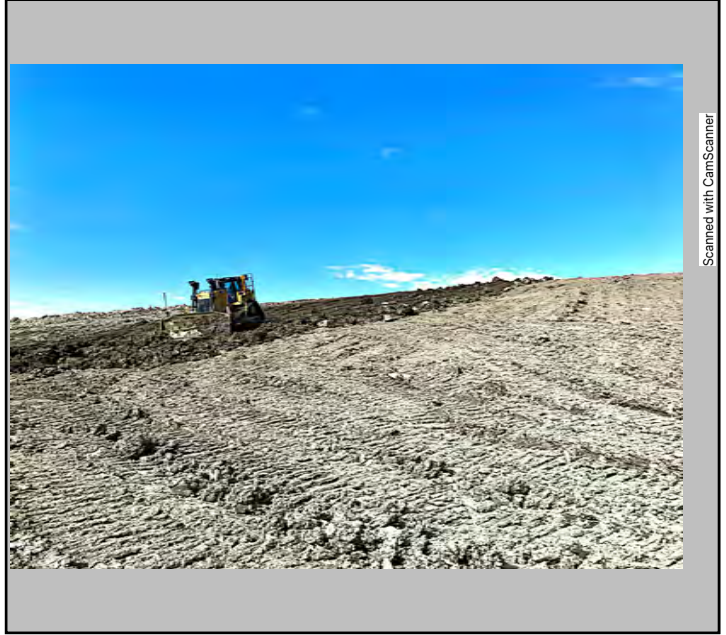
Photo #: 2

Dozer 420 Placing NCL Lift 3 on Panel 30.

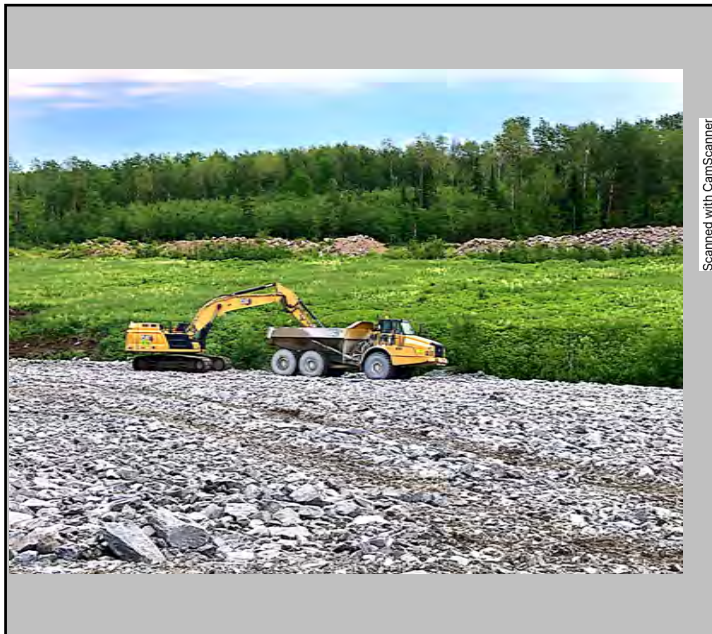
Photo #: 3

Excavator 836 removing oversize rock from toe of rock slope south of STA 0+661.

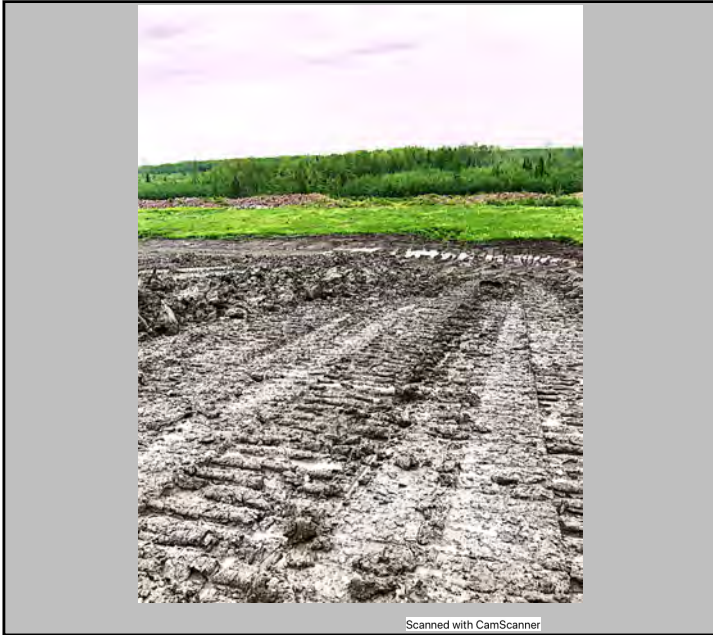
Photo #: 1

P31 L3/L4 water pooling on surface.

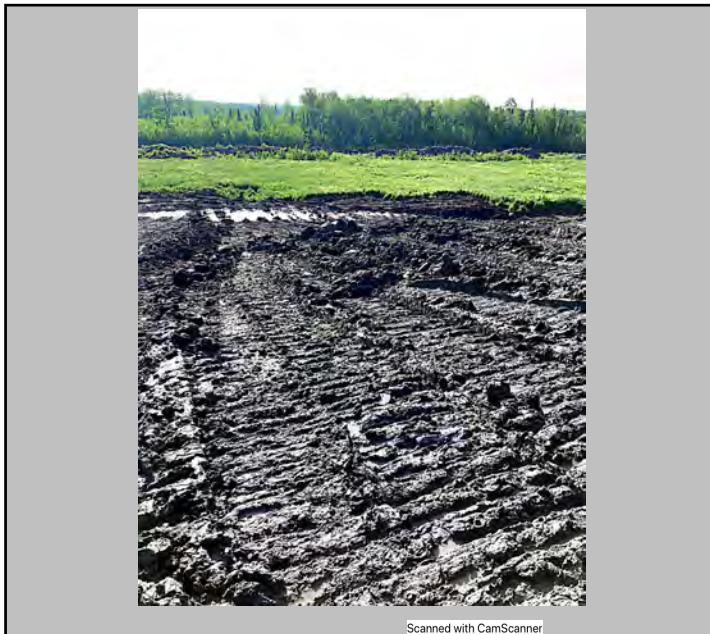
Photo #: 3

Panel 31, Morning. Standing water visible at toe.

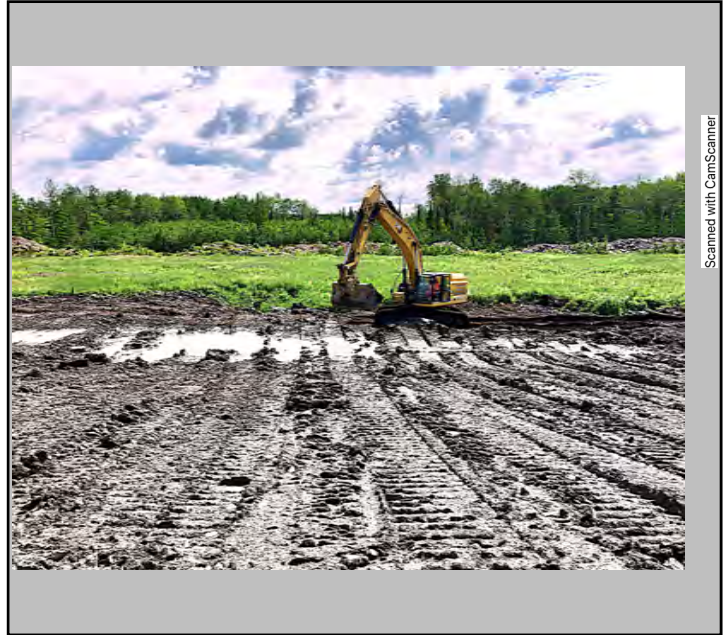
Photo #: 6

Excavator 836 creating drainage paths for standing water on P31.

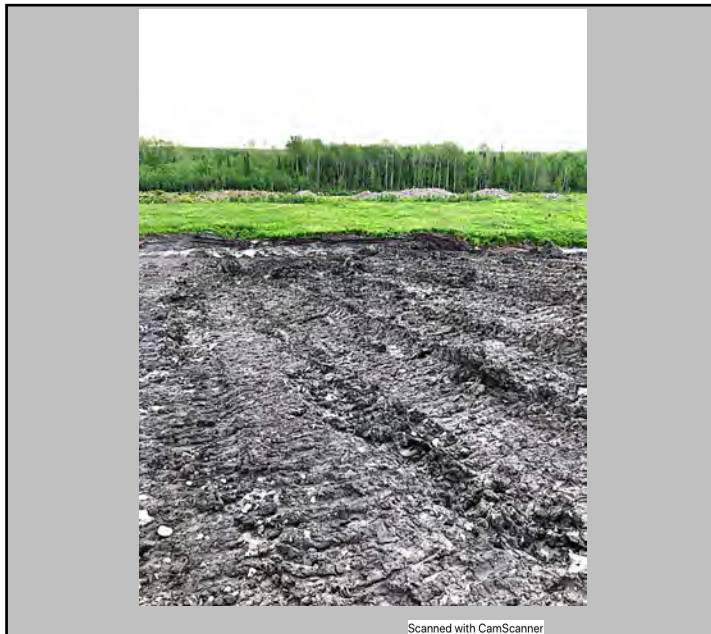
Photo #: 7

P31 L3/L4 some standing water in the morning

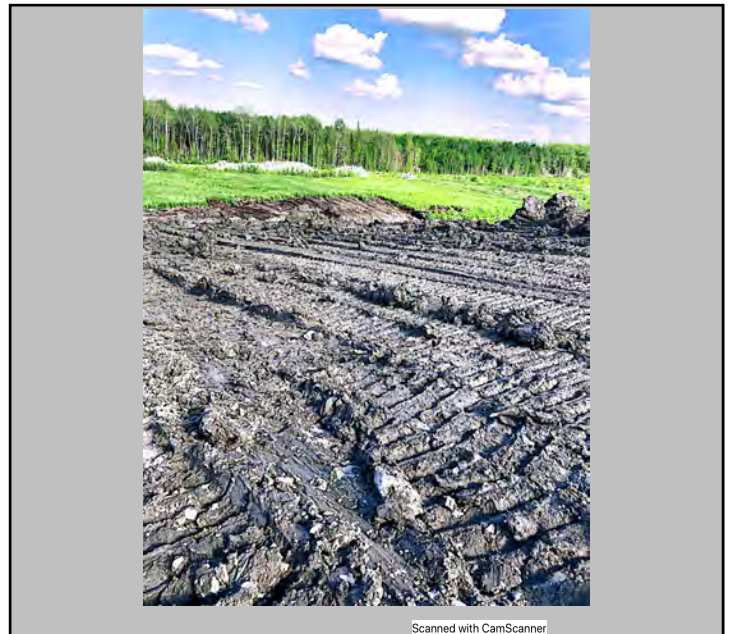
Photo #: 8

P31 mostly dried and workable in the afternoon.

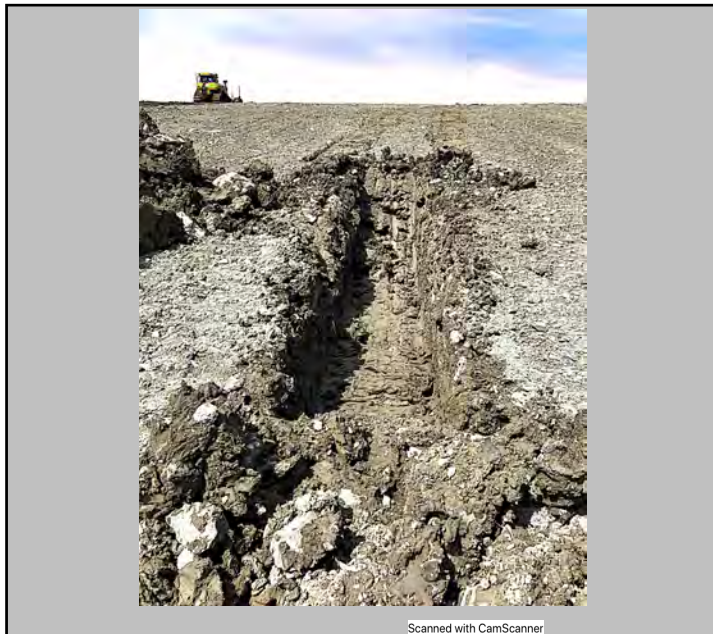
Photo #: 7

Excavated hydraulic conductivity testing location.

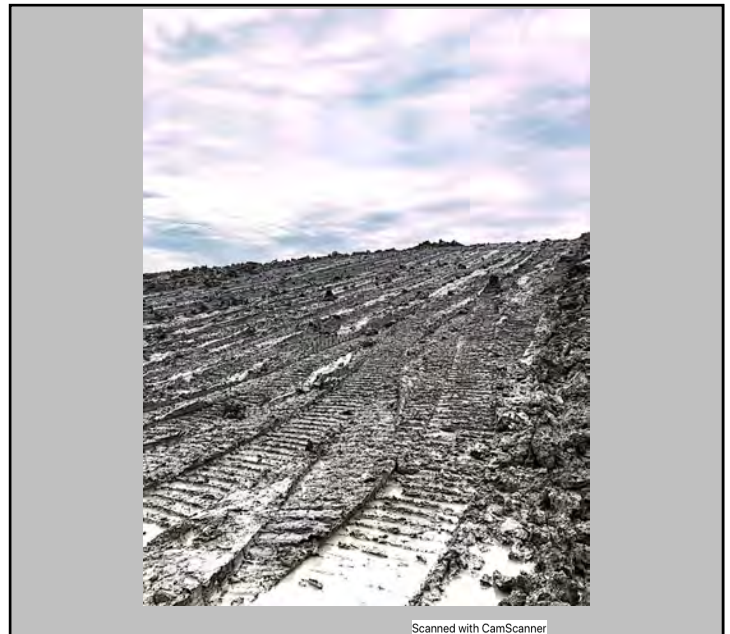
Photo #: 4

NCL L3 P32 full coverage finishing work still required.

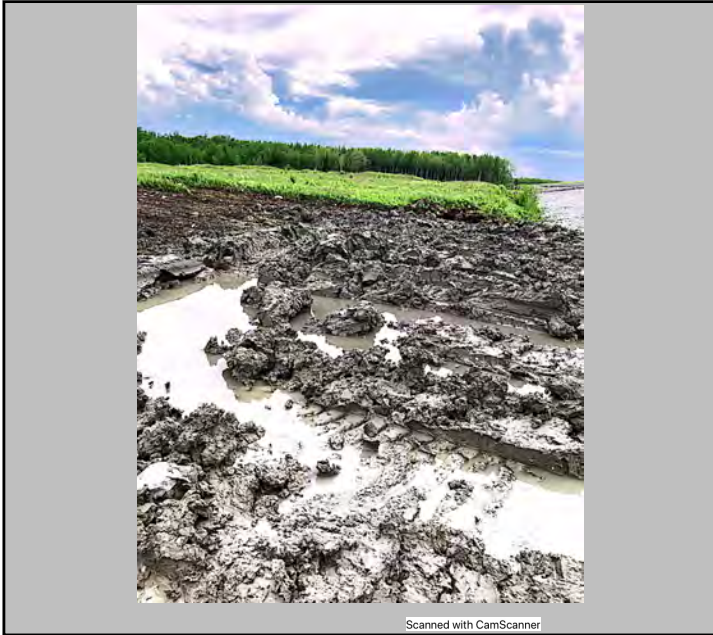
Photo #: 5

Standing water on the toe of NCL L3 P32 after rain.

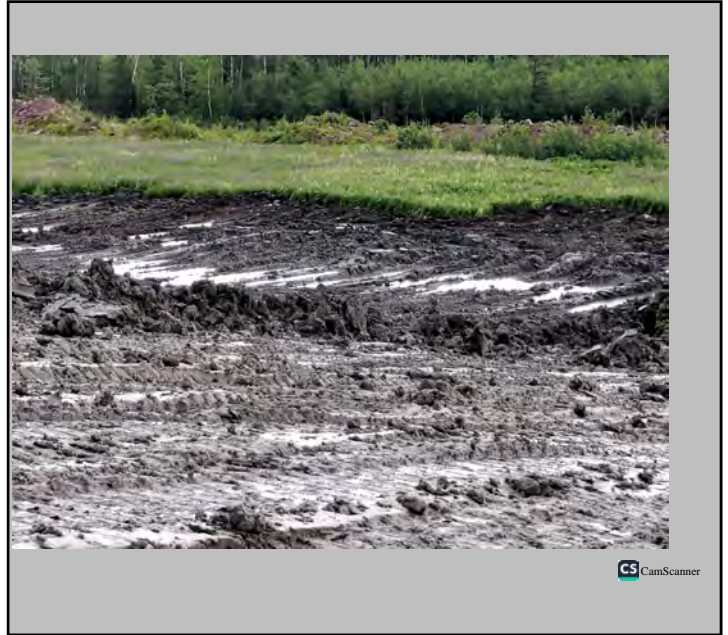
Photo #: 6

Water pooling at the toe of the the panels.

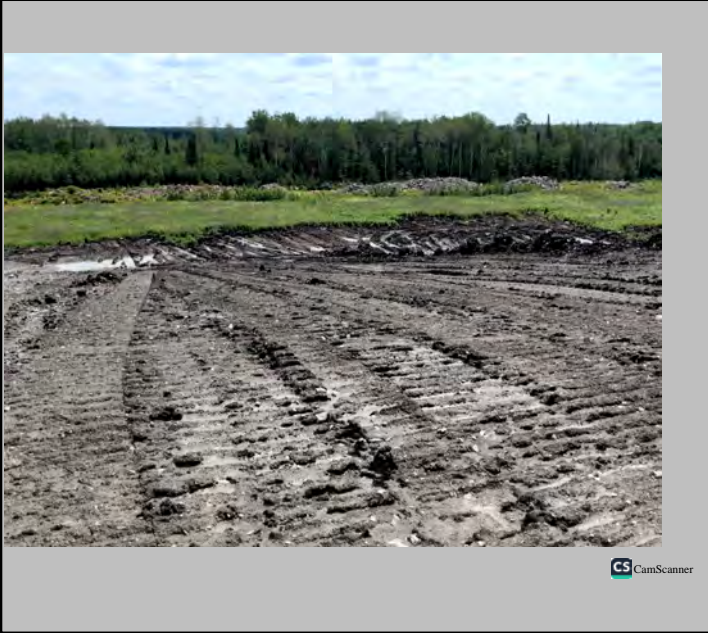
Photo #: 1

Water pooling at the toe of the panels.

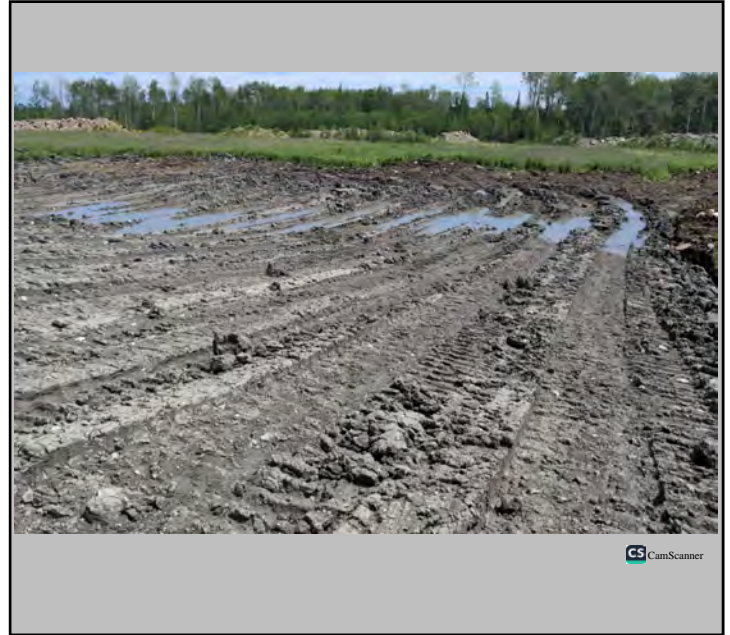
Photo #: 2

Water pooling at toe of Panel 32 NCL Lift 3.

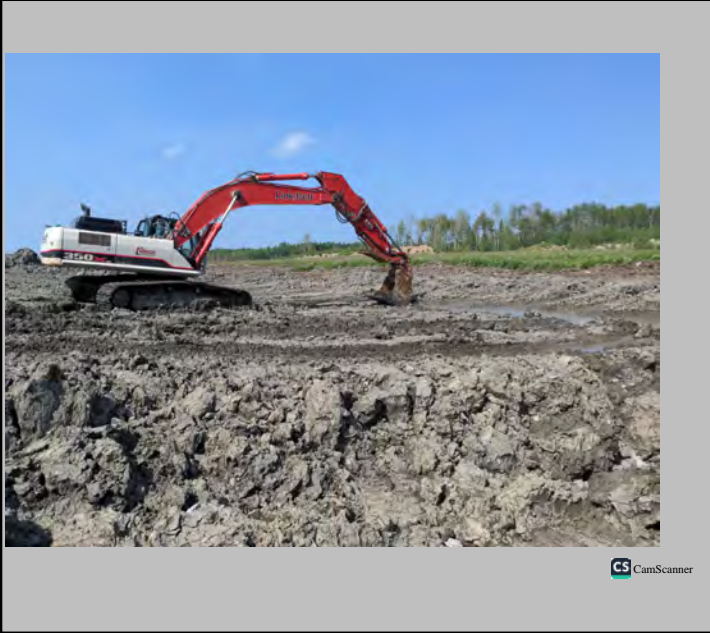
Photo #: 5

Creating positive drainage at the toe of Panel 32.

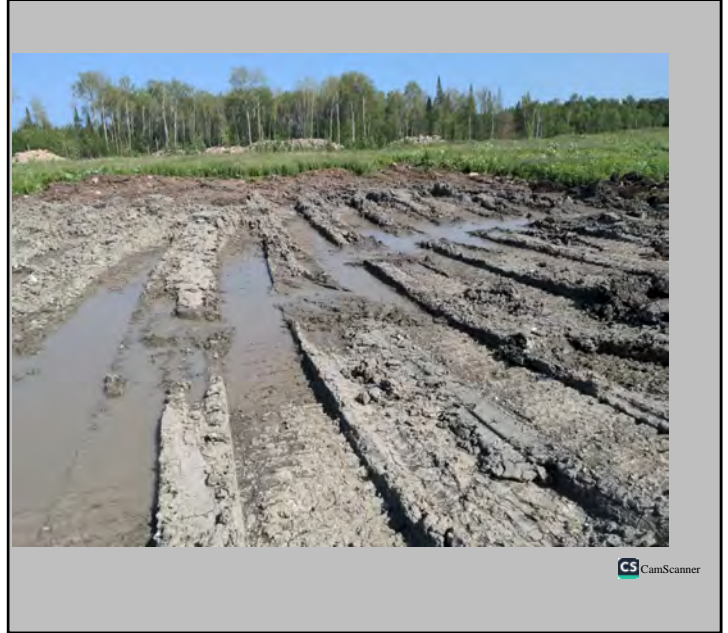
Photo #: 6

Water draining away from the toe of the panels.

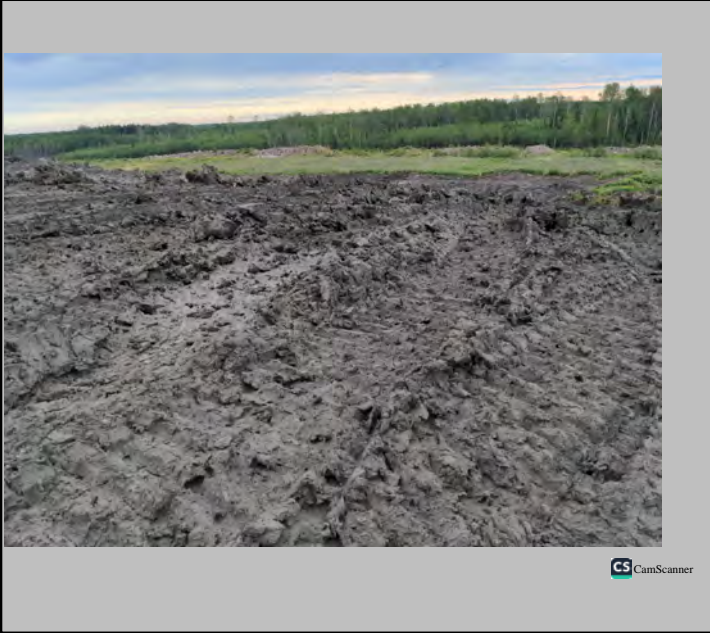
Photo #: 1

Panel 33 CCL Lift 2. Material from North Stockpile visually wet and difficult to place.

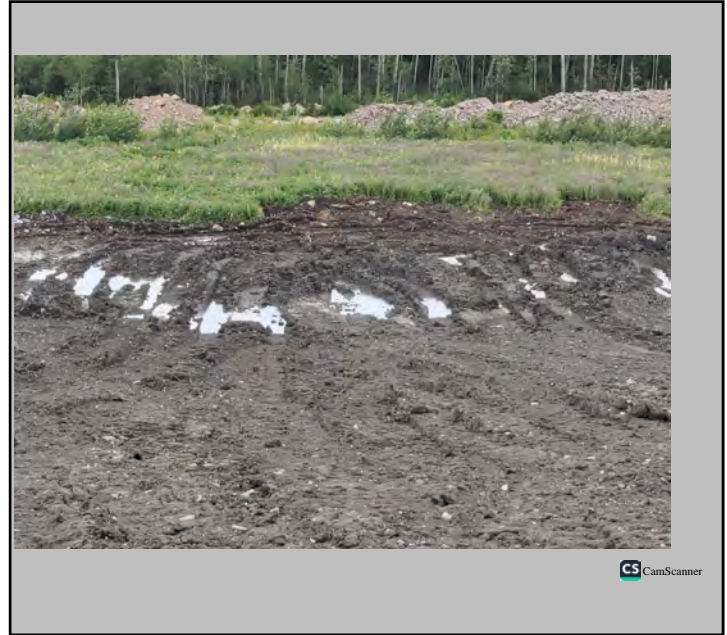
Photo #: 2

Panel 32 toe pooled water.

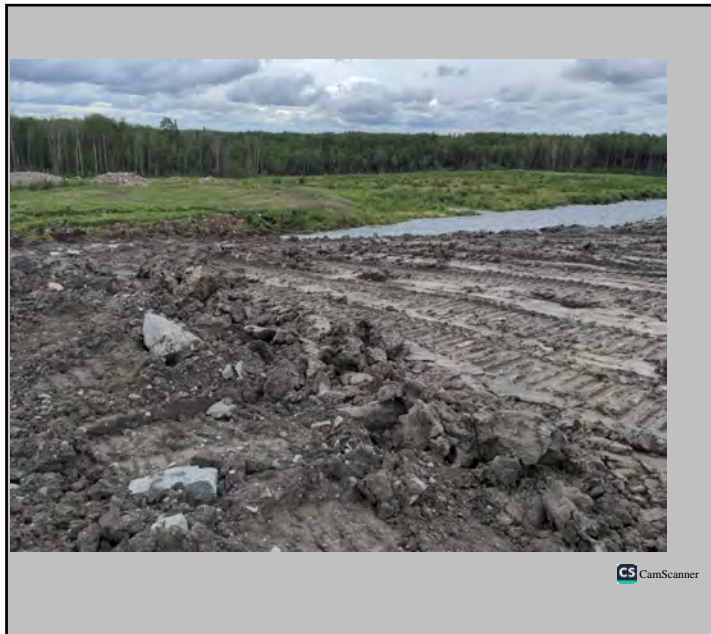
Photo #: 3

Panel 33 CCL Lift 2.

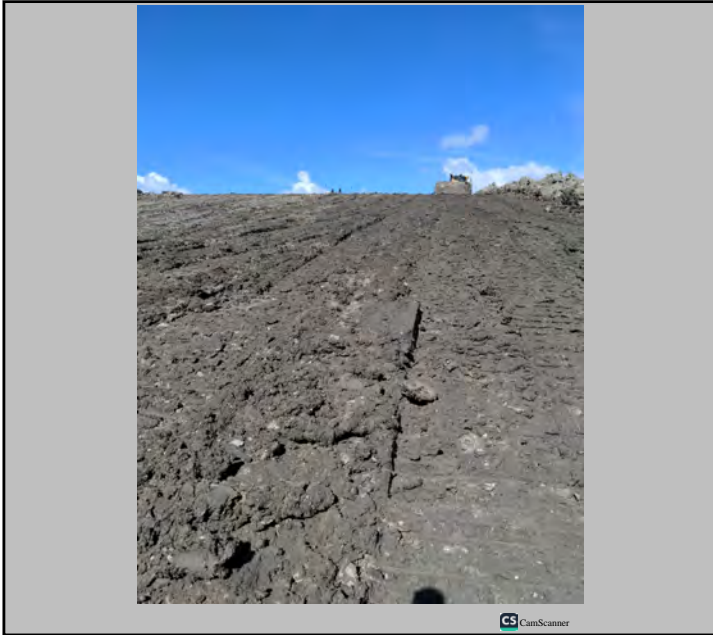
Photo #: 1

Panel 32 NCL Lift 3 complete.

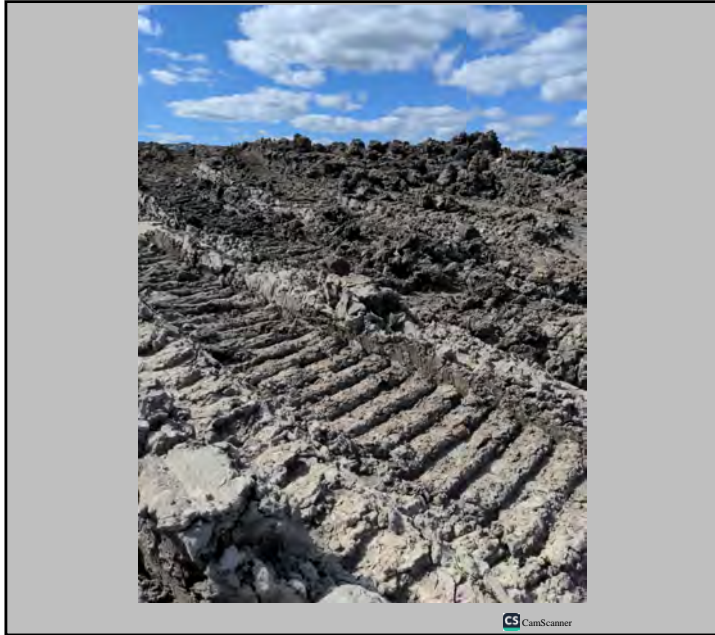
Photo #: 5

Panel 33 CCL Lift 2 placement.

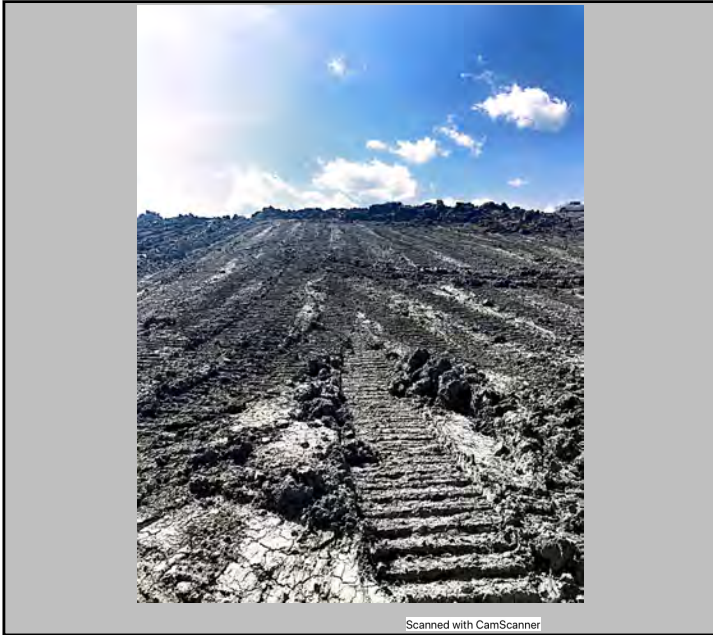
Photo #: 1

NCL L4 P32 In Progress.

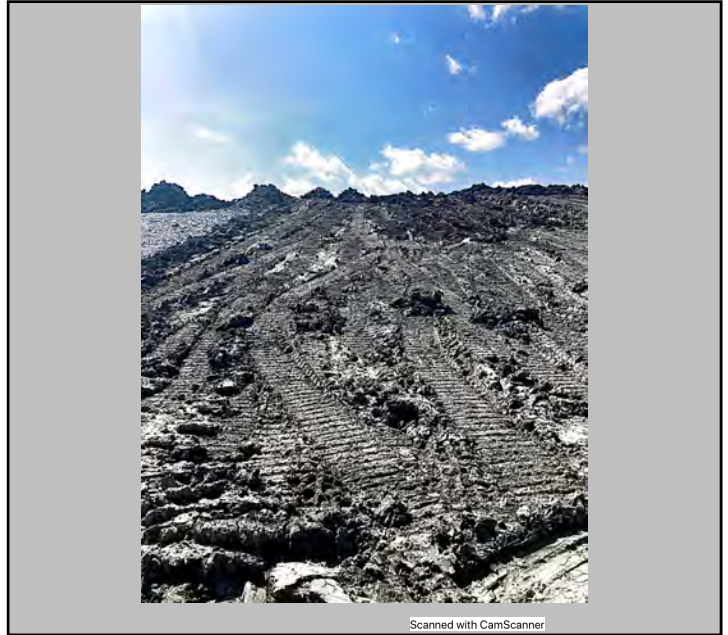
Photo #: 2

CCL L2 P33 In Progress.

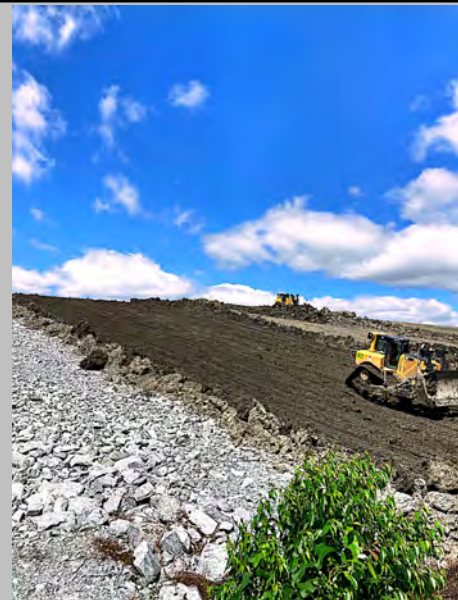
Photo #: 4

P33 CCL L2 up to grade.

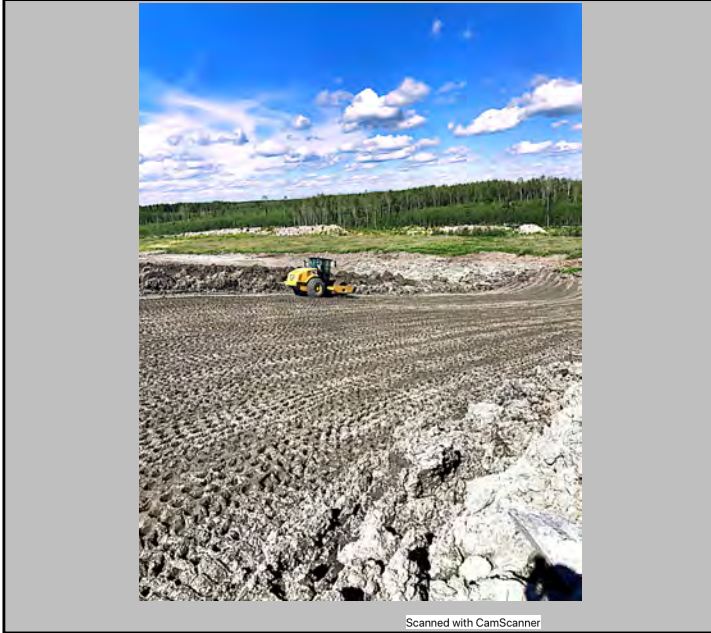
Photo #: 5

P33 CCL L2 compacted by Cat CP56B packer.

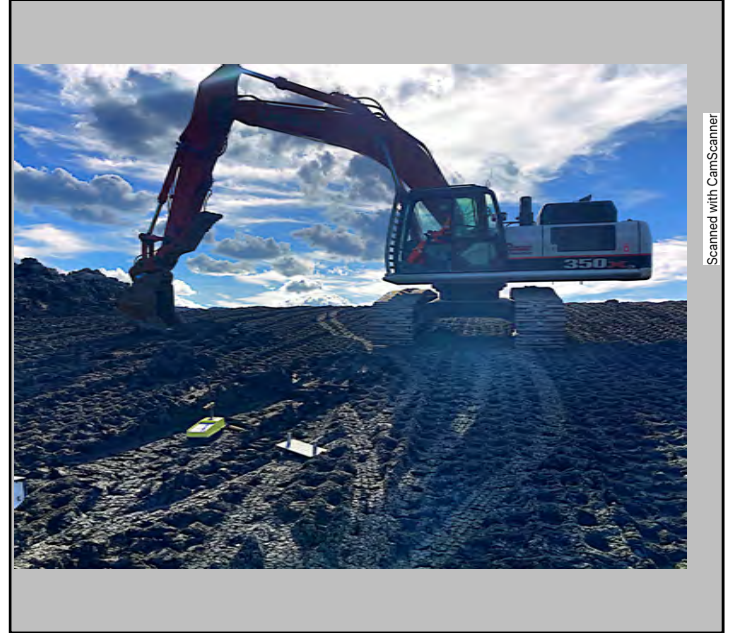
Photo #: 6

Excavator LB350 made test pads on P33.

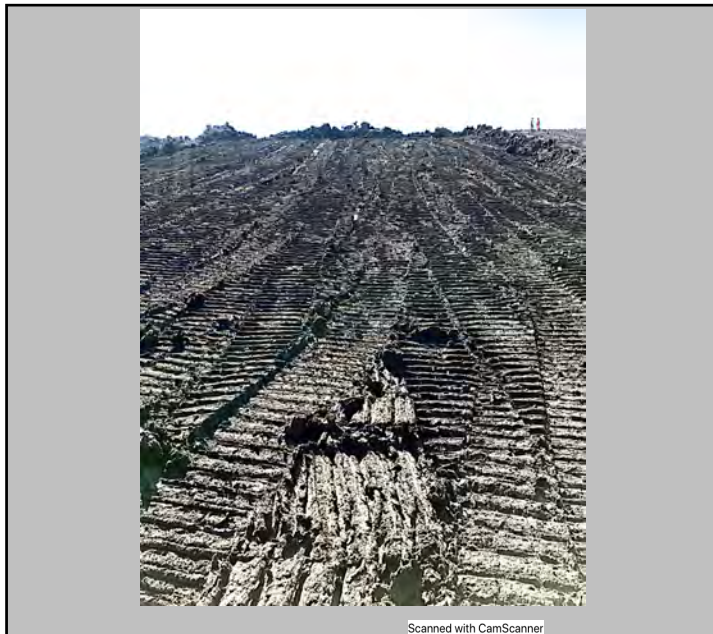
Photo #: 7

P33 NCL L3 Complete

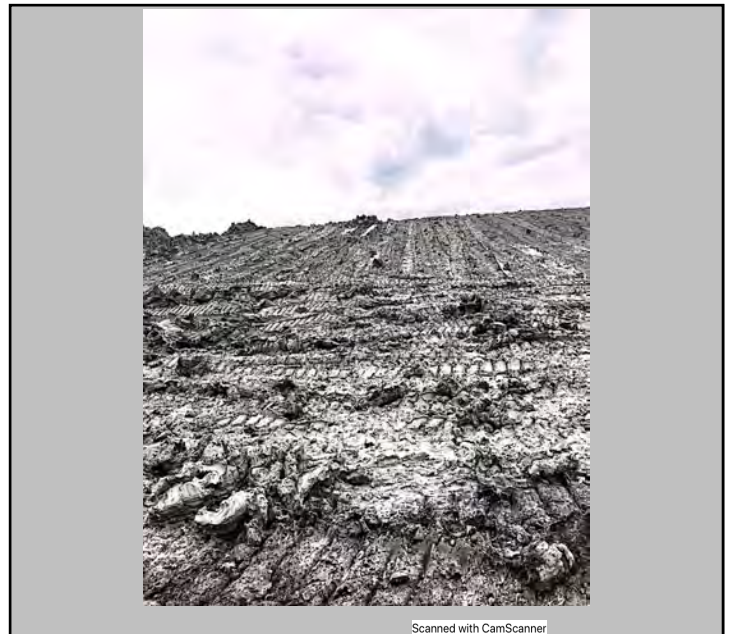
Photo #: 4

NCL L4 P33 placed, awaiting final grading.

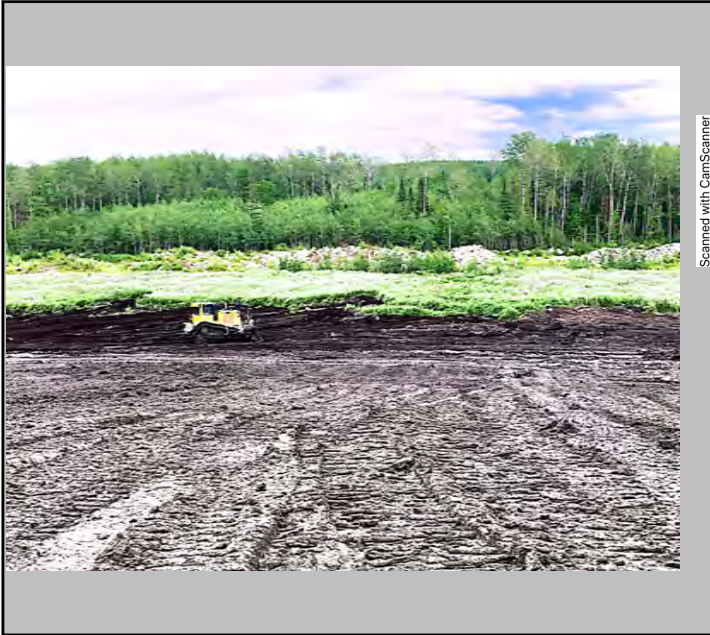
Photo #: 5

Dozer 420 sloping toe of P30-P33 for drainage.

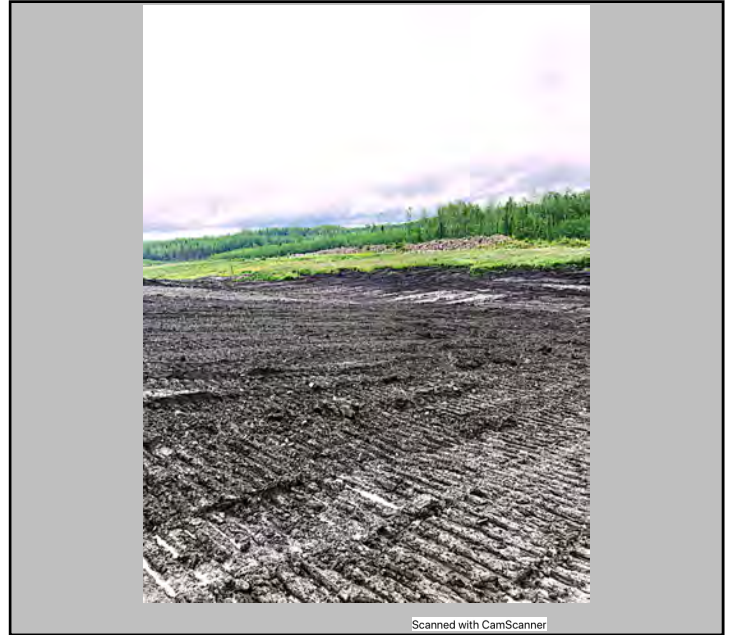
Photo #: 6

Complete toe slope south end of P30.

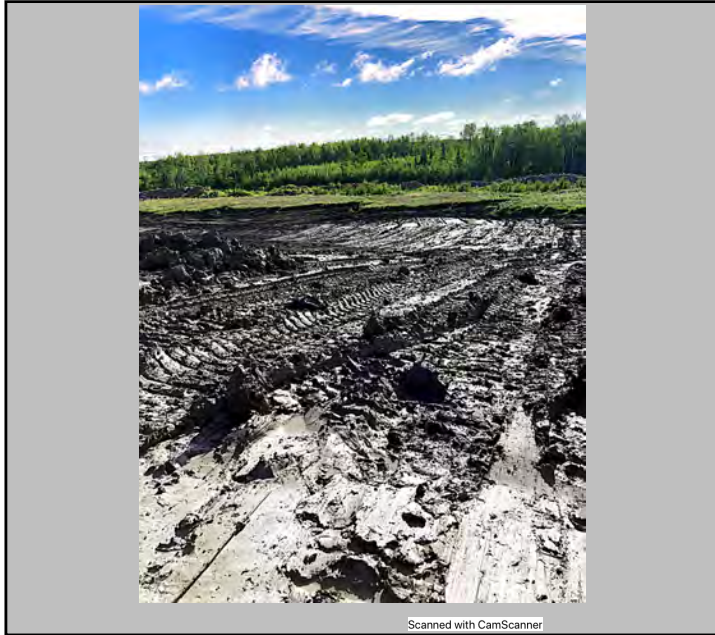
Photo #: 1

P33 morning.

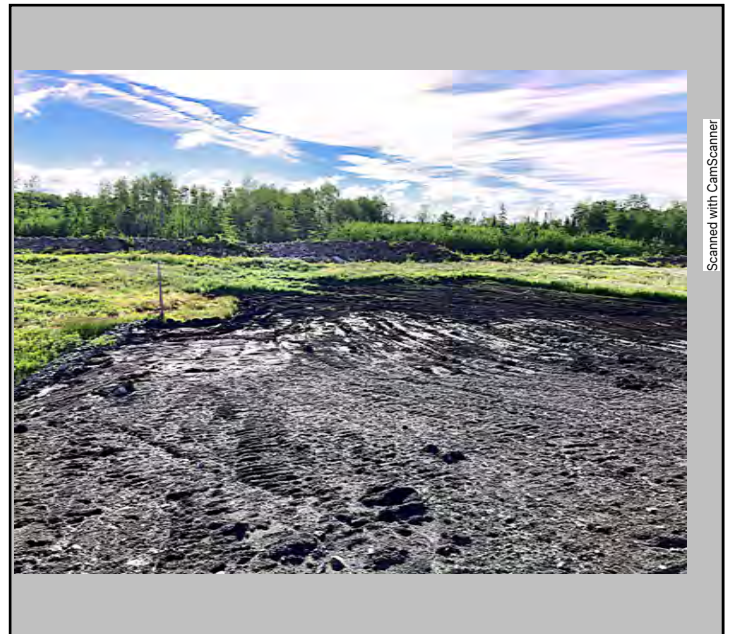
Photo #: 4

Toe of P30.

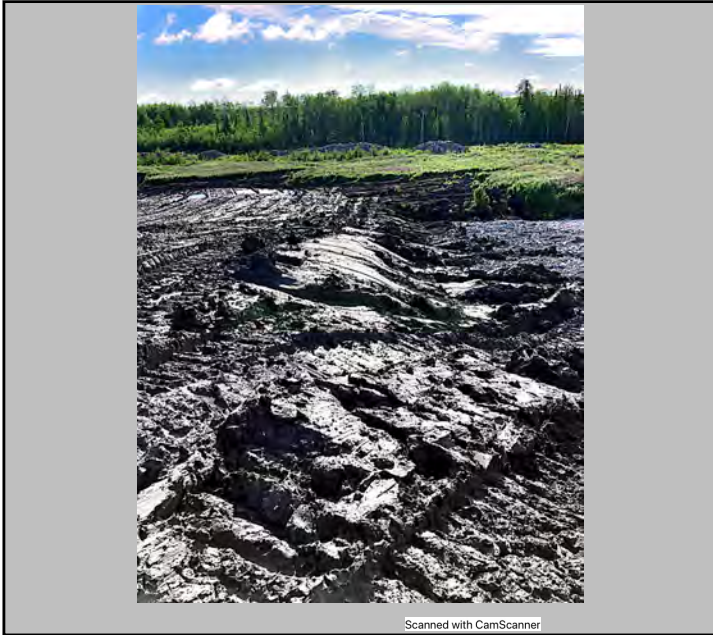
Photo #: 5

South edge of P33 sloped.

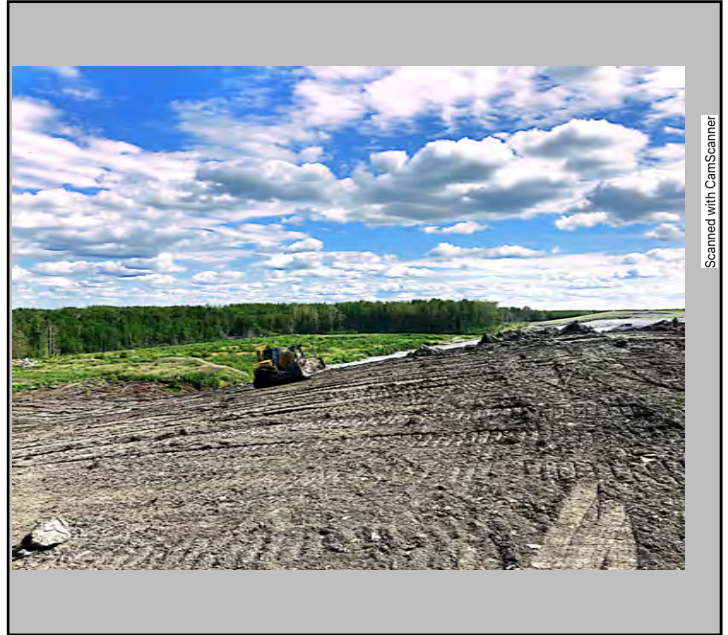
Photo #: 6

Dozer 420 track packing P33

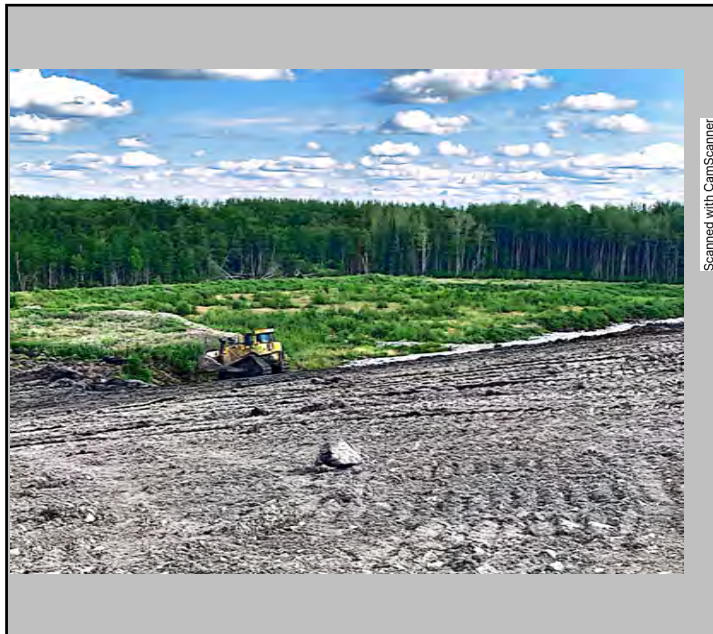
Photo #: 7

Dozer 420 grading P33.

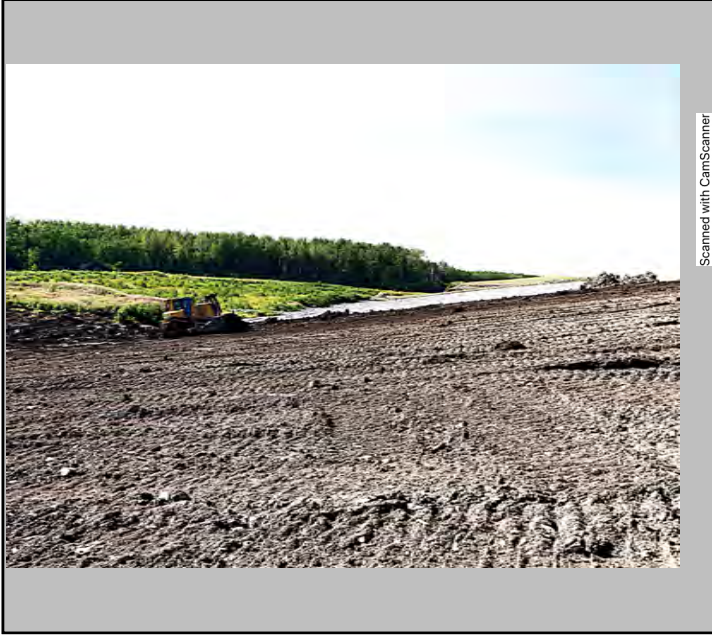
Photo #: 1

Dozer 420 grading P33 NCL L4.

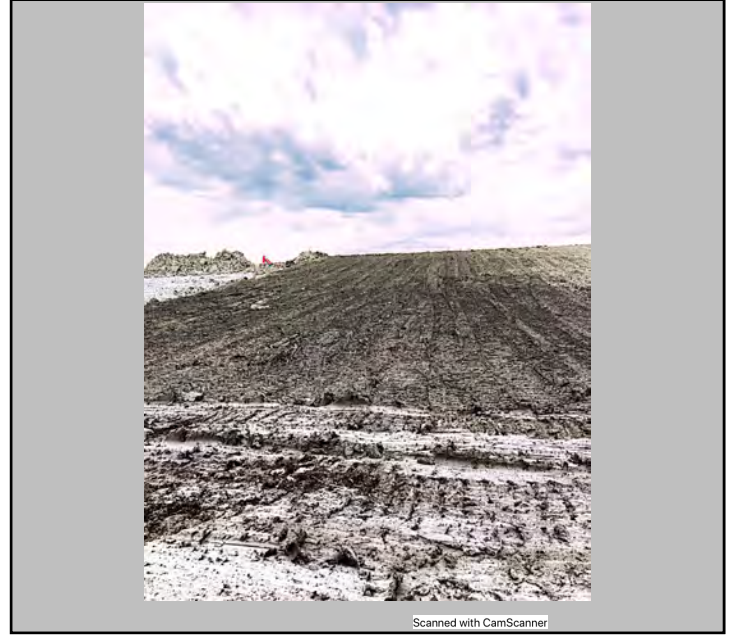
Photo #: 2

P33 NCL L4 complete.

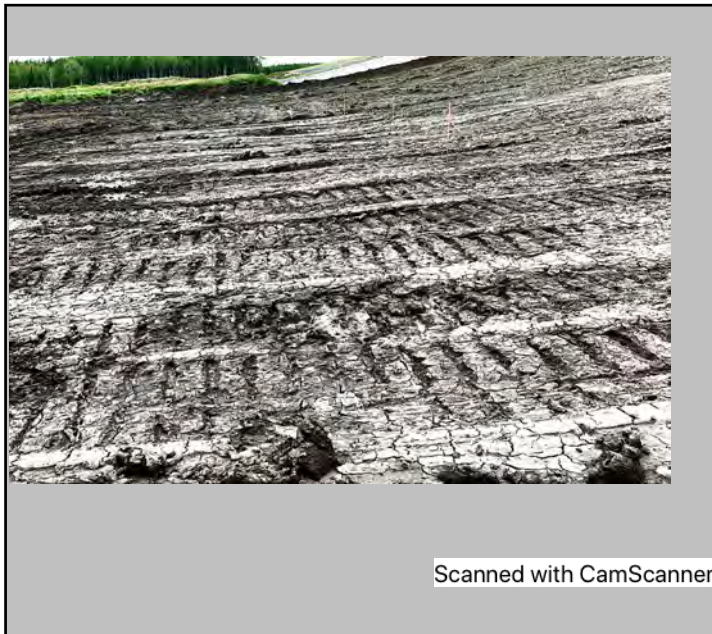
Photo #: 3

P30 Toe sloped to drain past the key trench.

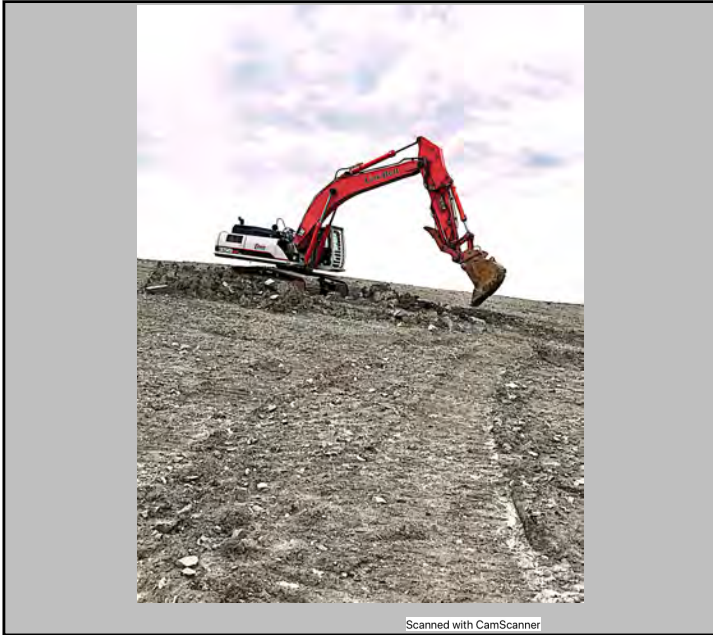
Photo #: 5

LB350 filling Okane's bore hole test pits.

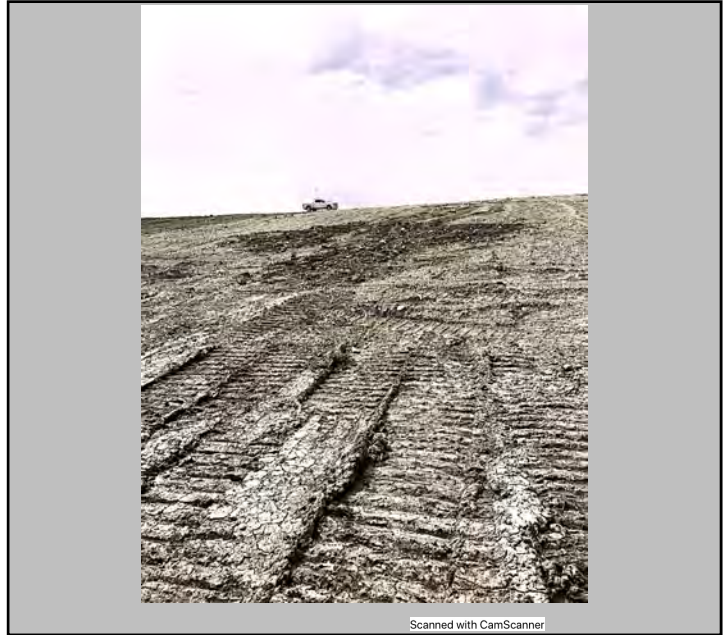
Photo #: 6

Bore hole test pits filled.

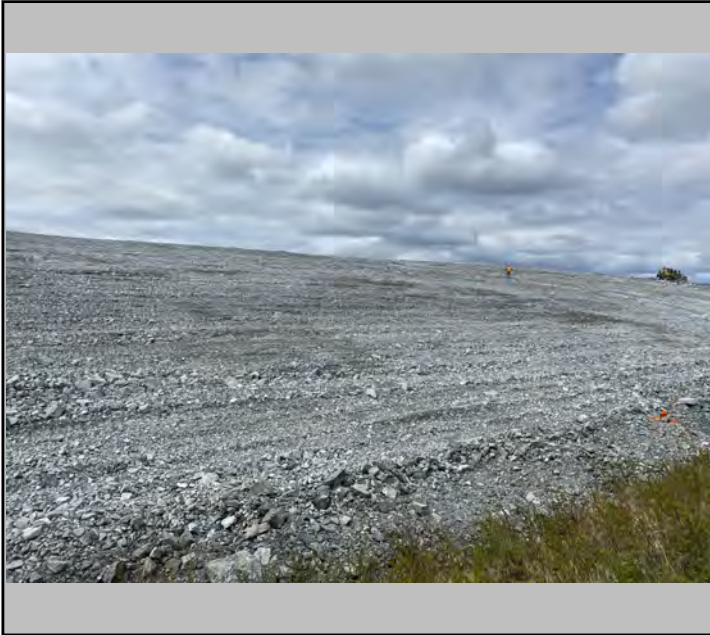
Photo #: 1

Slope preparation in progress (0+690 - 0+783)

- Slope preparation and survey for 0+690 - 0+783 complete and pending material placement.
- CQA Informed that the previously identified northern borrow area (S499-S503 & S506-S507) will likely not be available for use in cover system construction. Current plan is to utilize material from the southern borrow area for the start of construction. Pockets of material in this area were previously deemed unsuitable for CCL use during the 2021 construction season.
- Met with Travis Alexander to view the southern borrow area and discuss the current material conditions. Okane cautioned that in its current state the southern borrow area contains areas with large quantities of rock that could impact the hydraulic conductivity of CCL lifts. New Gold is aware and plans to sort through the area to obtain material for CCL placement during the hauling process.

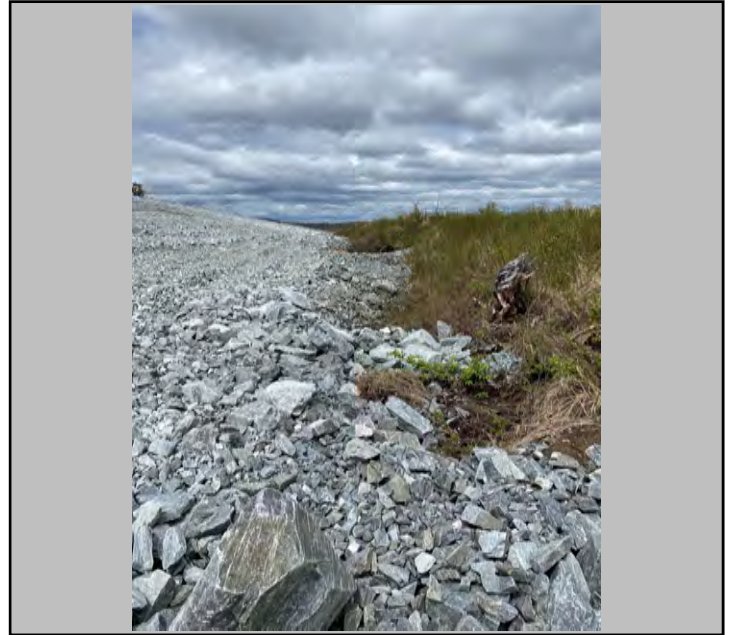
Photo #: 2

0+690 - 0+783 toe

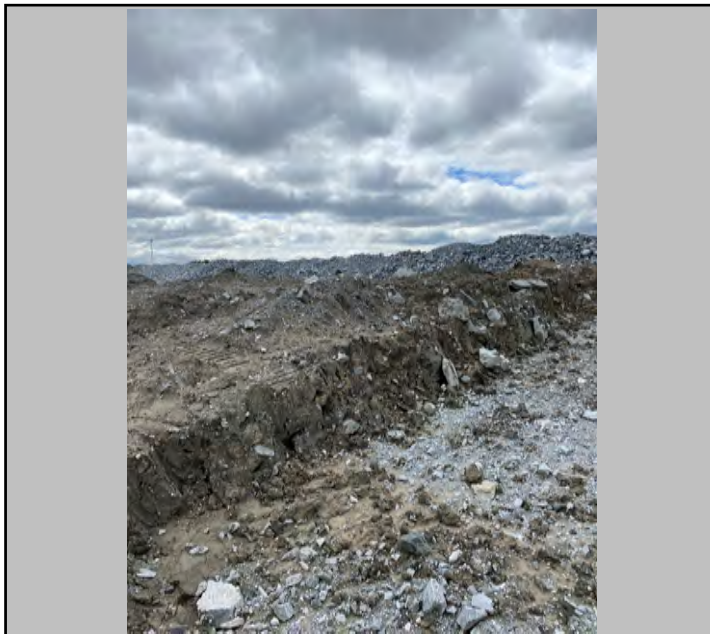
Photo #: 3

Southern borrow area (S504-S505)

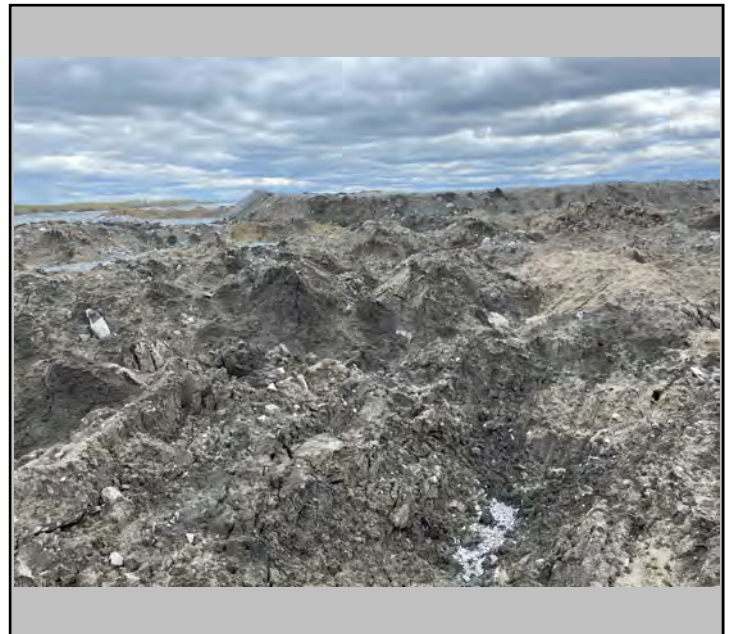
Photo #: 4

Northern borrow area (S499-S503 & S506-S507)

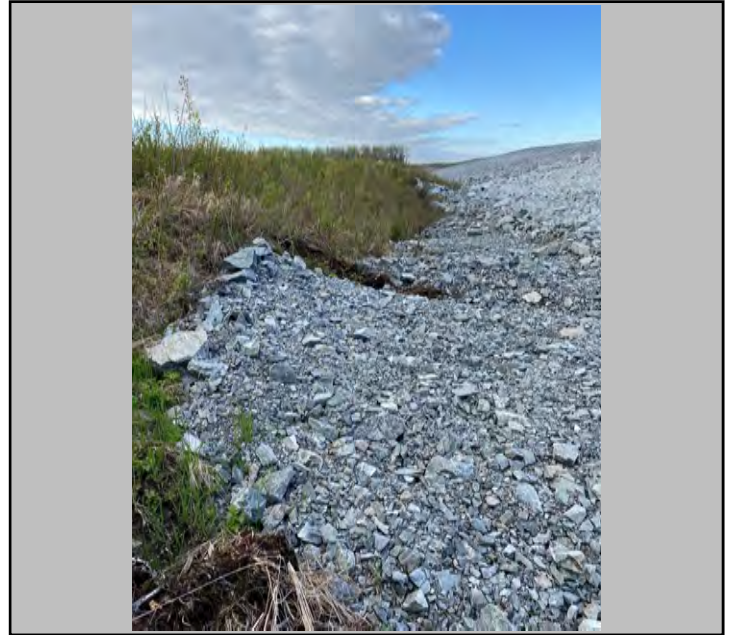
Photo #: 2

WR at toe of slope

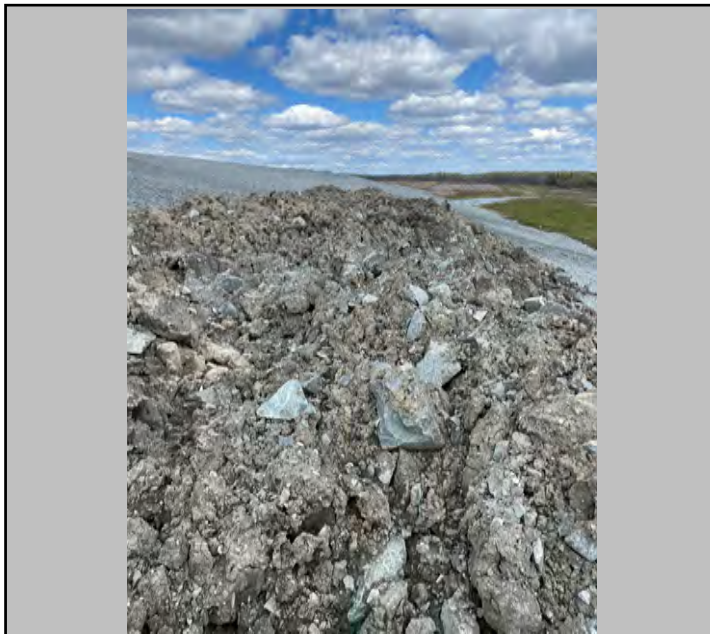
Photo #: 3

Stockpiled material (S508)
