**NEW GOLD RAINY RIVER MINE
APPENDIX B
EMRS RECORD OF CONSTRUCTION**

2022 EMRS Progressive Reclamation Record of Construction

1003-223-001

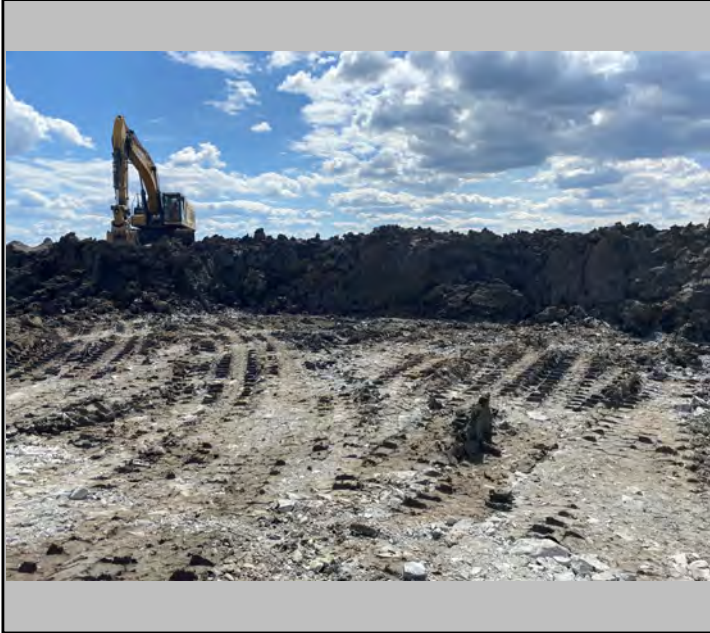
Photo #: 1

- Lift placement initiated from central borrow source (approximately STN 1+202.8, O/S -665.9). Lift placement still in progress.
- Material appears dark brown, pliable, moist, with little stone.
- Areas of L1 containing minor amounts of frozen material. These areas began to thaw throughout the placement process and exposure to warm temperatures.
- S509 taken by Tulloch from material first dumped on the slope as no proctor results are available from the central borrow area.

Central borrow area used for P30

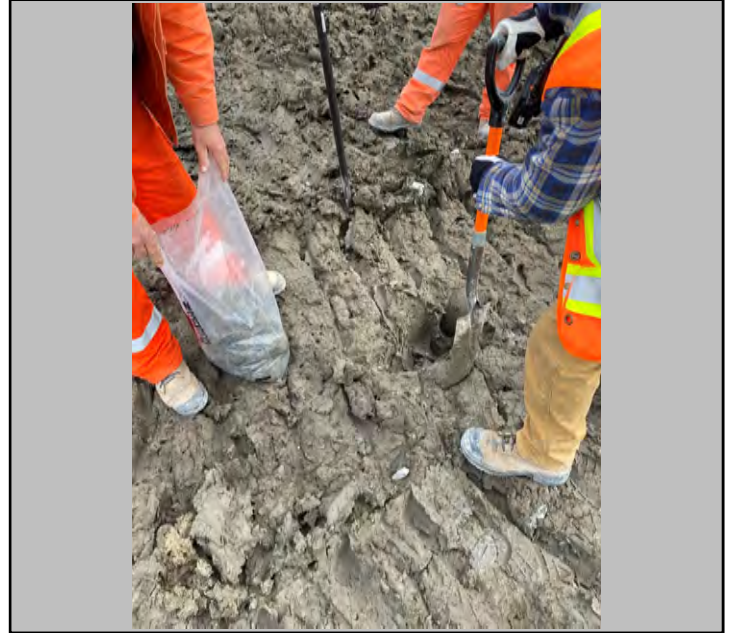
Photo #: 2

S509

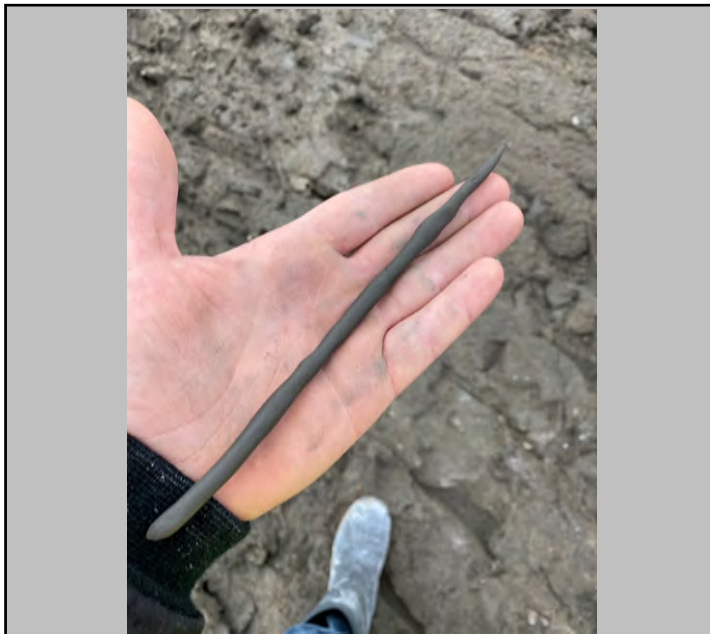
Photo #: 3

P30, L1 material

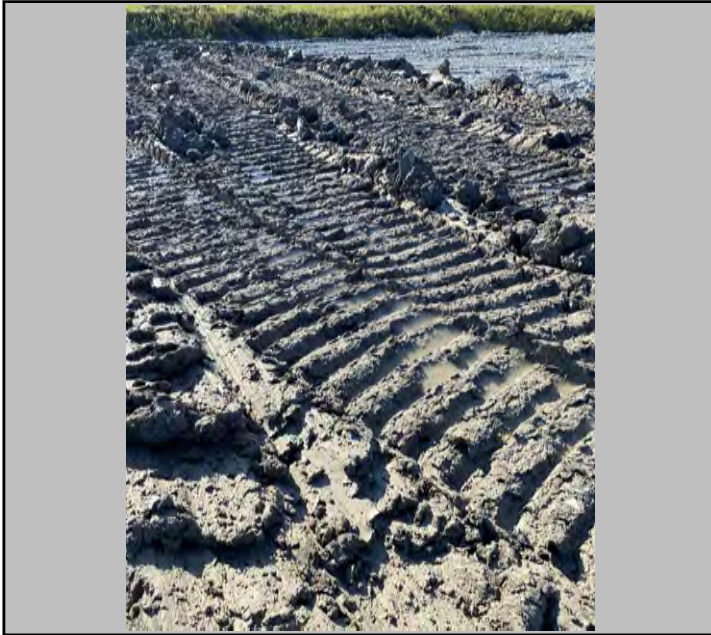
Photo #: 1

Standing water on P30, L1 following overnight showers

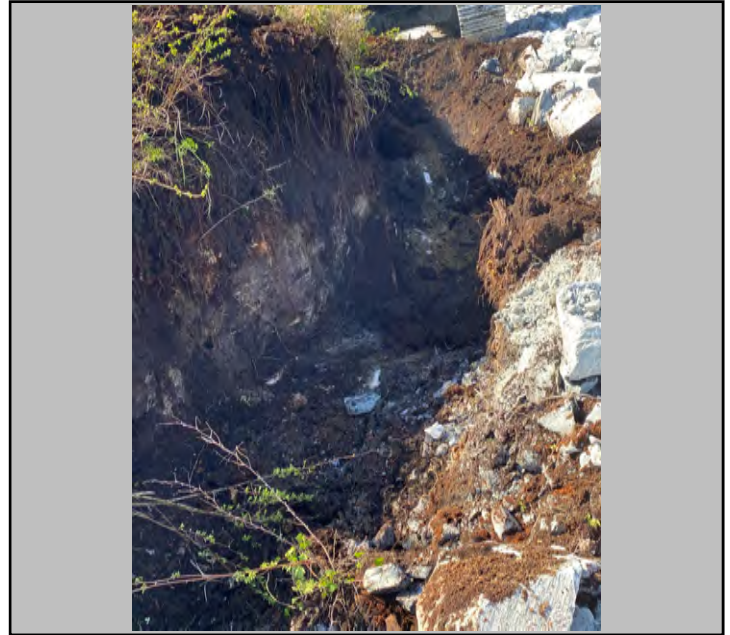
Photo #: 2

P30 key trench dug to varying depths to bedrock at North end

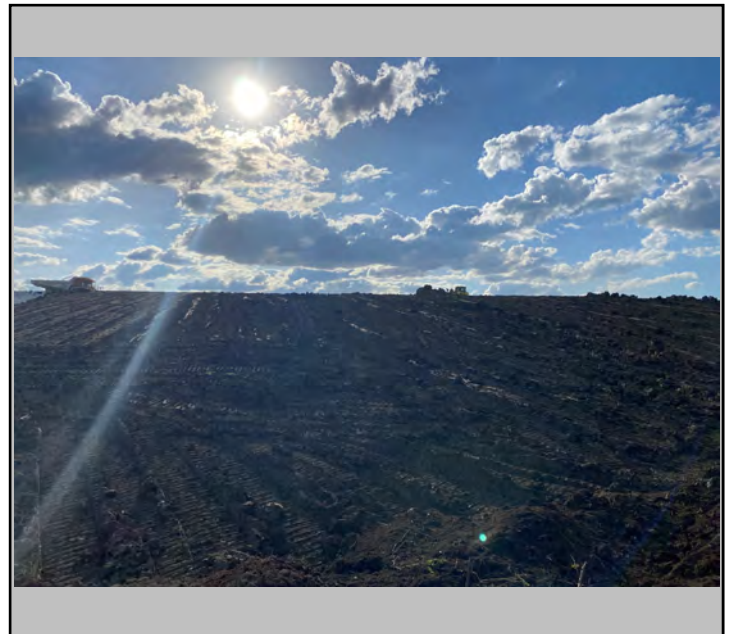
Photo #: 4

- While the material was drying New Gold began widening P30, L1 to the full size of the approved area (90m). Okane is comfortable with the new panel size in the current conditions but cautioned against increasing panel sizes to the point where CCL lifts can't be covered in a timely manner.

P30, L1 at end of day

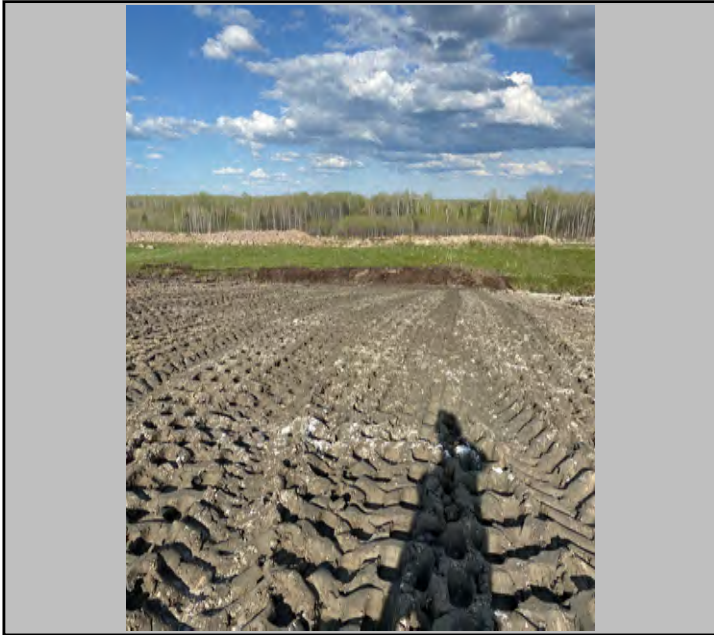
Photo #: 5

Compacted area of P30, L1

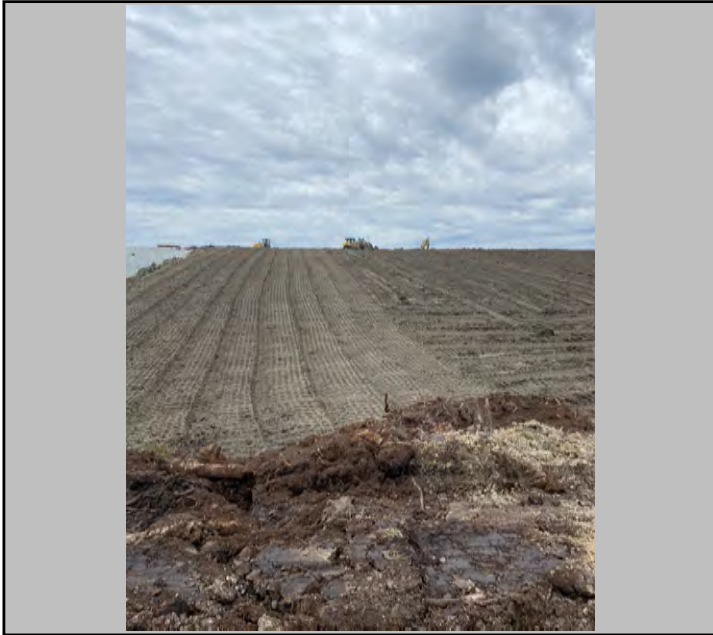
Photo #: 1

- Nuclear density gauge results on South half of P30, L1 showed moisture contents greater than 30 percent in some areas, resulting compaction below 95%. Upon further investigation into these locations the material appeared dark brown/grey, moist, and pliable. Secondary nuclear density gauge results next to high moisture content locations resulted in lower moisture contents and adequate compaction results.

P30, L1 compaction

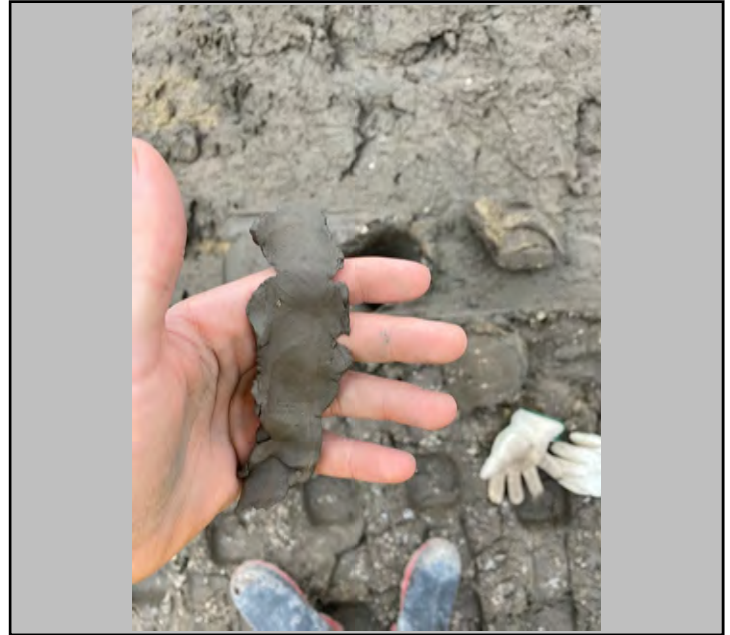
Photo #: 2

D460 material

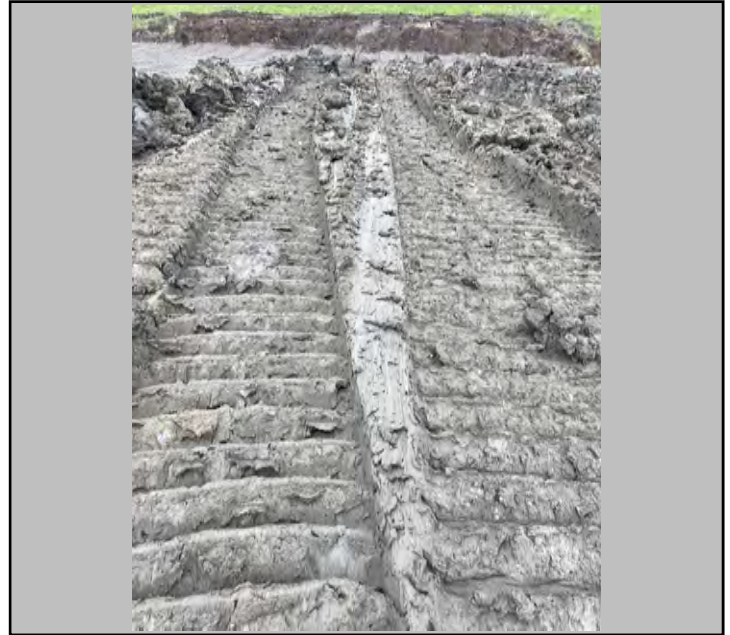
Photo #: 6

P30, L2 material

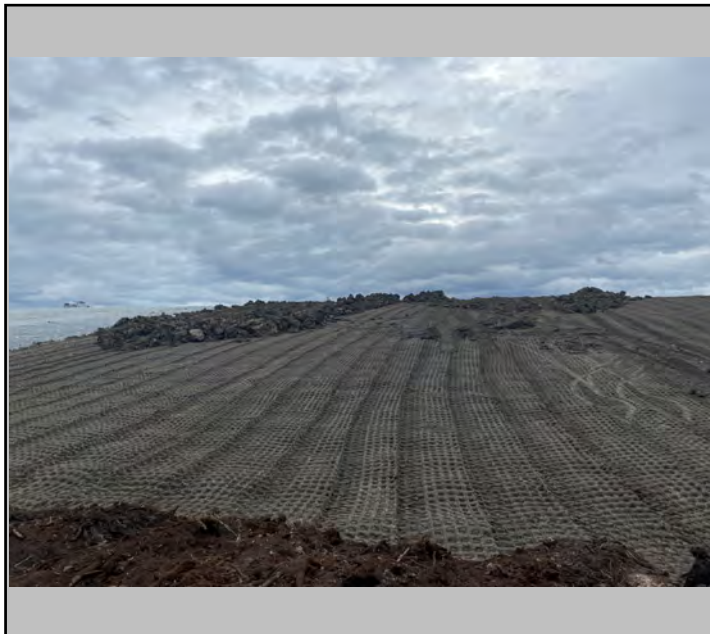
Photo #: 7

P30 at end of day

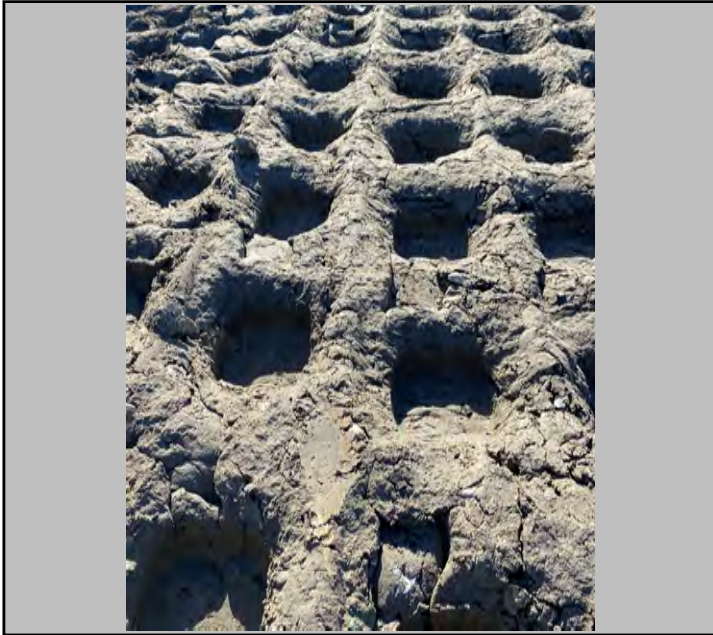
Photo #: 1

P30, L1 upon morning inspection

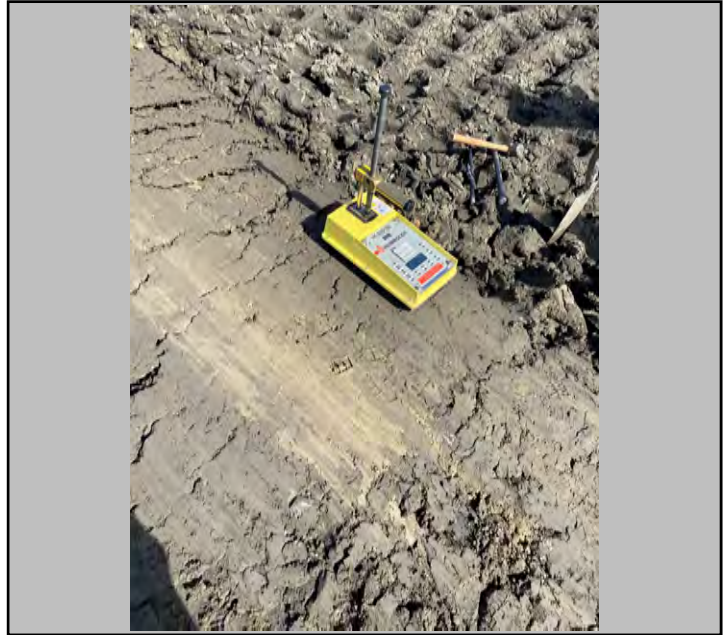
Photo #: 2

D469 in progress

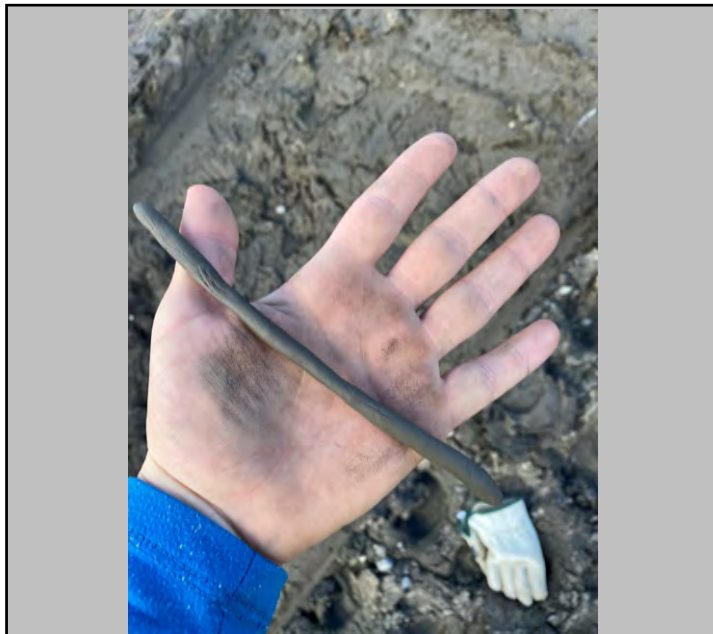
Photo #: 3

D470 material

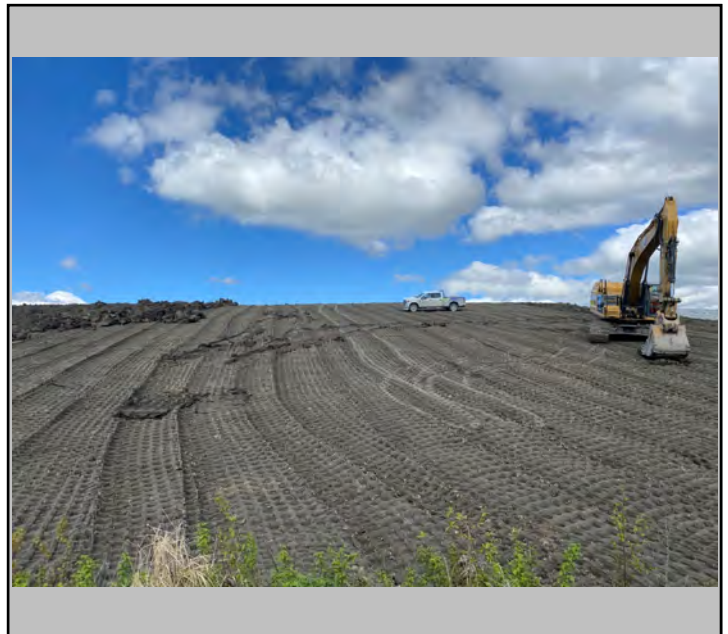
Photo #: 4

P30, L2 testing completed

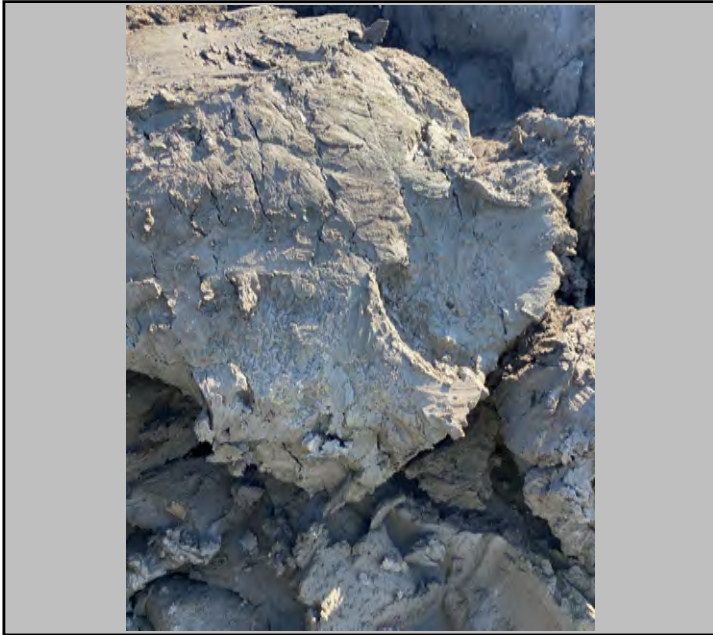
Photo #: 5

Chunk of frozen material in P30, L2

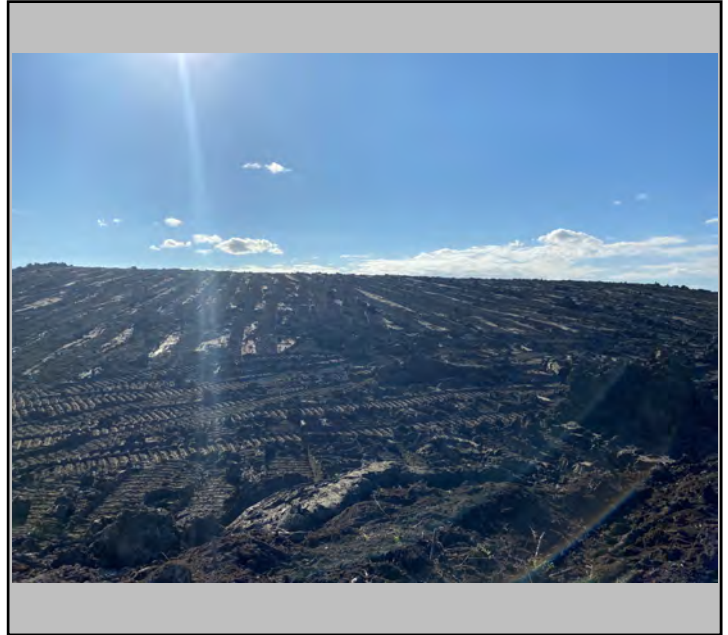
Photo #: 6

P30, L2 placed to cover the entirety of L1

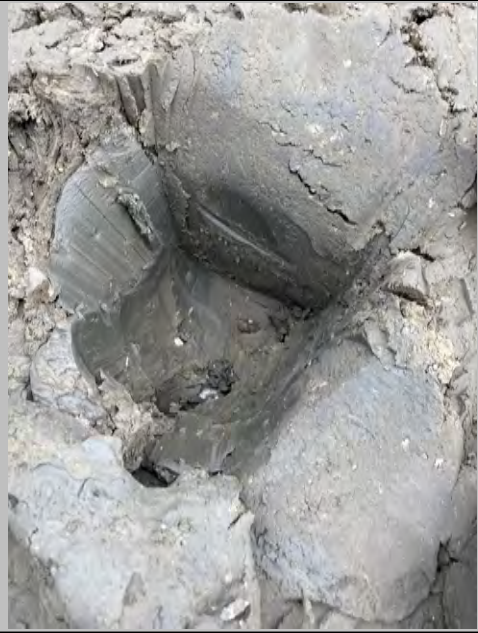
Photo #: 2

- Moisture results of 33.1% and 40.5% for densities D477 & D478 obtained in a small area while testing the South half of L2. Upon investigation the material wasn't wet and appeared consistent with other areas within the lift. A reduced moisture content is expected for D478 once lab results are available and the location has been flagged for hydraulic conductivity testing.

D478 material

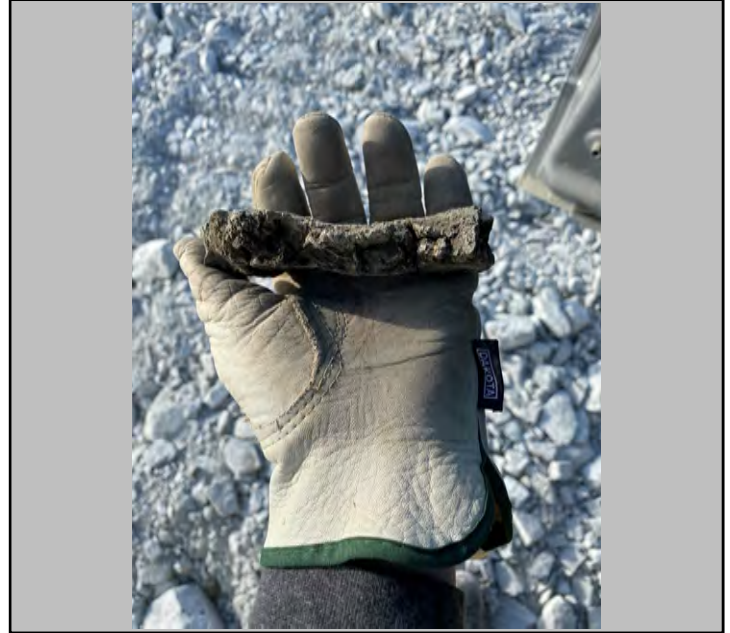
Photo #: 6

P30, L2 desiccation depth at end of day

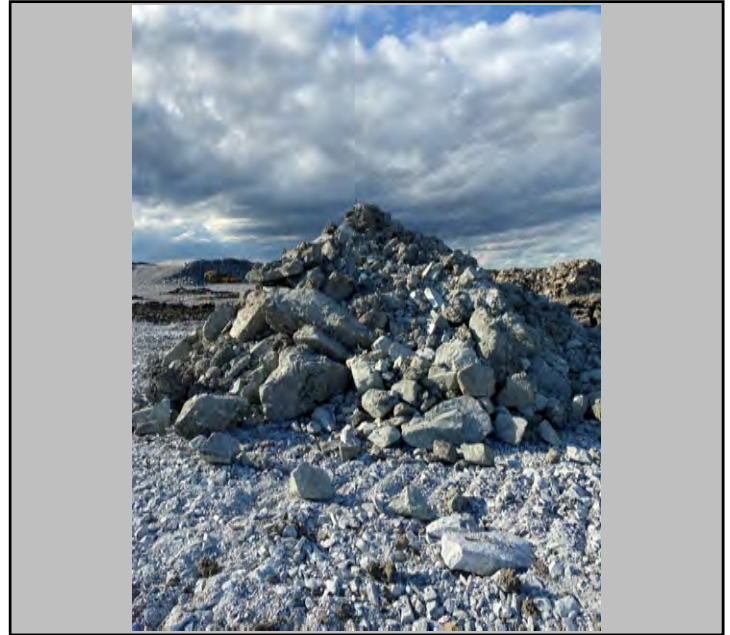
Photo #: 2

- One actively hauled load of material was dumped next to P30 in the morning. Upon inspection the load was comprised primarily of stone and CQC was notified of the material. CQC spoke with the dozer operator and the pile was left to the side and not included in the P30 NCL.
- Downloads for cover trial monitoring stations P1 & P2 as well as repair of P2 tipping bucket completed.

Load of stone dumped from active haul

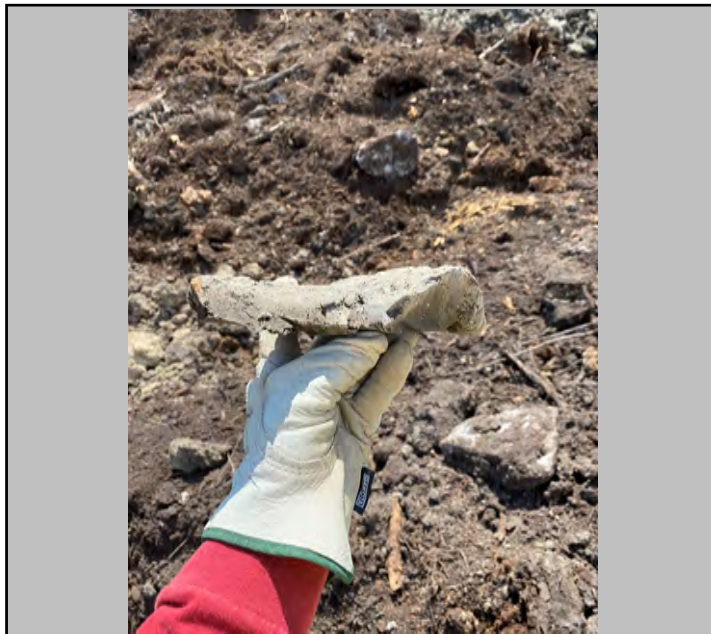
Photo #: 3

- At this point CQA met with CQC to discuss the current level of desiccation. With no capacity to wet or disc the material it was determined the best course of action was to continue covering L2 with the current NCL material which was visually moist and pliable.

Issue #	Description	Location	Resolution	Monitor	Status
1	South side of P30, L2 reaching concerning levels of surface desiccation prior to coverage	South half of P30, L2 toe	South half P30, L2 covered with as much dark brown, moist, and pliable NCL material as possible prior to end of day by dozer	Yes	Open
				Choose:	Choose:
				Choose:	Choose:
				Choose:	Choose:
				Choose:	Choose:

Depth of surface desiccation on south side of P30, L2 upon inspection

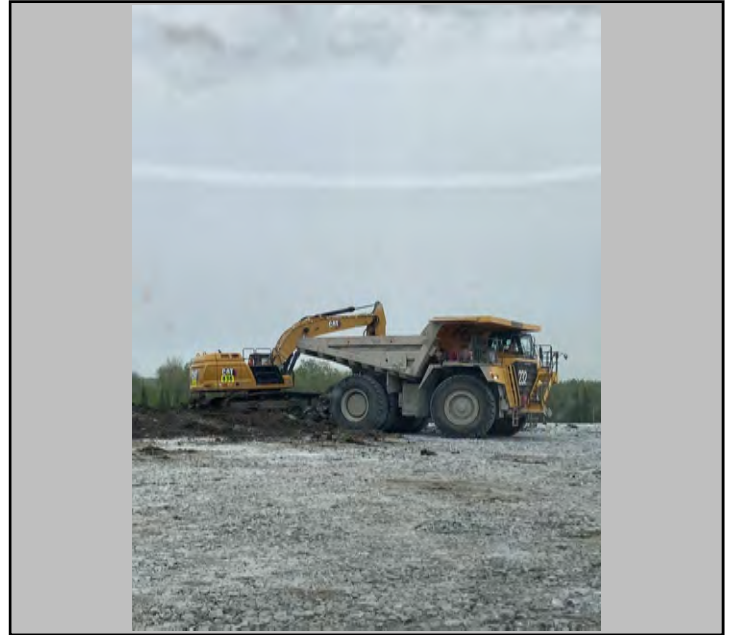
Photo #: 2

Previously piled load of stone removed

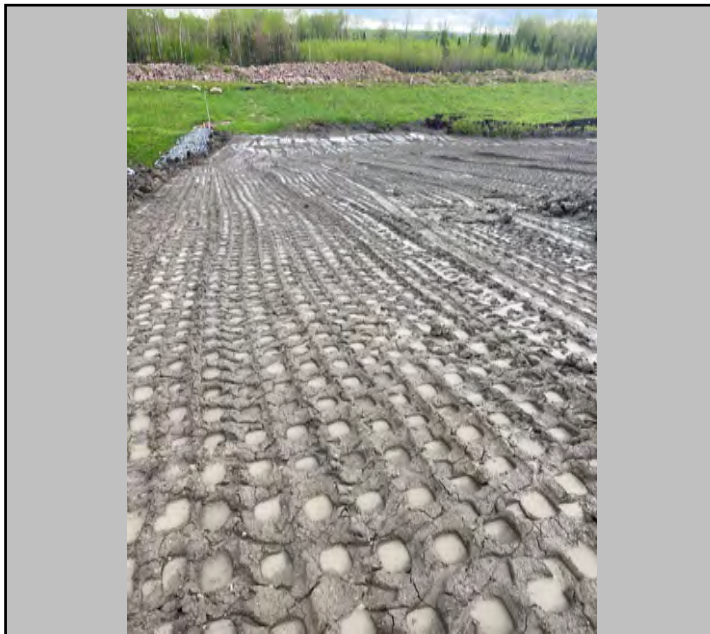
Photo #: 3

- Areas still exposed were rehydrated by light showers in the morning until heavy rain caused the material to become too wet with standing water in the sheepsfoot holes and at the toe.

- at 11:00 construction was halted until 14:00 due to lightning proximity. During this shutdown periods of heavy rain occurred. Once the work stoppage was lifted both L2 and L3 were very wet and standing water was present throughout the panel. CQA contacted CQC to inform them of the conditions and work on the EMRS was stopped for the remainder of the day while the material was left to dry.

L2 conditions after heavy rainfall

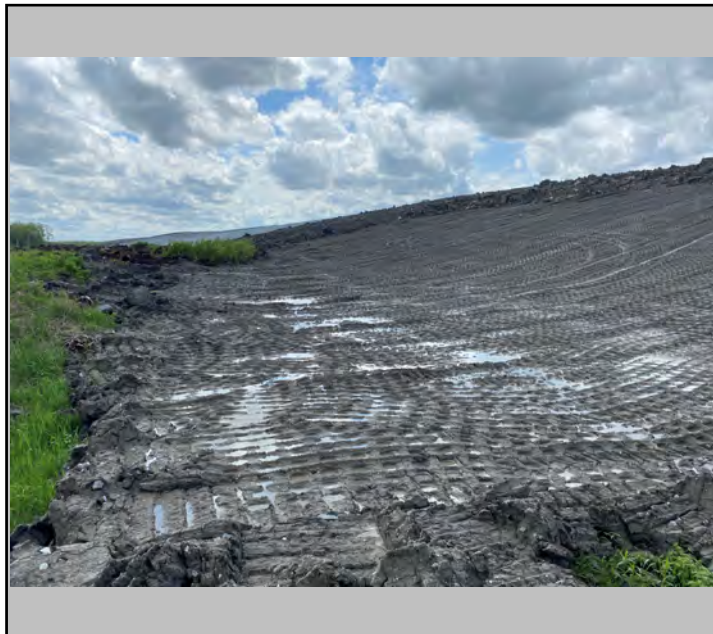
Photo #: 3

P30, L2 toe upon afternoon inspection

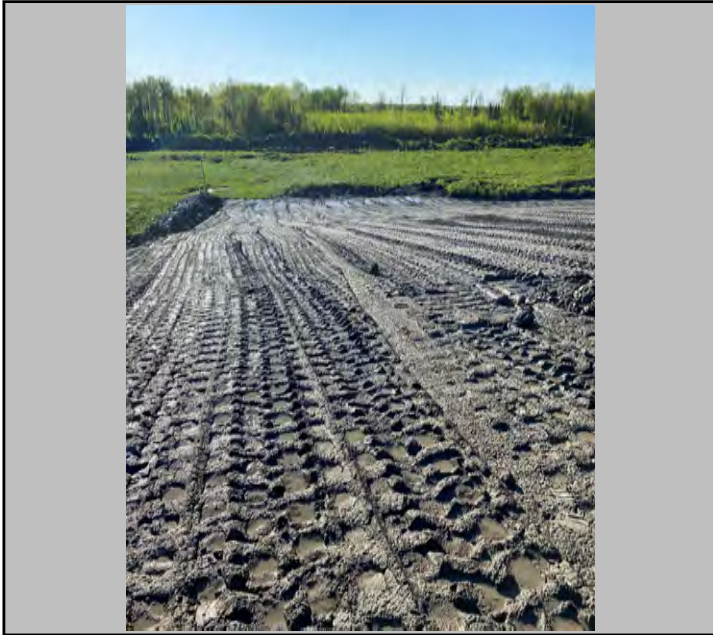
Photo #: 1

- Standing water visible in sheepsfoot marks on the slope with larger areas of standing water at the toe upon morning inspection.
- Warm temperatures and moderate winds throughout the day aided in the drying process of L2. Upon an evening inspection the standing water in the sheepsfoot marks had dried with moist material remaining in the indents. A thin layer of crust had formed on the slope, with areas of standing water still present at the toe.

P30, L2 morning conditions

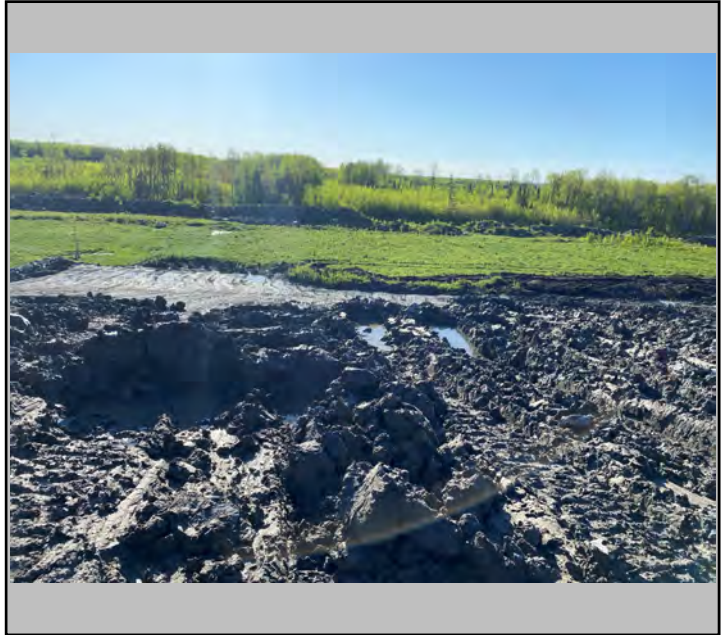
Photo #: 2

- L3 material visually wet following rain with areas of standing water scattered throughout the lift upon morning inspection.
- Improved weather conditions aided the drying of L3. Upon an evening inspection there was a thin layer of crust at the surface of L3 with wet material underneath. Standing water was still present in dozer ruts and at the toe.

P30, L3 morning conditions

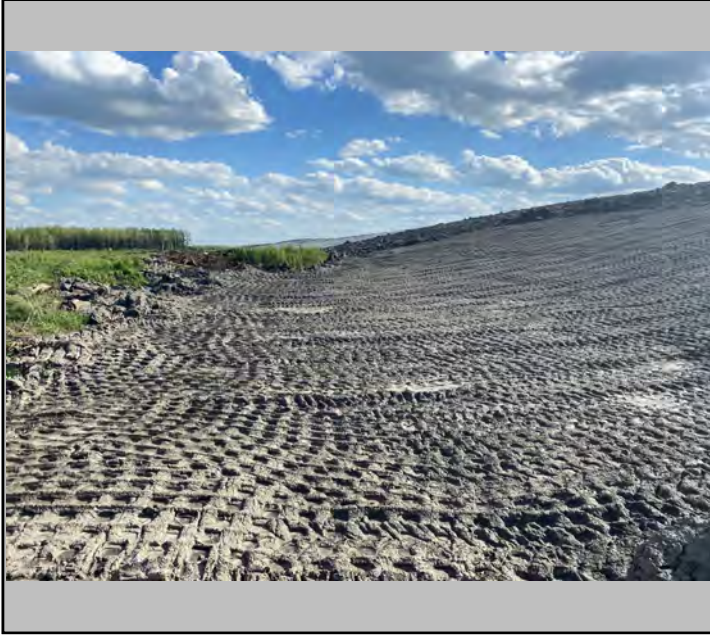
Photo #: 5

P30, L2 toe EOD conditions

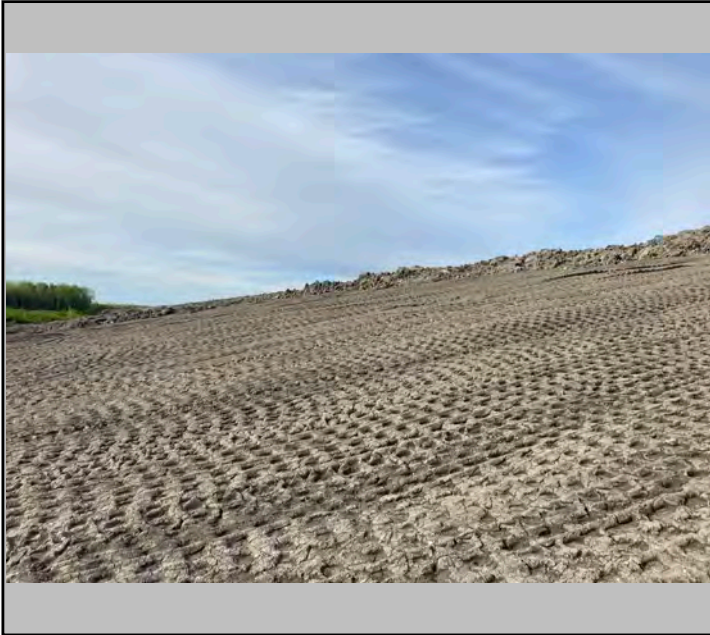
Photo #: 1

- Bottom of sheepsfoot roller divots showing some moisture with the top showing a thin crust.
- Very light afternoon showers keeping L2 slightly moist.
- Standing water at toe of slope minimal.

P30 L2 conditions in the morning

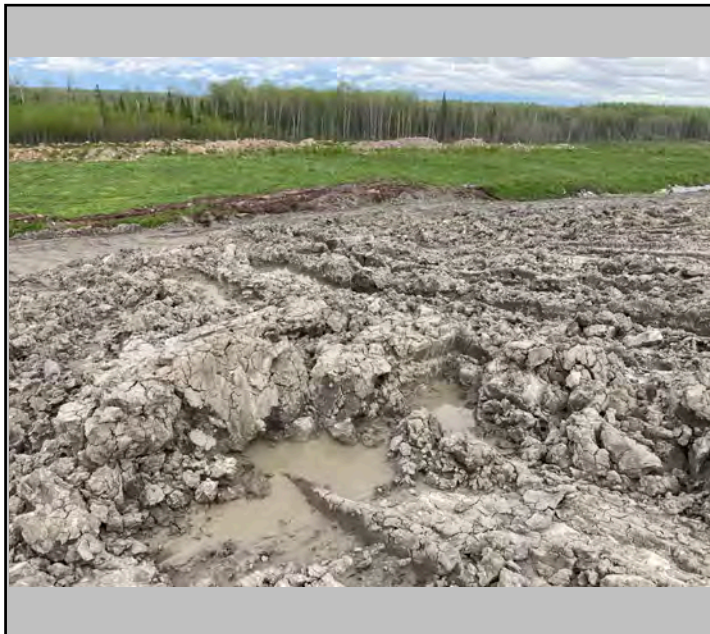
Photo #: 3

- Material drying continues at L3 with a thin crust forming on top, underlain by moist material.
- Pockets of standing water still present.

P30 L3 material drying at end of day, some
pockets of water still present

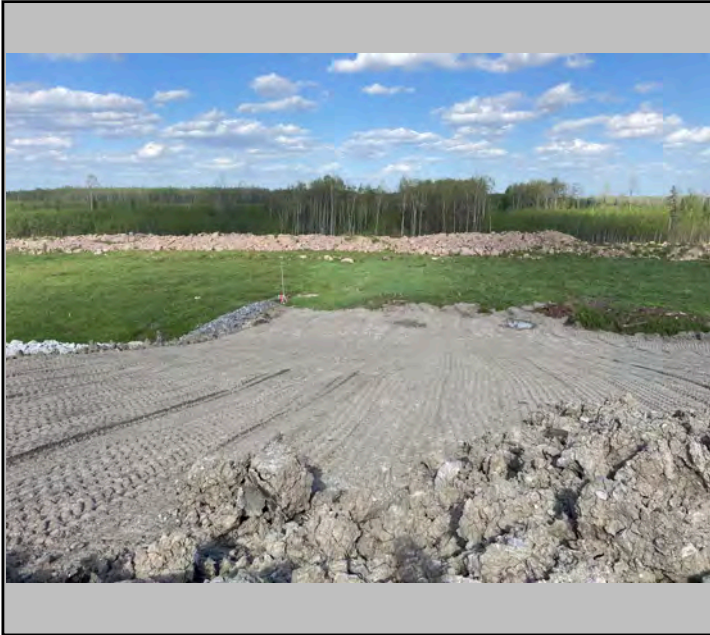
Photo #: 1

- All previous moisture from heavy rainfalls had dried with the exception of two visibly moist areas at the toe.
- Desiccation reaching approximately 2-4cm throughout L2.

P30 L2 dried by end of day

- No cover system construction completed.
- Met with Mitchell Hearn of New Gold to discuss current conditions and plans for resuming cover construction. New Gold advised that cover construction likely would not resume until Monday, June 6th.
- Okane brought up concerns that rework would be required to the portion of P30 L2, as it has been uncovered since May 27th. Okane advised New Gold that the desiccated top layer of L2 will need to be skimmed, replacement material added, and re-compacted.

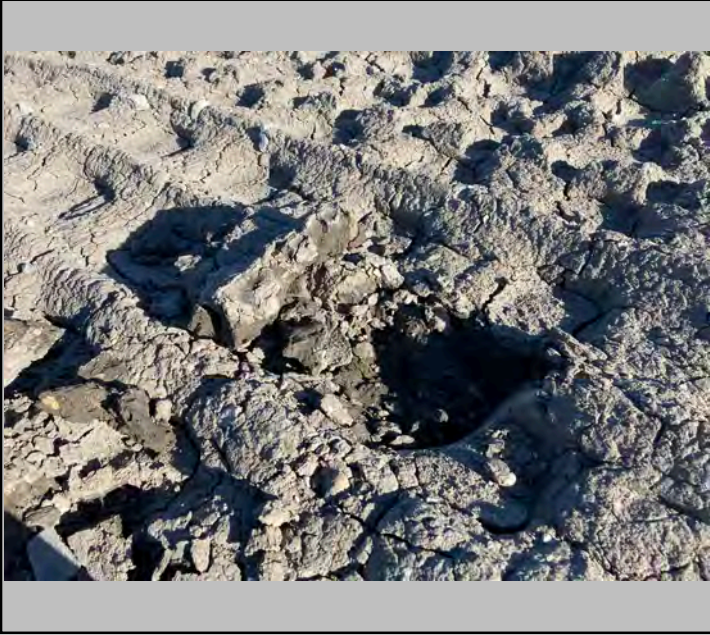
Photo #: 1

P30 L2 desiccation continues

Issue #	Description	Location	Resolution	Monitor	Status
1	South side of P30, L2 reaching concerning levels of surface desiccation prior to coverage	South half of P30, L2 toe	South half P30, L2 covered with as much dark brown, moist, and pliable NCL material as possible prior to end of day by dozer	Yes	Open
				Choose:	Choose:
				Choose:	Choose:
				Choose:	Choose:
				Choose:	Choose:

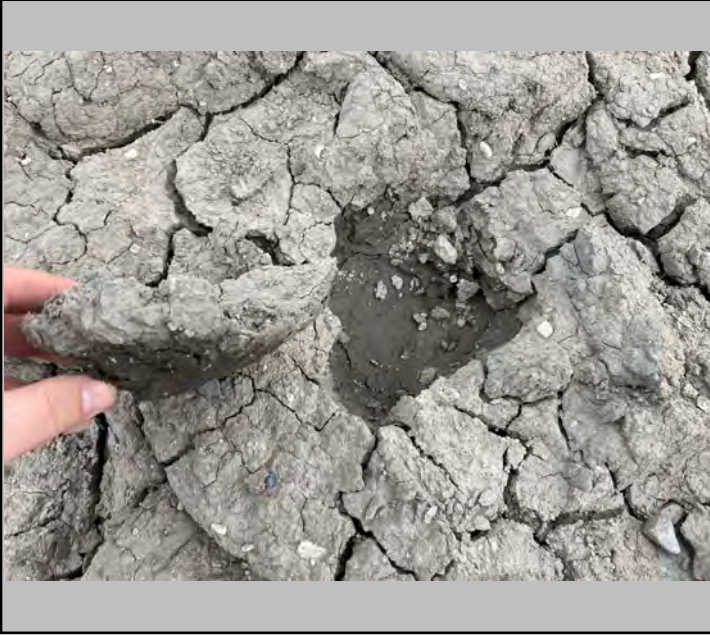
Photo #: 1

P30 L2 desiccation continues

Issue #	Description	Location	Resolution	Monitor	Status
1	South side of P30, L2 reaching concerning levels of surface desiccation prior to coverage	South half of P30, L2 toe	South half P30, L2 covered with as much dark brown, moist, and pliable NCL material as possible prior to end of day by dozer	Yes	Open
				Choose:	Choose:
				Choose:	Choose:
				Choose:	Choose:
				Choose:	Choose:

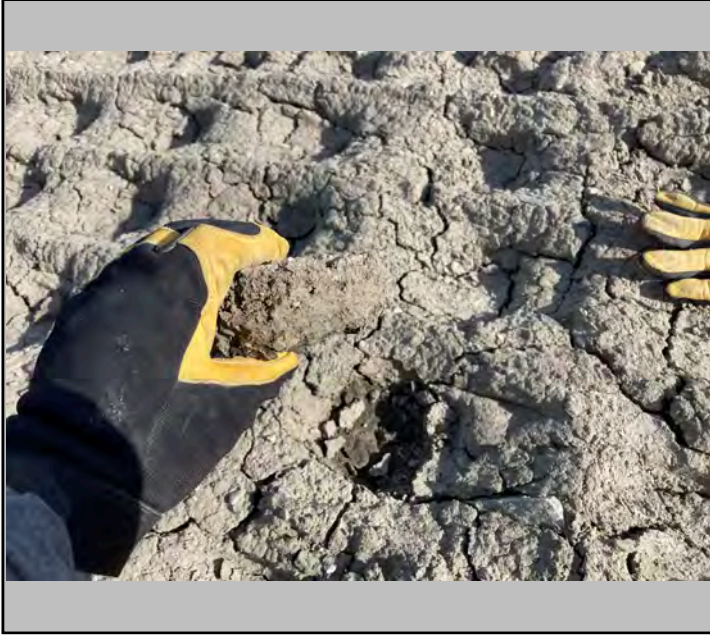
Photo #: 1

P30 L2 desiccation continues

Issue #	Description	Location	Resolution	Monitor	Status
1	South side of P30, L2 reaching concerning levels of surface desiccation prior to coverage	South half of P30, L2 toe	South half P30, L2 covered with as much dark brown, moist, and pliable NCL material as possible prior to end of day by dozer	Yes	Open
				Choose:	Choose:
				Choose:	Choose:
				Choose:	Choose:
				Choose:	Choose:

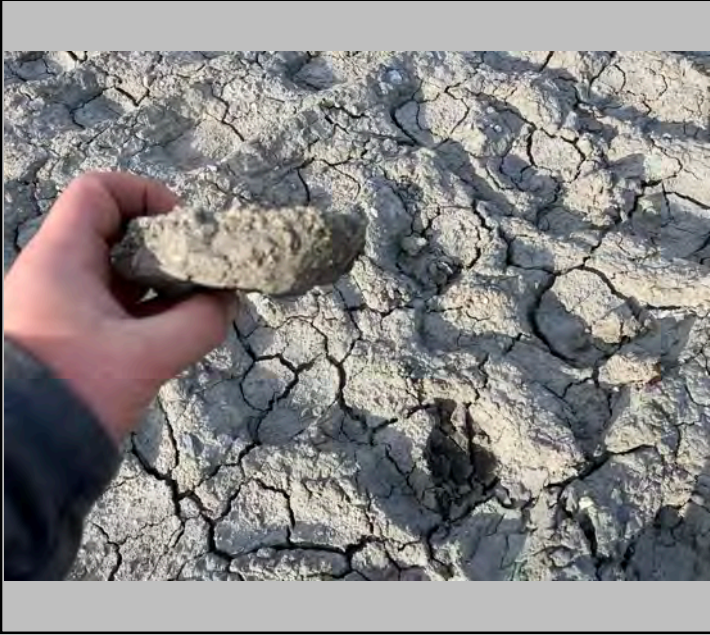
Photo #: 1

P30 L2 desiccation continues

Issue #	Description	Location	Resolution	Monitor	Status
1	South side of P30, L2 reaching concerning levels of surface desiccation prior to coverage	South half of P30, L2 toe	South half P30, L2 covered with as much dark brown, moist, and pliable NCL material as possible prior to end of day by dozer	Yes	Open
				Choose:	Choose:
				Choose:	Choose:
				Choose:	Choose:
				Choose:	Choose:

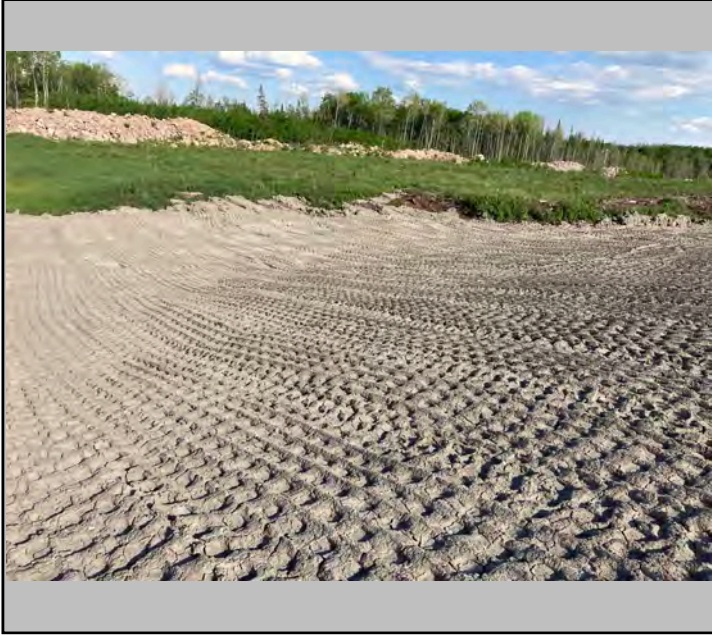
Photo #: 1

P30, L2:
- Desiccation advancing throughout L2.
- Morning showers did not affect L2 as material was dried by end of day.
- Significant cracking throughout L2 due to dryness and time.

P30 L2

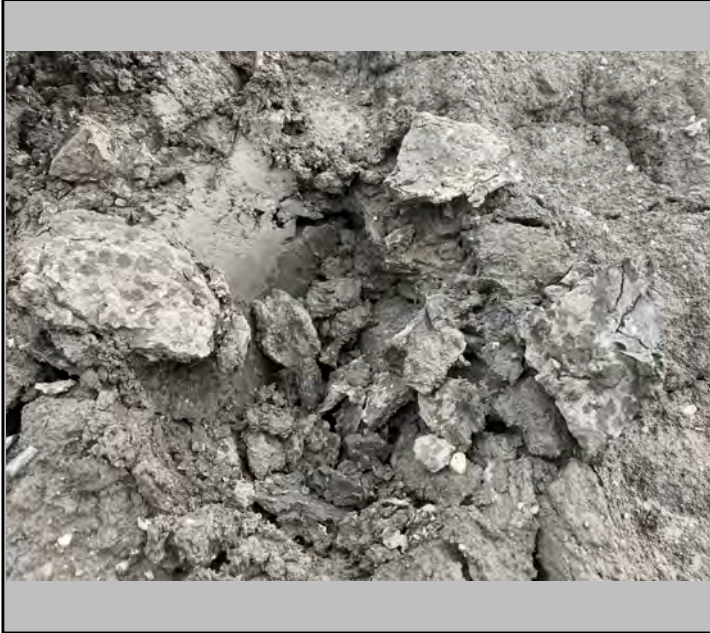
Photo #: 1

P30, L2:
- Heavy afternoon rainfall moistened top crust of L2.
- Some dry material still present underneath moist top layer.
- Cracking of L2 still present after rainfall due to extreme drying.

Dry material still present under rain moistened
P30 L2 crust

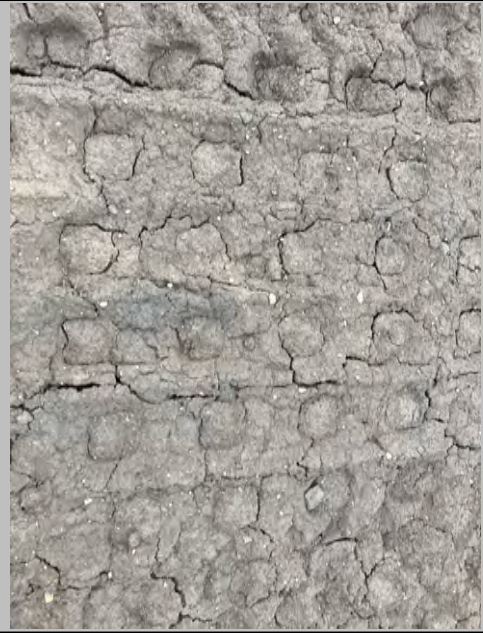
Photo #: 2

P30 L2 cracking still present

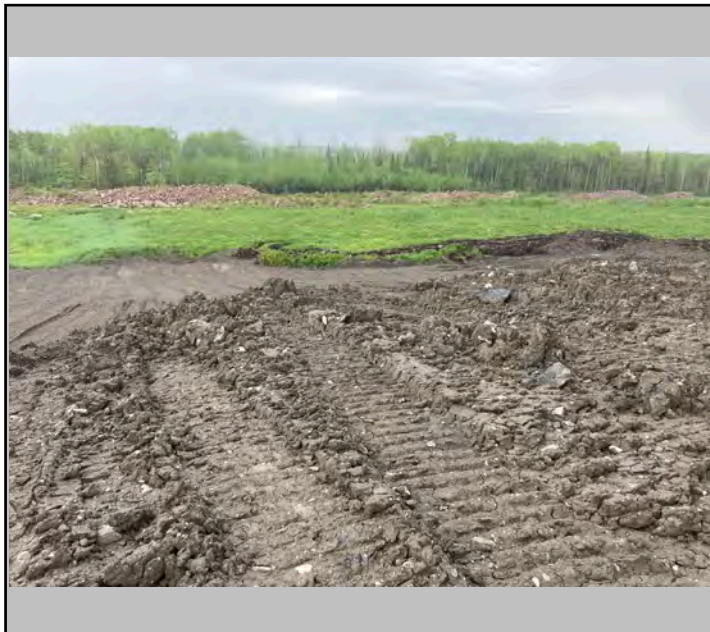
Photo #: 3

P30, L3:
- Material moistening from rainfall.
- Pockets of standing water present

P30 L3 material moistening

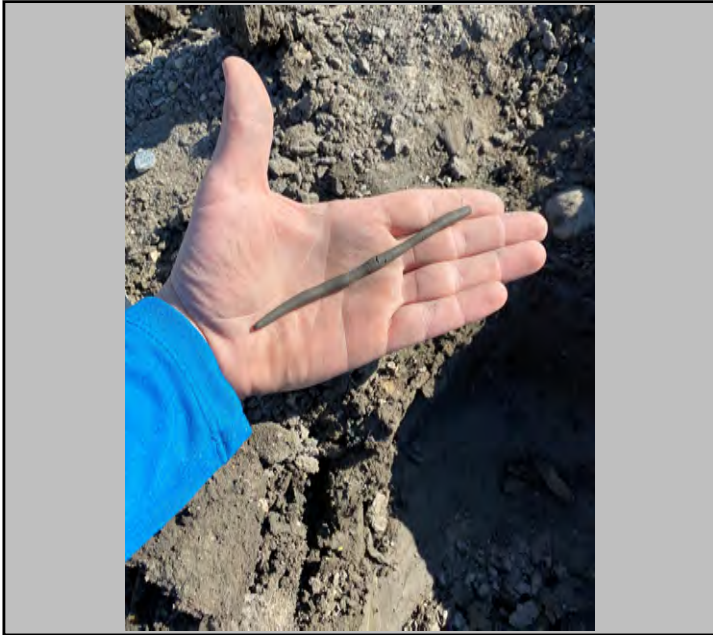
Photo #: 1

- Three spot checks completed on the exposed areas of L2. Brownish grey, moist, pliable material was reached at a depth of approximately 150mm in all three locations.

P30, L2 spot check #1 material

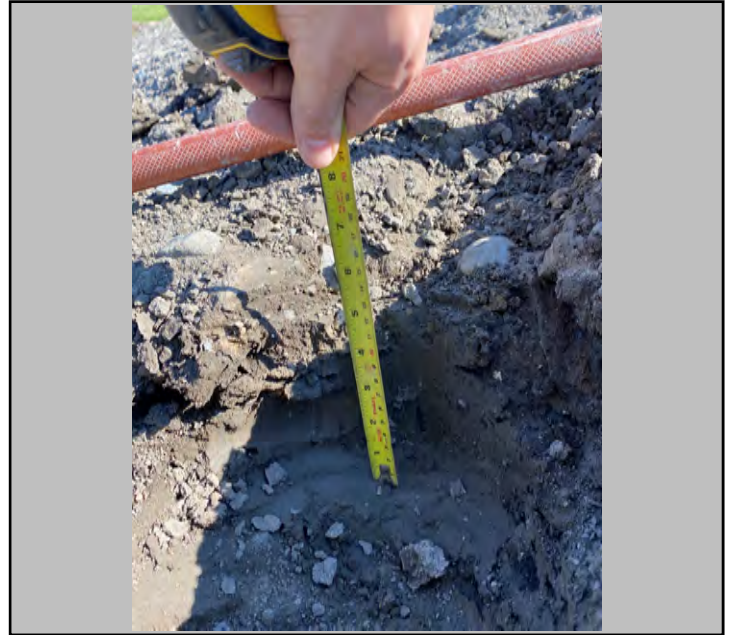
Photo #: 2

P30, L2 spot check #1 depth

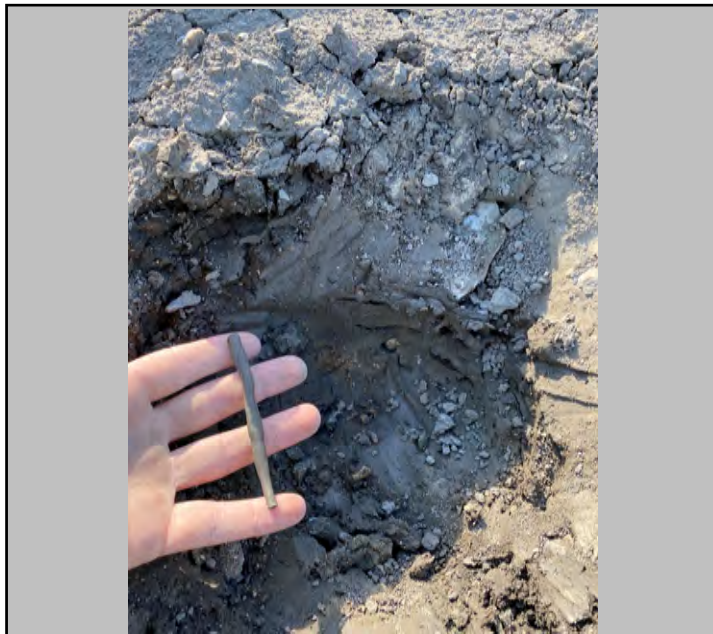
Photo #: 3

P30, L2 spot check #2

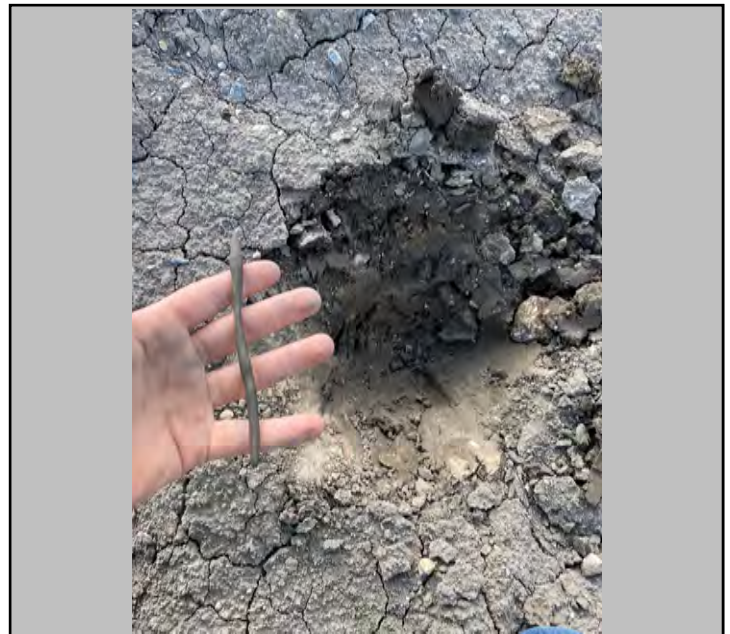
Photo #: 4

P30, L2 spot check #3

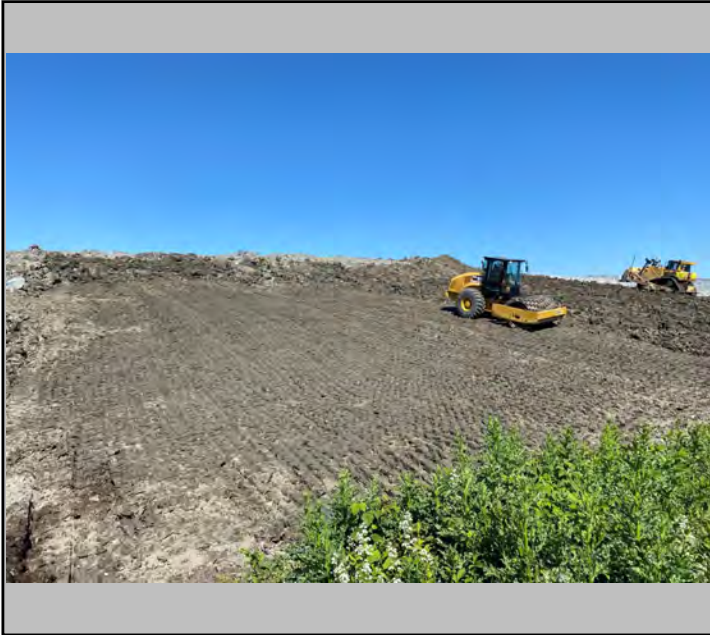
Photo #: 1

P30, L2 compaction following rework

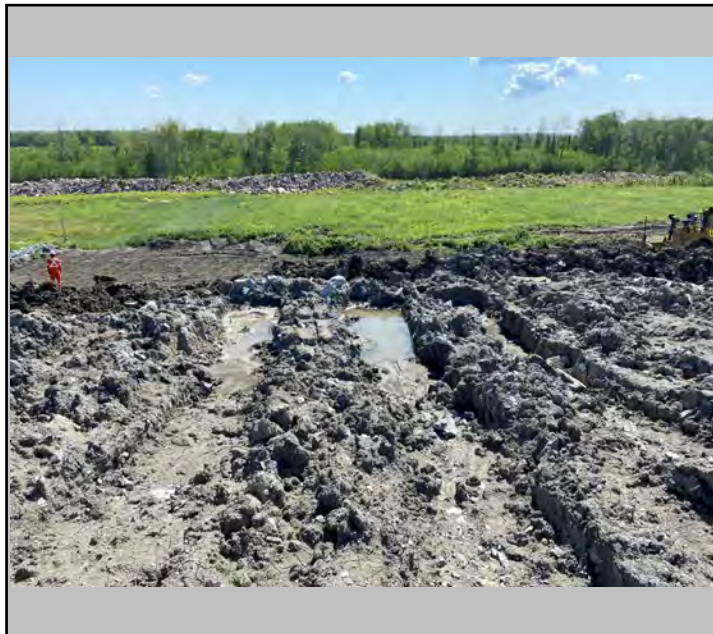
Photo #: 7

Pockets of water on P30, L3 prior to mixing material

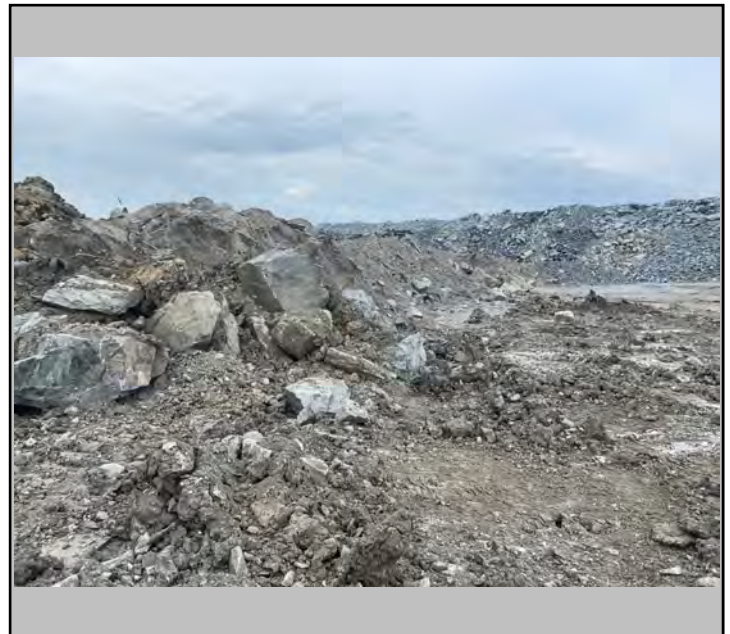
Photo #: 4

Area within southern borrow area with large volume of stone
