**NEW GOLD RAINY RIVER MINE
APPENDIX B
EMRS RECORD OF CONSTRUCTION**

2022 EMRS Progressive Reclamation Record of Construction

1003-223-001

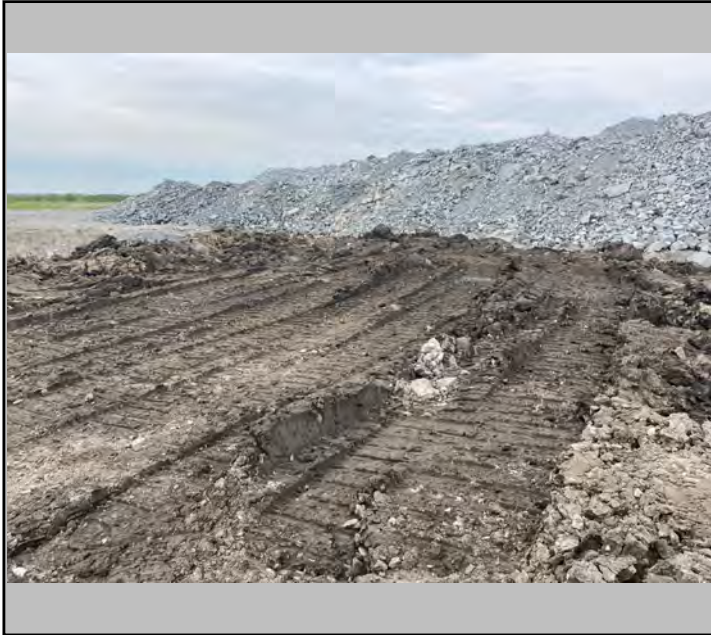
Photo #: 5

Area within southern stockpile with reduced rock content

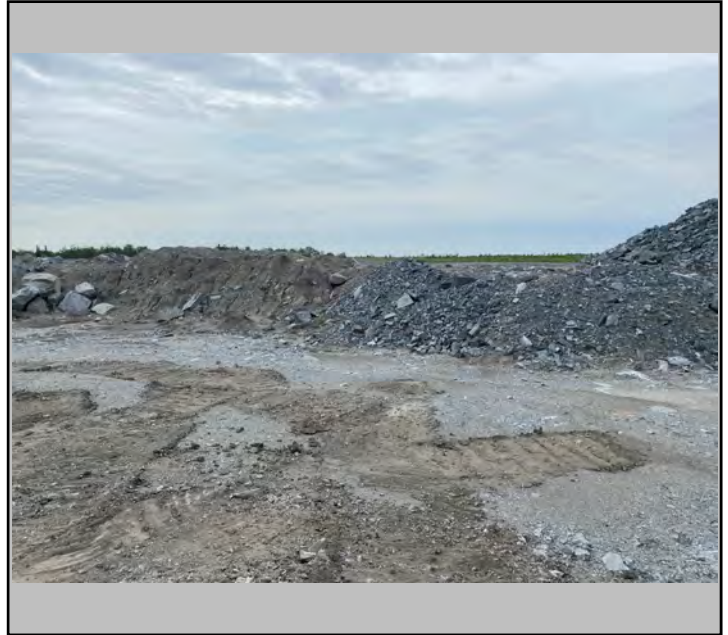
Photo #: 6

Area within southern borrow area with large volume of stone

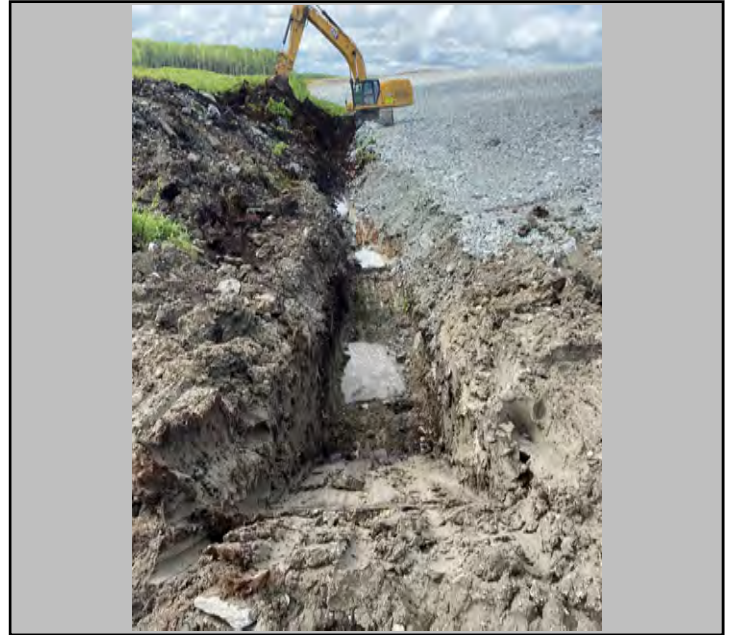
Photo #: 2

P31 key trench dug to varying depths with bedrock reached throughout

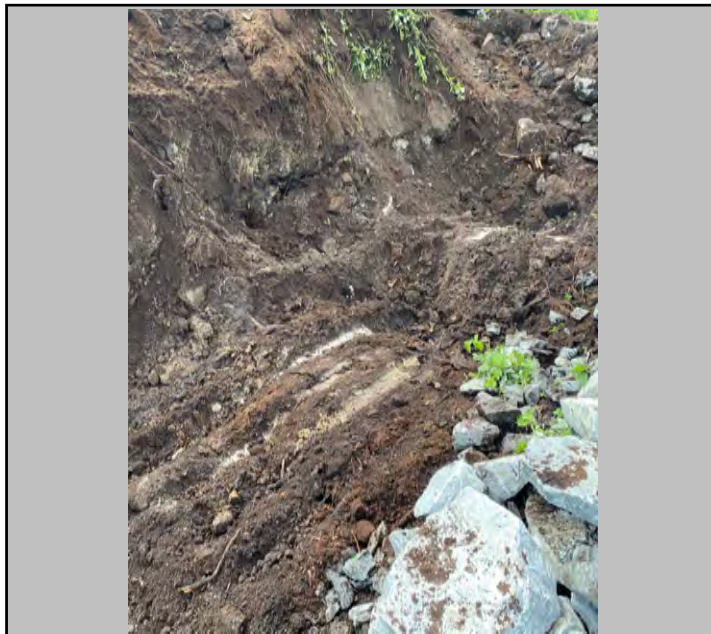
Photo #: 3

Shallow excavation at south end of key trench completed to bedrock

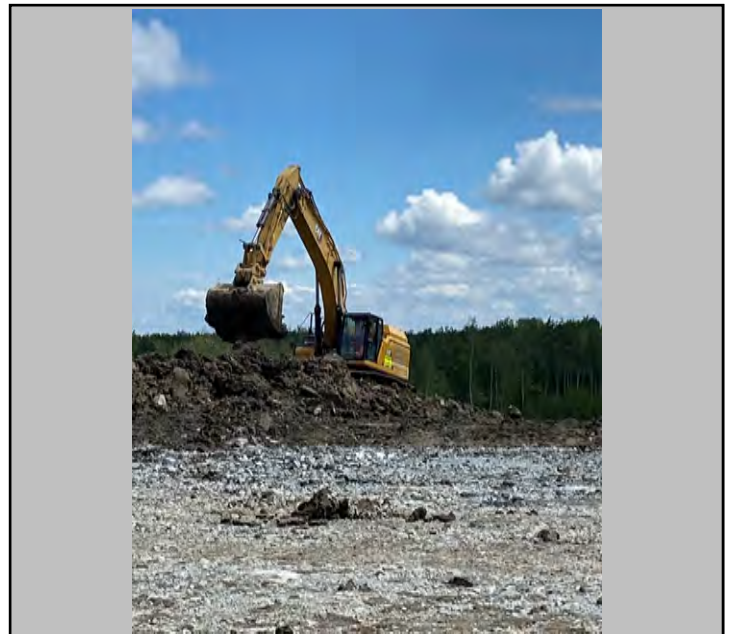
Photo #: 4

Excavator pulling back the bench/crown of P30 to ensure adequate overlap with P31, L1

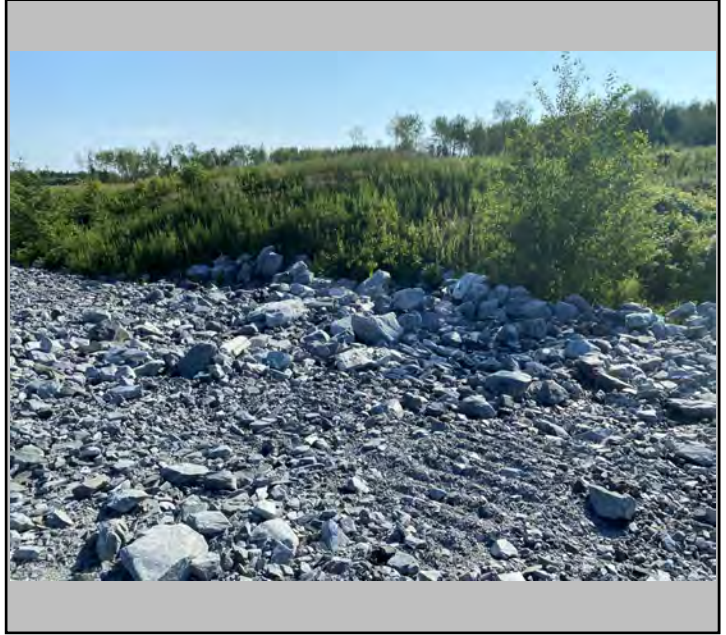
Photo #: 2

Waste rock piled at toe of slope

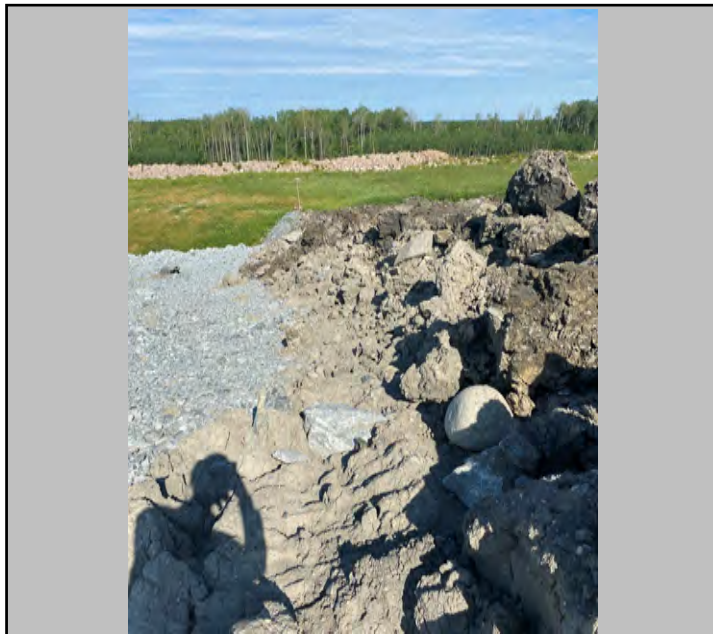
Photo #: 3

- Met with CQC to discuss P30, L4 following completion to grade. CQA noted areas of raised material at the toe to be flattened and excess coverage required on the north end of P30 to protect CCL material while construction progresses south.
- Elevation of topsoil berm greater than that of L4 in areas resulting in potential difficulty achieving drainage off the cover system. Once the raised material at P30 toe is flattened, P30 is to be monitored to evaluate runoff.

North end of P30 prior to coverage

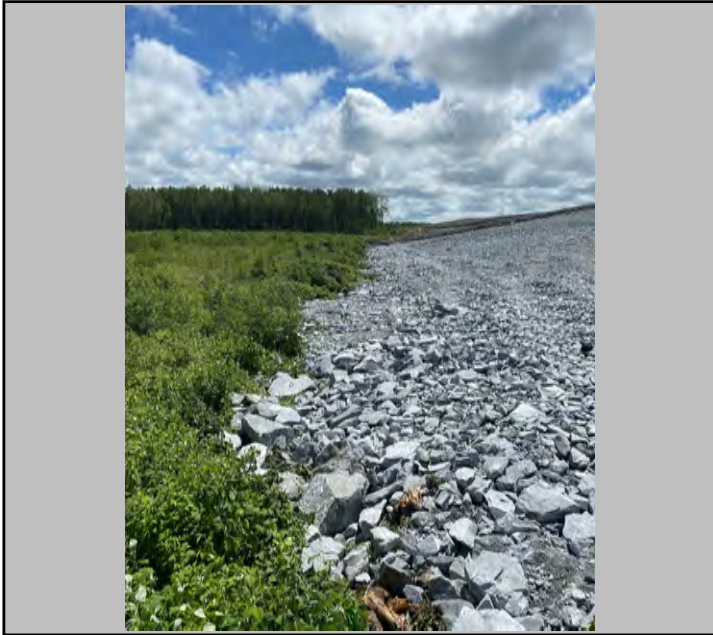
- Surveyed the waste rock surface as a check and as a record of construction to allow for the determination of proper cover system layer thicknesses in all areas;

- Inspected and approved that the waste rock surface met technical specifications for cover system placement;
- Carried out material control tests on materials in excavations and stockpiles prior to compaction to determine the adequacy of the materials for use in the cover system construction as per the Technical Specifications;

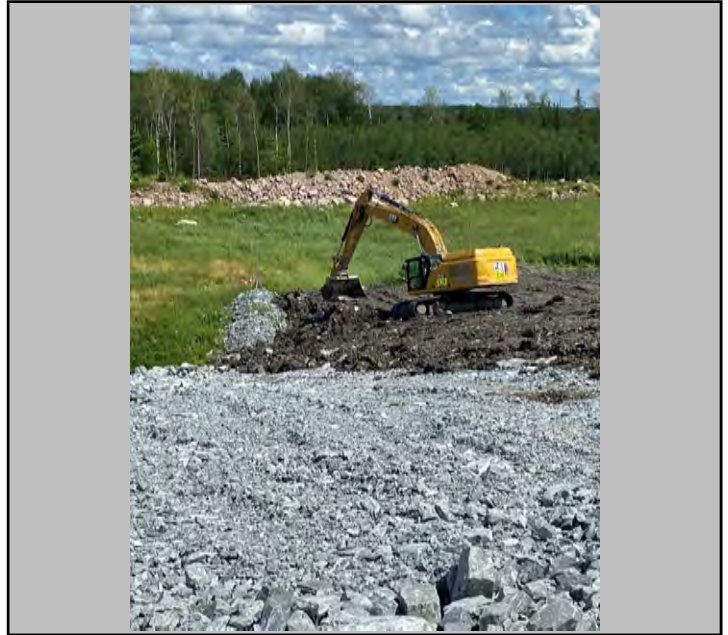
- Verified that appropriate construction techniques were used in cover system construction, as outlined in the Technical Specifications (compaction energies applied to CCL, equipment used, surface preparation, CCL exposure times, loosening of NCL, etc.);

- Verified lift thicknesses were within tolerances outlined in the Technical Specifications;

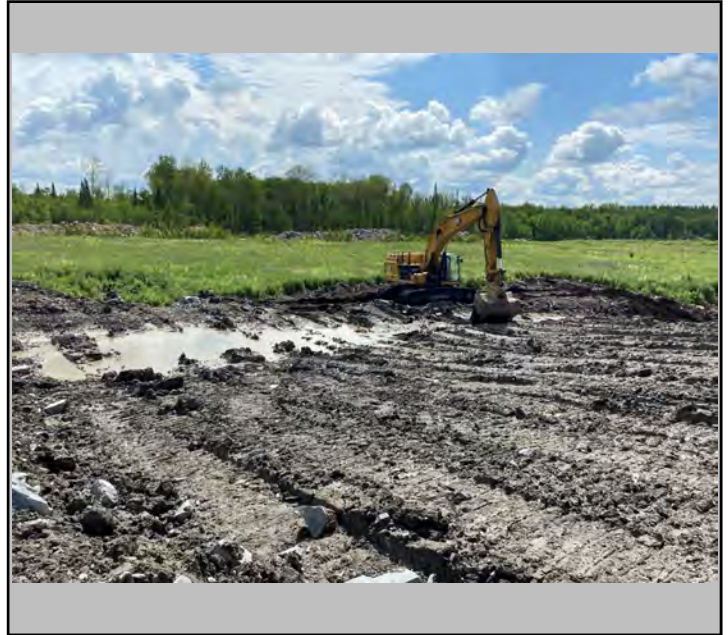
A combination of visual analysis by CQA/CQC and stockpile samples were completed pre-emptively at each borrow source to help determine the suitability of the stockpiled material prior to use in panel construction. Where material was deemed unsuitable for use in CCL construction, it was left for use in subsequent NCL lifts.

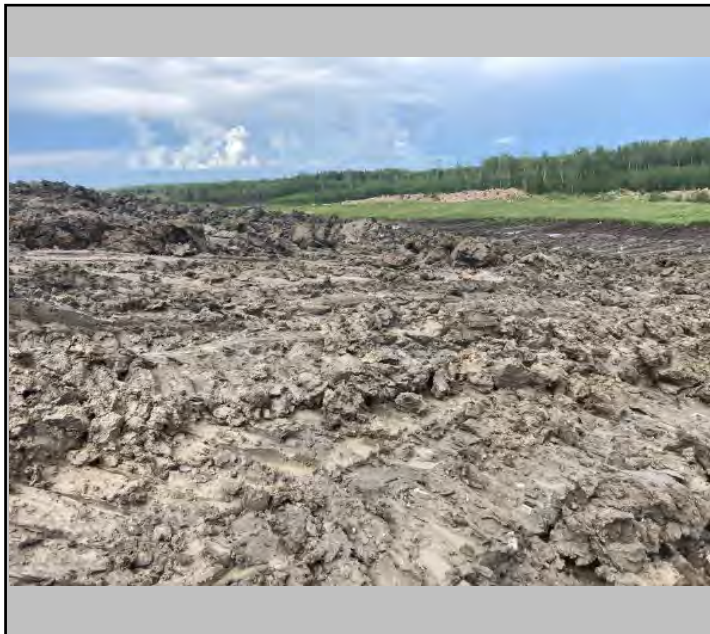
Photo #: 3

P33, L1 material following rainfall

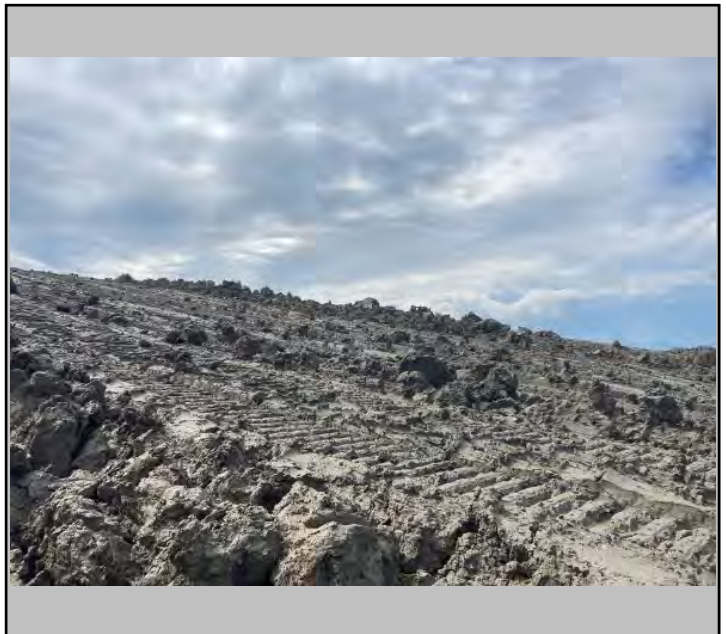
Photo #: 4

P32, L3 material following rainfall

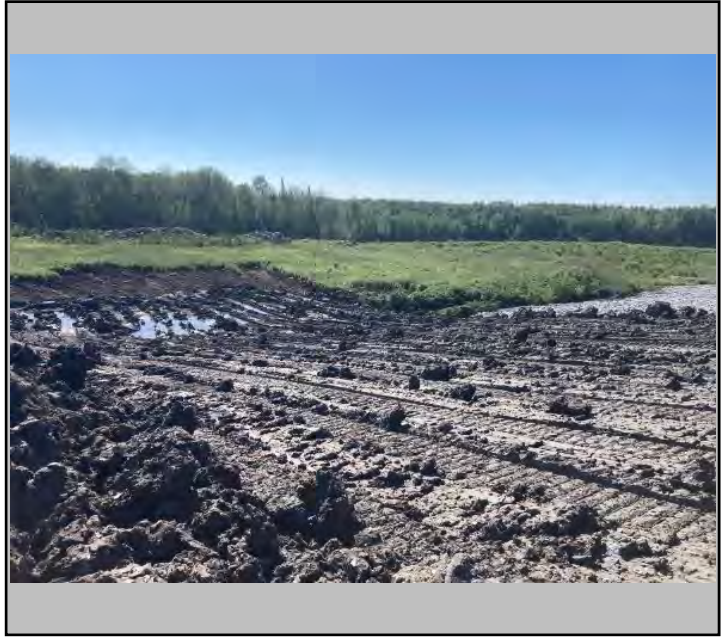
Photo #: 2

Standing water at toe of P32, L3

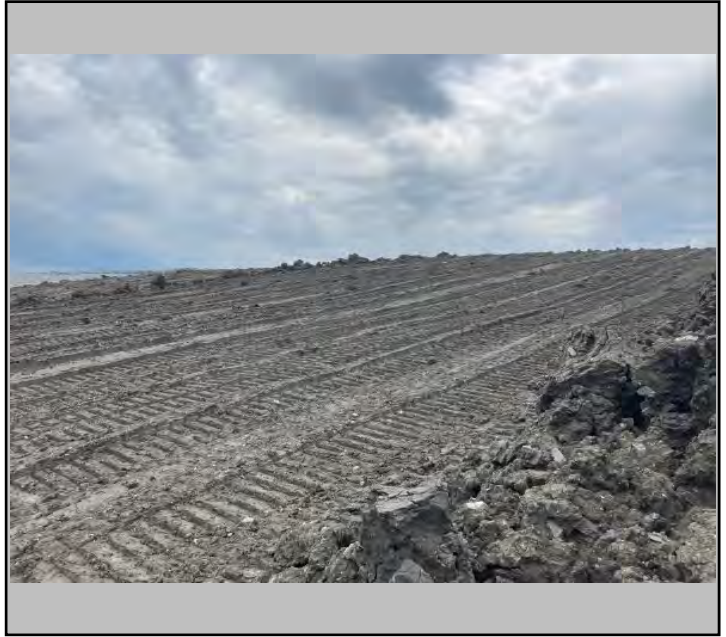
Photo #: 2

P32, L3 material very wet

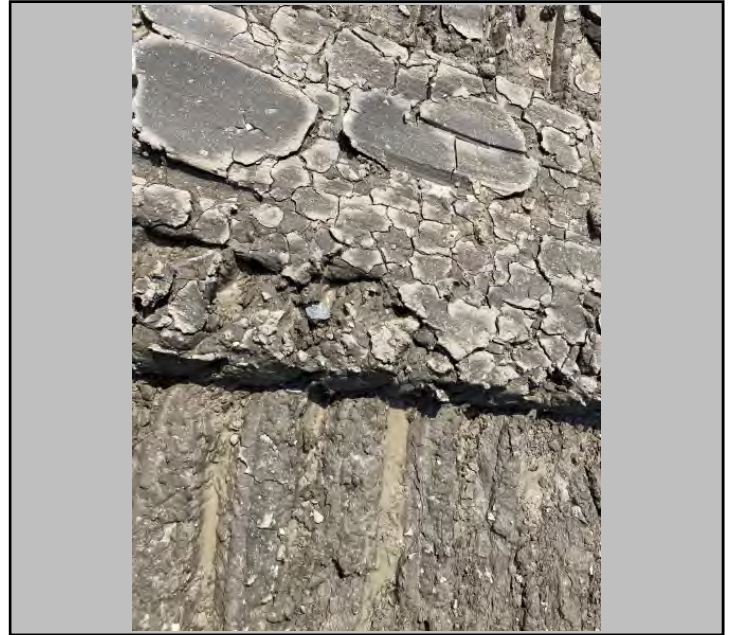
Photo #: 3

Draining water from toe of P33, L1

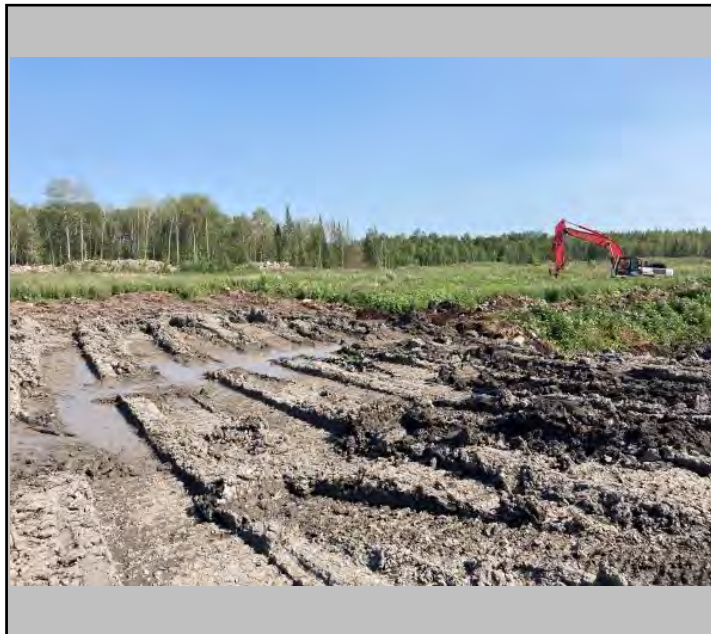
Photo #: 4

New test pit dug beside
EMRS22_BP_P30_L2_B28_220714

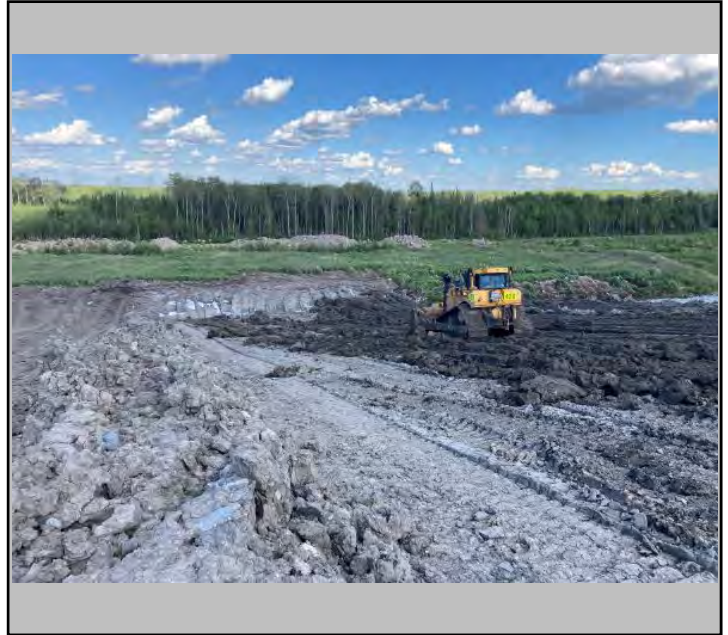
Photo #: 3

Material used in P33, L1. Dark grey with streaks of lighter brown material present

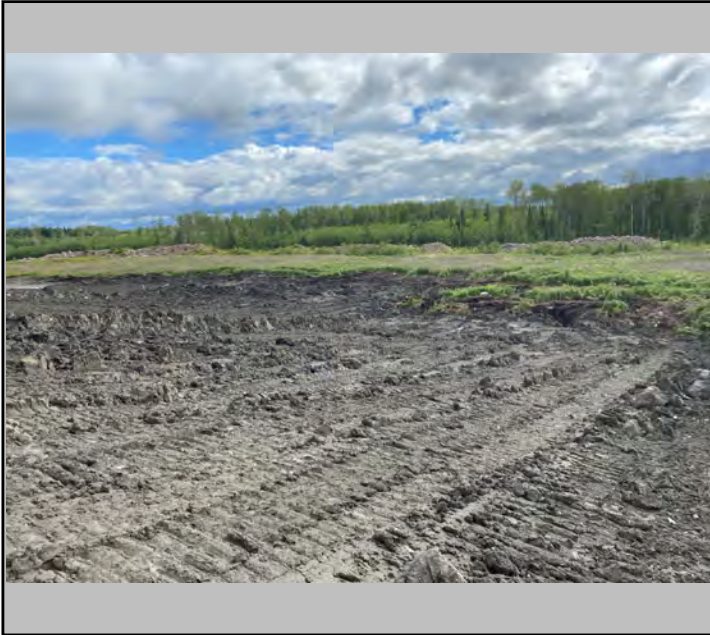
Photo #: 2

P32, L3/L4 morning conditions

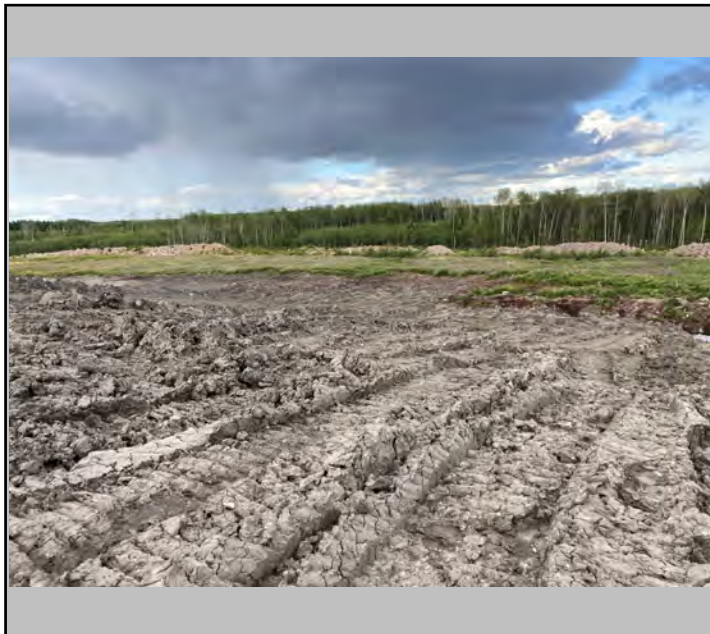
Photo #: 4

P32, L3/L4 end of day conditions

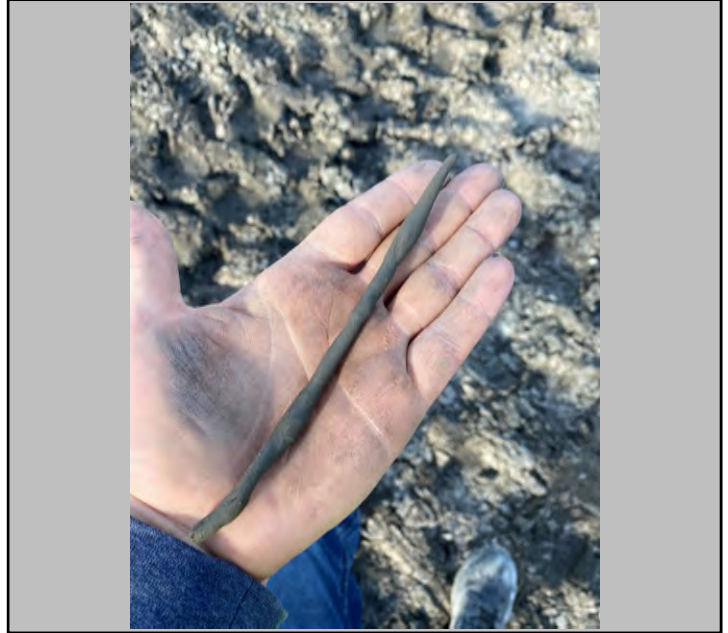
Photo #: 5

- Varied results obtained during testing of the bench. D520 yielded a moisture content of 32%, but following in-situ inspection the material appeared moist and pliable. Lab moisture content results to be used for corrected results. Results became more consistent as testing progressed on the slope producing satisfactory results.

D520 material

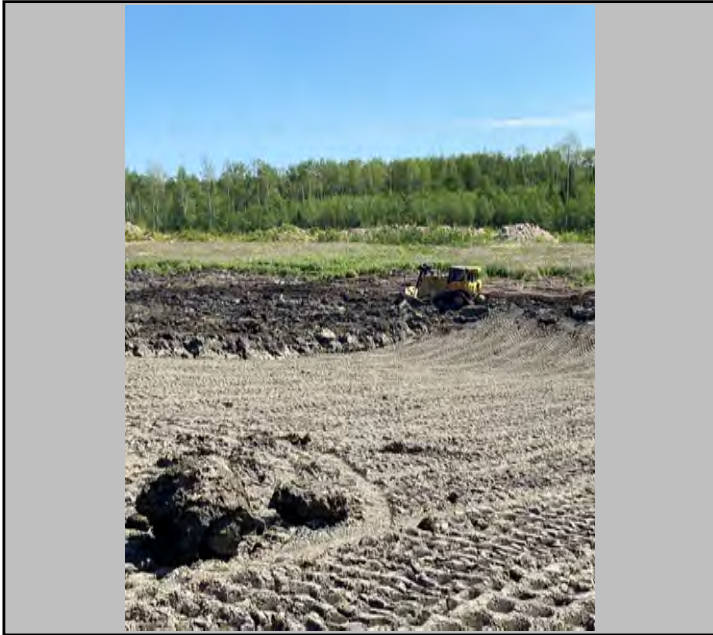
Photo #: 1

Dozer utilized to cut back topsoil berm east of key trench

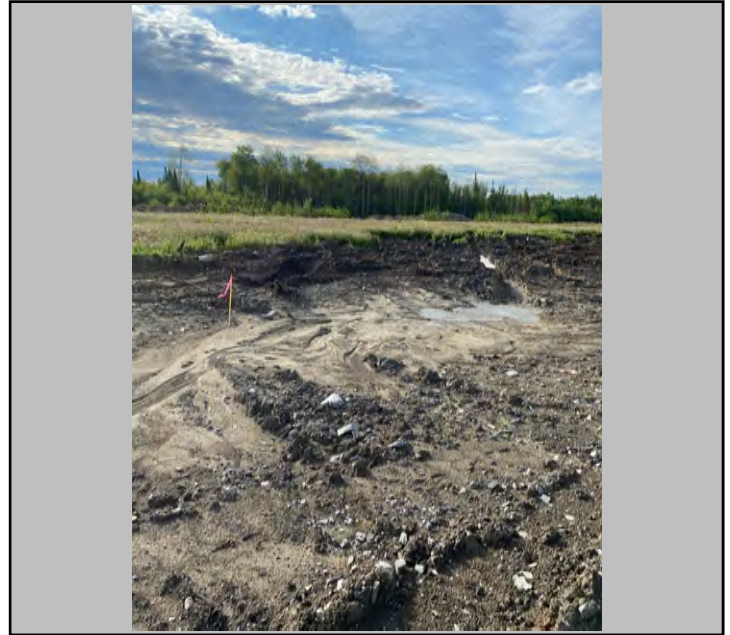
Photo #: 6

Area of P30 toe where pooling occurs. Ditch made by excavator in order to limit pooling.

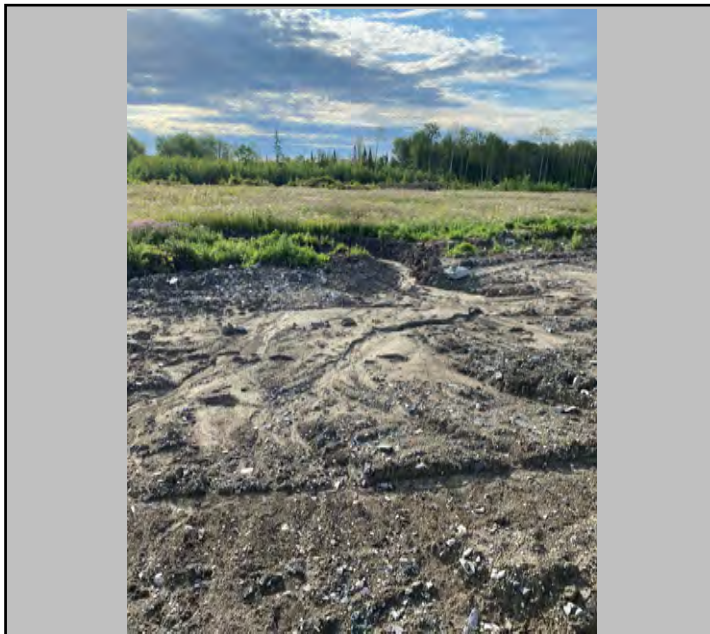
Photo #: 7

Second area of P30 toe where pooling occurs. Ditch made by excavator in order to limit pooling.

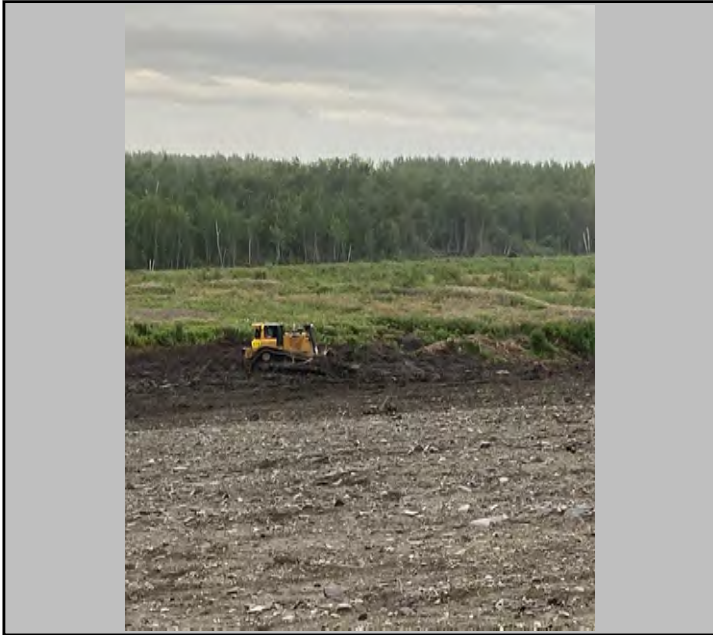
Photo #: 1

Dozer cutting back topsoil berm east of P33 key trench in anticipation of rain

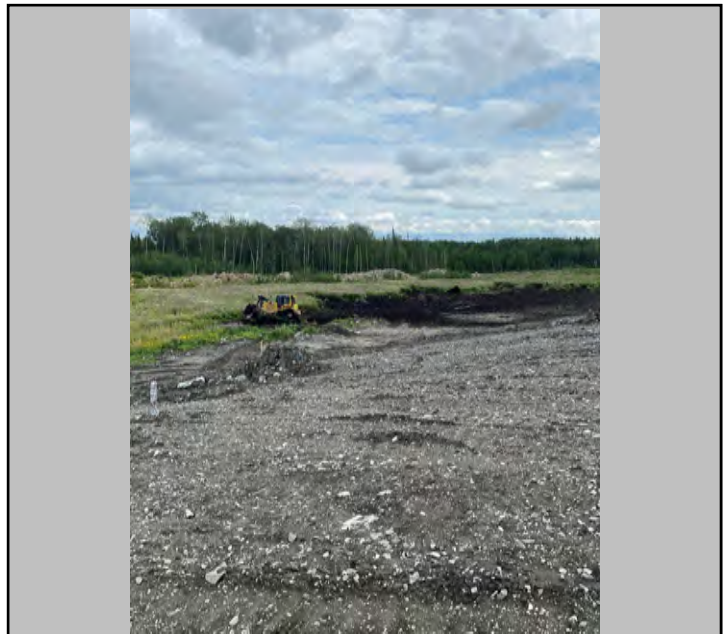
Photo #: 4

Dozer cutting back topsoil berm east of P30 to achieve drainage past key trench
